**Building Number:** 18

**Original Name:** Dining Hall

# Building Number: 18

**BUILDING #18: REQUIRED ARCHITECTURAL AND STRUCTURAL REPAIRS**

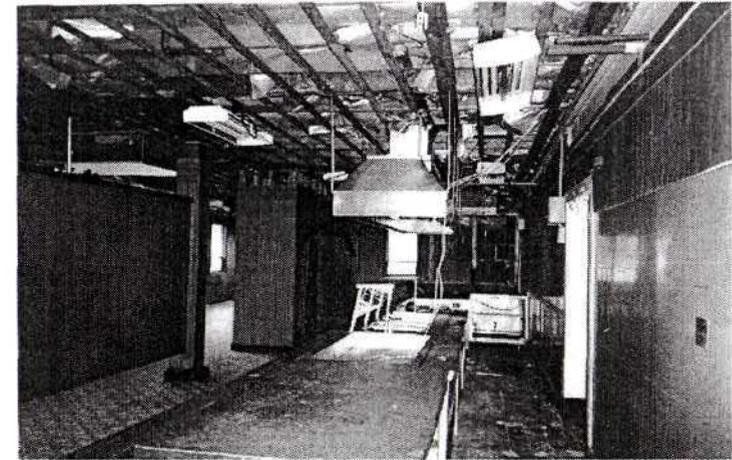
Interior; existing serving area.

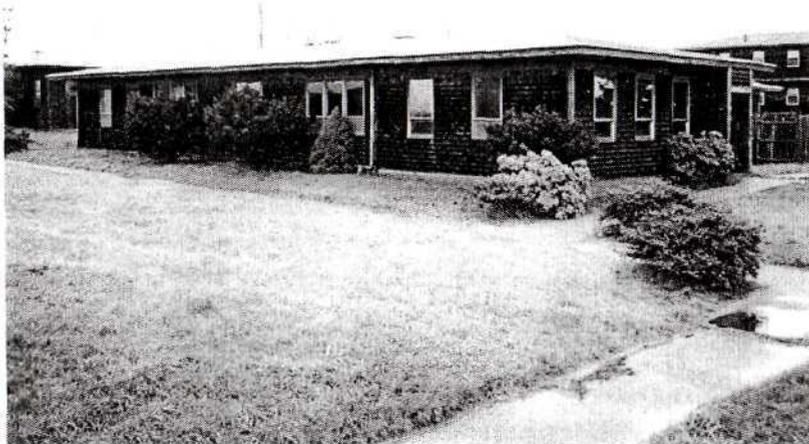
View from southwest.

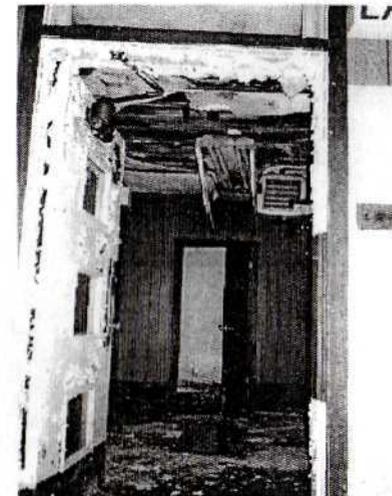
Interior; severely damaged vestibule.

Very low pitch hipped roof with clerestory "tower" and deep overhangs in **fair condition**. Roof leaks damaged interior finishes in north vestibule and above hood in kitchen. A roof pitch this shallow (10 degrees) clad with asphalt shingles is likely to fail over time. Recommend repair and replacement of entire roof, adding ice and water barrier throughout. Ventilators in **fair condition**.
