Building Number: 22
Original Name: Theater
Est. Year of Construction: 1951

Building Number: 22

IV MECHANICAL, ELECTRICAL, FIRE PROTECTION AND PLUMBING REPORTS – BUILDING NUMBER 22

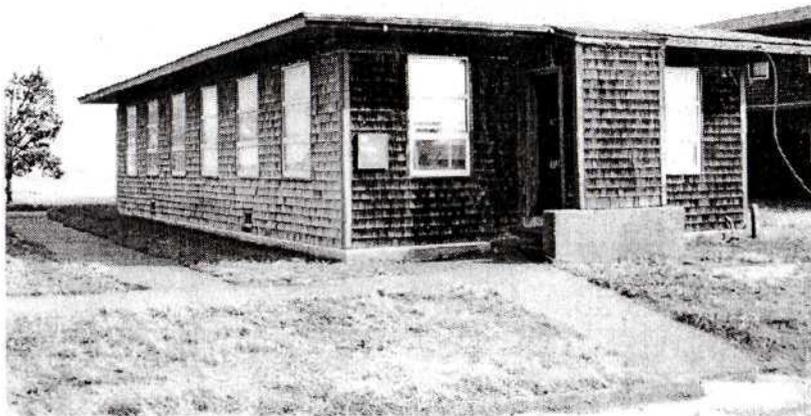
View from northwest.

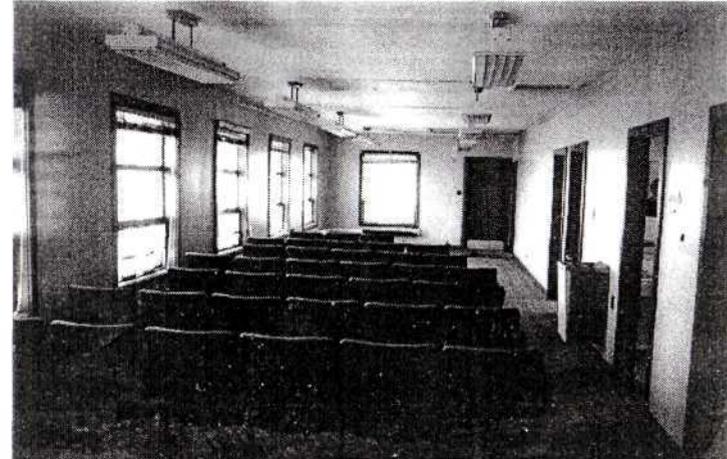
Interior of theater.

- *Ceiling*
Painted drywall finish in **fair/poor condition**. Large cracks in drywall and peeling paint from water damage. Large leak in main theater space. Repair and refinishing advised.
- *Wall*
Painted drywall finish in **fair condition**. Refinish recommended.
- *Trim*
Wood baseboard, window and door trim is in **fair condition**. Paint is peeling and cracking. Refinishing recommended.
- *Floor*
Carpet on plywood subfloor throughout most. VAT in bathrooms. **All in fair condition**. Water damage to carpet. Replacement advised.

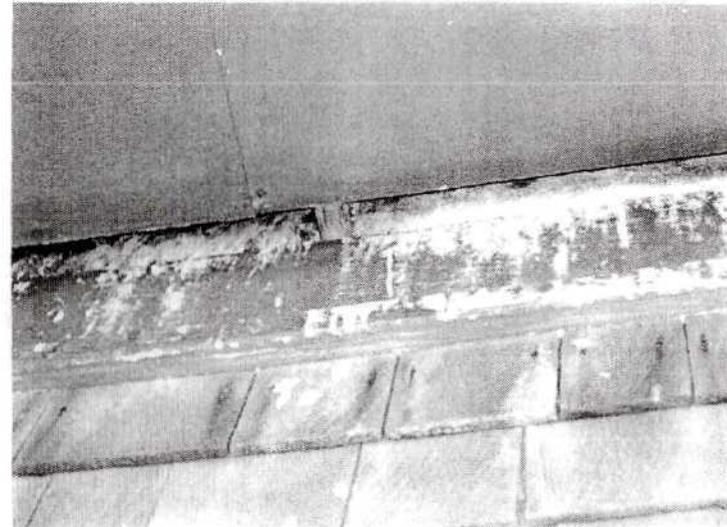
Detail of pest-related problems at soffit.

- *Roof*
Asphalt roll roof in **fair/poor condition**. Advise replacement of all 16 squares. Some deterioration of overhangs. Missing downspout at gutter over entrance.
- *Wall*
Exterior is sheathed in white cedar shingles that have been weathered. **Overall condition is fair/poor**; replace 800 SF. Bird infestation at eaves and wall (?) No vent screens.
- *Trim*
Wood trim is in **fair condition**. Replace rotted areas (+/- 110 LF) and sheathing below, especially at vestibules.
- *Foundation*
CMU walls and crawl space in **good condition**.

5. Remove and replace damaged soffits	30	lf
6. Remove and replace exterior doors, hardware	2	ea
7. Remove windows and replace with metal-clad wood windows	17	ea

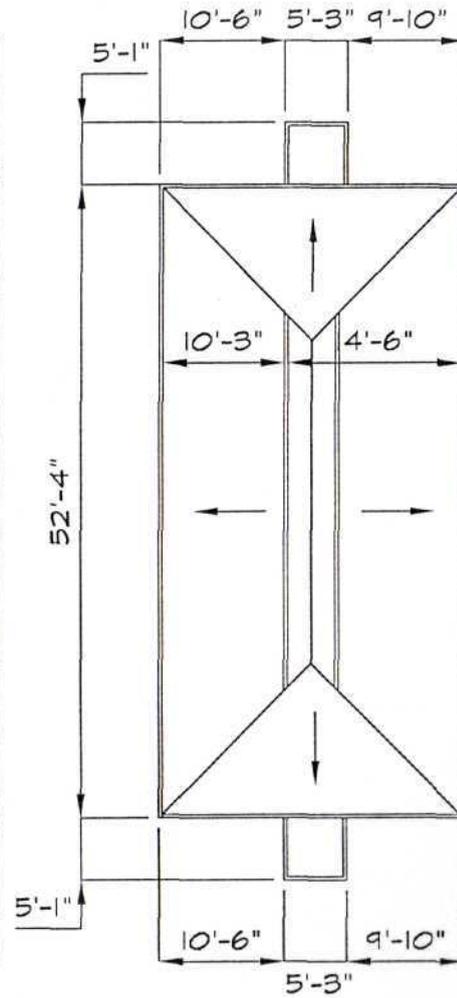
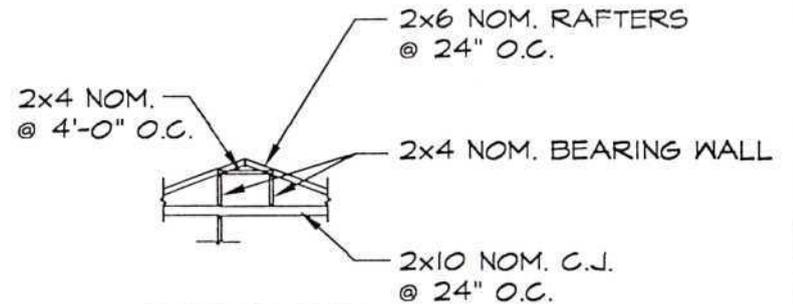
22 ROOF

ROOF
20° ROOF SLOPE
