Building Number: 31
Original Name: Electrical Power Building
Est. Year of Construction: 1957

IV MECHANICAL, ELECTRICAL, FIRE PROTECTION AND PLUMBING REPORTS – BUILDING NUMBER 31

Building 31 Power Plant, Truro Air Base, North Truro, Massachusetts

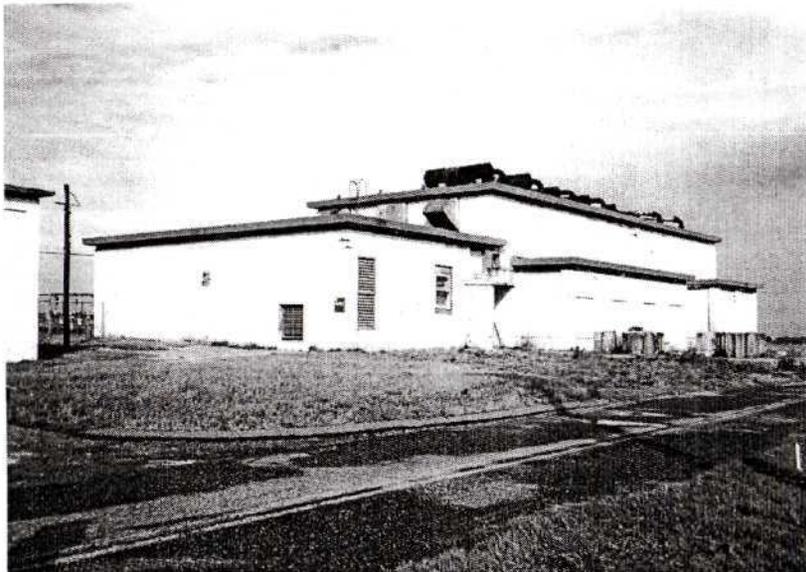
View from Southwest.

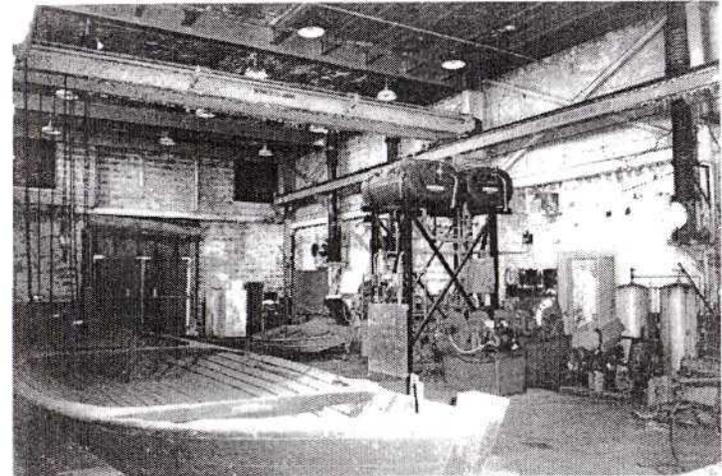
Interior - turbine room.

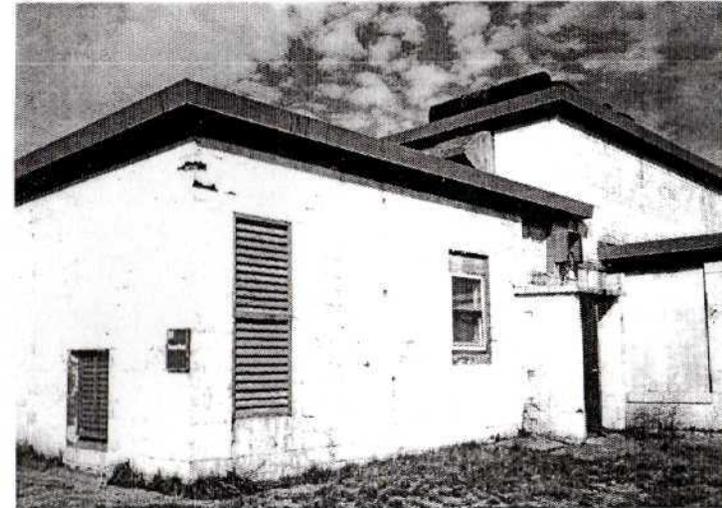
View of entrance area from southwest, showing cracks in CMU.

- *Roof*
Flat roof built-up with stone ballast; pipes, tanks and ventilators. **Fair condition.** Some localized leaks. Roof replacement recommended.
- *Wall*
Exterior is constructed of painted concrete masonry unit (CMU) in **poor condition.** Former vertical openings, metal hoods and louvered ventilators (some blocked up). Some failed and/ or spalled blocks; advise rebuilding of +/- 1,000 SF and repoint 100%. Recommend repair and repointing of CMU and waterproofing all walls.
- *Trim*
Metal cladding is in **fair condition** at fascia, but concrete parge and painted soffits are **poor.** Advise to repair all.
- *Foundation*
Poured concrete slab on grade.

1. Remove and replace damaged soffits	475	lf
2. Install alum. roof edge (cant, nailer, flashing)	475	lf
3. Repair/rebuild damaged CMU masonry, including needle bms.	1,000	sf

4. Scrub coat and paint/seal exterior CMU masonry	5,300	sf
5. Remove and replace exterior doors, hardware	4	ea
6. Remove windows and replace with metal-clad wood windows	4	ea

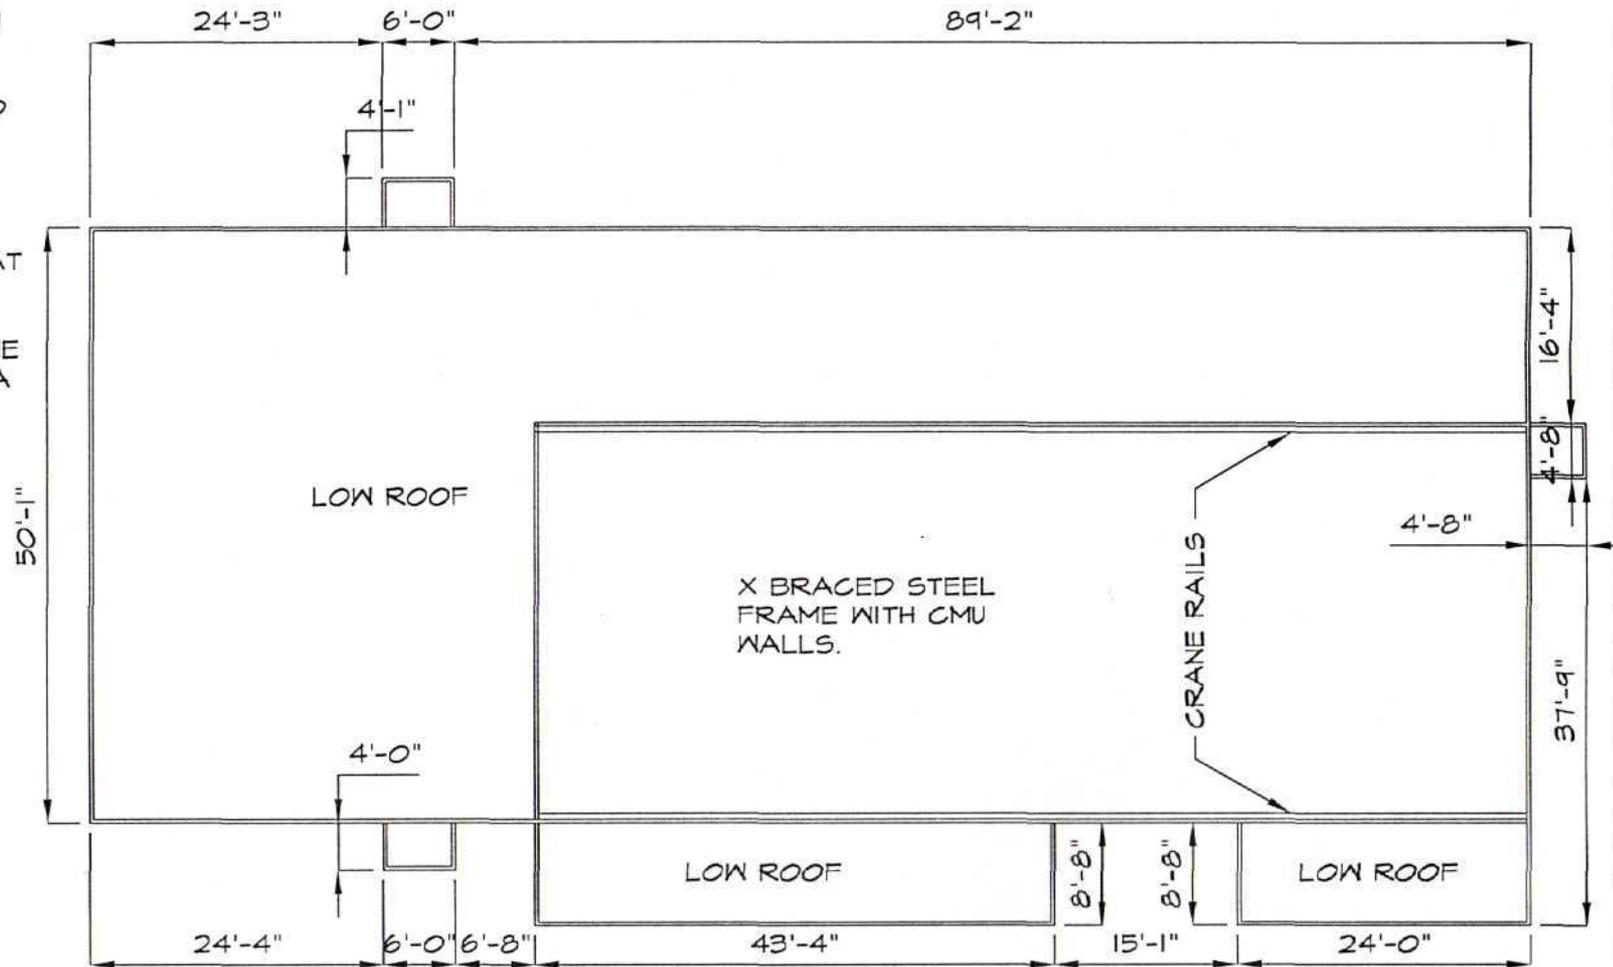
Building Number: 31

1. ALL WALLS ARE CMU
2. THE WALLS MUST BE WATERPROOFED AND THERE ARE SOME CRACKS THAT MUST BE REPOINTED.
3. ALL ROOFS ARE FLAT CONCRETE SLABS.
4. SOME COLUMNS IN THE STEEL FRAMED AREA ARE RUSTED.
