Building Number: 33

Original Name: Multi-Purpose / Recreation Building

Est. Year of Construction: 1951

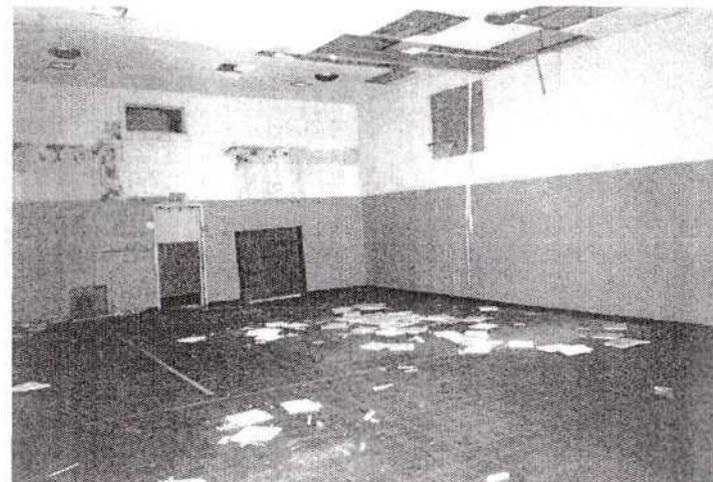
Interior of gymnasium.

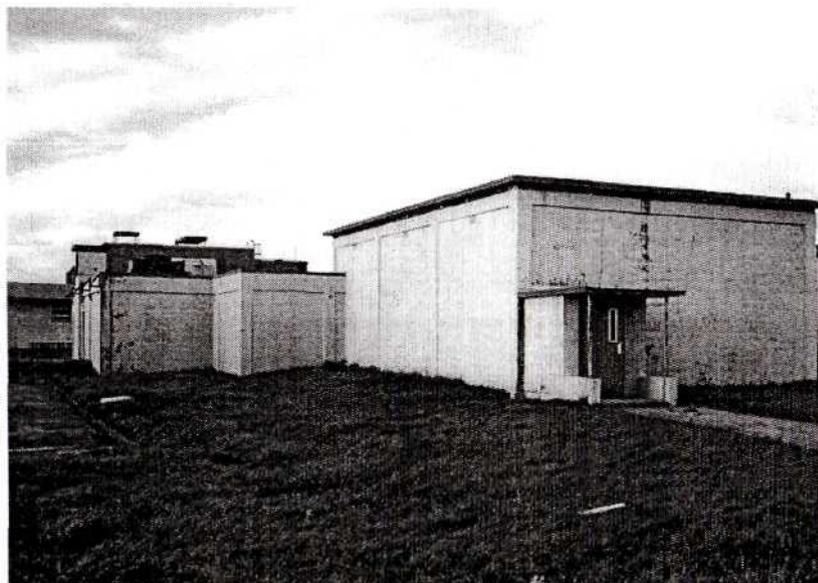
View from southwest.

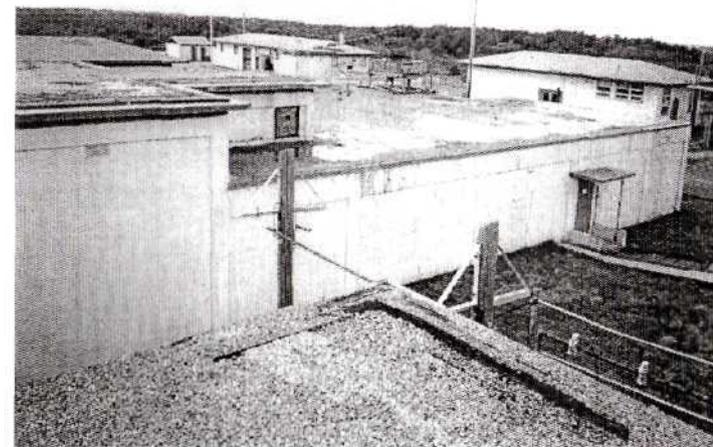
View from roof of Building # 31 (southeast).
