Building Number: 37

Original Name: Auto Maintenance Shop

Est. Year of Construction: 1951

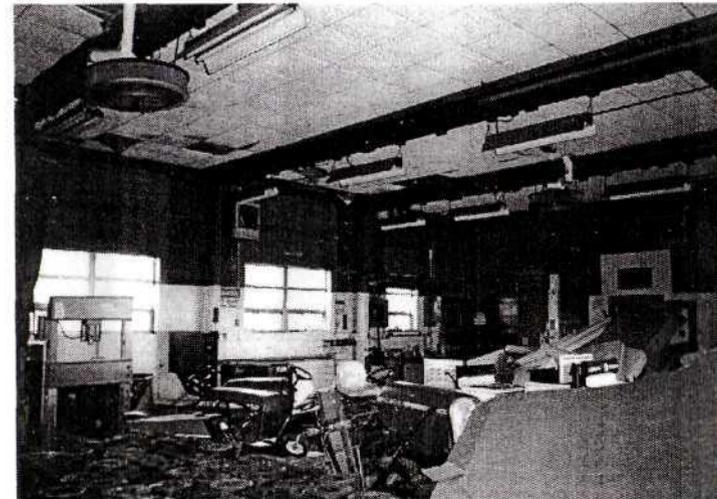
Interior of garage.

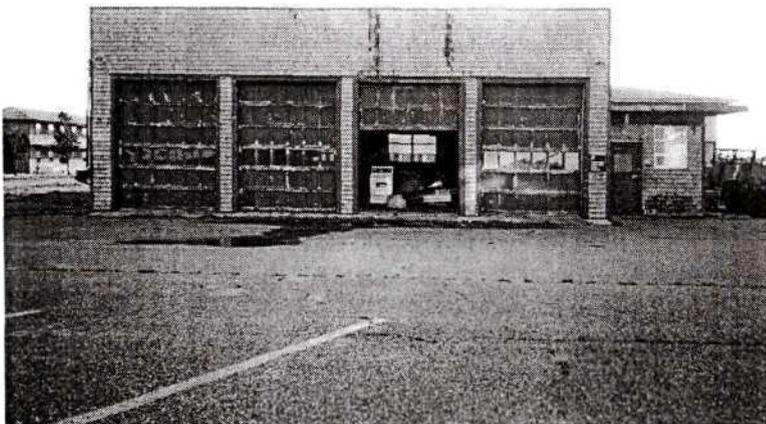
View from east.

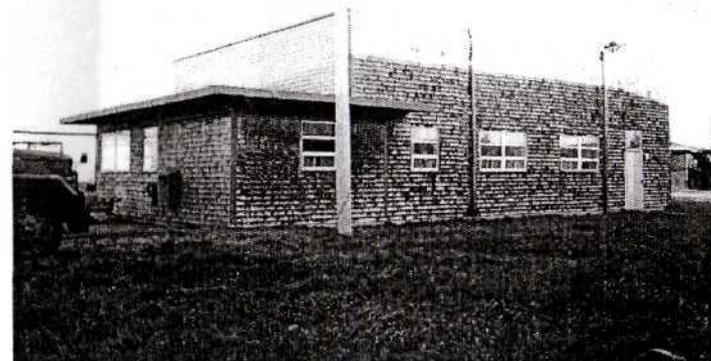
View from northwest.
