Building Number: 106
(Same as 102, 104 and 108)

Original Name: Family Housing

Site Access: Yes
 Demo Permitted?: Yes
 Project# 07394
 Location: Building #106

Project: Former Air Force Station
 Location: North Truro, MA

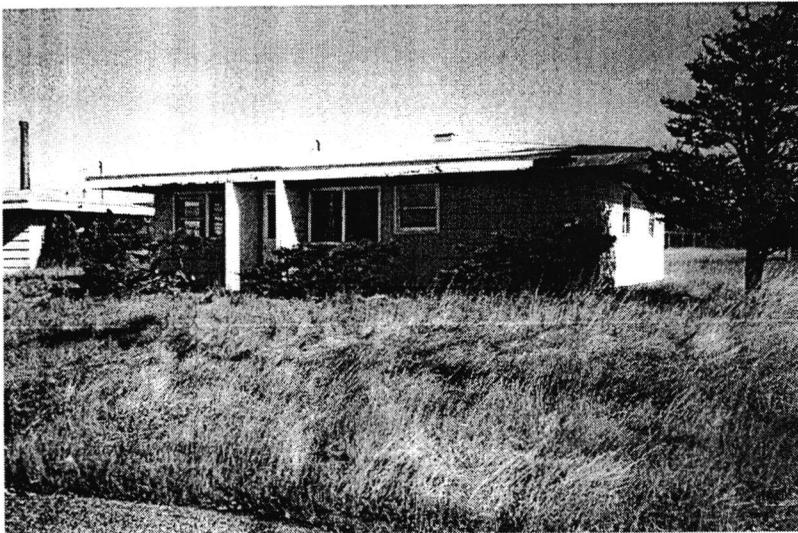
View from southwest.

- *Roof*
Low-pitch hip roof covered with roll asphalt in **fair condition**. Possible leaks at vents. Deep overhangs need repair; paint is peeling and cracking.
- *Wall*
Wood frame sheathed in cement asbestos shingles. 3 painted wood flush doors – one has vestibule. 2 are entrances to building; one to the “closet” that houses the elec. panel. 8 double-hung and one picture window – all wood with aluminum storm windows. All paint is cracked and peeling.
- *Trim*
Wood window and door trim and wood fascia in **poor condition**. Door trim is rotted on east wall. All trim needs to be repainted.
- *Foundation*
Poured concrete; rectangular plan. Concrete pads. 1 step up at all doors.
