VII. Appendix

Photographs

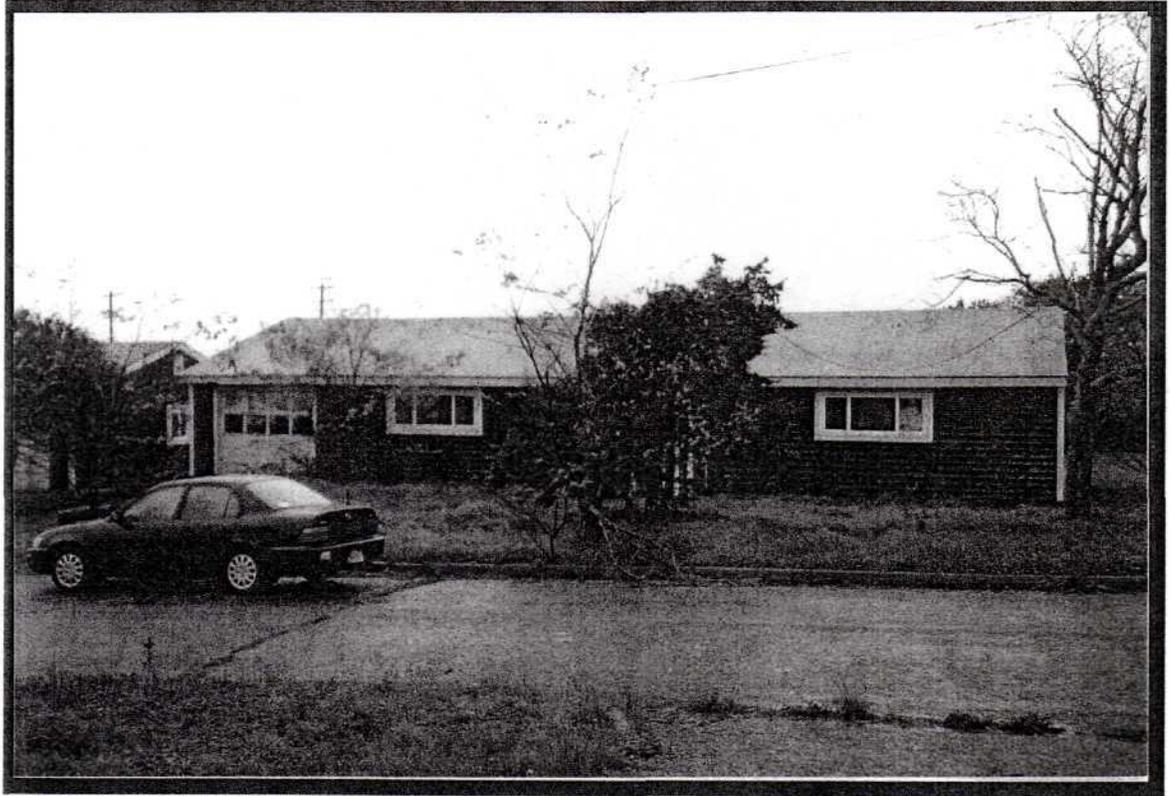
Photo 1: View of exterior LBP trim, Building #203.

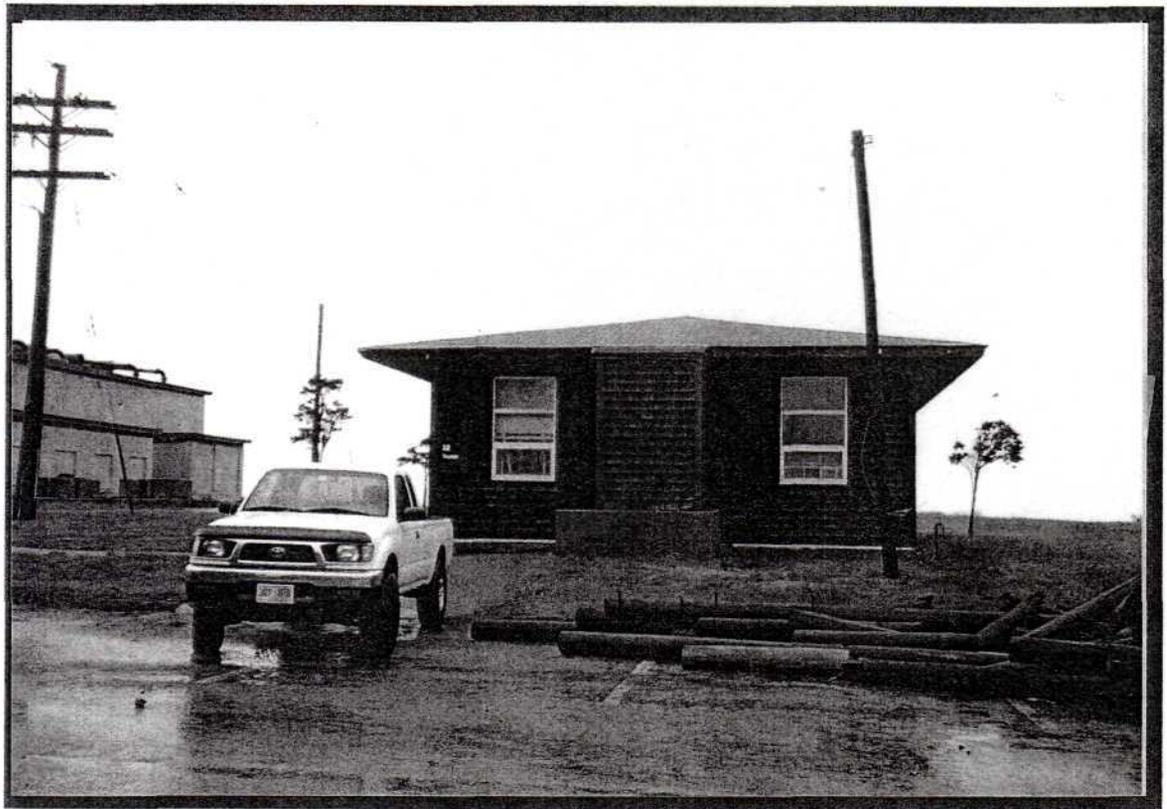
Photo 3: View of suspect creosote utility poles, LBP exterior eave and window casings, Building #22.

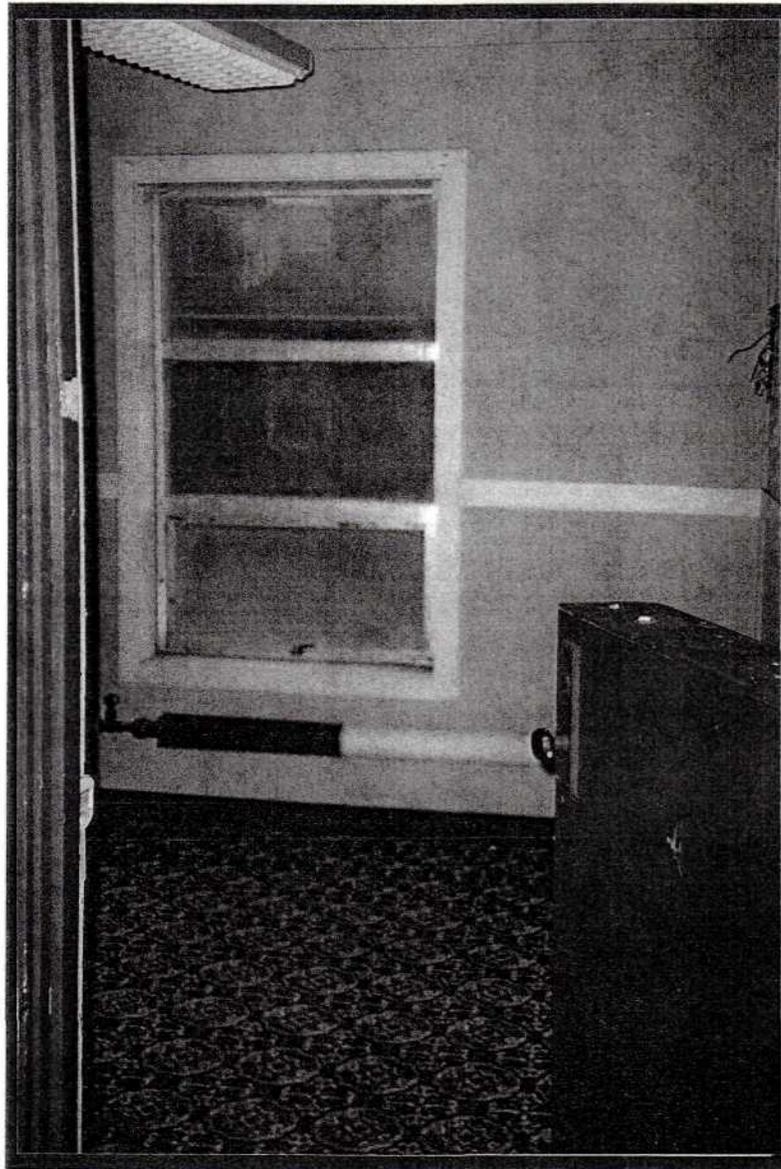
Photo 4: View of LBP-coated interior wall, ticket office, Building #22.

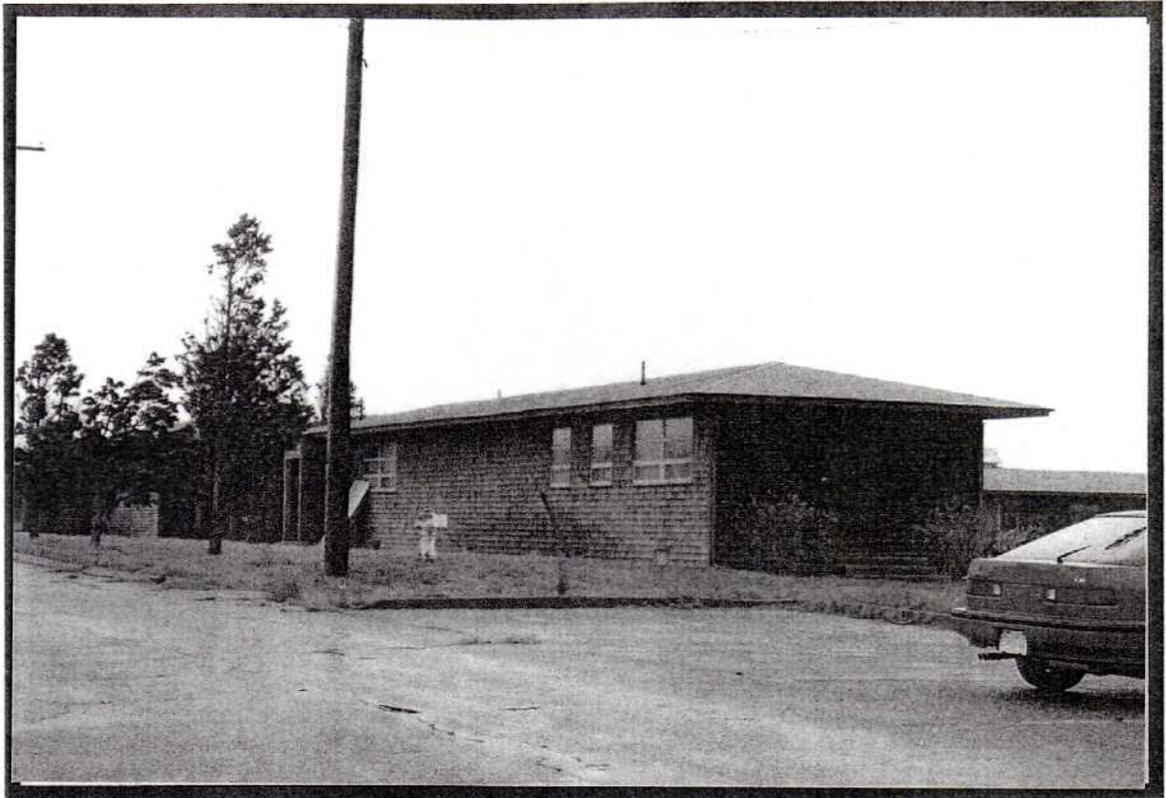
Photo 5: View of LBP-coated exterior eve, Building #14.

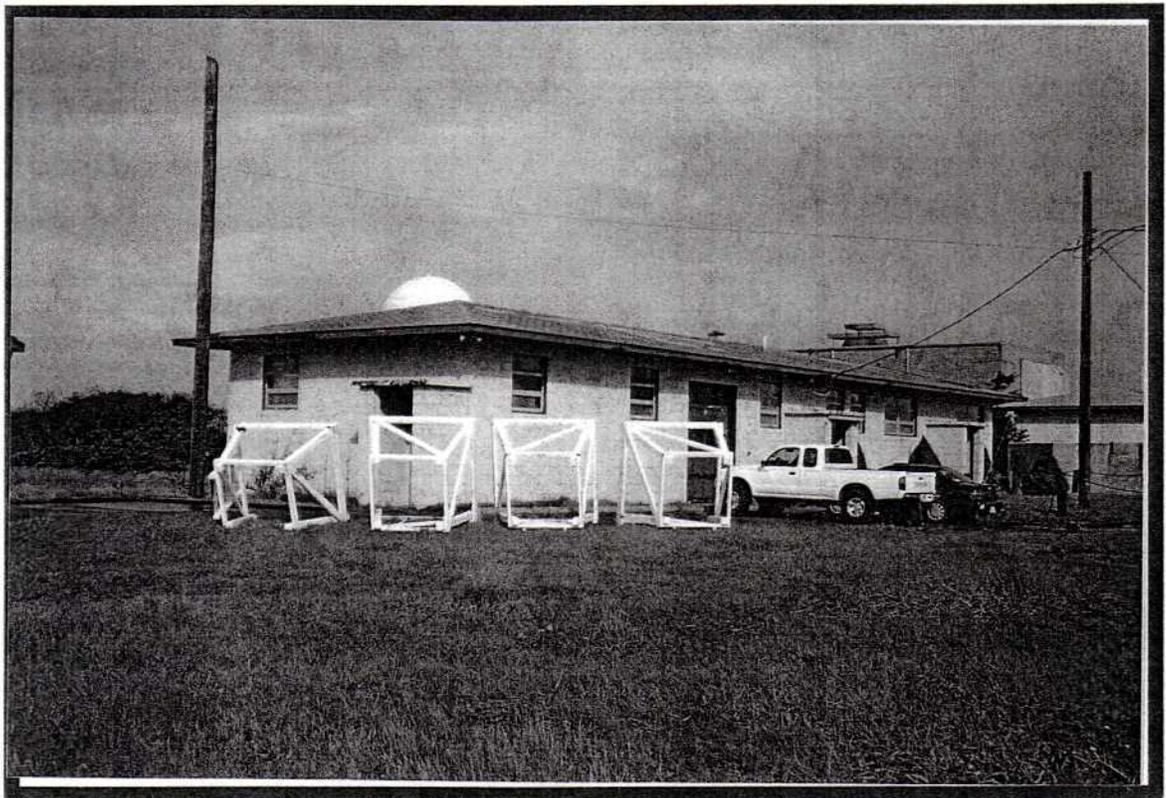
Photo 6: View of LBP-coated exterior eve (asbestos material), Building #36.

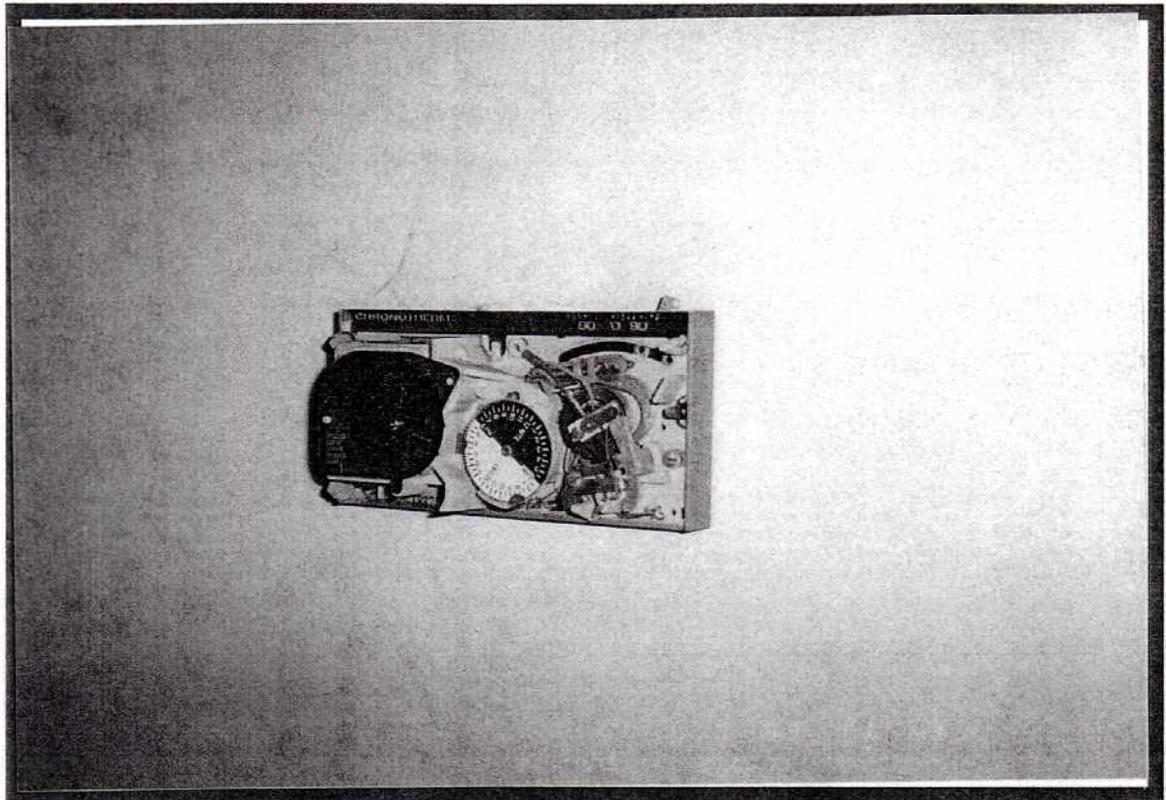
Photo 7: View of liquid mercury thermostat ampule, Building #203.

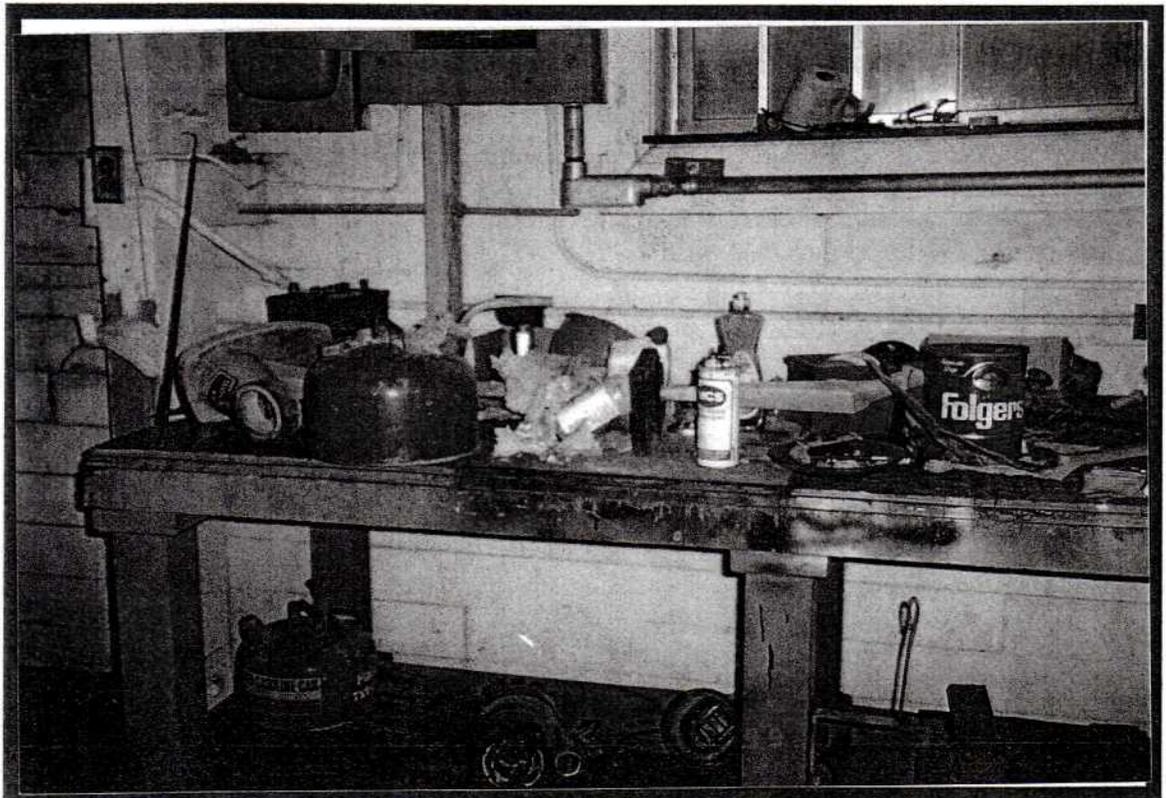
Photo 8: View of miscellaneous OHM, Building #37.

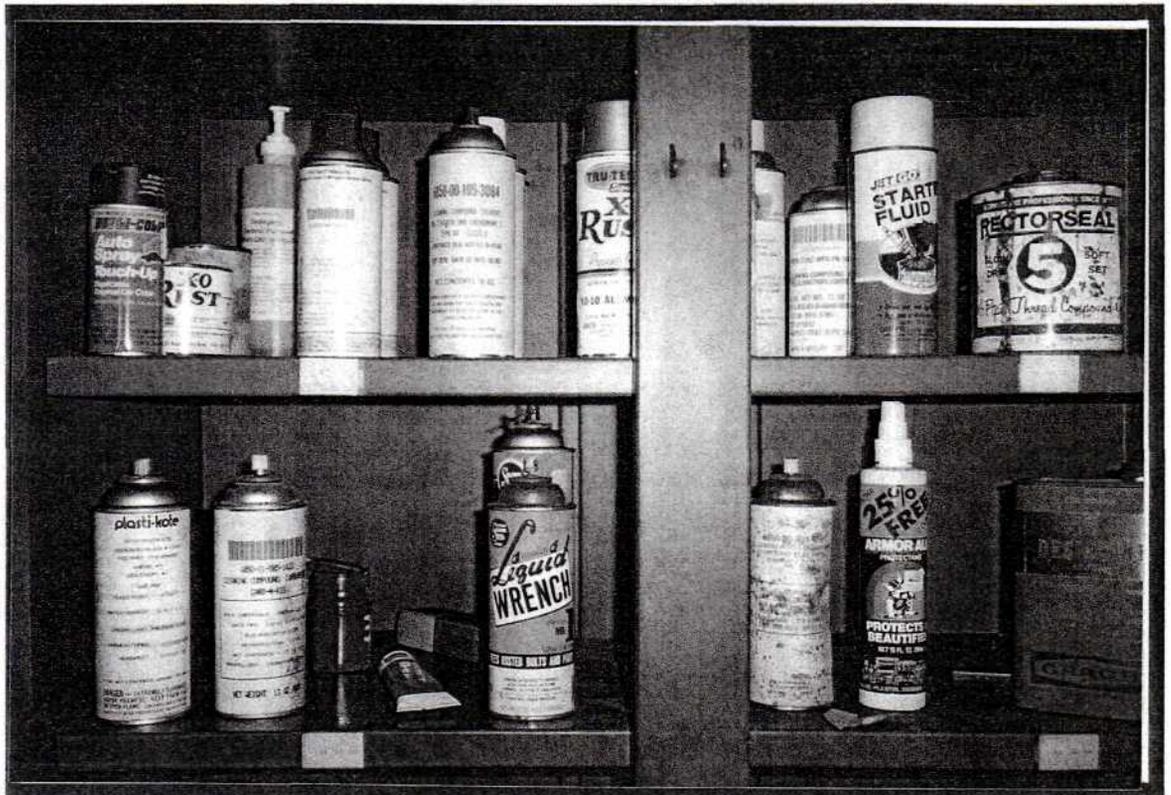
Photo 9: View of miscellaneous OHM, Flammables closet, Building #36.

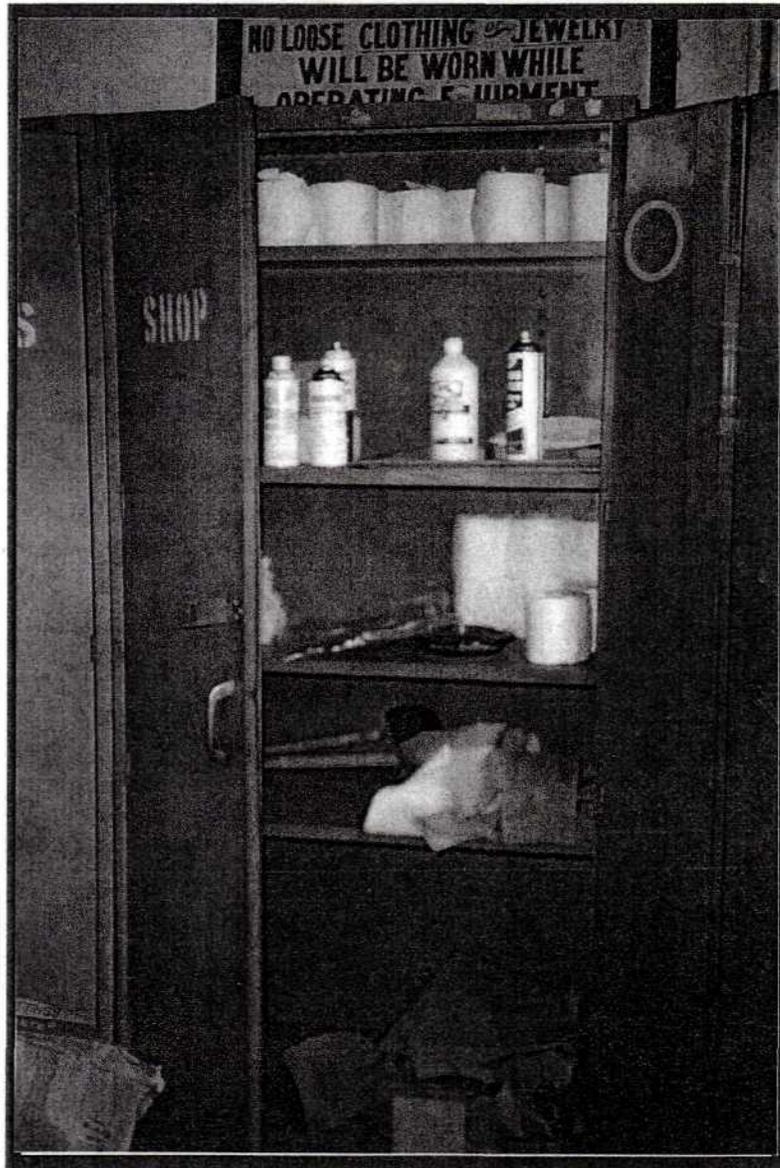
Photo 10: View of miscellaneous OHM, Supplies closet, Building #36.

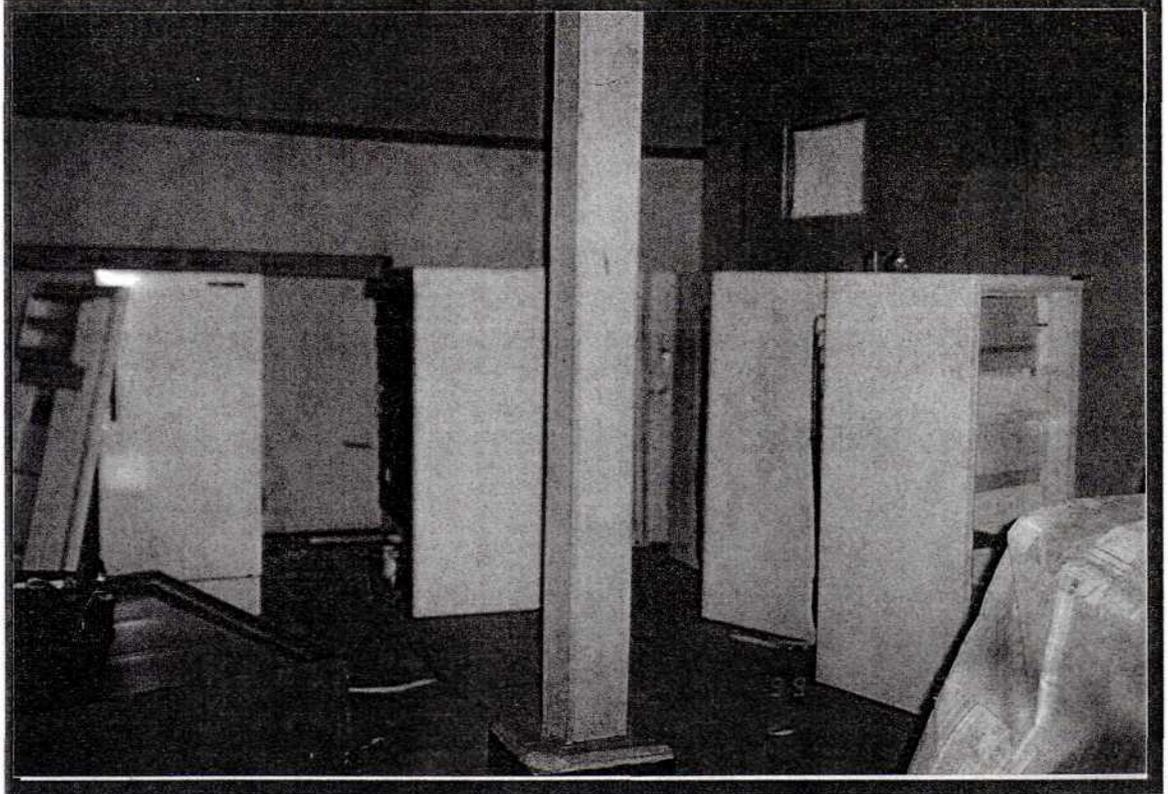
Photo 11: View of CFC-containing refrigerators, Building #17.

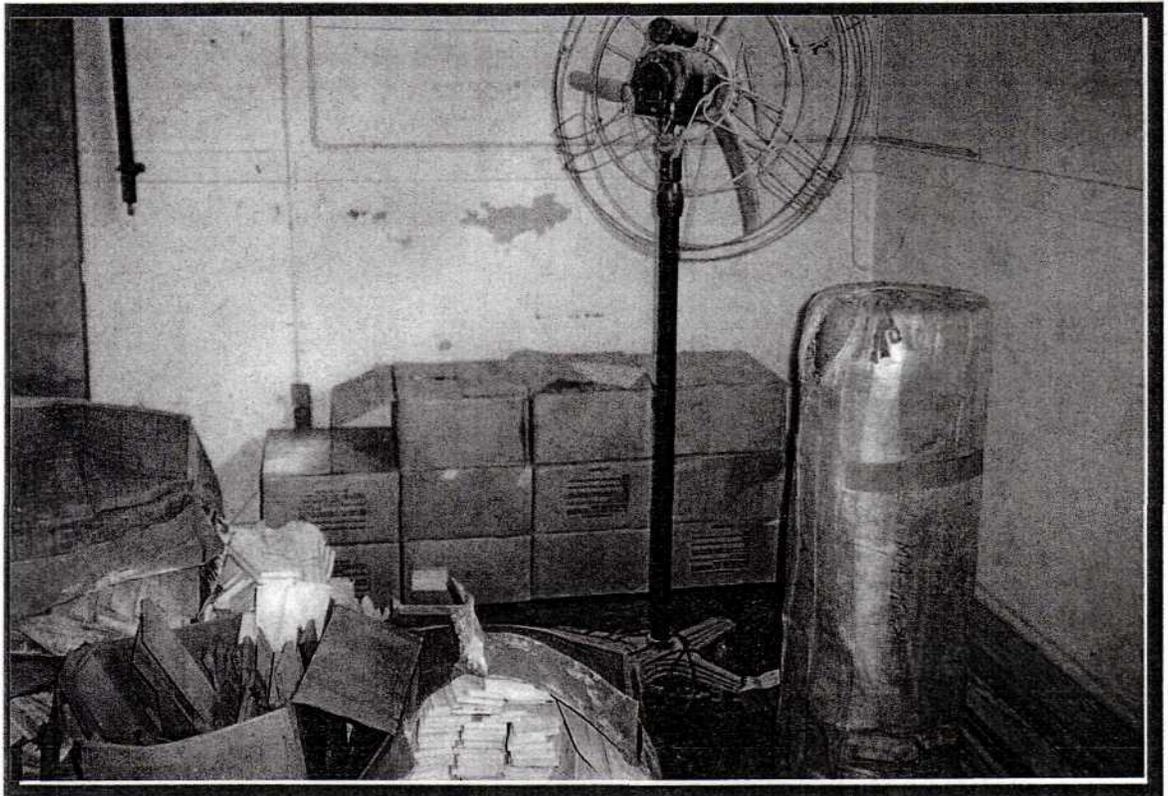
Photo 12: View of cases of scouring powder, Building #17.

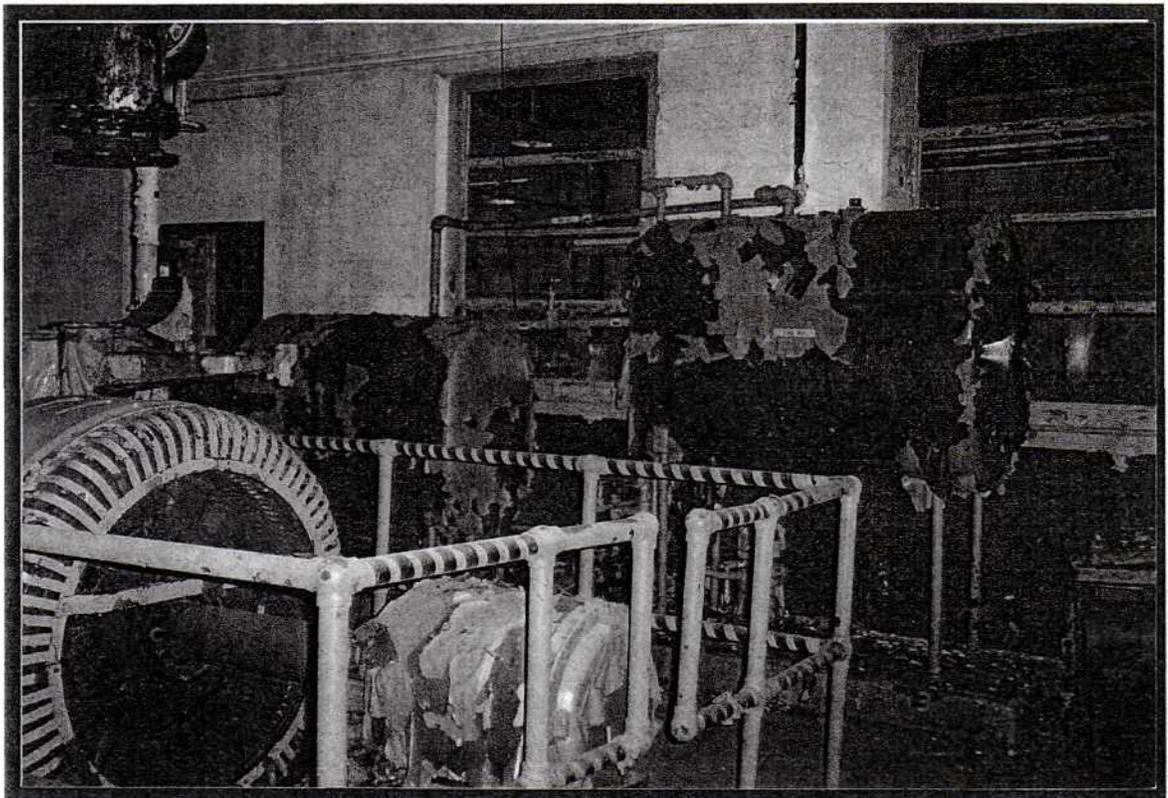
Photo 13: View of LBP-coated ASTs, handrails and floor debris, Building #31.

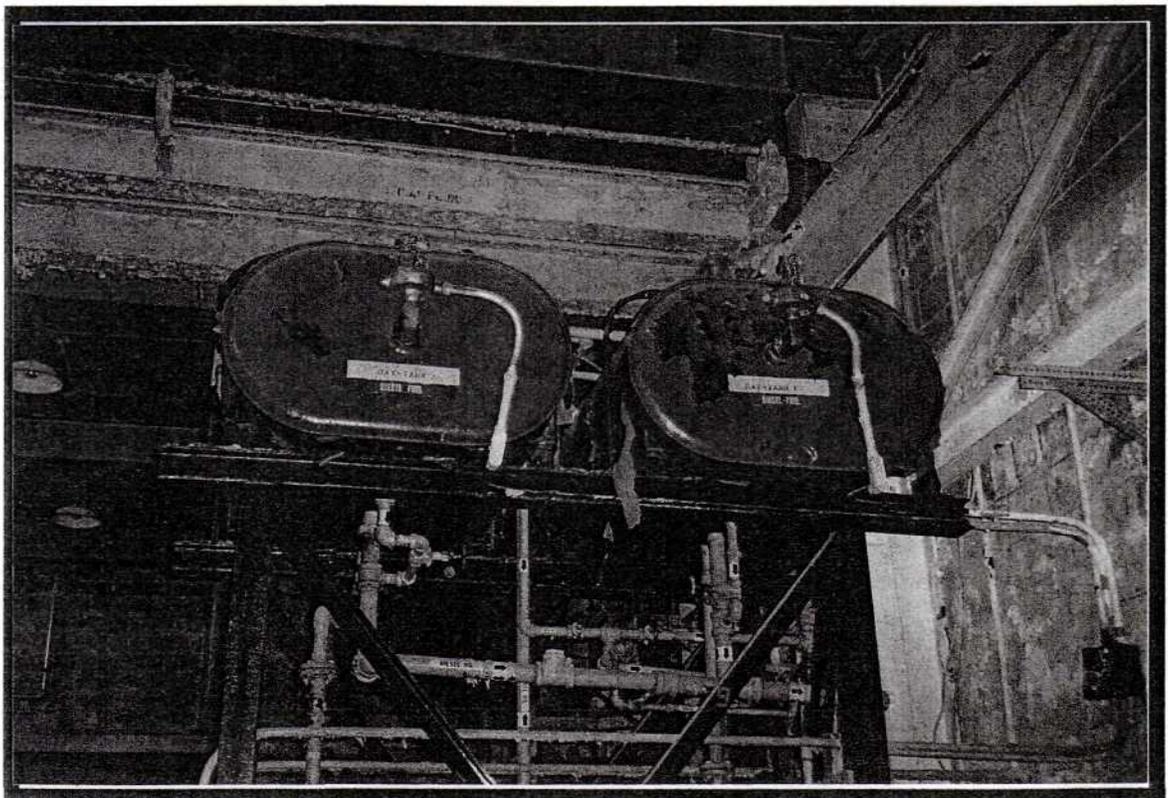
Photo 14: View of LBP-coated diesel fuel ASTs, ladder support and yellow crane beams, Building #31.

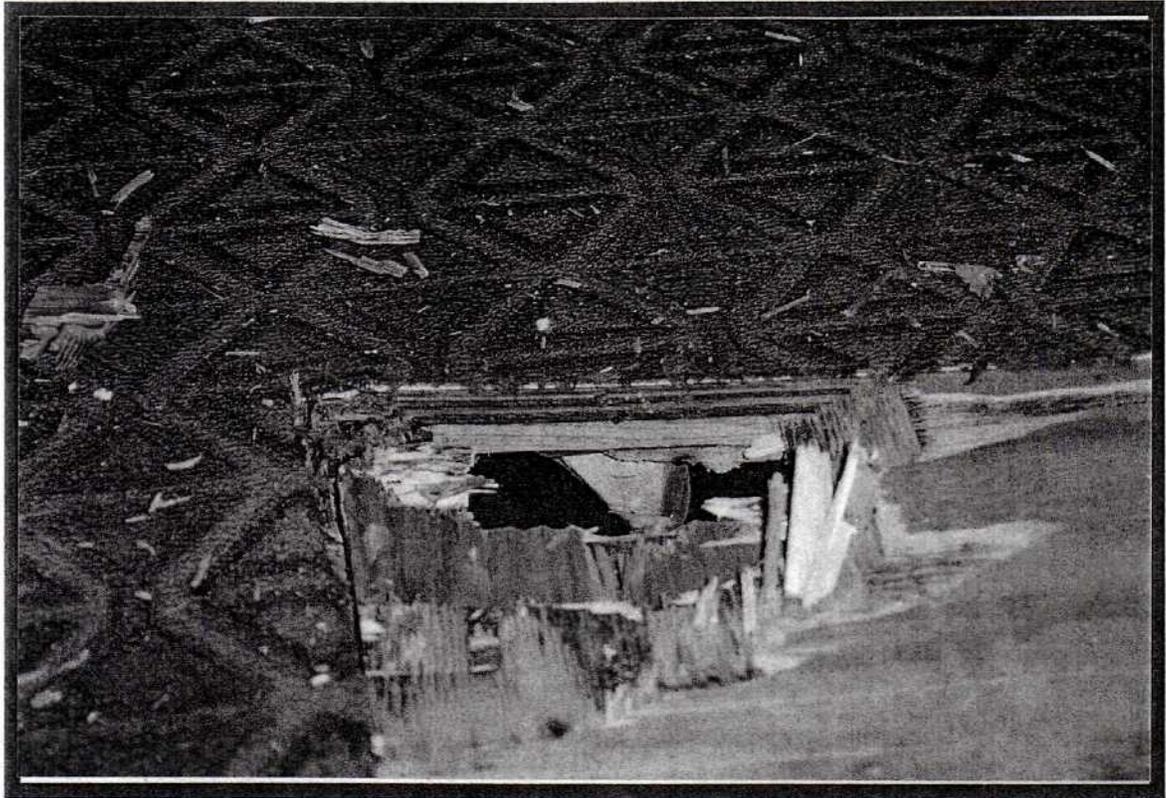
Photo 17: View of multiple layers of asbestos floor tile, Building #22.

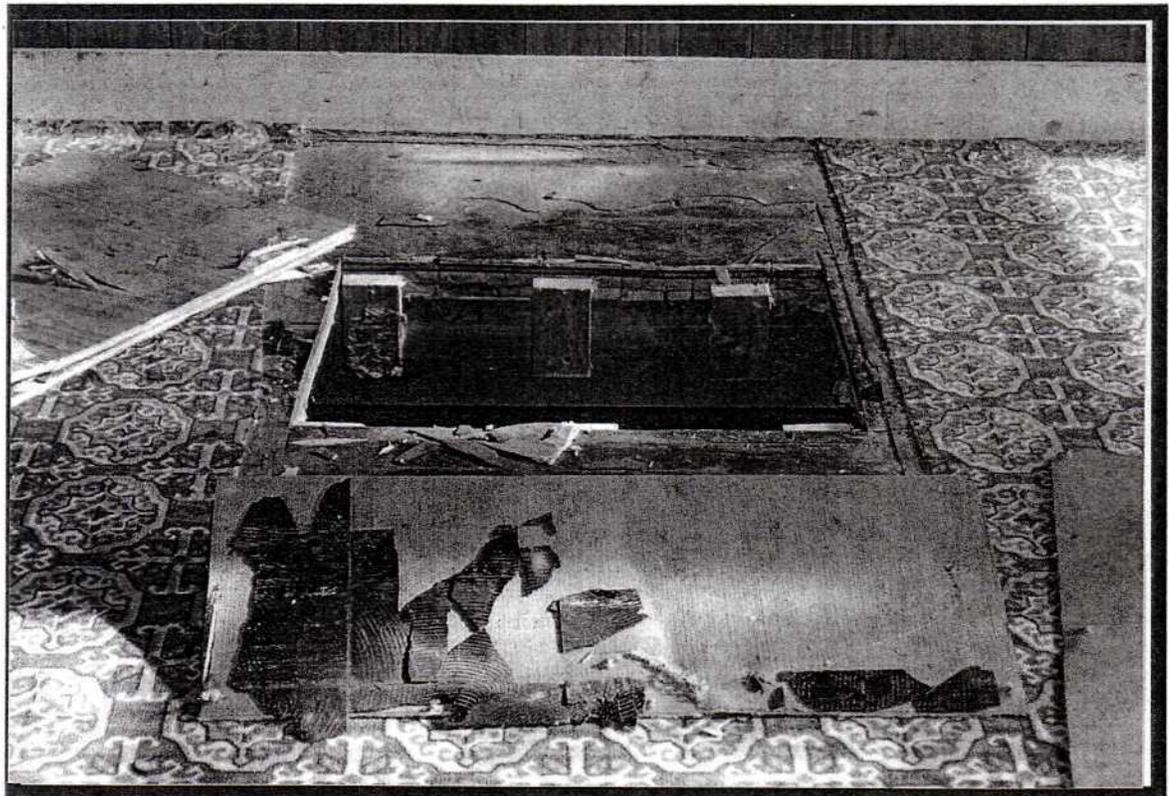
Photo 18: View of multiple layers of asbestos floor tile, Building #16.

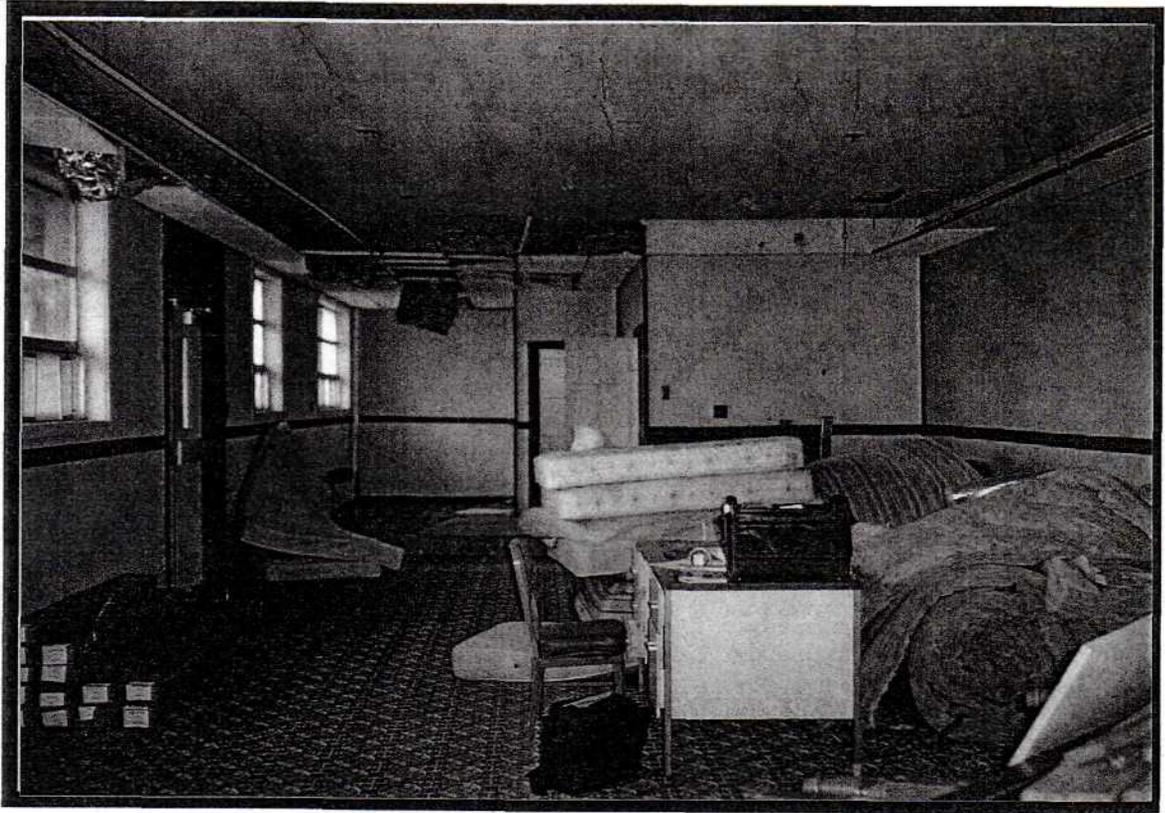
Photo 19: View of LBP-coated sheet rock walls, Building #14.

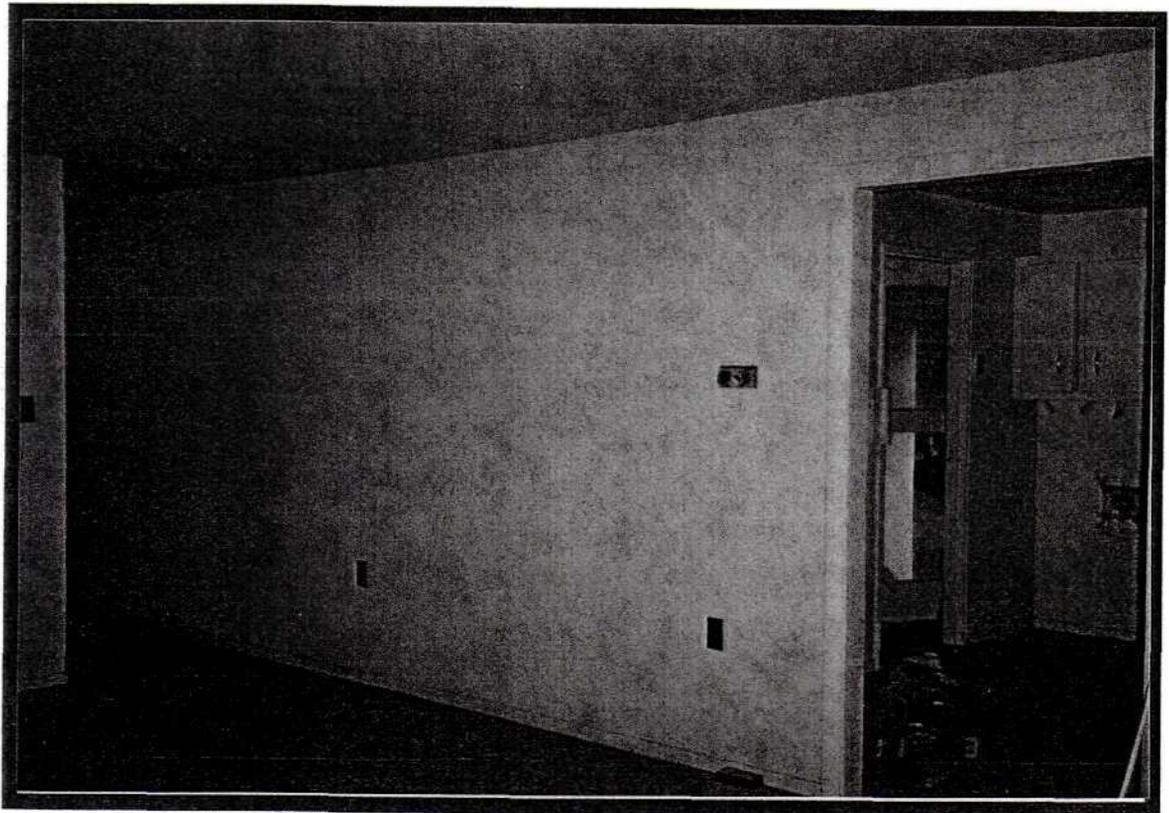
Photo 20: View of asbestos sheet rock/joint compound walls, Building #203.

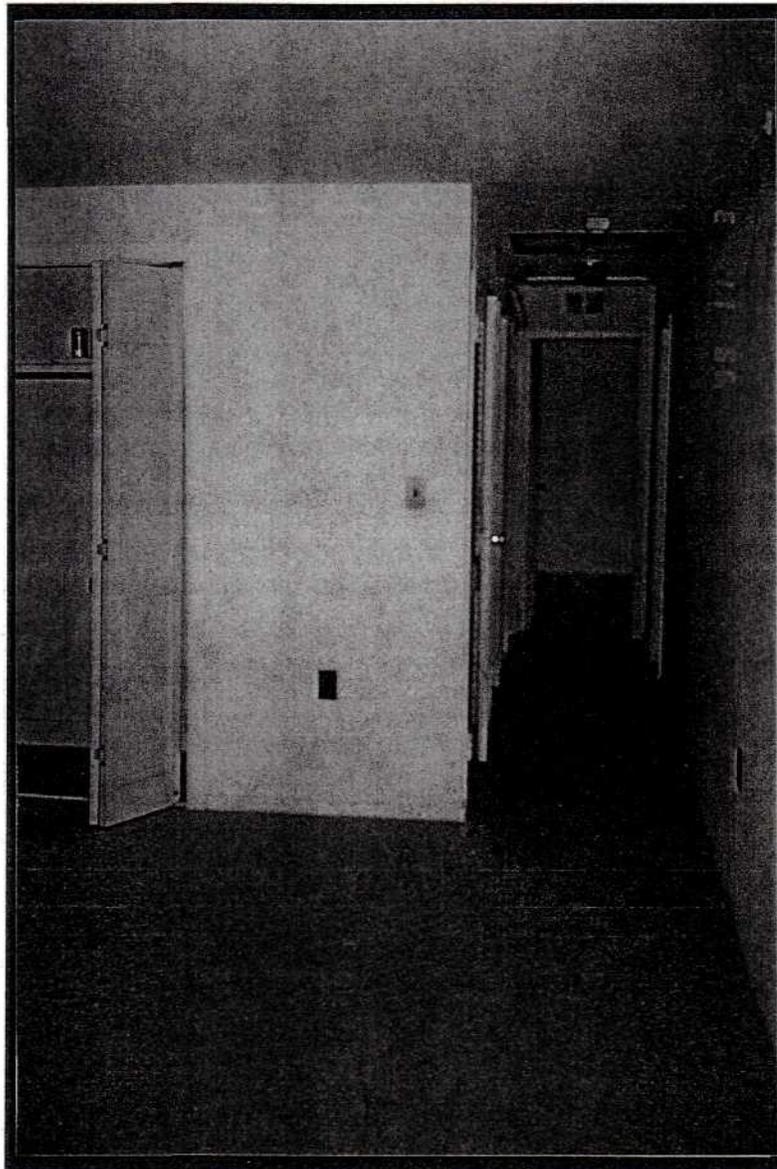
Photo 21: View of asbestos linoleum and sheet rock/joint compound walls, Building #203.

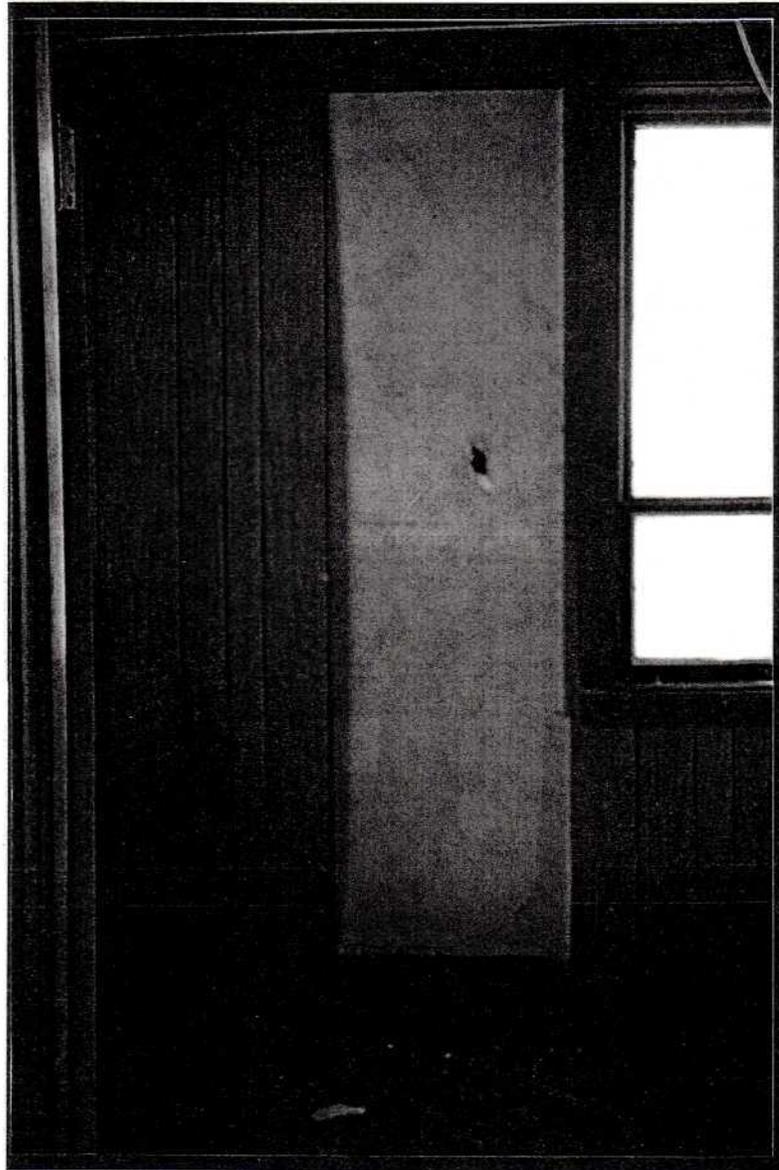
Photo 22: View of LBP-coated sheet rock walls, Dining Room, Building #18.
