VI. Individual Building Survey Forms

Building Number: T5

Original Name: NCO Club / Mess

Est. Year of Construction: ca. 1951

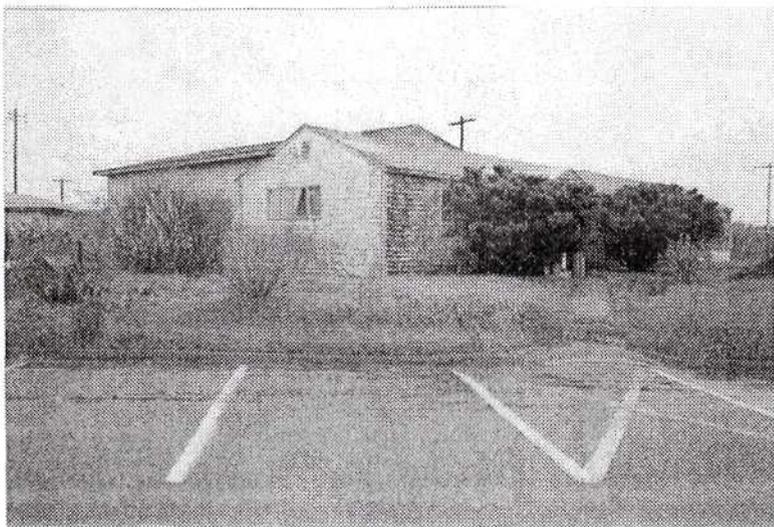
View from north.

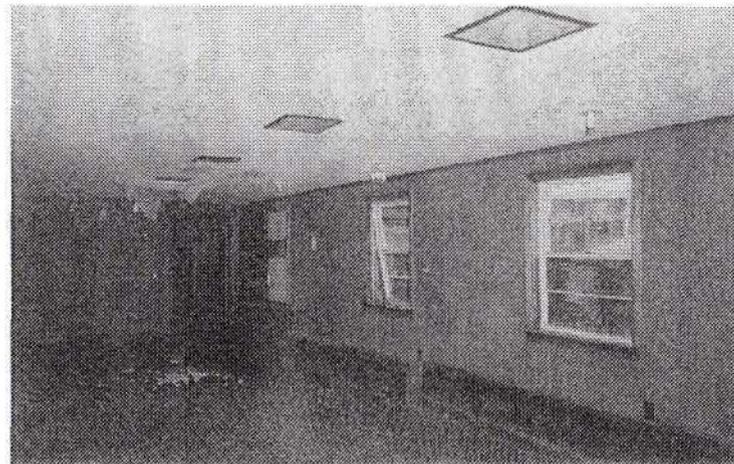
Interior – southwest wing.

Interior ceiling is in **fair/poor condition**. Roof leaks have damaged the southwest wing and the main club space. Repair advised. Painted finish on the rest is peeling and needs refinishing.

Interior walls are primarily covered with wood paneling and wallpaper over drywall. Overall, the **condition is fair to good**. A hole in the southwest wall is the most critical damage aside from mildew.

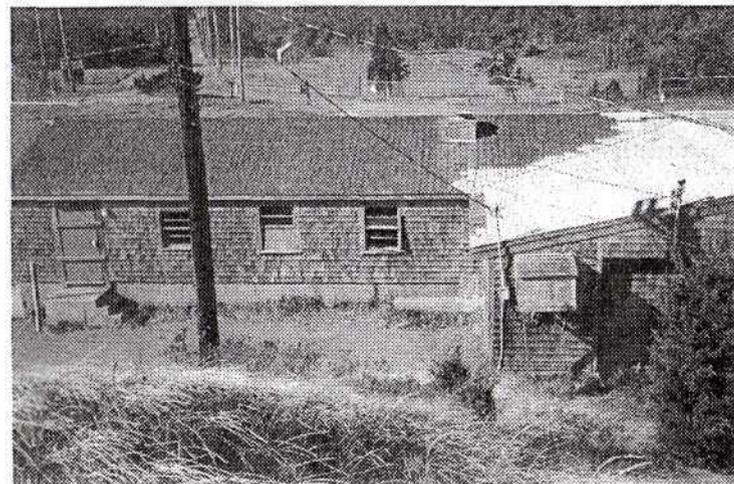
View from southeast.

The concrete masonry unit (CMU) foundation has cracks needing repointing and is in **poor condition**. All piers sit on sand; sand has been eroded around piers – condition is aggravated by "crowded" roof configuration at southeast elevation and location by dune. All CMU piers must be rebuilt or replaced with another foundation system (e.g., fill and new slab-on-grade to match adjacent S.O.G. wings). Several cracks and overall structural problems appear to be the cause of settlement and lack of control joints. Cracks need repointing. Concrete stair is in fair/ good condition.

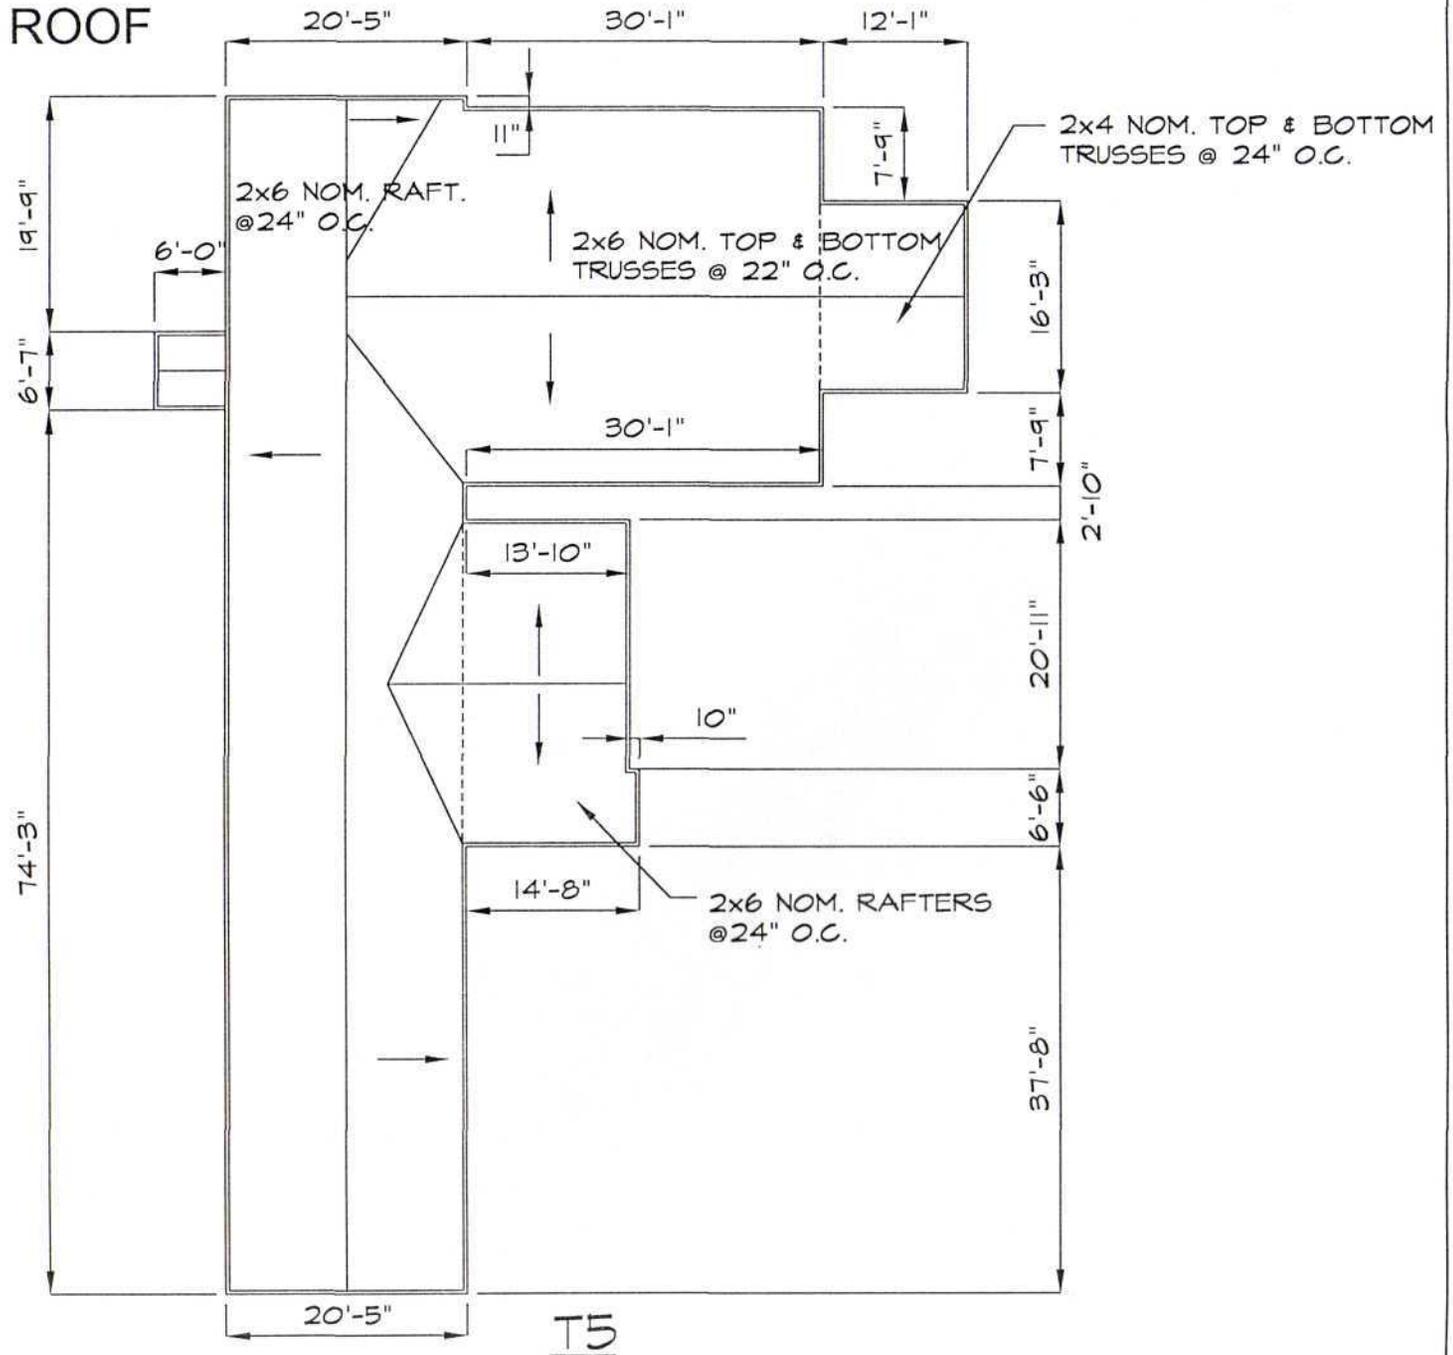
Building Number: T5 ROOF

Asphalt shingle roof is in **poor condition**. Several leaks have damaged interior finishes in the southwest wing. Recommend replacing entire roof over southwest wing and patching the north side to prevent further damage.

11. Remove and replace asphalt shingle roof	44	sq
12. Install blown-in cellulose insulation at attic, R22	3,625	sf
13. Install blown-in cellulose insulation at walls, cut & patch	1,000	sf
