Existing Conditions

This chapter describes through narrative text, contemporary photographs, and labeled base mapping, the current conditions and extant landscape features associated with the Portsmouth Village Historic District. The purpose of documenting the park's existing landscape is three-fold. The primary role of the existing conditions documentation is to convey the range and breadth of landscape features by identifying, describing, and locating them on a map. This documentation serves as a baseline of information for the rest of the document. The second purpose is to generate an inventory of park features that can be utilized to develop several cultural landscape analyses and assess National Register eligibility and integrity. The final role is to provide a record of the landscape that may prove useful to future research efforts.

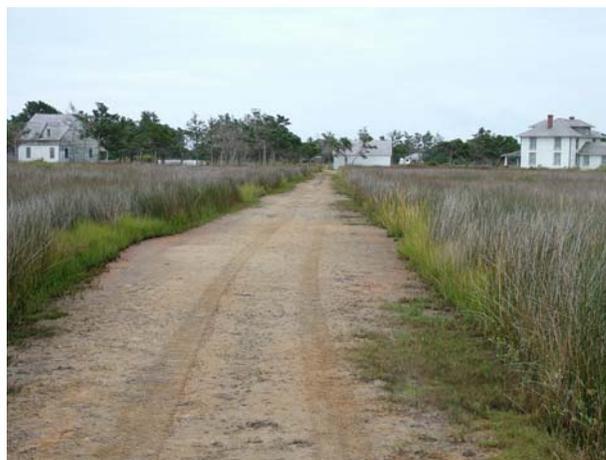
Haulover Point Road. This road is a long, straight, sand road that extends between Haulover Point and the Old Straight Road (Fig. 47 and Fig. 48). The northern portion of the road frequently floods, and remains wet, causing visitors difficulty when they arrive on the island. The road is generally in good

FIGURE 47. View south along Haulover Point Road.

condition, except for where ponding occurs near the boardwalk.

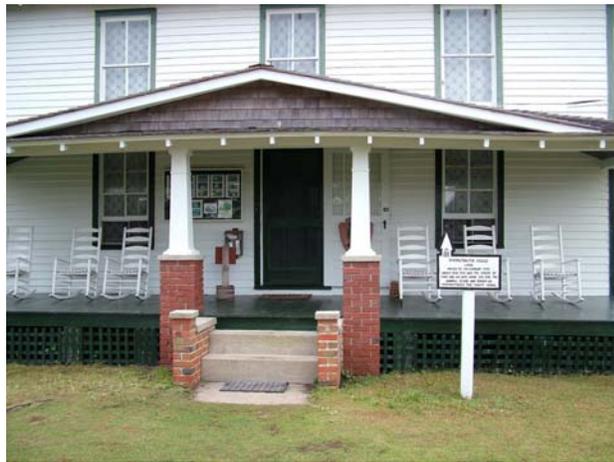
FIGURE 59. Brick and concrete steps lead to the Dixon-Salter House porch.

Dixon-Salter House, brick and concrete steps. A concrete stair, consisting of two risers with a ground-level concrete landing, provides access to the front porch of the Dixon-Salter House (Fig. 59). The stair is flanked to either side by 18-inch-tall brick walls capped with concrete. These steps appear to have been repaired recently and are in good condition.

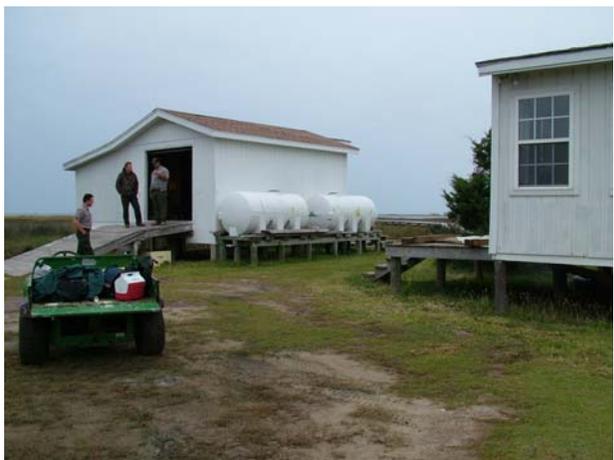
FIGURE 61. A wood ramp provides access for vehicles into the T. T. Potter Shed.

T. T. Potter, ramp to shed. A simple wood ramp, approximately eight feet wide, provides vehicular access into the shed (Fig. 61). The ramp is not edged in any way. This ramp appears to be in good condition.

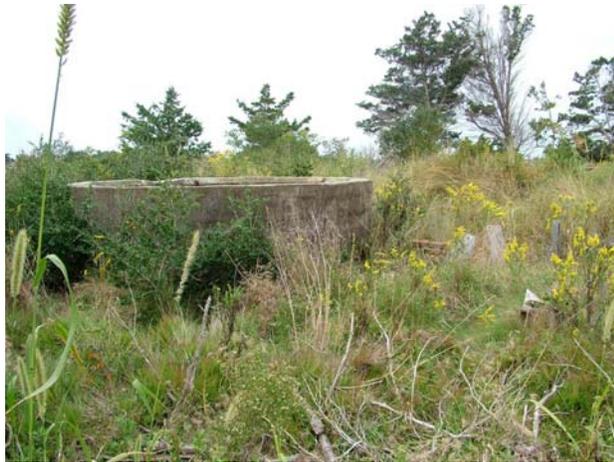
Keller cistern. In close proximity to the Keller-Styron Cemetery there are two round cisterns once associated with the Ed Keller House, now in ruins. The concrete cistern is approximately three feet high and ten feet in diameter (Fig. 99). The brick cistern is slightly smaller. They are currently open to the air. These cisterns are exhibiting some signs of deterioration and are in fair condition.

FIGURE 99. The concrete cistern near the Keller-Styron Cemetery.

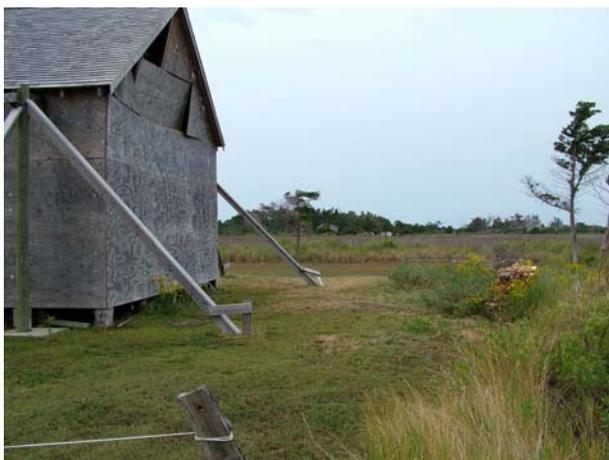
FIGURE 121. Temporary barriers limit access to the mothballed George Dixon House.

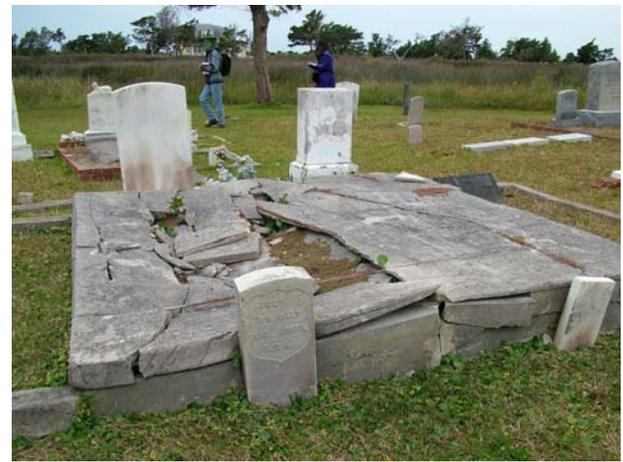
FIGURE 131. The condition of some of the concrete vault covers in the Community Cemetery is poor.

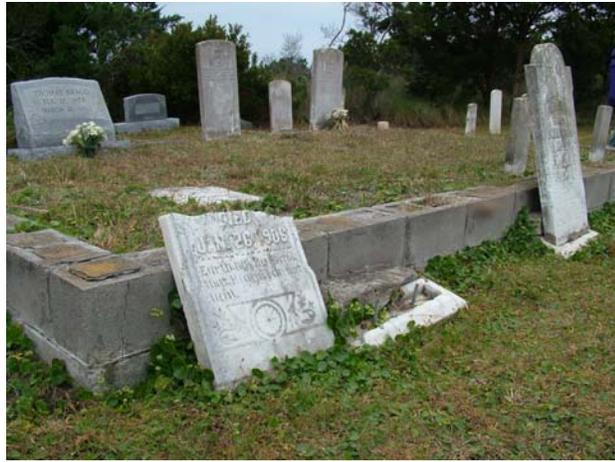
FIGURE 134. There are condition problems with many of the headstones in the Portsmouth Cemetery.

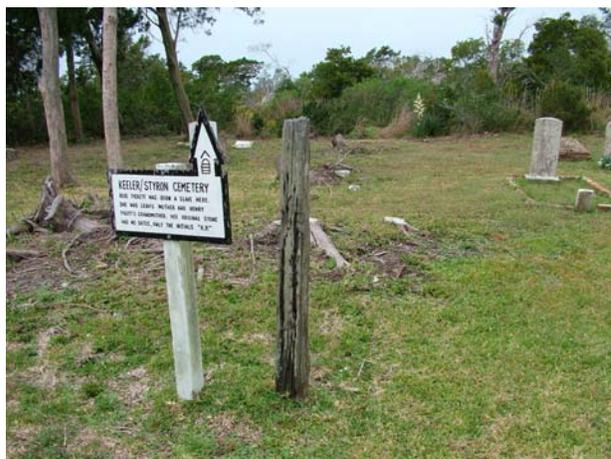
FIGURE 137. Remnant fence post at the Keller-Styron Cemetery.
