Cape Lookout National Seashore

Washington Roberts House

Historic Structure Report

October 2003

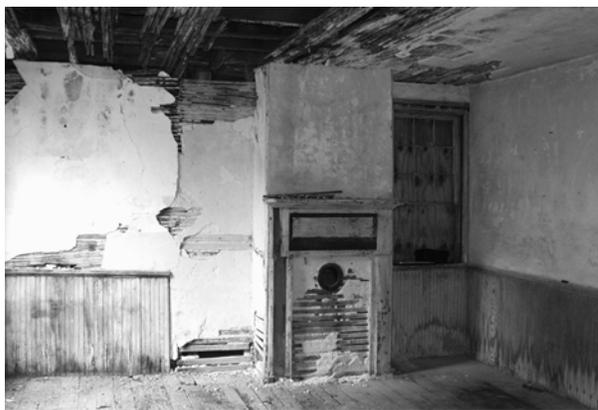
FIGURE 16. View of chimney in Room 103, absence of wainscot indicating extent of original chimney. (NPS-SERO-CR, 2003)

In Room 103, areas of the west wall left open by removal of the old chimney were repaired with plaster on wood lath to match the earlier plaster but

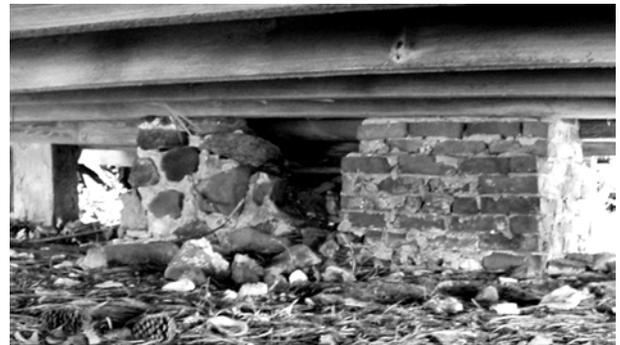
FIGURE 18. View of chimney base, with original stone chimney base at left, existing brick chimney at right. (NPS-SERO-CR, 2003)

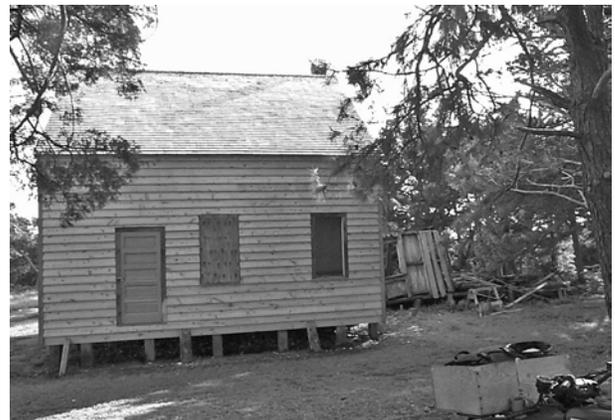
FIGURE 26. View of Roberts House after exterior rehabilitation and Hurricane Isabel. (NPS-SERO-CR, 2003)

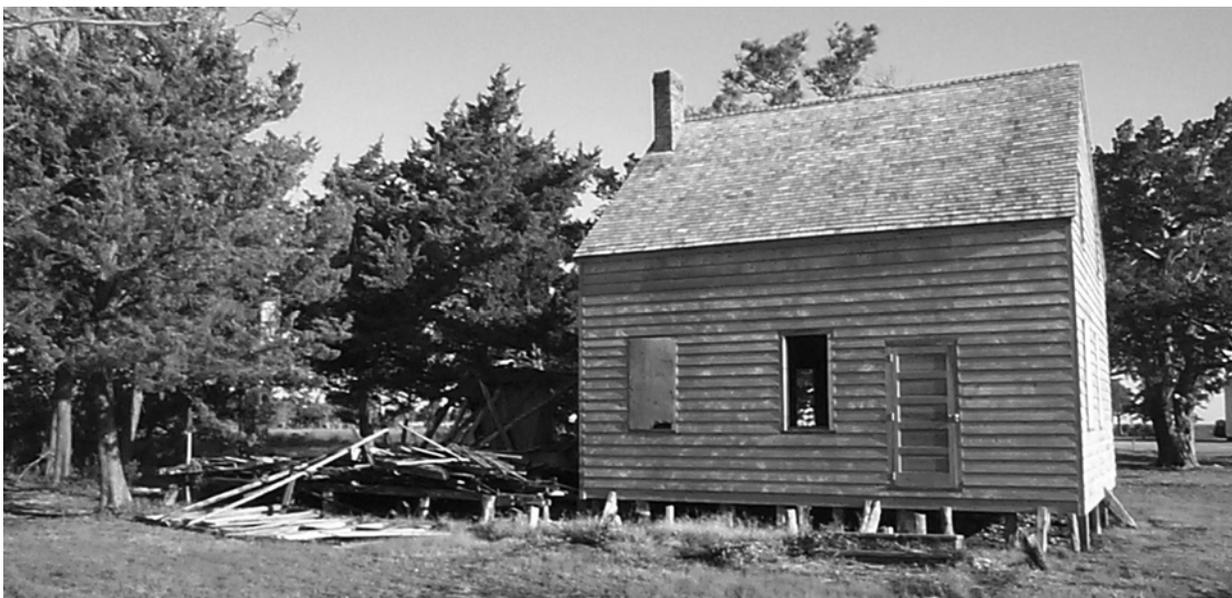
In September 2003, as this report was being completed, Hurricane Isabel swept the Outer Banks with the eye coming ashore around Drum Inlet a few miles south of Portsmouth. Although only a Category 2 hurricane, the storm’s surge inundated the entire island and a number of structures sustained significant damage. The nearby George Dixon House was severely damaged, but little, if any, damage was sustained by the main block of the Roberts House. Unfortunately, wind and water completed destruction of the house’s ruined kitchen wing. It was partially reconstructed in 2006.

FIGURE 27. View of Roberts House after exterior rehabilitation and after destruction of kitchen by Hurricane Isabel. (NPS-SERO-CR, 2003)

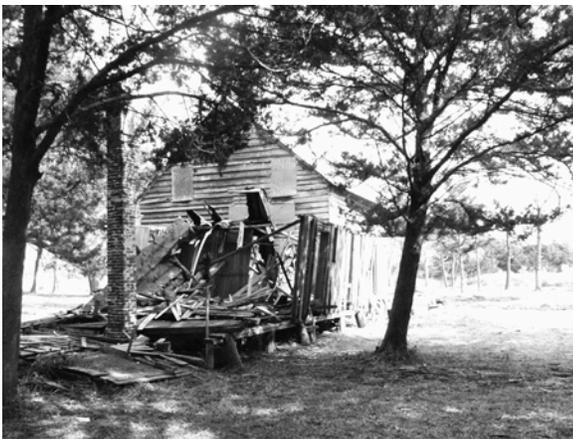
FIGURE 29. View to east, showing ruined kitchen wing in foreground. (NPS-SERO-CR, 2002)

Total neglect of the roof covering has subjected the kitchen wing to water penetration and resulting rot, so that the entire roof structure, the west end wall, and part of the south wall have now collapsed. Except for window sash and doors, however, the character and dimension of all of the original materials and the original floor plan can be identified in the the existing ruins of the building.

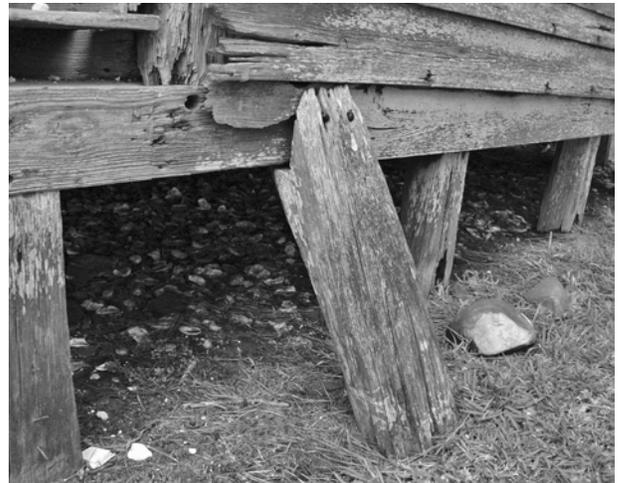
There are three braces each on the south, east, and north sides of the main block of the house, but there is only one brace on the west side. A 90-degree notch has been cut into the sloping face of that brace, probably to support the framing of the wooden, "coffin-like" cistern that once stood in that area. Part of the sill on the west side is covered by the kitchen wing and could not be examined, but with the original chimney in that location, additional bracing may have been unnecessary. Some of the original braces may have been replaced over the years, with the ones on the north and west sides of the house most likely to be original. Condition varies, however, and a number are badly deteriorated.

FIGURE 31. View of appears to be a typical "bird's-mouth" hurricane brace on north side of house. (NPS-SERO-CR, 2002)

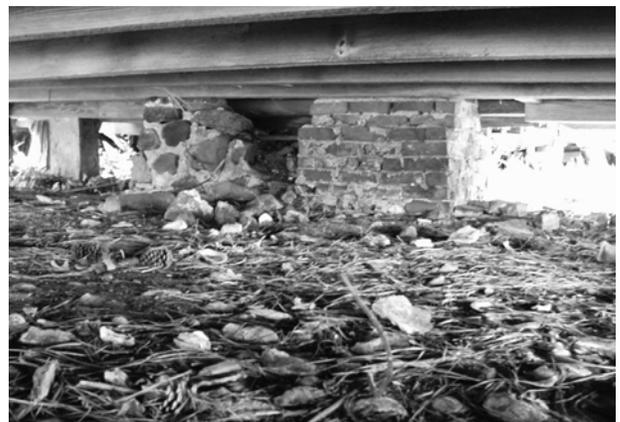
FIGURE 32. View of chimney foundation, with brick at right marking existing chimney base and stone at left marking larger extent of original chimney. (NPS-SERO-CR, 2002)

The present inside chimney replaced the original outside chimney which sat in the same location. The foundation for the original chimney appears to have been built of stone, but it is not known if the entire chimney stack was stone as well. The framed opening in the floor apparently accommodated a hearth, while the breaks in the exterior siding show it to have been an outside chimney, with the chimney breast flush with the interior walls and the stack above the second floor fireplace rising outside the walls and not penetrating the roof.

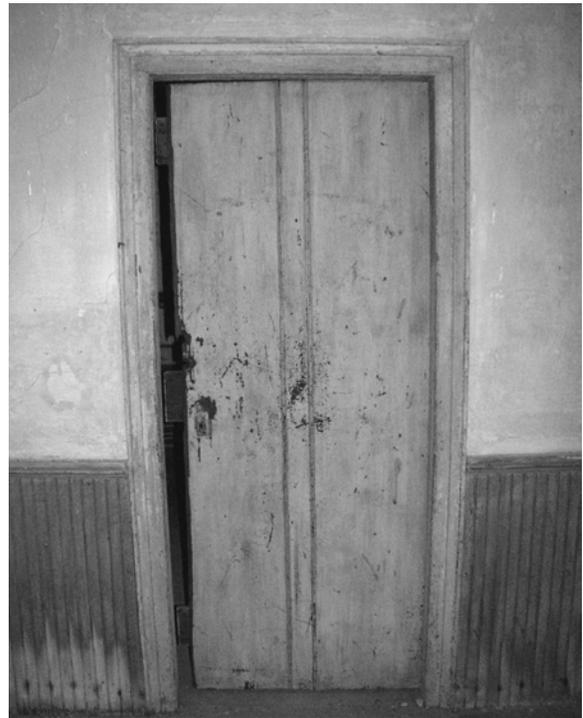
frames. The surviving door is historic and is probably typical of the original interior doors. Measuring 6'-6" by 2'9", it is constructed with three beaded boards, two around 12" wide, and a center board about 5" wide, held together by three chamfered ledger boards. The door is hung on 4-1/2" butt hinges and originally was fitted with a large rim lock. Only the lock catch remains in place on the jamb, the lock having been ripped off by thieves, splintering the door in the process.

FIGURE 42. View of outside face of door D-9 to Room 102. (NPS-SERO-CR, 2002)
