Portsmouth Village Cultural Landscape Report

Cape Lookout National Seashore
Carteret County, North Carolina

Cultural Landscape Report

December 2007

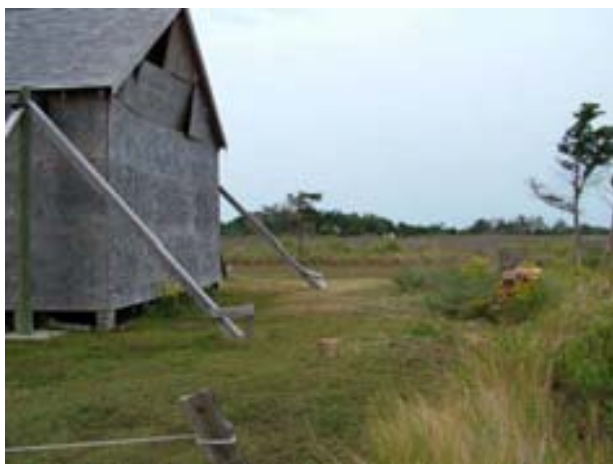
FIGURE 121. Temporary barriers limit access to the mothballed George Dixon House.

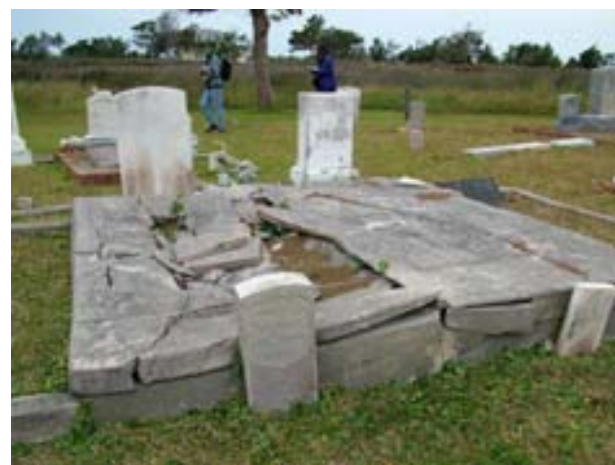
FIGURE 131. The condition of some of the concrete vault covers in the Community Cemetery is poor.

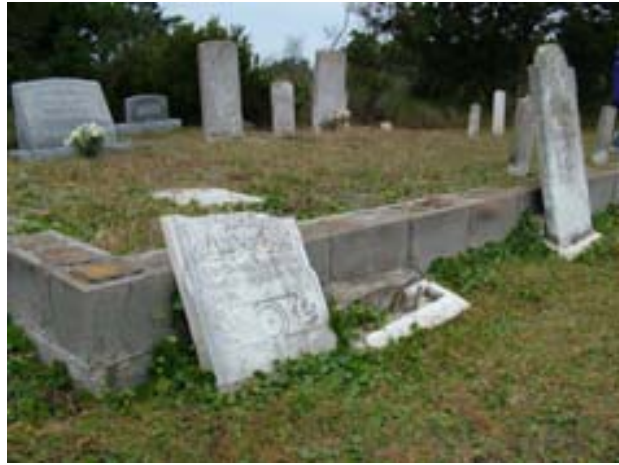
FIGURE 134. There are condition problems with many of the headstones in the Portsmouth Cemetery.

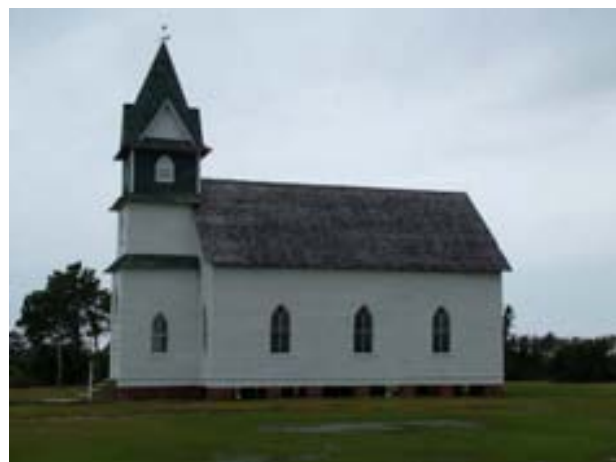
FIGURE 167B. The same view in 2006. Note the loss of the low fence near the base of the church, and foundation vegetation. Mown grass characterizes the landscape around the church in both photographs.

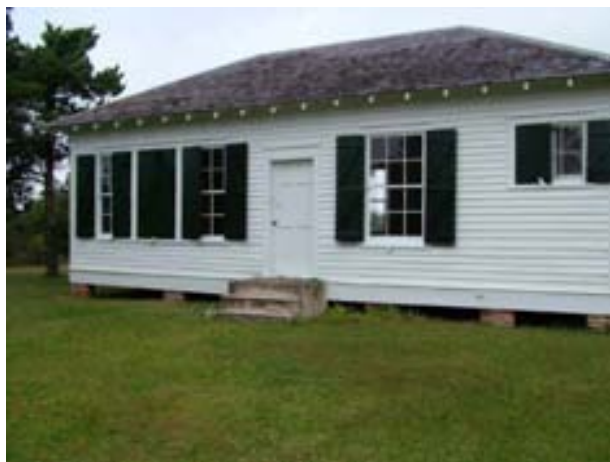
FIGURE 168B. The same view in 2006. Note the loss of the brick landing and walk, changes in paint color on the door and shutters, the reconfiguring and reshingling of the roof, and the loss of foundation plantings since 1969.

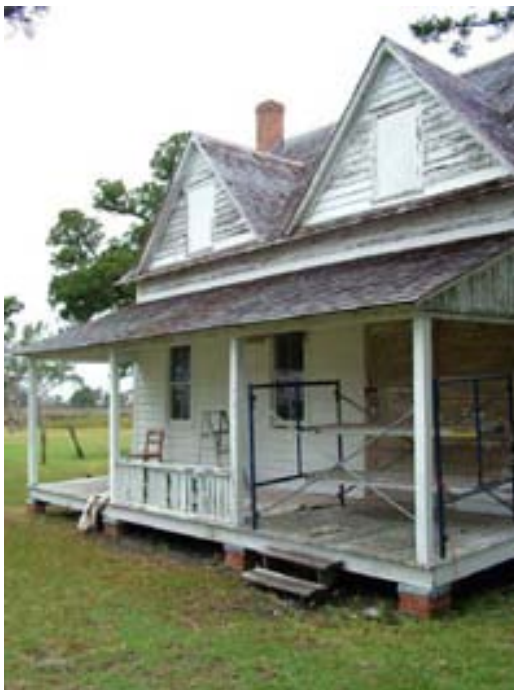
FIGURE 178B. The same view in 2006. Note the replacement of the central dormer with two dormers and alteration of the porch posts and railing. Woodwork beneath the porch is no longer present.

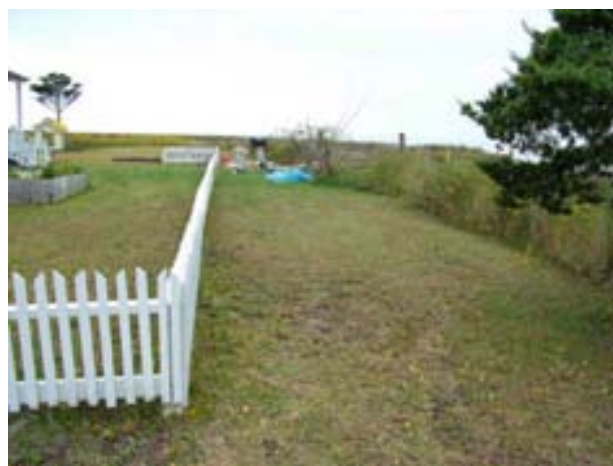
FIGURE 183B. The Henry Pigott House yard is relatively similar in 2006, with the primary exception of the loss of vegetation to the exterior of the fence. Segments of the picket fence are missing in the rear.

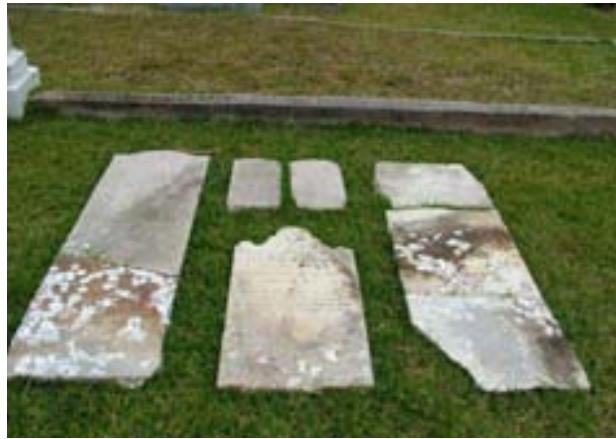
FIGURE 204. Biological growth and sugaring have affected these grave markers.

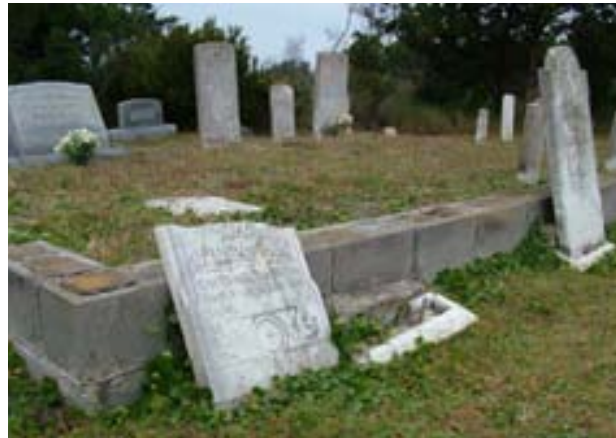
FIGURE 205. Some grave markers have cracked into multiple pieces.

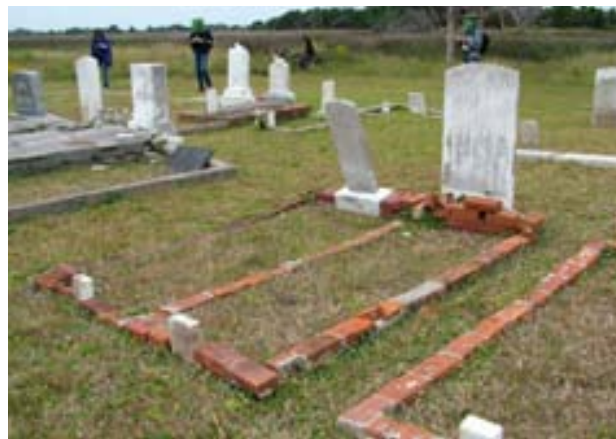
FIGURE 206. Some grave markers are displaced from their original position, such as the marker at left in the foreground.

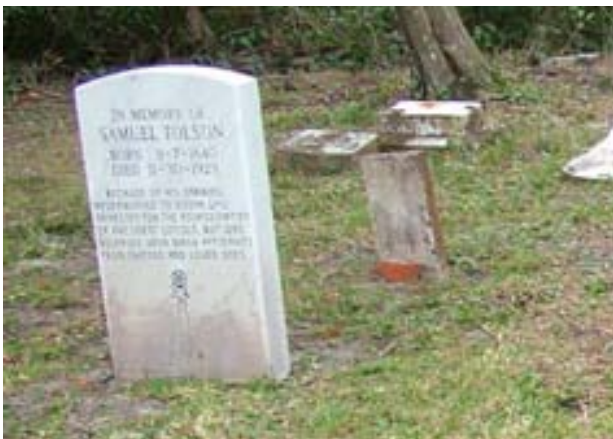
FIGURE 209. Rising damp has discolored the Samuel Tolson marker.
