HISTORIC STRUCTURE REPORT

Hoover Block

Dayton Aviation Heritage National Historical Park
Dayton, Ohio

January 1999
Final Report

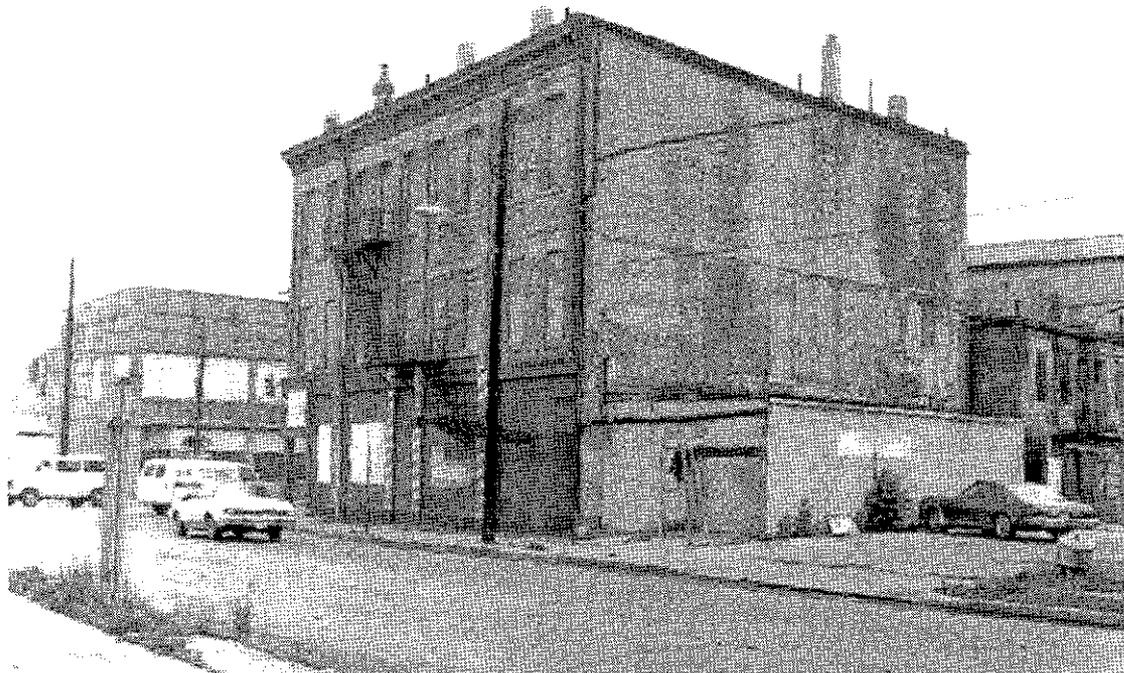
Figure 9 View of the southwest elevation of the Hoover Block, 1986. Note that almost all of the building's openings have been infilled with masonry. Also, the brick face of the upper stories seems to have several large areas of spalling and erosion. (Aviation Trail, Inc.)

Figure 9 shows that almost all of the building's west and south openings have been infilled with masonry. The brick face of the upper floor elevations seems to have several large areas of spalling and erosion on both elevations. The southwest corner at the ground level has been cut away, leaving the corner column independent from the storefront. The upper half of the west elevation storefront appears to be boarded over with wood paneling, bearing signage from Aviation Trail, Inc. The rest of the first floor, along the west elevation, is painted a dark color, with lighter diagonal stripes distinguishing the pilasters. Within the two northernmost bays, an area of white has been painted, and a large directional arrow has been painted in the bay just south of center, below the fire escape.

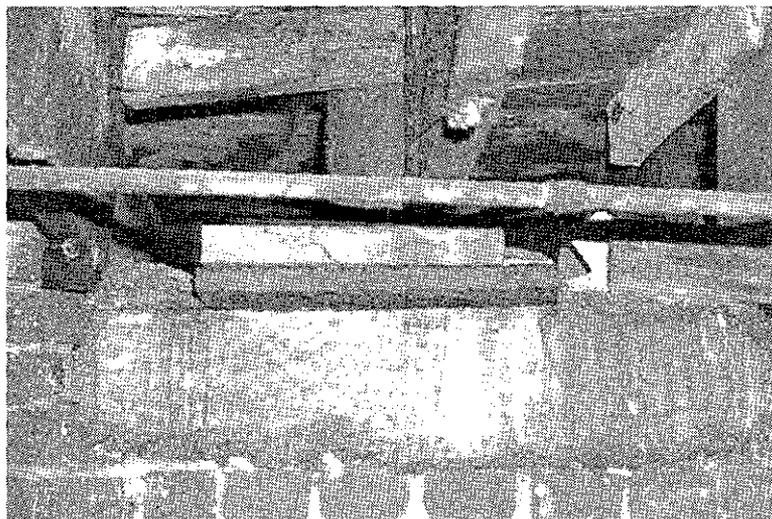
Figure 5 shows a different type of column bearing that has been built into the east interior wall. A bearing block of concrete has been added to the original wall, and the base plate for the steel column from above rests on this concrete. The concrete extends the full thickness of the wall and was measured to be 7 inches high, and the detail is typical of the east wall line. The column bearing conditions between the east and west interior walls are distinctly different in execution and workmanship, indicating that they were modified at different times.

Figure 5 East interior basement wall, first floor column concrete bearing block, third column from north; note base plate overhangs (photo 1:24, Fitzpatrick Structural Engineering, P.C., October, 1996)

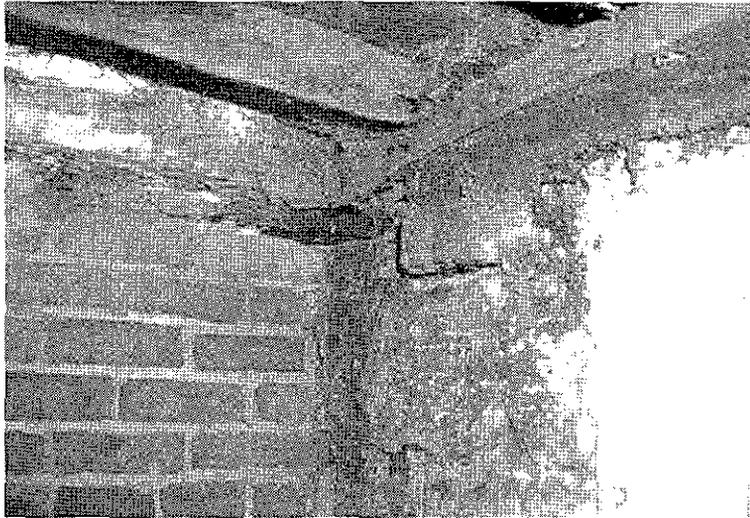
Figure 11 Floor framing at north end of east basement; water stains and wood rot; note limestone threshold at upper left (photo 1:12, Fitzpatrick Structural Engineering, P.C., October, 1996)

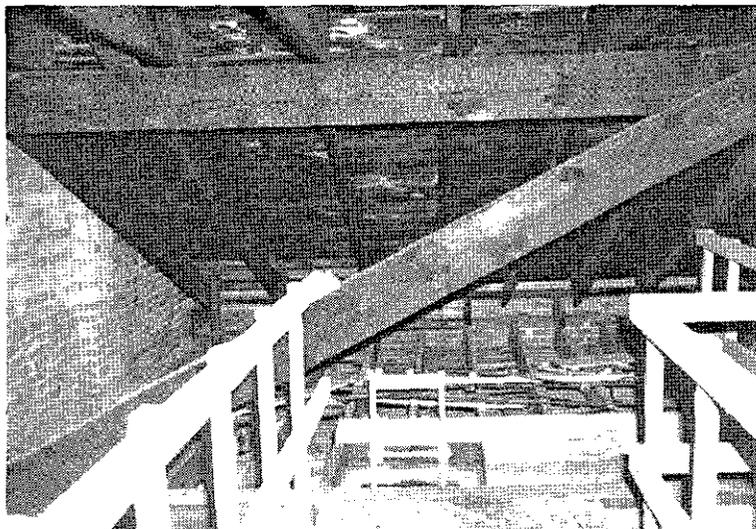
Figure 19 East end of Truss 3; note charring fire damage on top member; fire damage and water staining at joists and sheathing (photo 3:27, Fitzpatrick Structural Engineering, P.C., October, 1996)

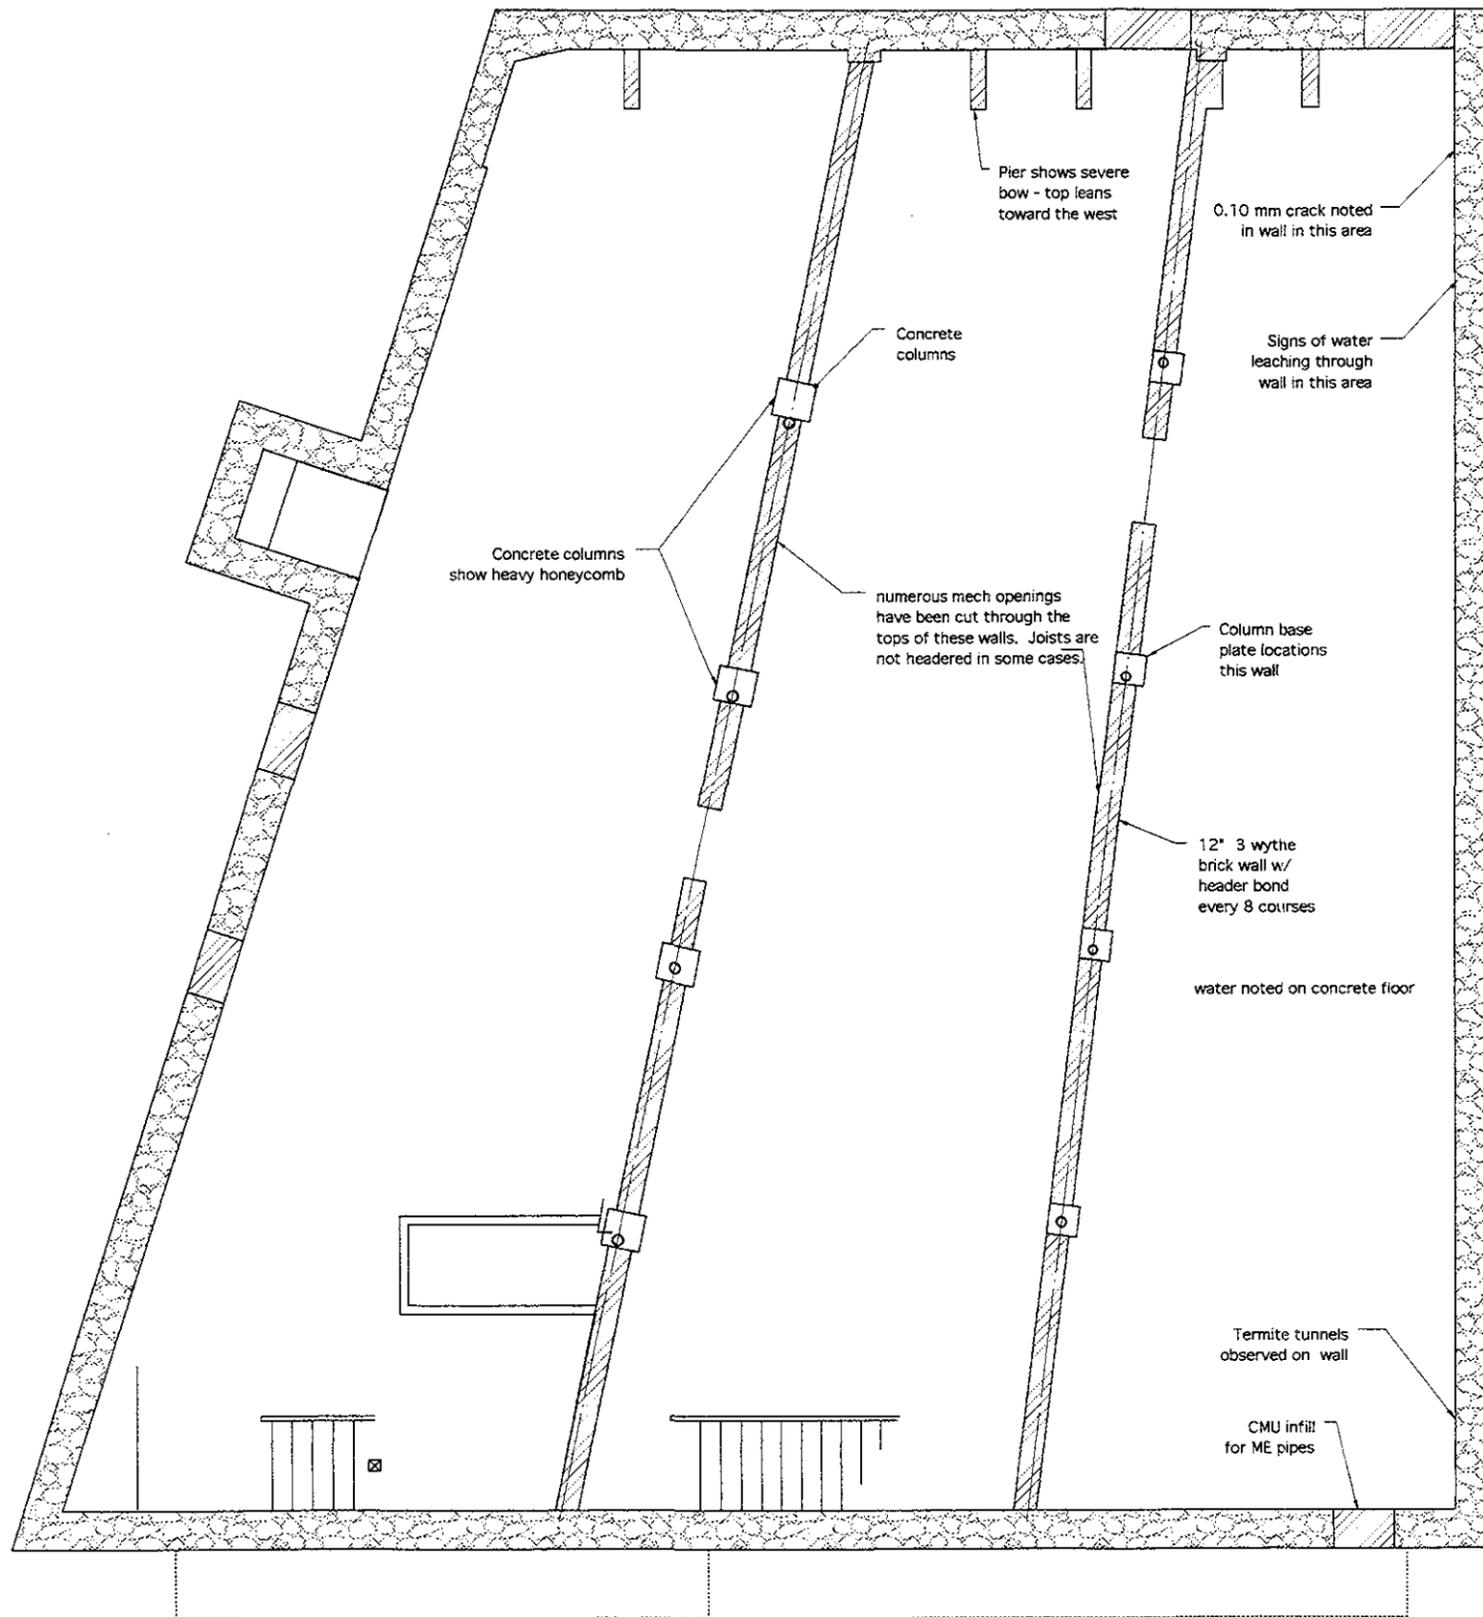
Pier shows severe bow - top leans toward the west
