HISTORIC STRUCTURE REPORT

Wright Hall Carillon Historical Park

Dayton, Ohio

March 30, 2006
Final Submission

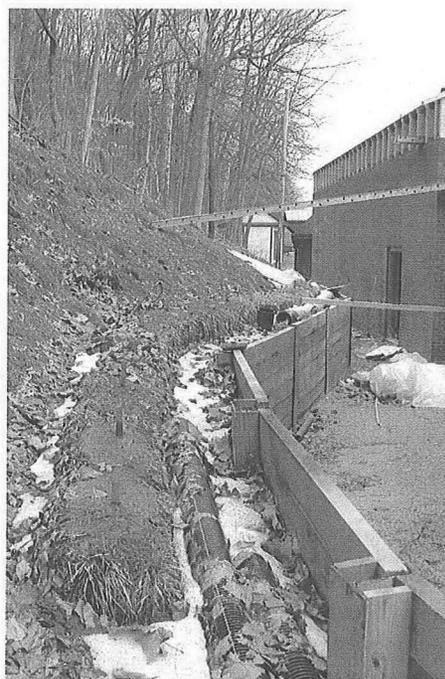
All of these systems remain intact. At the time of survey, the gutters on the south, west and east elevations were not complete, with missing leaders and leader straps. Modifications were made for drainage into an underground system on the south side of the building in an effort to eliminate the water penetration into the building (figure 24).

Figure 24: Moraine siting, south side of Wright Hall

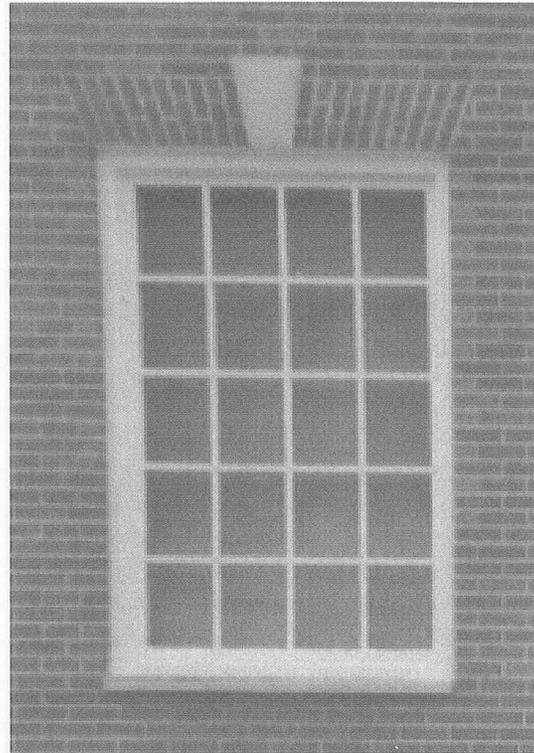
There is considerable evidence of brick pointing repair. This additional work may be explained by the

Figure 26: Window arch, typical

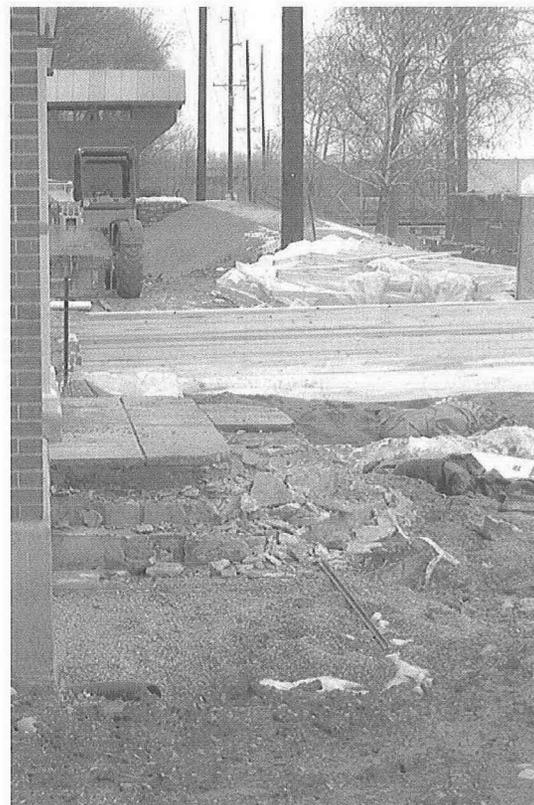
Figure 27: Dismantled front steps.

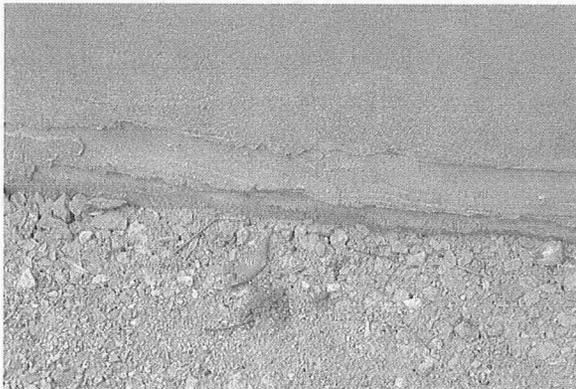
The recent drainage and diverting system installed appears to be functioning to solve the issue of runoff from the moraine. The resolution, however, of the ground water issue is not as clear. The clay-like, muddy texture of the fill immediately adjacent to the building is evident, while the fill from the drip edge to

Figure 28: Foundation condition at grade.

the retaining wall appears to maintain a coarse gravel appearance. This may be indicative of water retention adjacent to the building, or the perking of ground water up the exterior of the building.

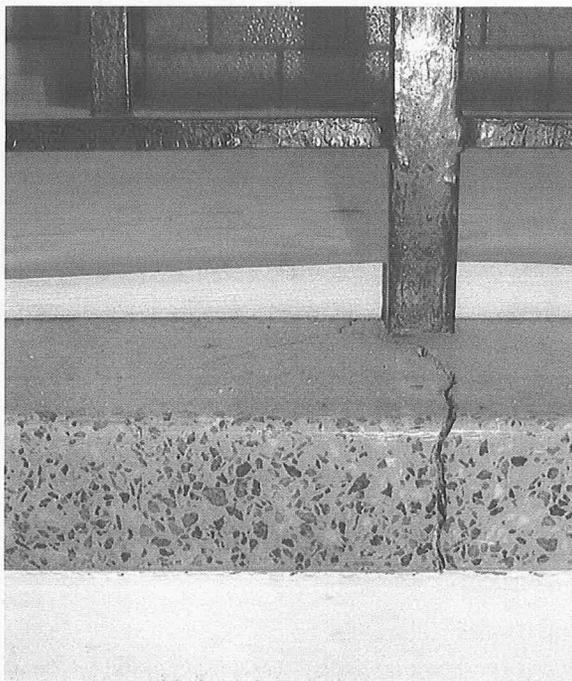
Figure 29: Crack in terrazzo floor.

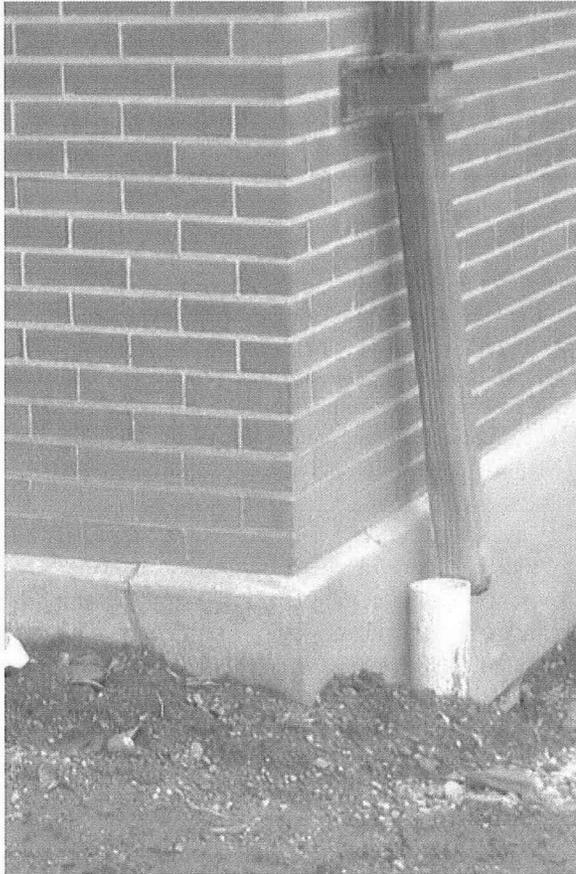
Figure 30: Evidence of cracking at floor on exterior

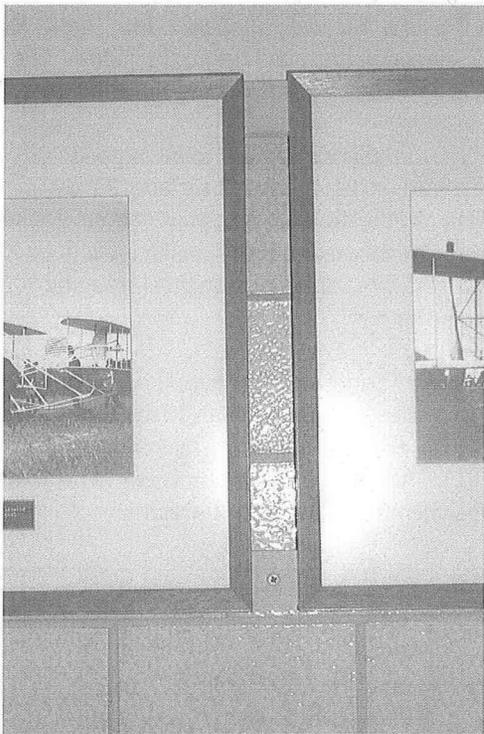
Glazed Brick: The glazed brick is generally in good condition, with some penetrations at the locations where the lower wood trim mounting rail is in place (figure 32). There is some mortar missing at the joints below the sills of each window corner.

Figure 32: Glazed brick at mounting rail.

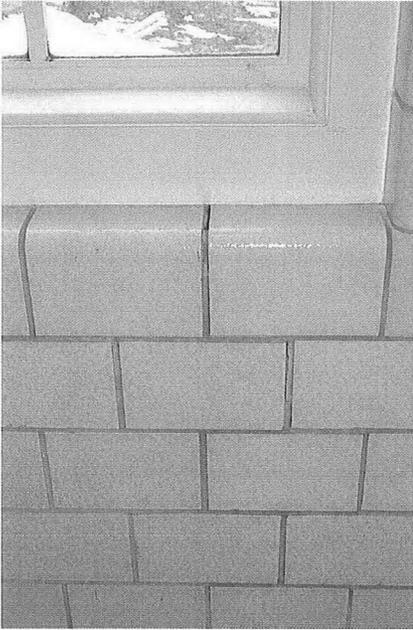
Figure 36: Glazed brick at window sill.

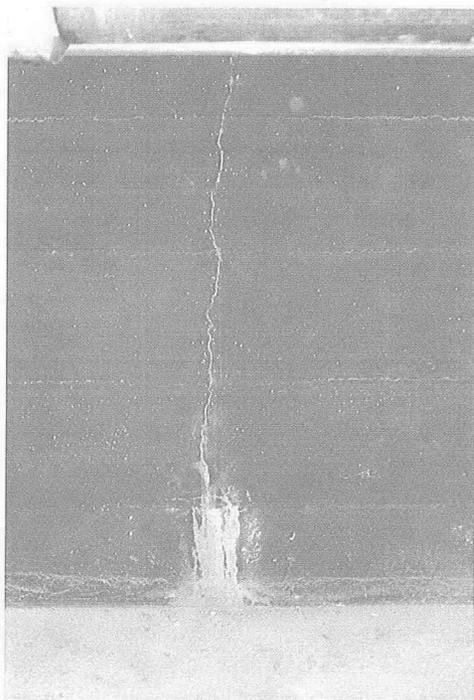
Figure 46: Interior wall foundation crack (QE|A 2000)

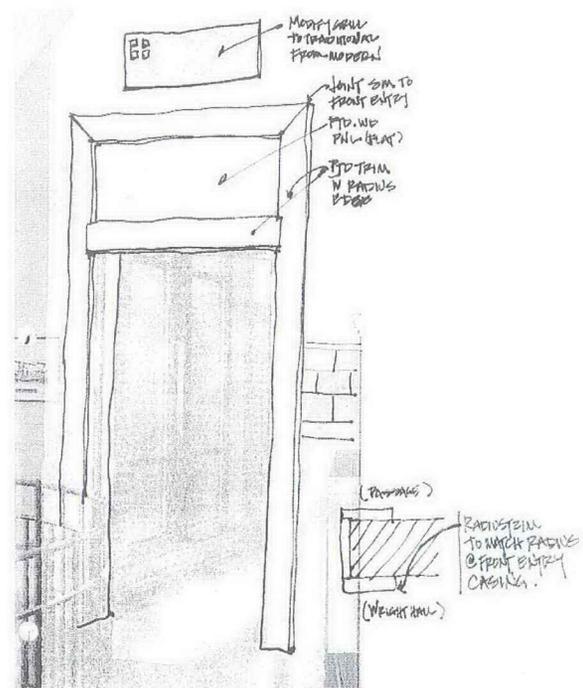
Figure 47: Proposed door trim simplification (QE|A 2000)

The recommendation is to maintain the east and west wing openings as doors and to modify the trim. In doing so, the trim should be simplified so that it is flat with a radius profile. The faux transom also should be trimmed out and the new opening replicated.

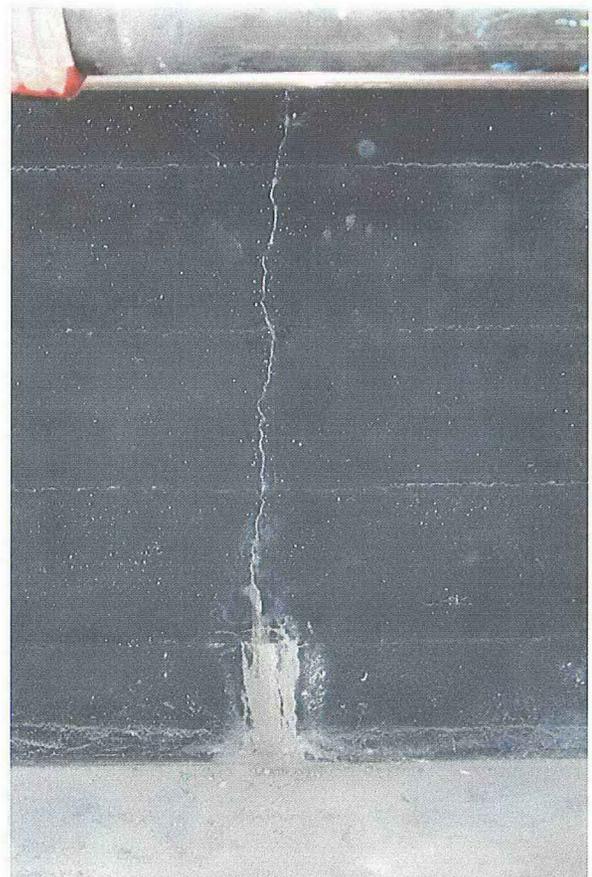
Wright Hall east plenum, thru-wall crack (QE|A 2000)

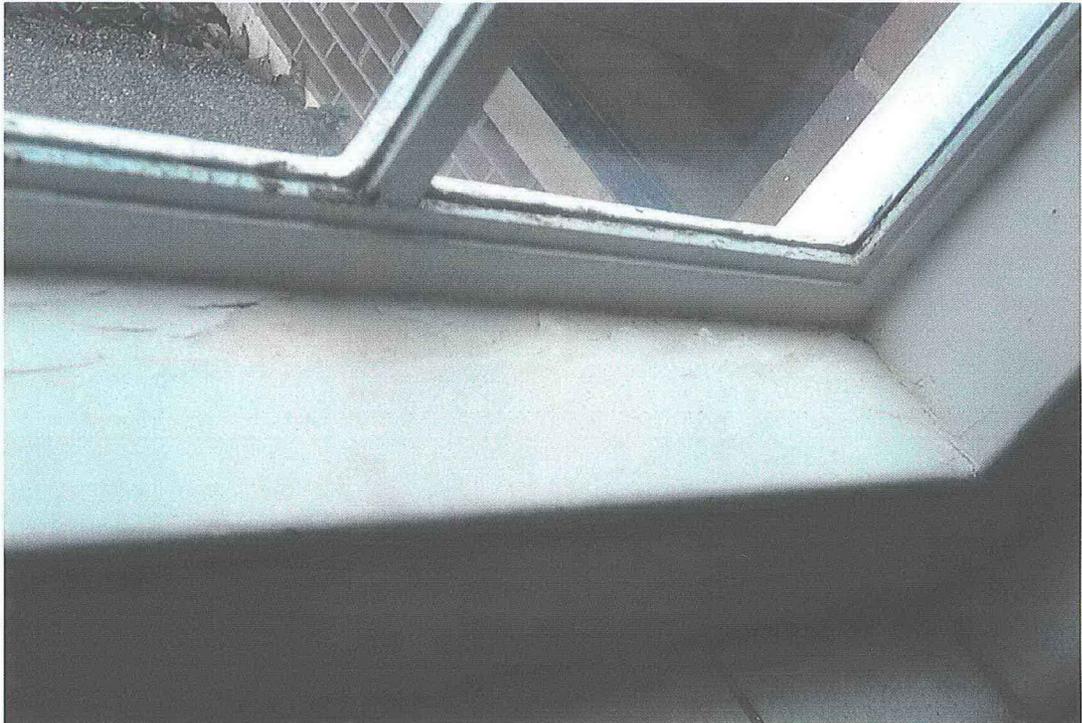
The remaining two windows on each side require some attention, as there is evidence of peeling paint and rusting metal.

Wright Hall interior, typical window condition (QE\A 2000)
