Fire Island Watch Hill Restaurant Structure Fire

Serious Accident Investigation

Factual Report

National Park Service
Fire Island National Seashore
October 29, 2019

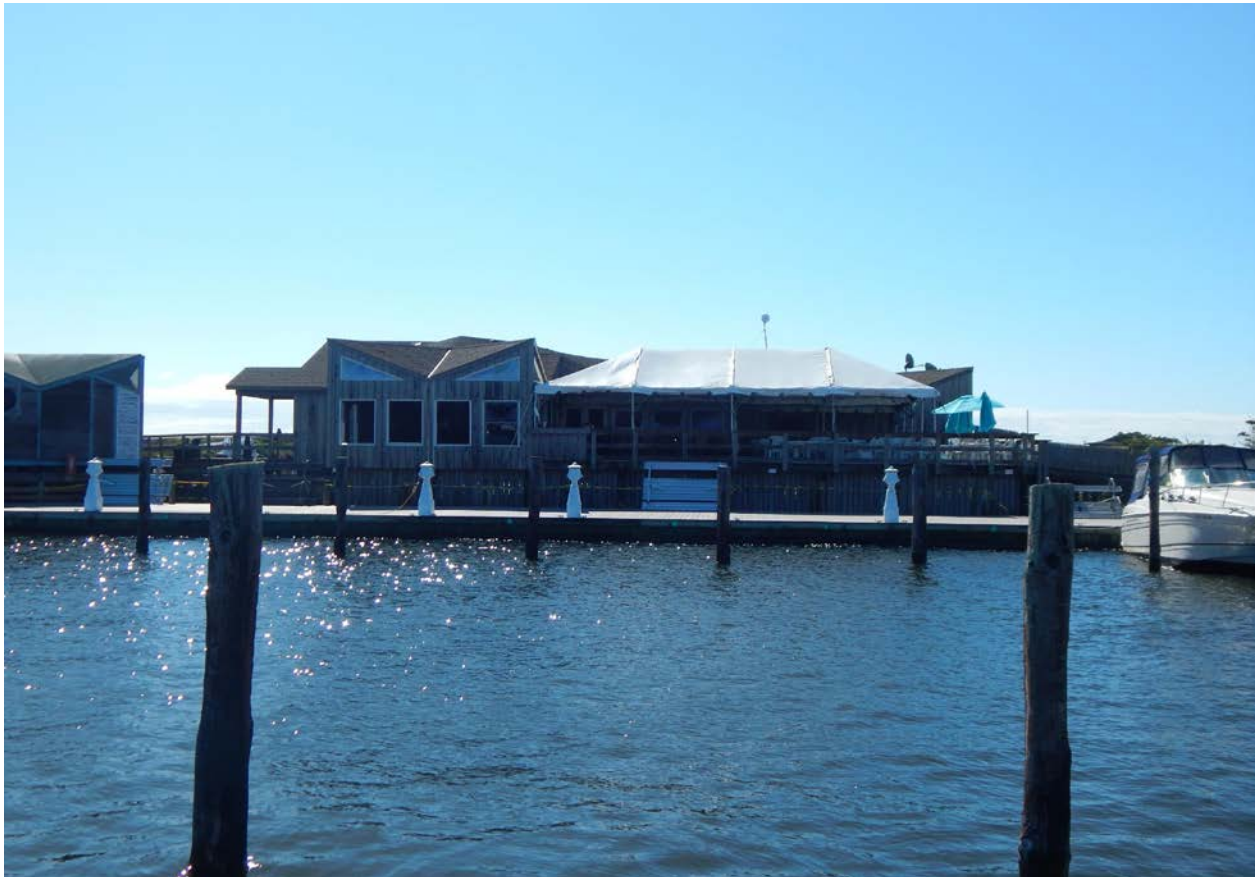
Photo 1 – Post Fire Photo of the West side of the restaurant

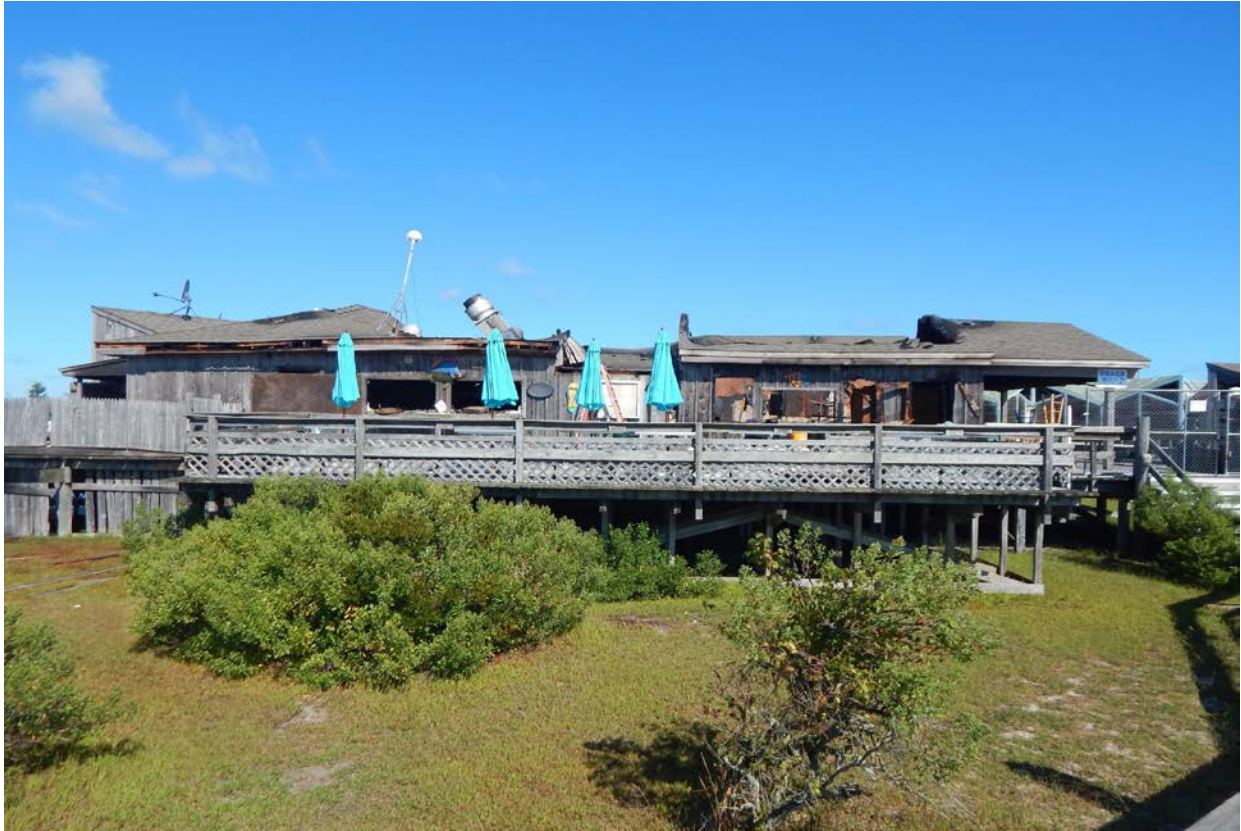
Photo 2 – Post Fire Photo of the East side of the restaurant

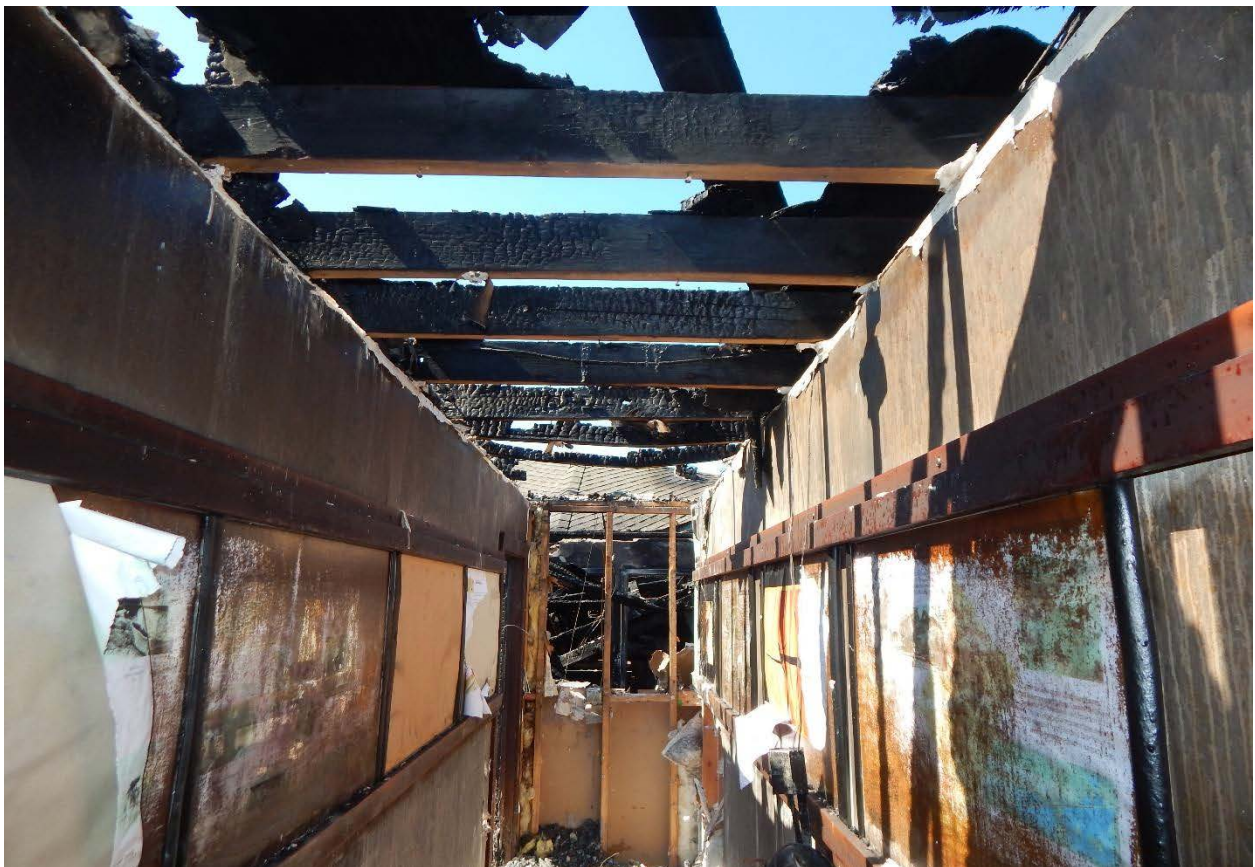
Photo 19 – Hallway to women's restroom – notice increased damage to ceiling joist closer to the women's restroom

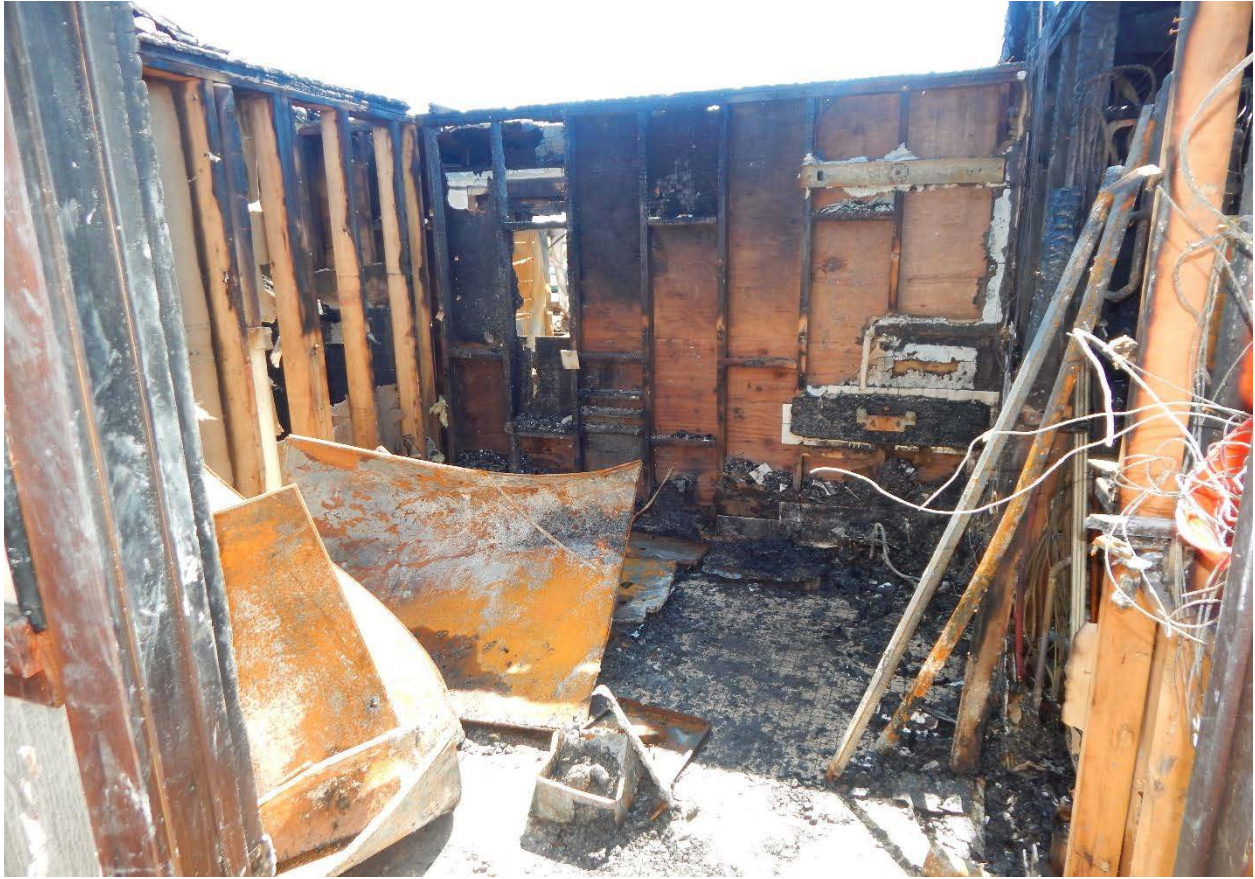
The area of most fire damage was found to be the women's restroom south wall that divides the restroom from the mechanical room. The propane fueled water heater is

Photo 20 – Women's restroom

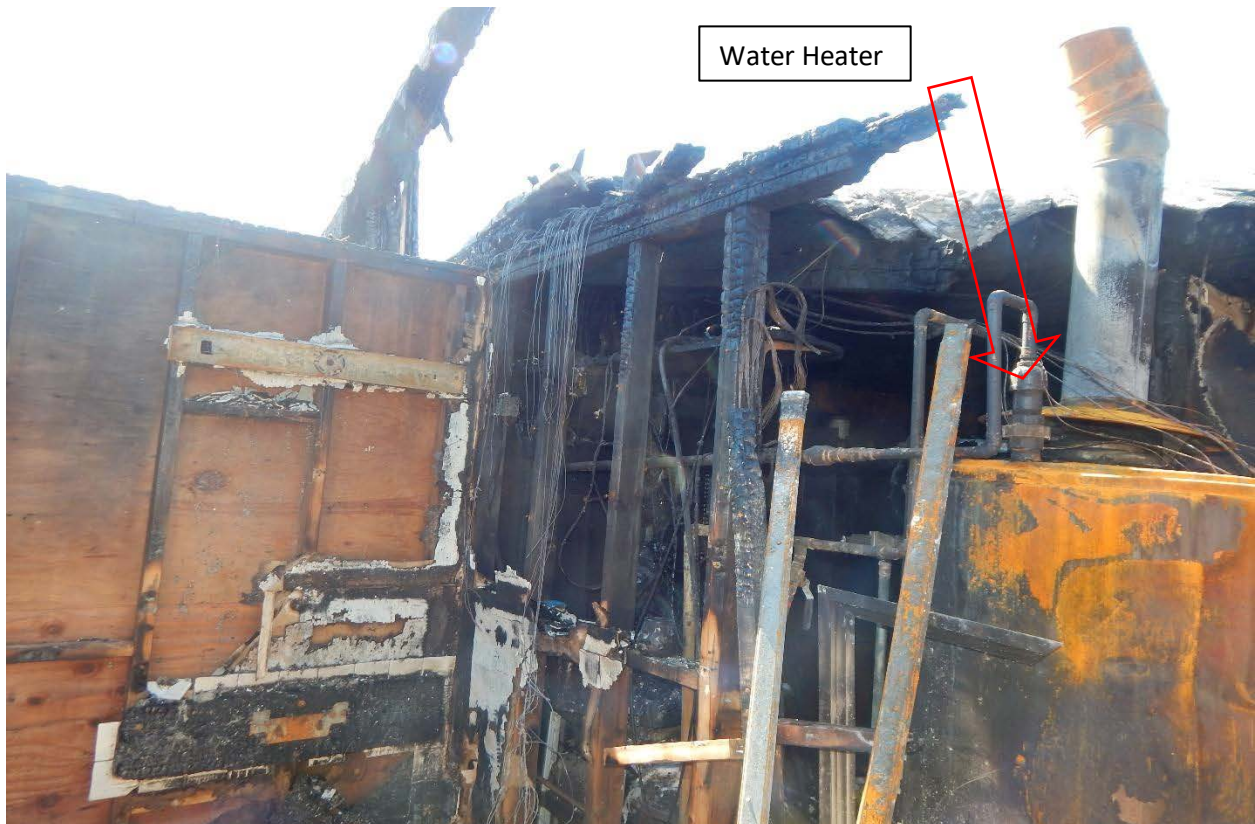
located in this area on the opposite side of the wall. The ceiling joists and all of the roof structure had been burned away in this area. The wall separating the women's restroom from the mechanical room was constructed of 2x4 wooden studs and top/bottom plates, gypsum board (sheetrock) was installed on the restroom side of the wall. The mechanical room side of the wall had no wall covering. The water heater was installed in a compact space with less than six inches of separation from the combustible construction on all sides except the front. The front of the water heater had combustible storage within eighteen inches of the burner opening. This combustible storage did not contribute to the fire due to the fact the material was intact after the fire with only smoke and heat damage. Two wall studs and approximately twenty-four inches of the top plate of the wall separating the women's restroom from the water heater were completely consumed by the fire. No other wall studs or top plates in the building were completely destroyed. The remainder of the mechanical room sustained heat and fire damage but the contents were not completely destroyed. The ceiling of the mechanical room was open to the roof deck and supporting members.

- Two wall studs and approximately twenty-four inches of the top plate of the wall separating the women's restroom from the water heater were completely consumed by the fire.

- Areas of heavy char and low burn were noted on the existing studs and bottom plate adjacent to the water heater.
 - The wall's wooden structural members may possibly have been the first fuel ignited.

Photo 21 – Wall separating the women's restroom for the mechanical room

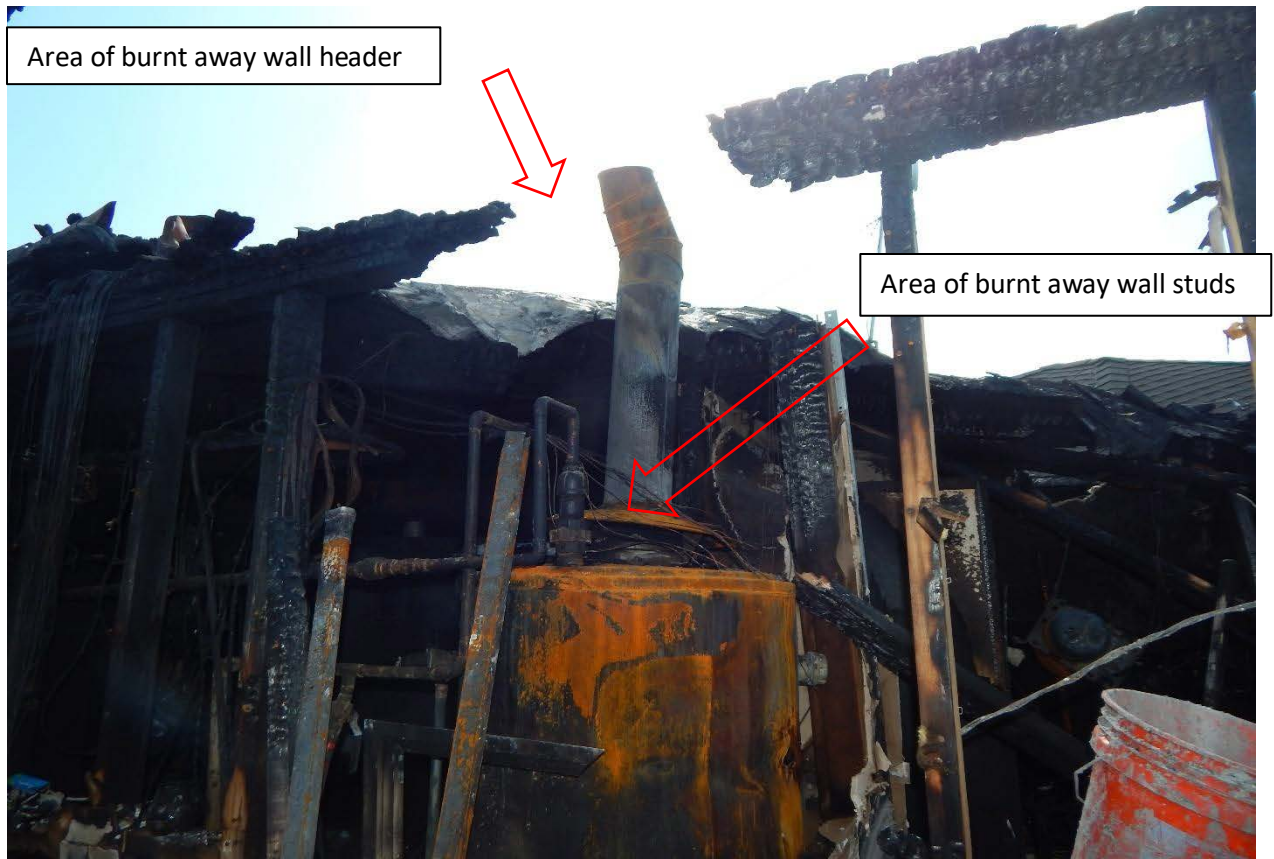
Photo 22 – Wall separating the women’s restroom for the mechanical room

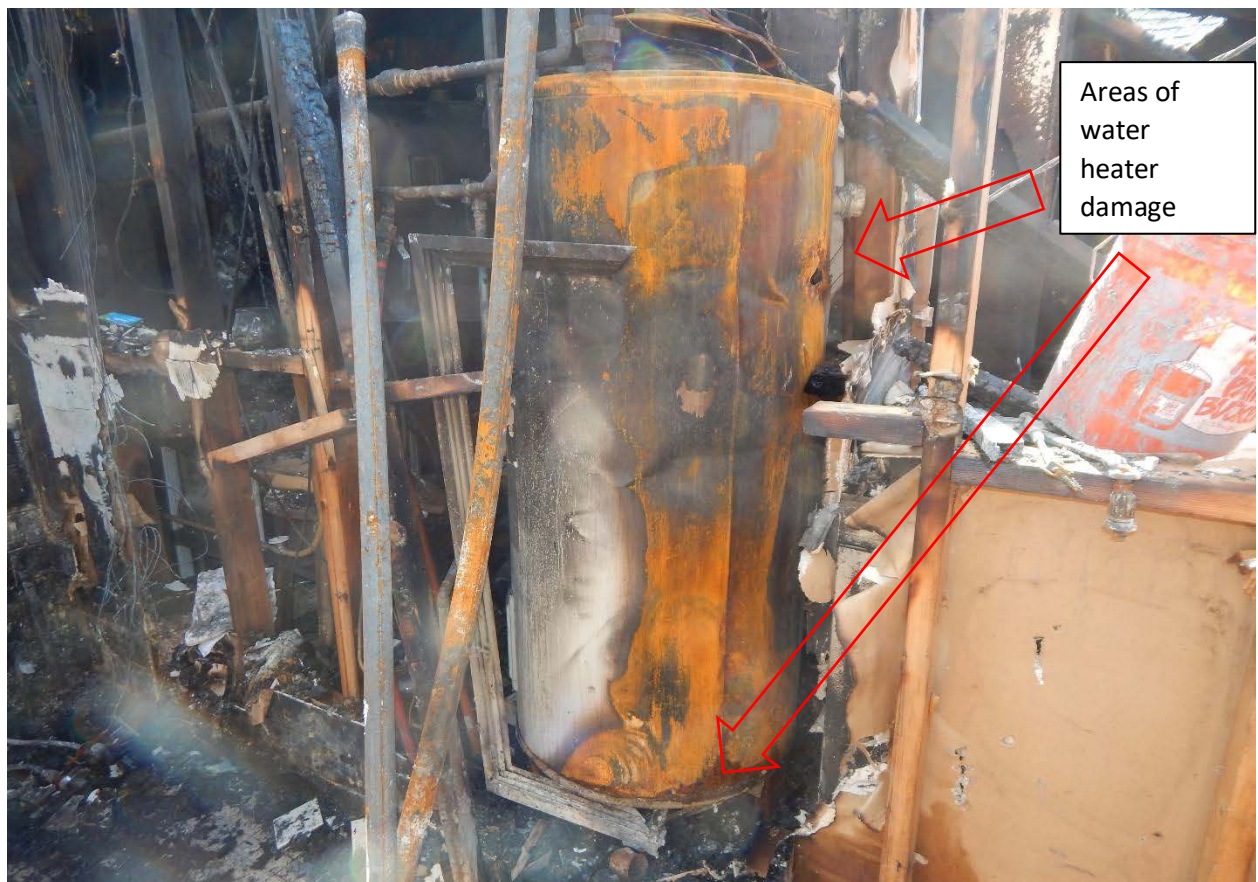
Photo 23 – Water heater as seen from the women’s restroom

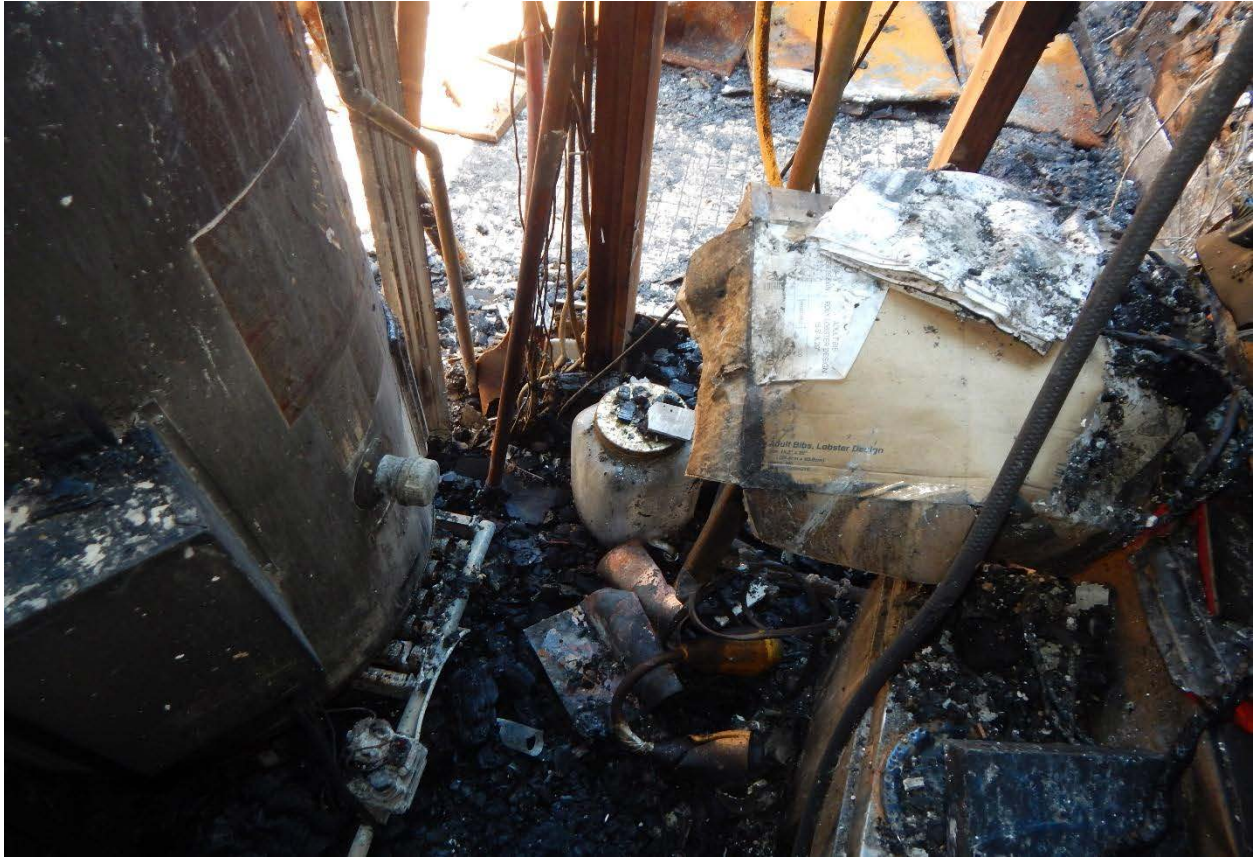
- Combustible storage: The mechanical room was used for storage of combustible material, such as soda machine distribution equipment, cleaning equipment, and supplies. A review of post-fire photographs does show a moderate amount of combustible storage within eighteen inches of the front of the water heater, however this material was still intact. It is not known if any combustible storage was on either side of the water heater.

Photo 24 – Water heater front with combustible storage nearby

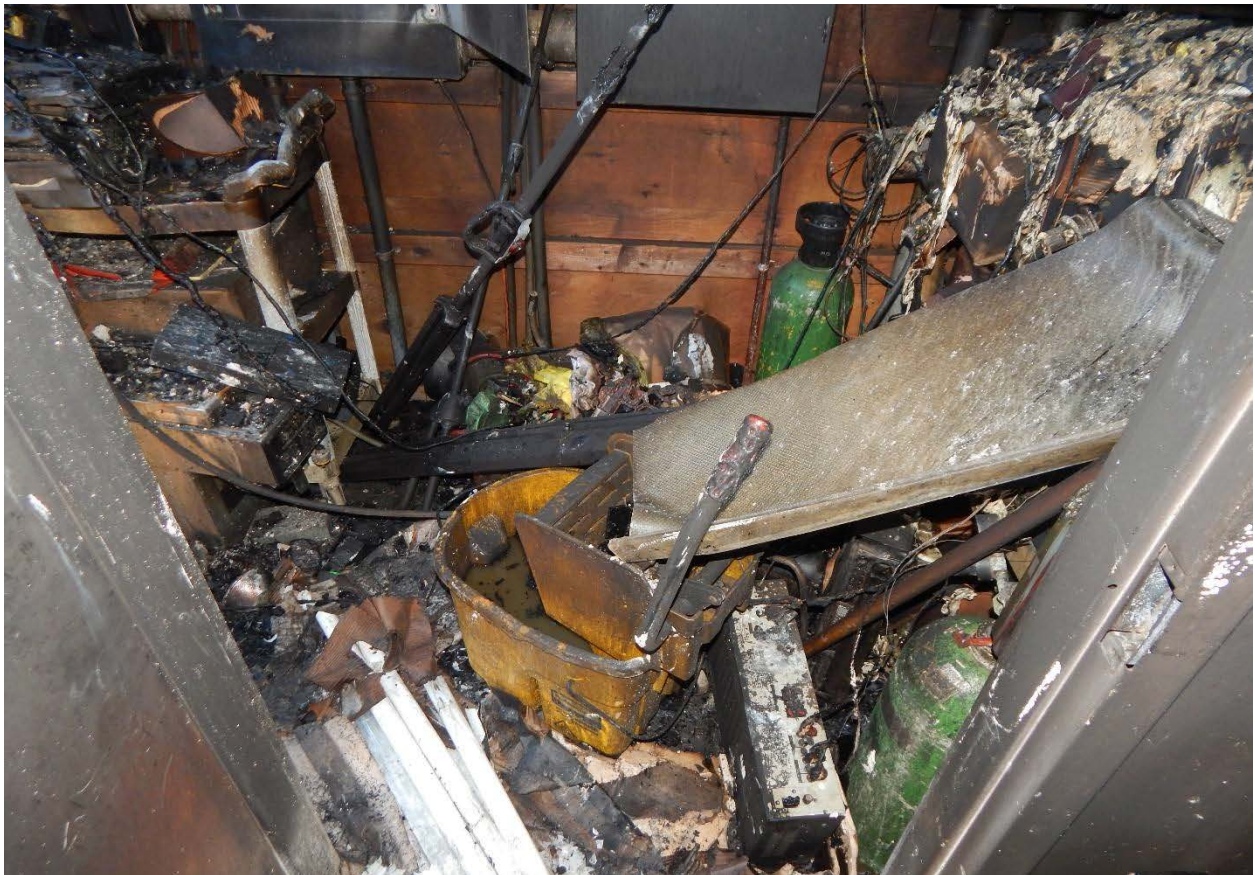
- Combustible construction: The building construction material consists of wooden walls, floors, joists, rafters, and roof deck. The mechanical room walls and ceiling were not covered, leaving the wooden structural members exposed to the interior of the room.

Photo 25 – Mechanical room with cleaning supplies, soda dispenser equipment and combustible storage

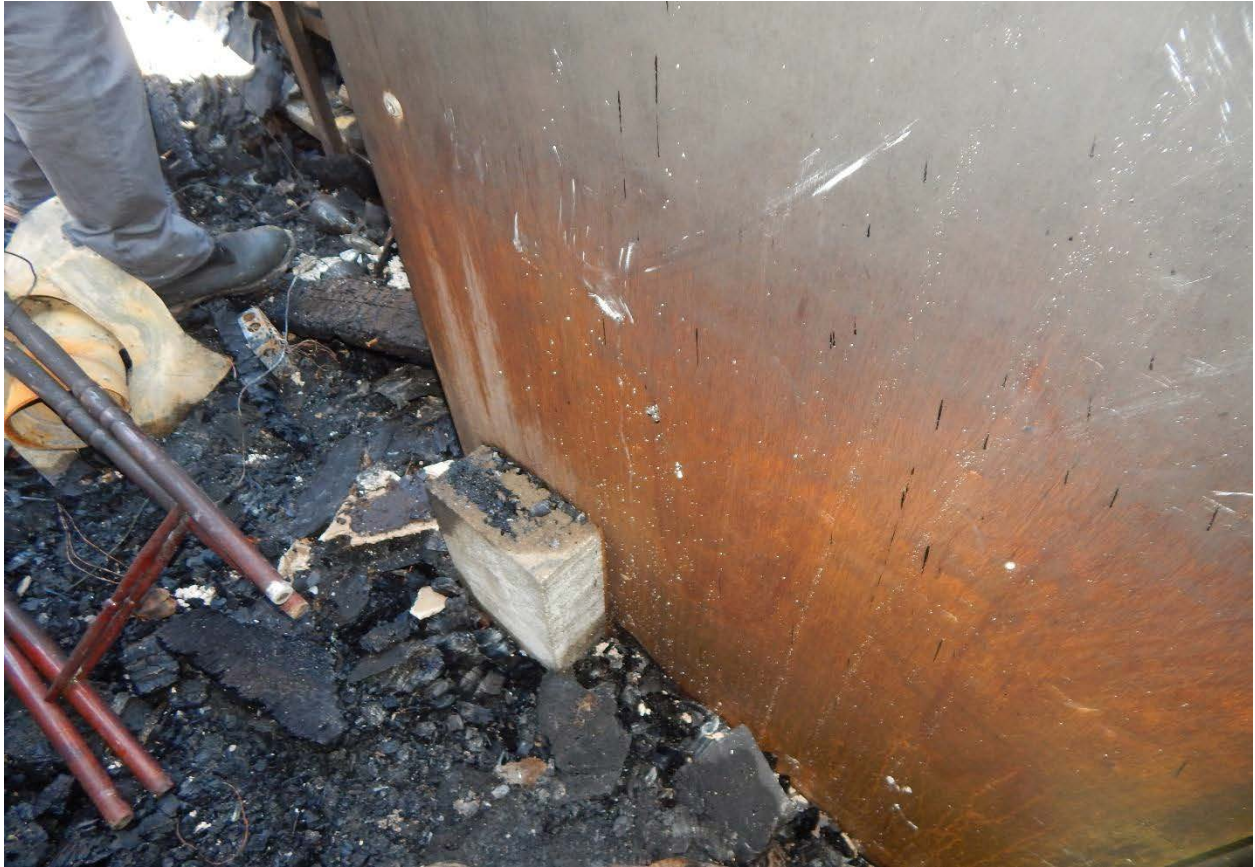
Three fire rated doors were found in the structure; mechanical room door, and two doors leading to the kitchen from the prep area. All of the fire rated doors were found to be held open with wooden wedges or a concrete cap block at the time of the fire. Although there were fire rated doors installed in these areas the walls in which they were installed were not rated assemblies. Due to these doors being open, the fire was able to receive an unrestricted supply of air from both the open ceiling area and open doors.

Photo 26 – Rated door to the mechanical room held open by a cap block

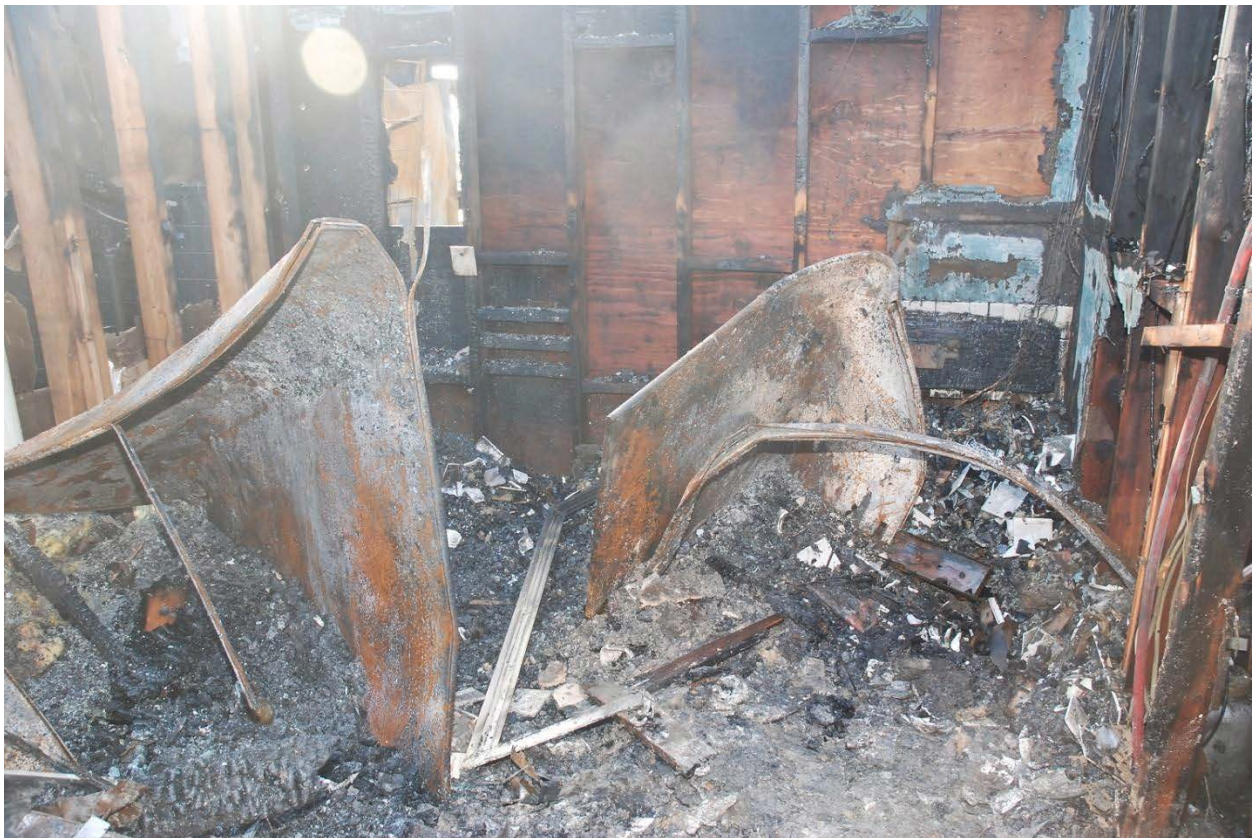
Photo 31 – Women's restroom before removal of fire debris

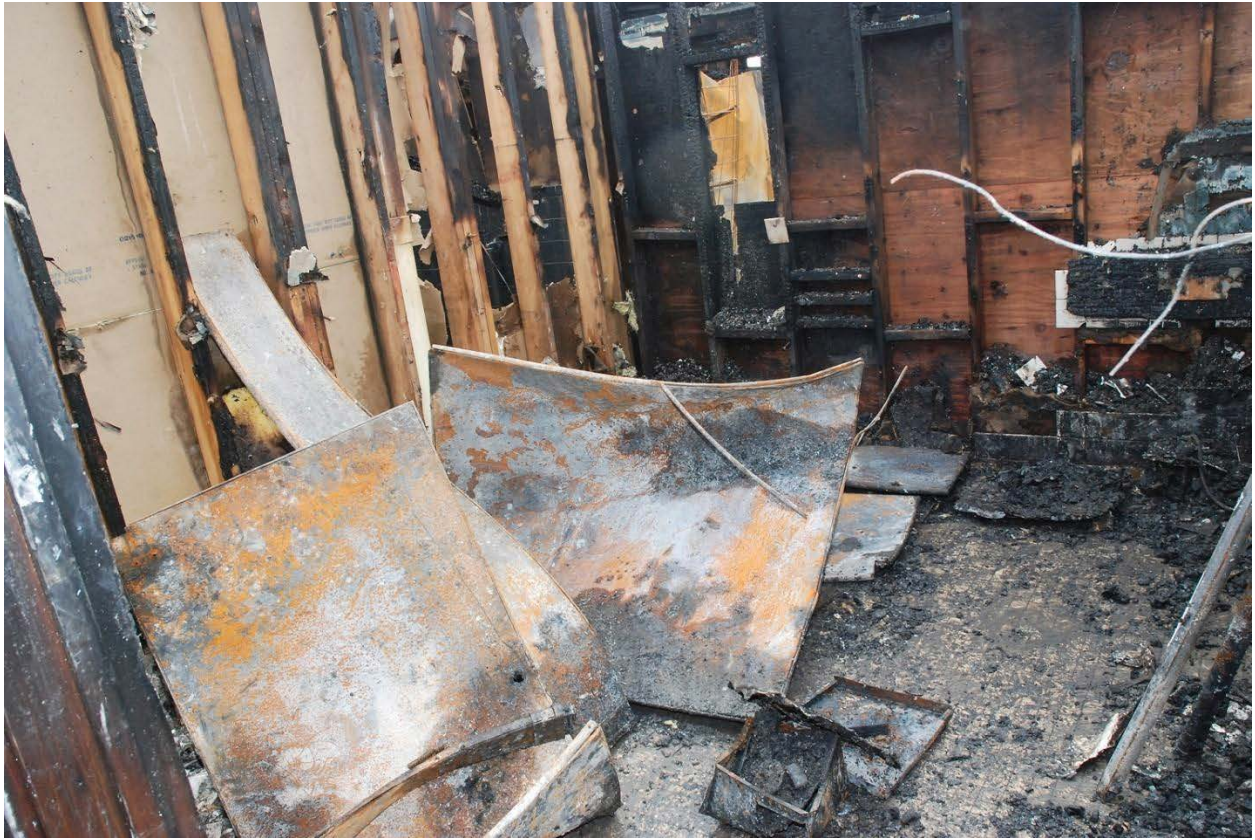
Photo 32 – Women's restroom after removal of fire debris

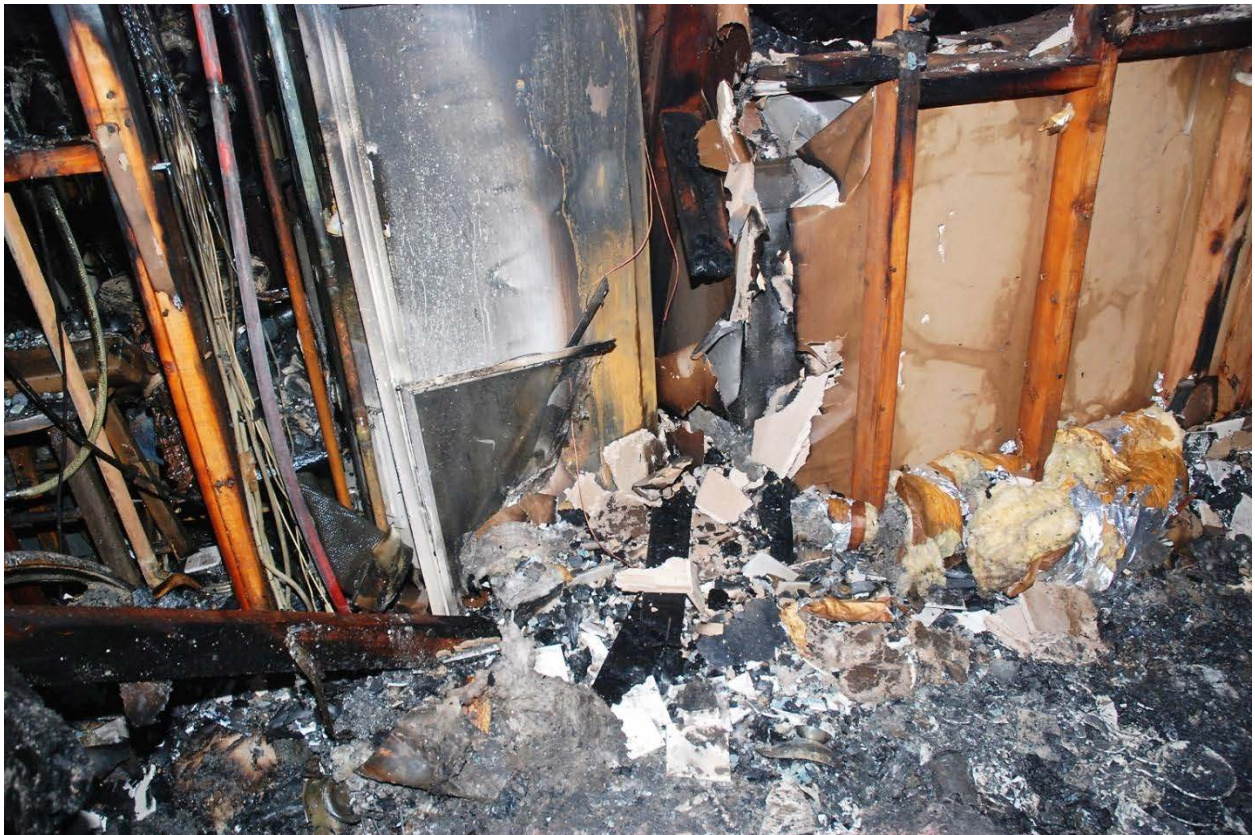
Photo 33 – Water Heater before debris has been removed

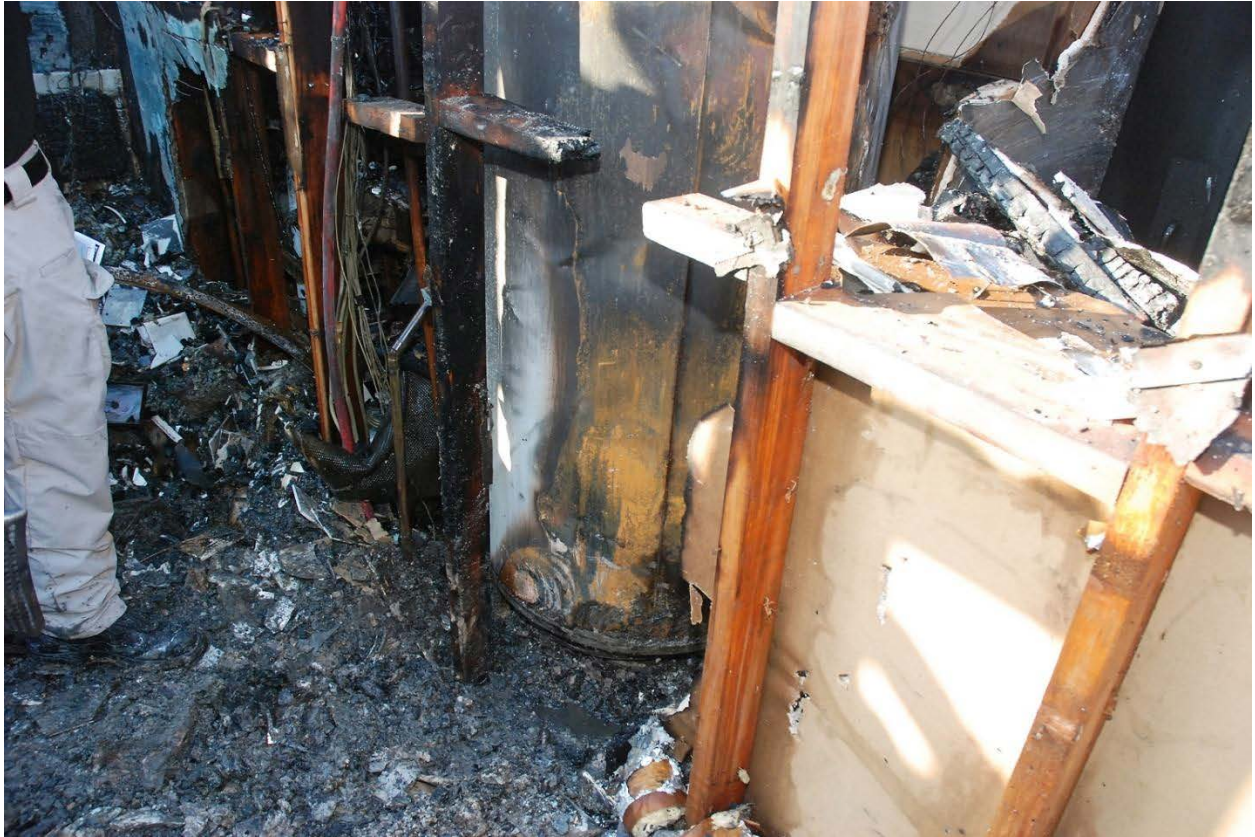
Photo 34 – Area of water heater after debris has been removed and area of burnt away wall studs

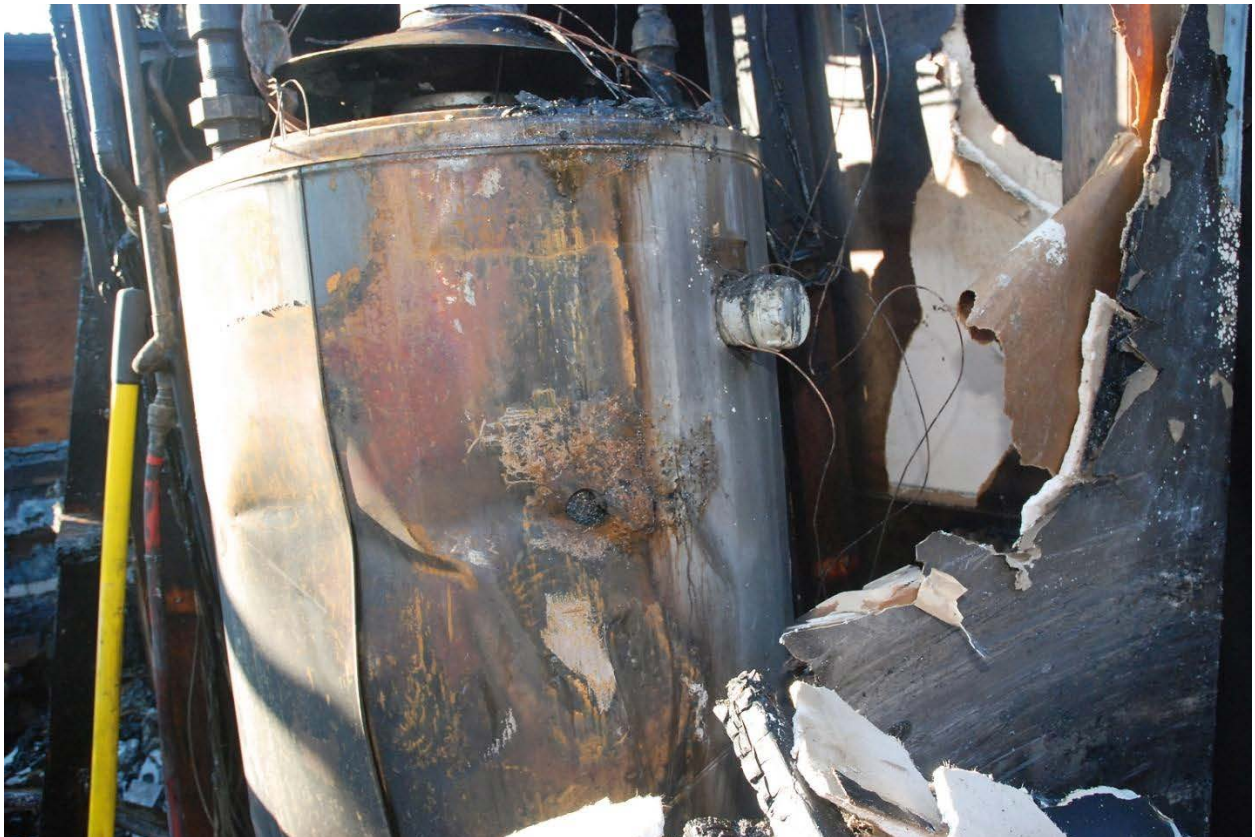
Photo 35 – Damage to water heater

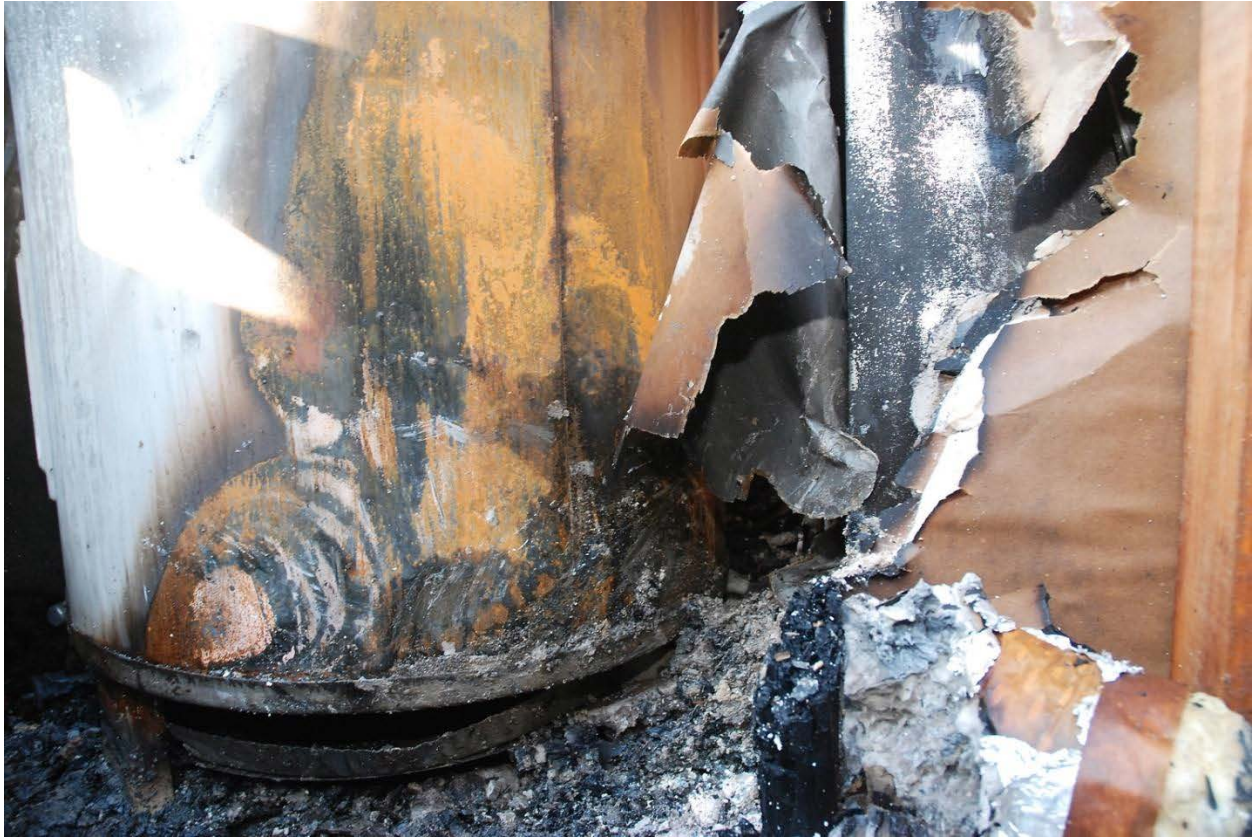
Photo 36 – Damage to water heater

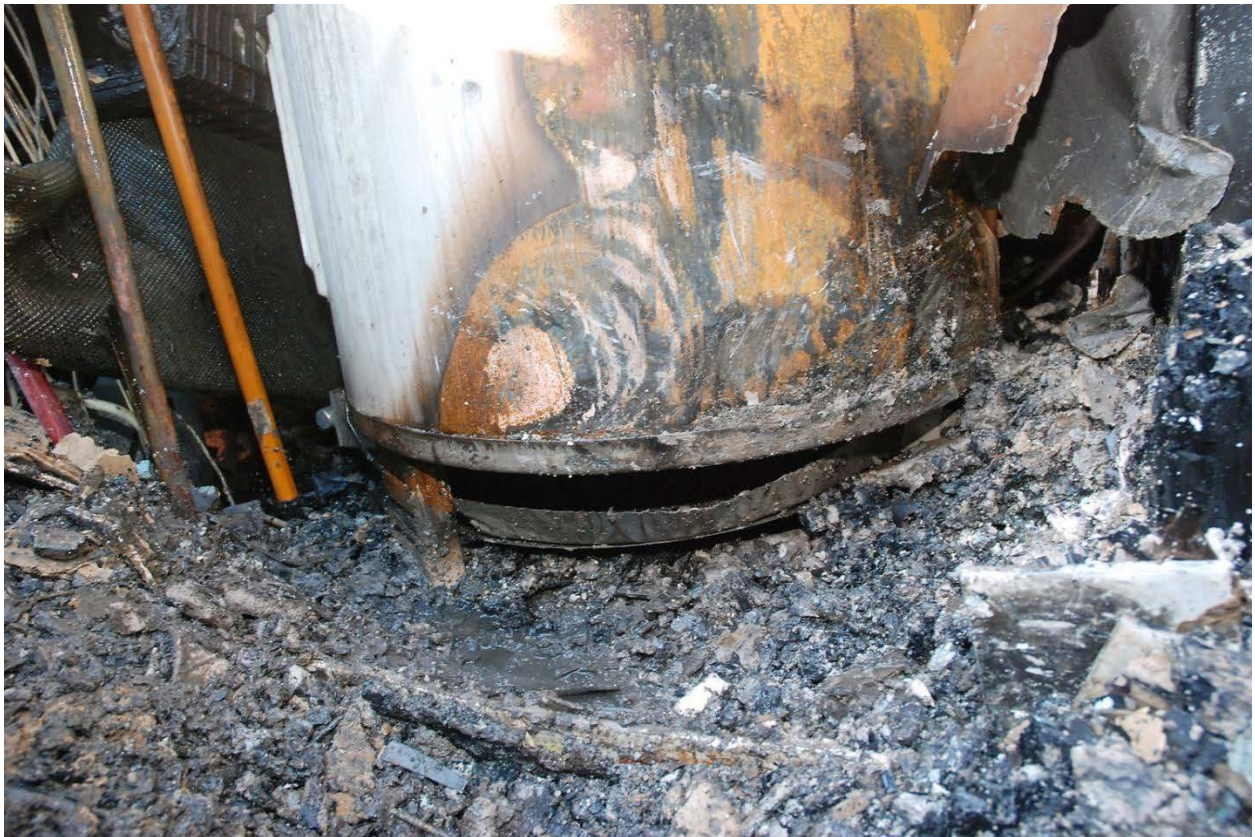
Photo 37 – Possible heat or fire pattern on water heater

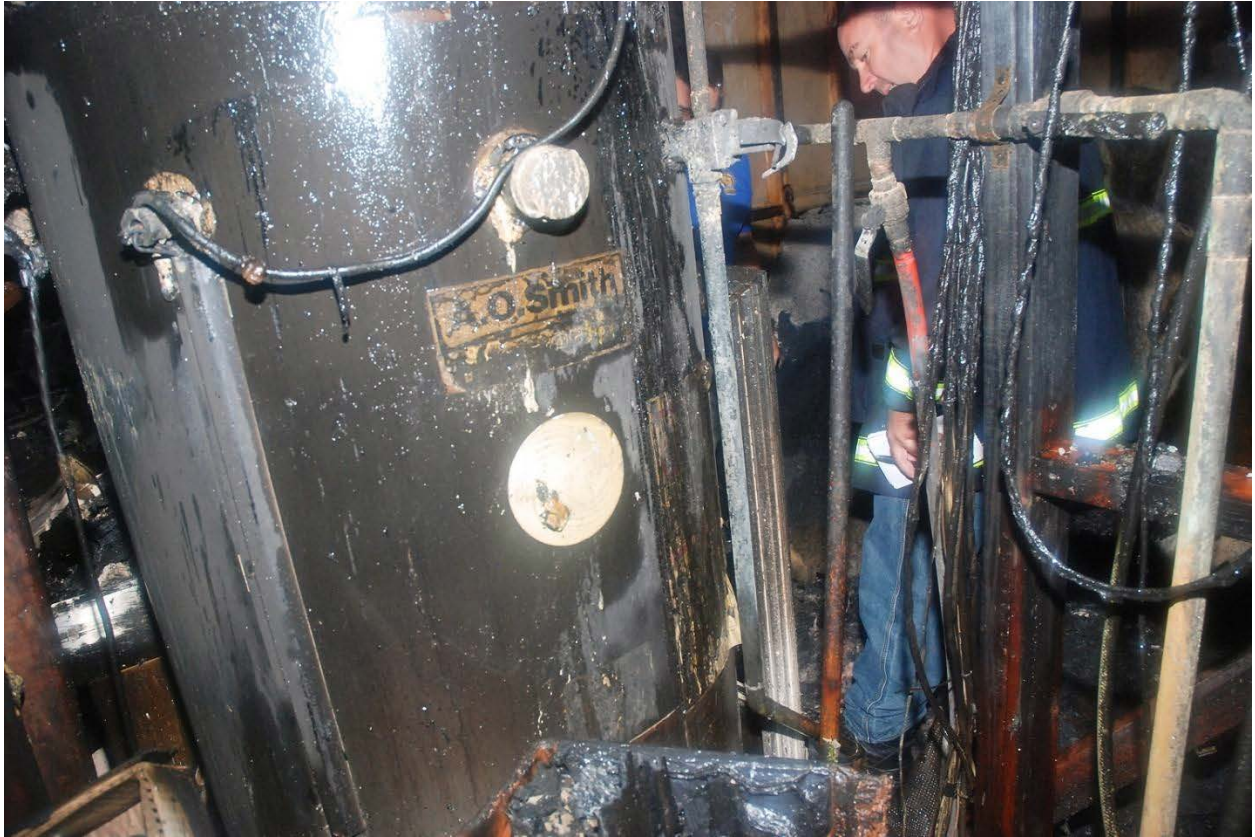
- Propane fueled water heater: The water heater was manufactured by the A.O. Smith Company. The model and serial number of the water heater were unable to be verified by either a data plate or from the park's records. The SCPD did discover that there were several fire hazard recalls for this make of water heater, but was unable to verify if the recalls pertained to this specific heater since the model and serial numbers were not available. It could not be determined if the deformities to the water heater visible in the photographs were in place prior to the fire or occurred as a result of the fire. The concessioner stated that the water heater would occasionally "flare out" due to excessive down draft from the water heater vent. This would cause the water heater to need to be reset. On September 3, 2019 two employees stated to the SCPD investigator that they had smelled propane briefly in the area of the mechanical room, but the smell had quickly dissipated. There were no records of the water heater having been serviced or repaired.

Photo 38 – Manufacturer of water heater
