historic structure report  
architectural data section

FREDERICKSBURG AND SPOTSYLVANIA  
COUNTY BATTLEFIELDS MEMORIAL  
CHATHAM

NATIONAL MILITARY PARK/VIRGINIA

Prepared by Gerald Karr  
Edited by Harlan D. Unrau

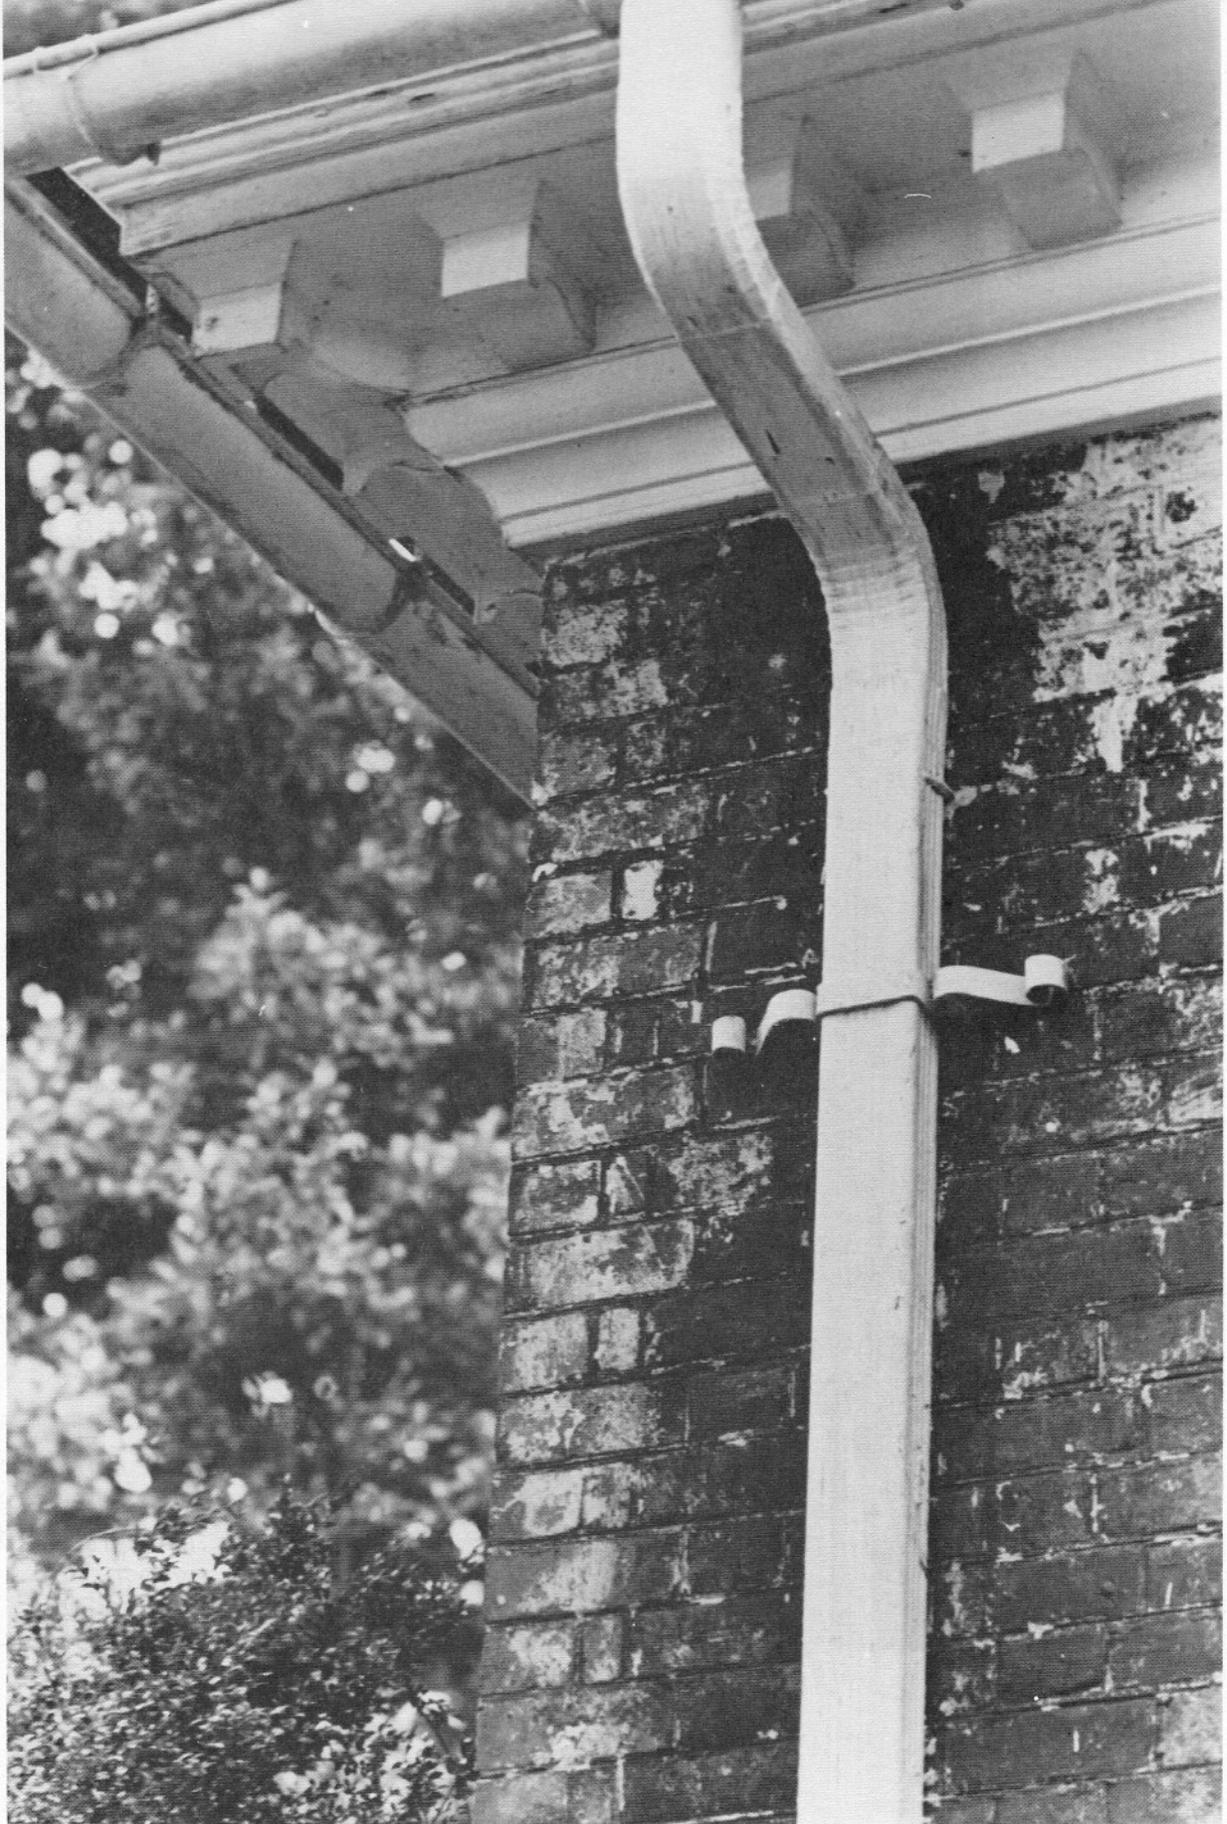
33. Chatham. Plantation House, Northwest corner, showing the rubber-brick corners employed throughout the building. Note also the extraordinary condition of the original bracketed cornice. Photograph by Gerald Karr, 1976.

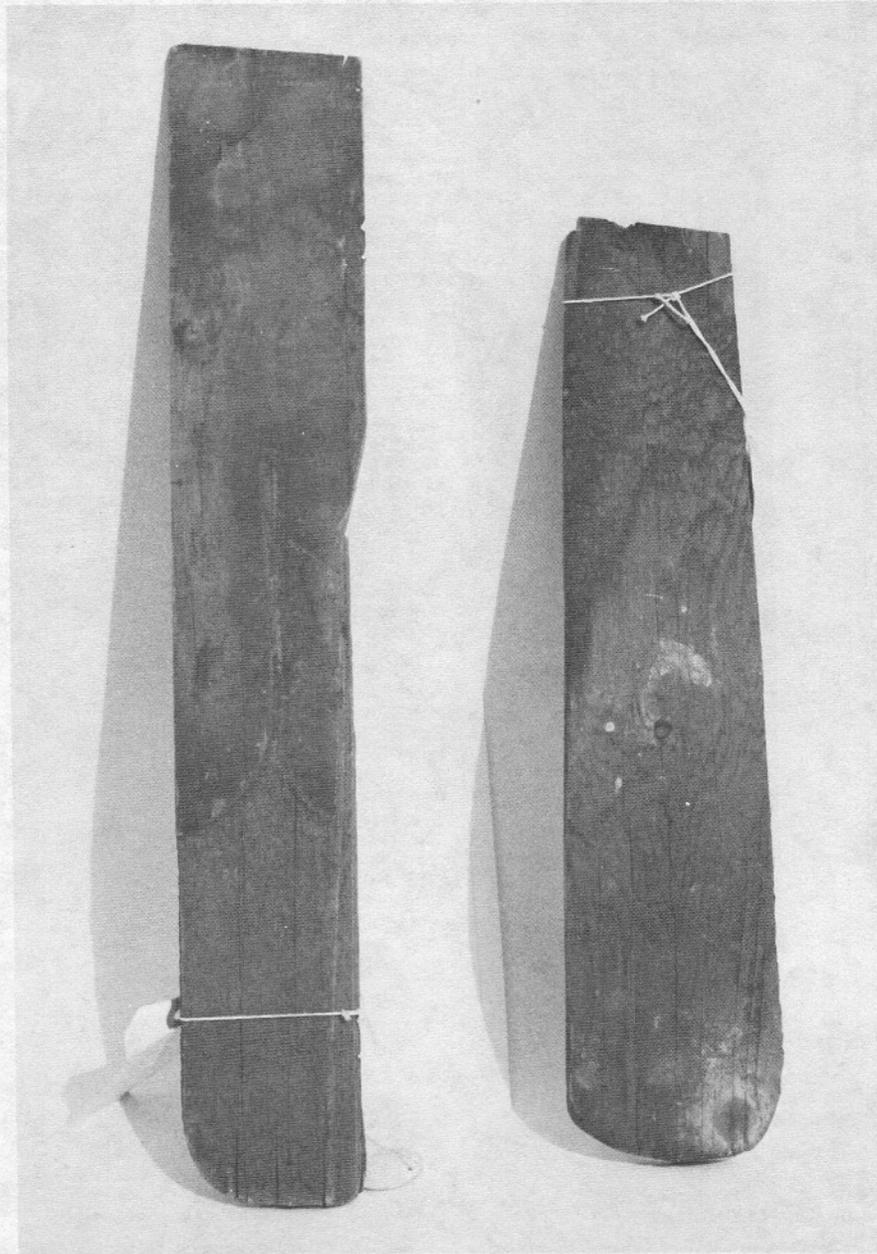
Believed to be the oldest of these shingles are two handsplit and drawknife-dressed cedar shakes with round 5/8-inch thick butts. One of these is considerably worn by erosion, leaving the pattern of the adjacent course etched on its surface. The extraordinary wear on this shingle indicates an especially long exposure before replacement. Civil War photographs reveal quite clearly that the shingles were square butted by 1863. One may assume that the building was re-roofed shortly before the war by Major Lacy, who also undertook several changes on the interior of Chatham. The other shingle was never installed, perhaps because it was too short. This artifact is especially valuable because it illustrates the degree to which finish and shaping was carried in making shingles for the house. From these two examples the length, width, thickness, spacing, and exposure of the original 18th century room can be determined.

34. Chatham. Plantation House. Shingles found in the attic during architectural investigation. The one on the left has the mark of erosion where it was exposed. The right shingle was never installed. Photograph by Gerald Karr, 1976.

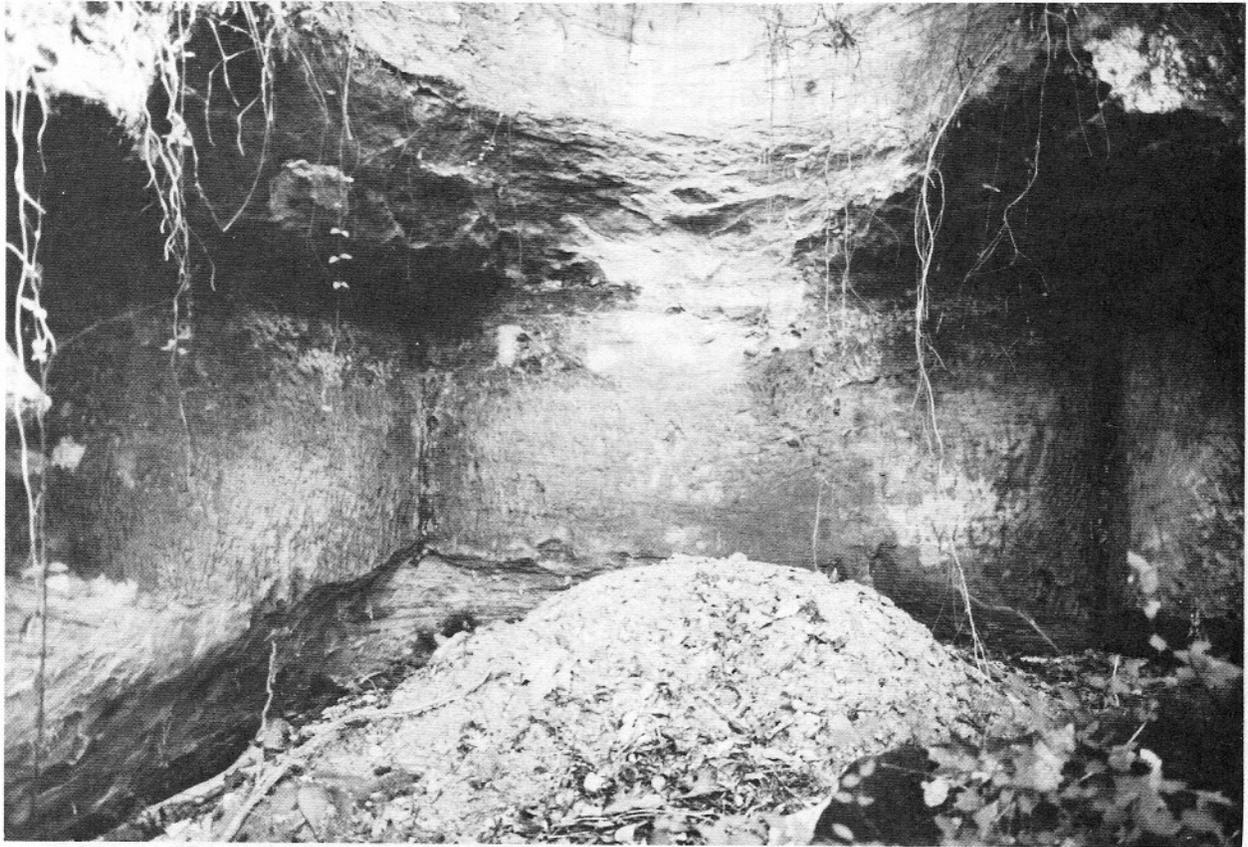
61. Chatham. Cave Remains. Possibly an ice house. The roof of the cave collapsed or was broken in reportedly during the Pratt residence. Photograph by Gerald Karr, 1976.

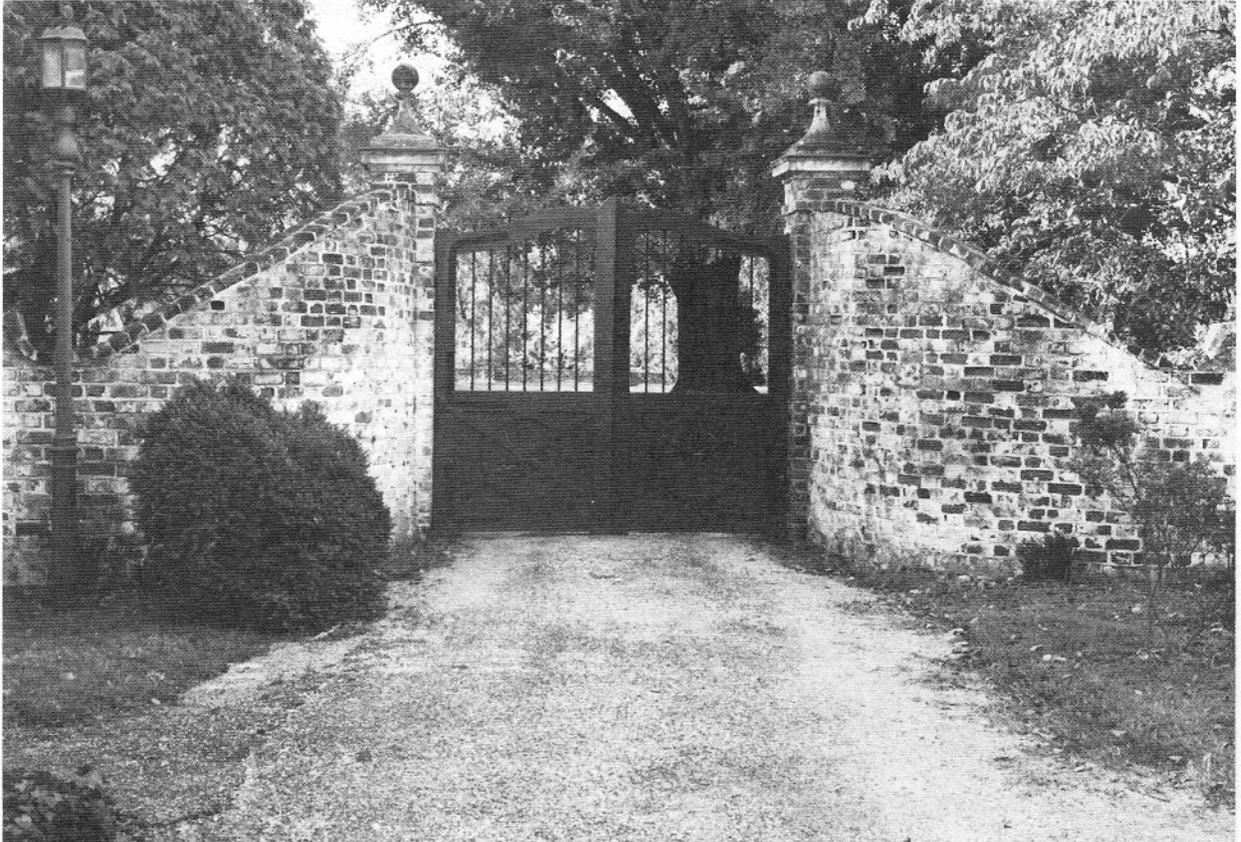
62. Chatham. Gate. The dark bricks are voids where the material has eroded away. Photograph by Gerald Karr, 1976.

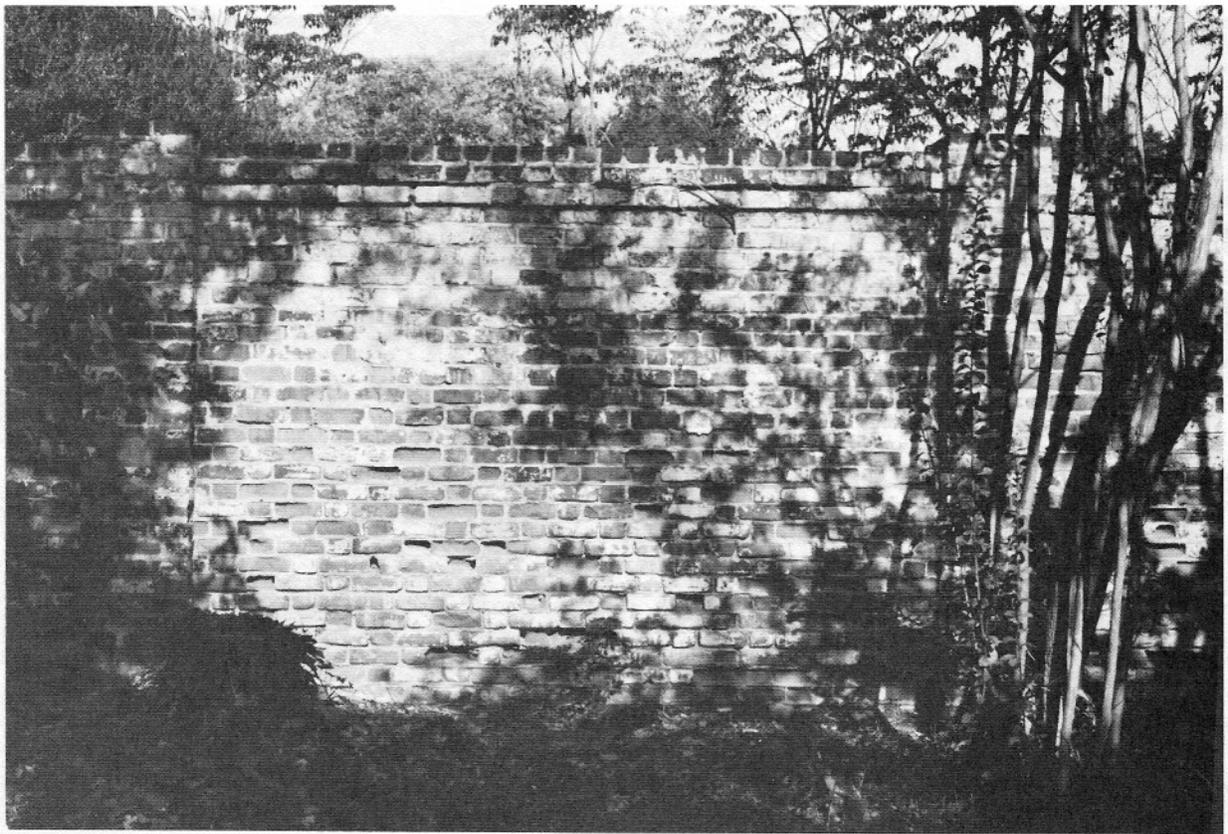
63. Chatham. Garden Wall. The deteriorated area is typical throughout the wall. Photograph by Gerald Karr, 1976.

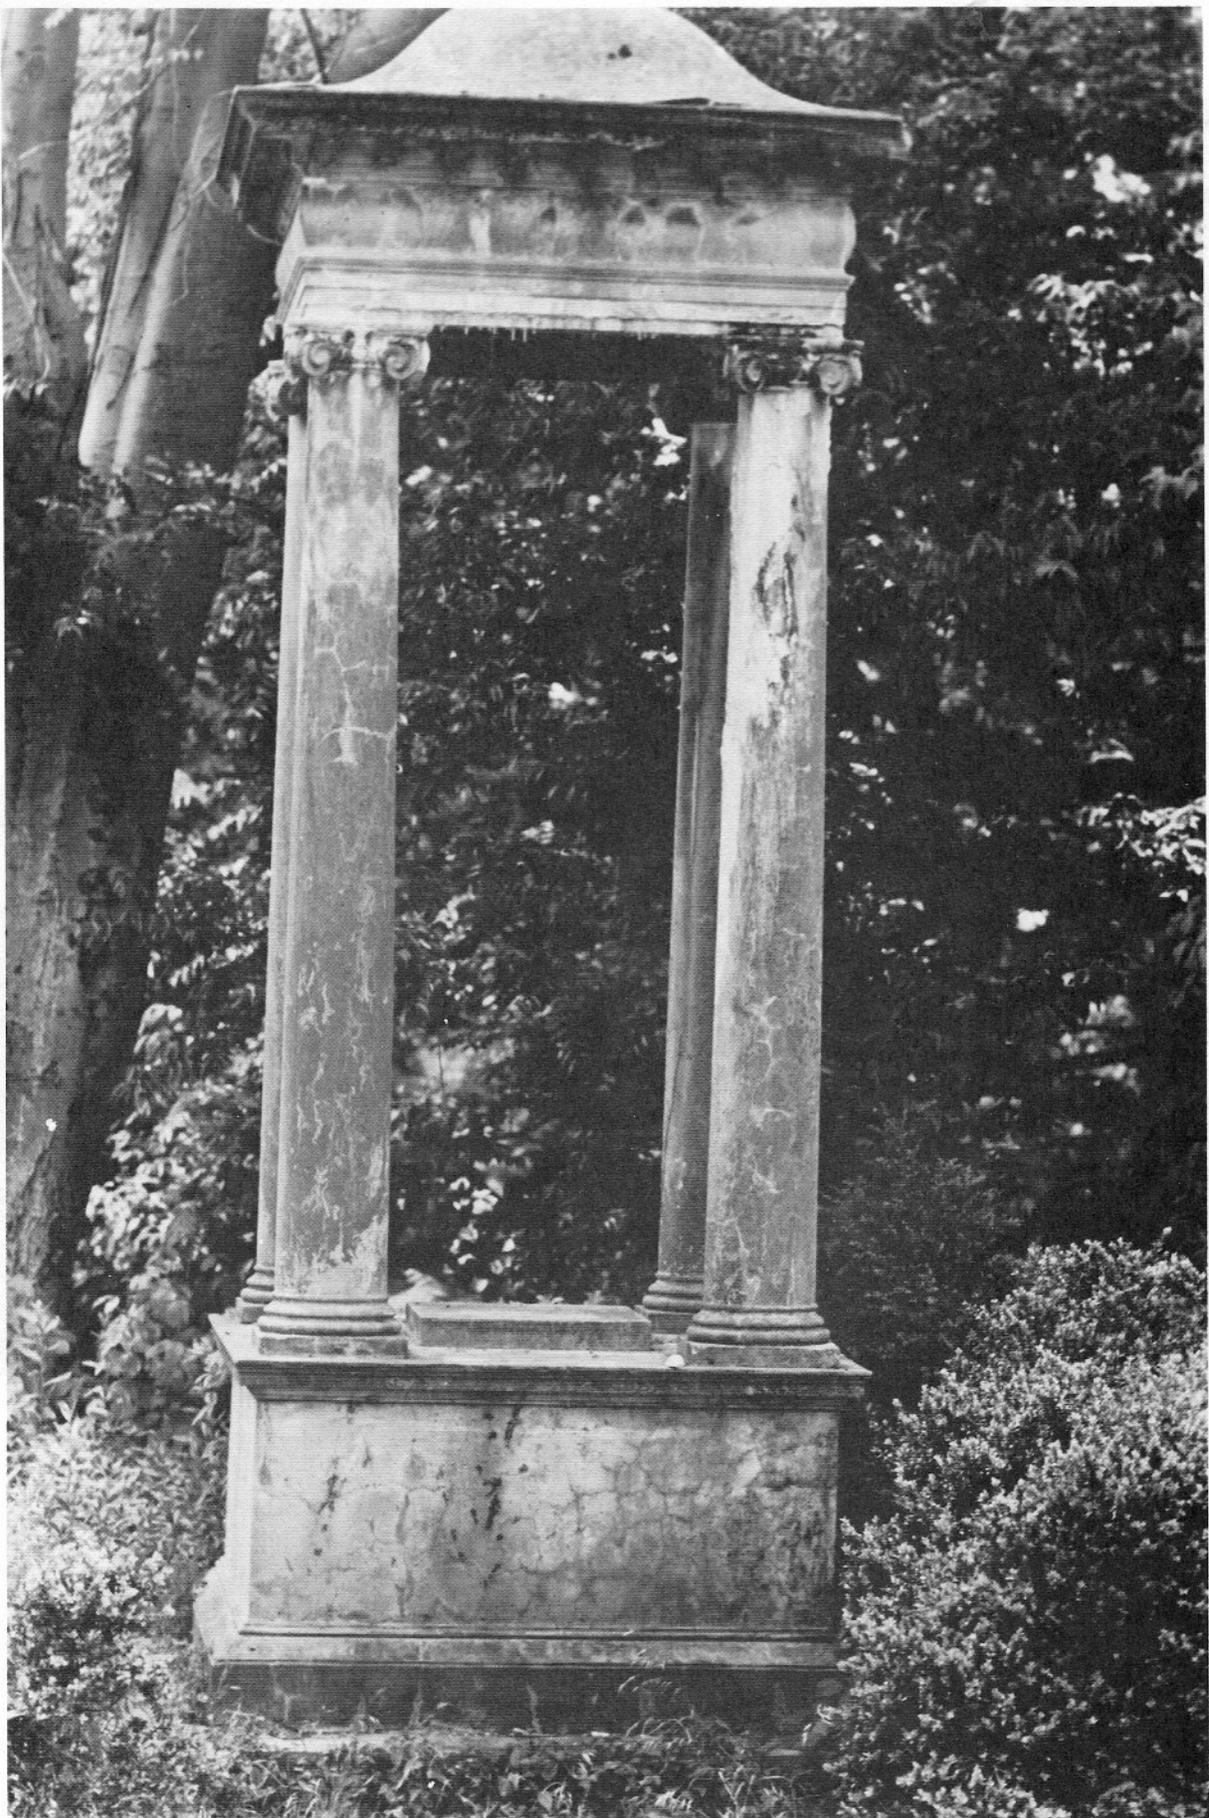
71. Chatham. Empty Temple. The severe water damage from leaks through the roof is apparent on the right column. Photograph by Gerald Karr, 1976.
