Alcatraz Barracks Building 64

Abbreviated Historic Structure Report

Produced by the
Cultural Resources and Museum Management Division
Golden Gate National Recreation Area
National Park Service
U.S. Department of the Interior
Washington, DC

September 2003

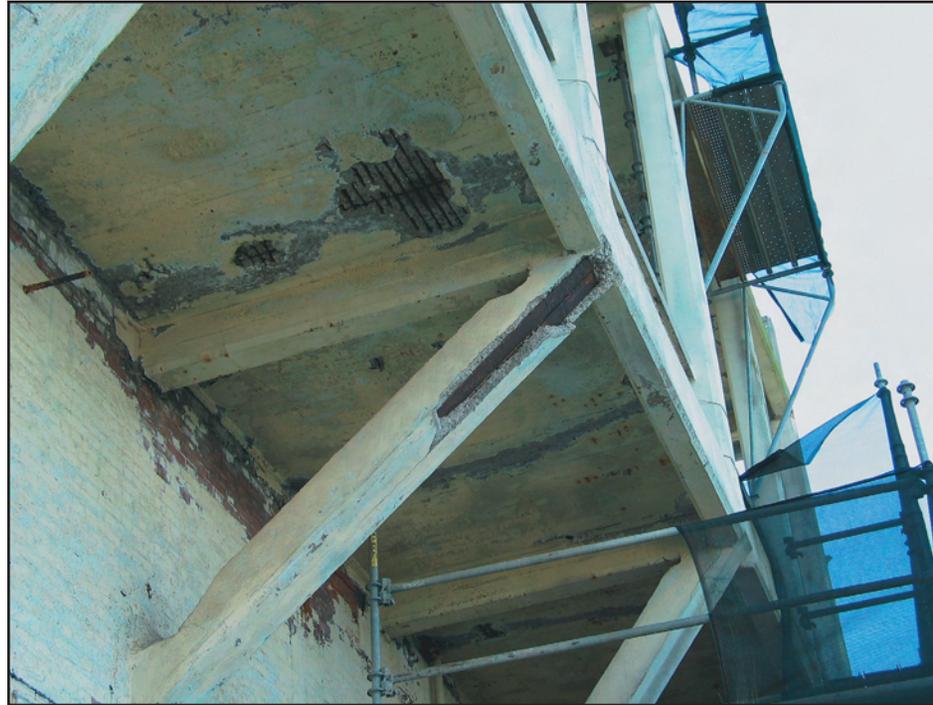
Top: View of underside of concrete balcony under repair, 2003. Photo Credit: John Martini.

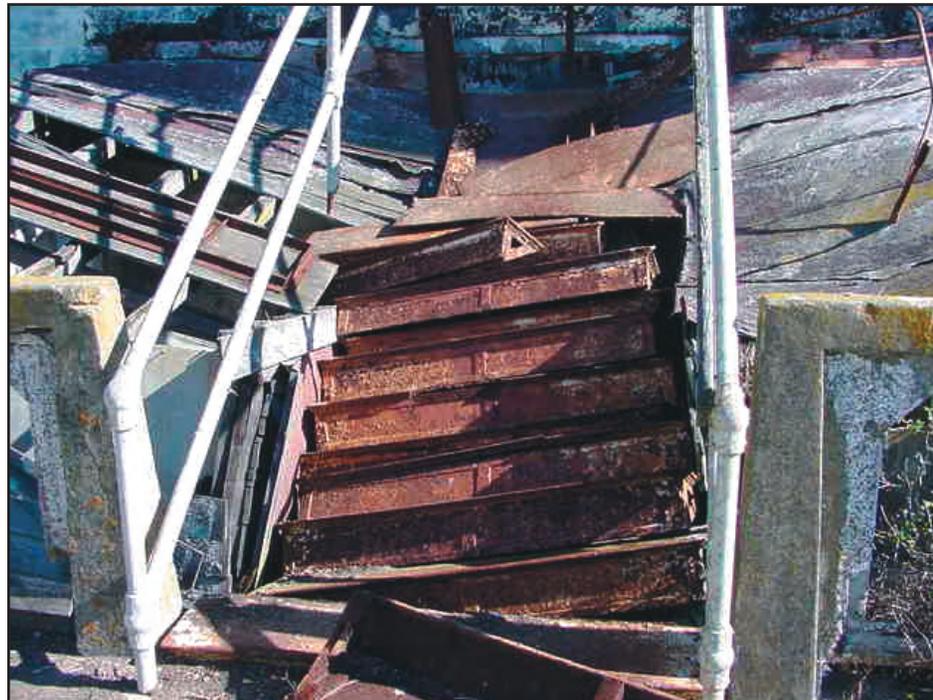
Bottom: Remnants of cast iron stair, south end, prior to wind storm, 2002. Photo Credit: Jane Lehman.

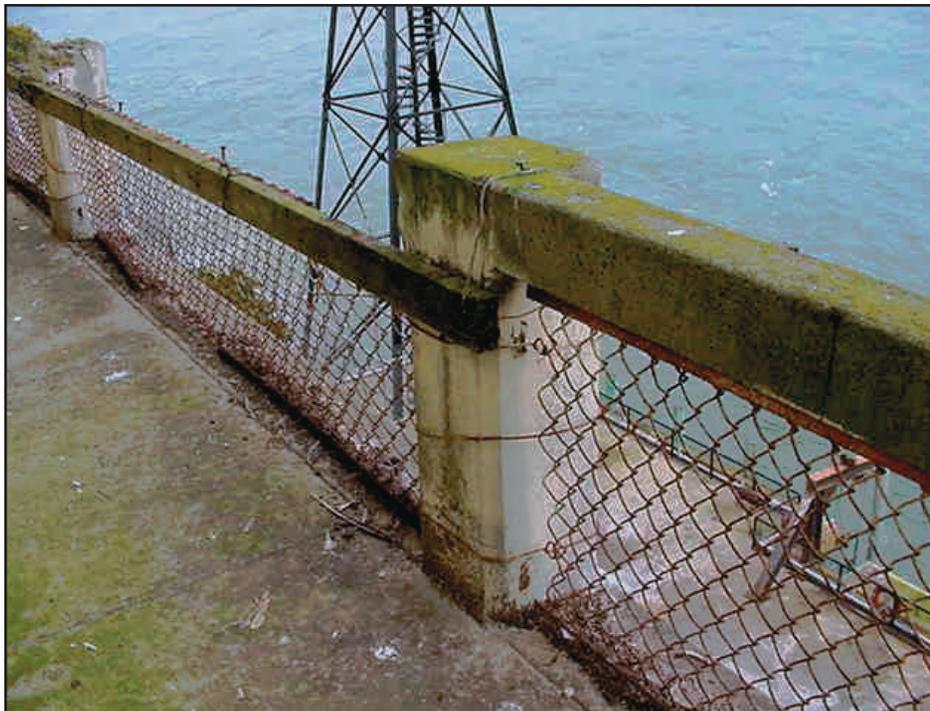
Bottom: Second floor balcony railing before repair, 2003. Photo Credit: Jane Lehman.

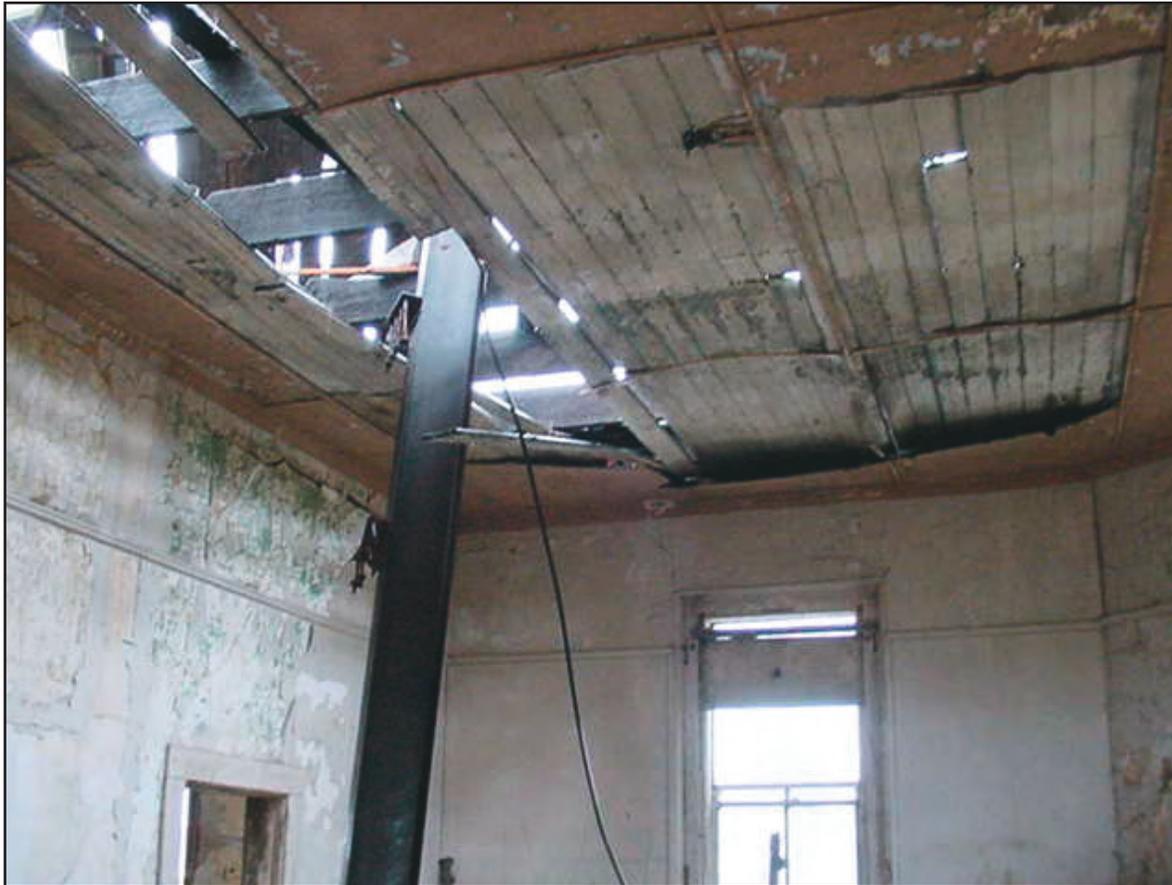
View of extensive ceiling damage at south end of third floor, 2003. Photo Credit: Jane Lehman.
