Buildings - Parade Ground

Structures - Parade Ground

Small-Scale Features - Parade Ground

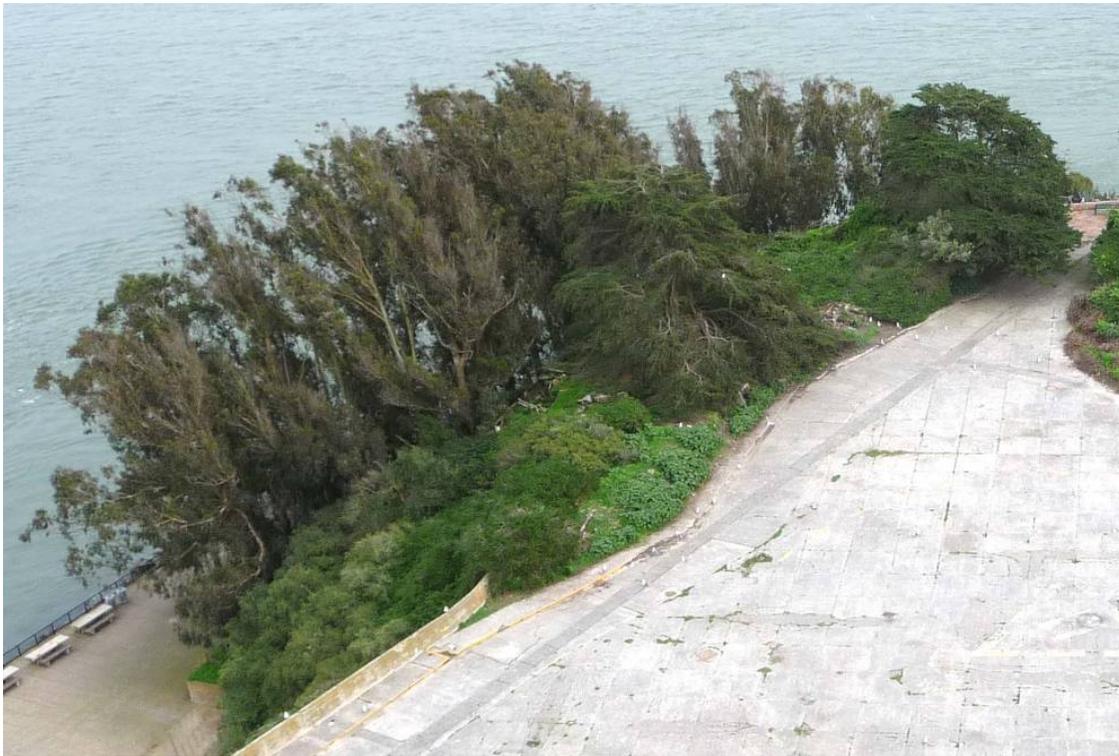
<i>Bldg #</i>	<i>Figure #</i>	<i>Description</i>	<i>Condition</i>
Officers Quarters' 72 and 73	72,73	3-322 3-323 3-325	<ul style="list-style-type: none"> ▪ Possible trash, debris - demolished in 1971 	Poor
Officers Quarters' 74 and 75	74,75	3-322 3-324 3-325	Both concrete foundations remain, but first floor building platforms are missing. A portion of Officers' Quarters 74 Foundation wall adjacent to sidewalk still remains. Area is scattered with debris. Demolished in 1971.	Poor
Officers' Quarters - Duplex	83	3-325	<ul style="list-style-type: none"> ▪ Trash, debris - demolished in 1971. Exposed stone foundation with building footprint platform. 	Poor
Apartment A Remnant	A	3-326 3-327	Large pieces of concrete debris surround the openings to both building entrances, creating two pronounced debris mounds. Vegetation has taken over the remaining area providing waterbird habitat. Demolished 1971.	Poor

Figure 3 - 322. Officers’ Quarters 72, 73, 74 and 75. Remnant materials under vegetation overgrowth (MBD P1030924-Crop.JPG)

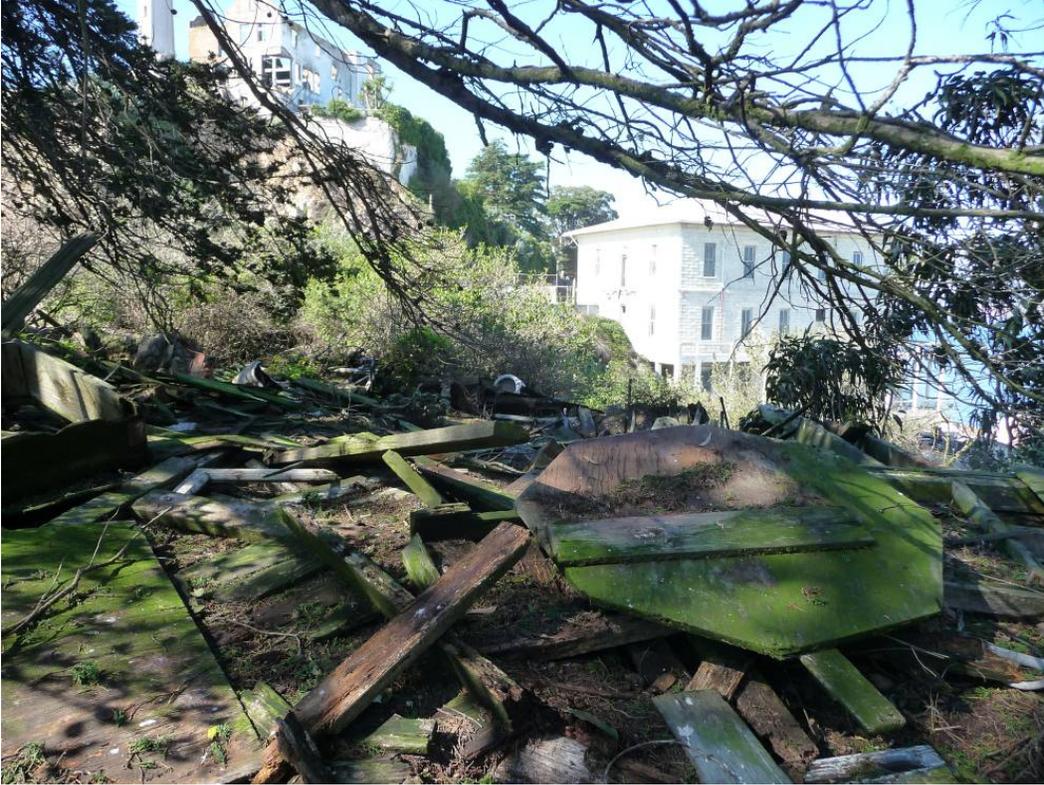
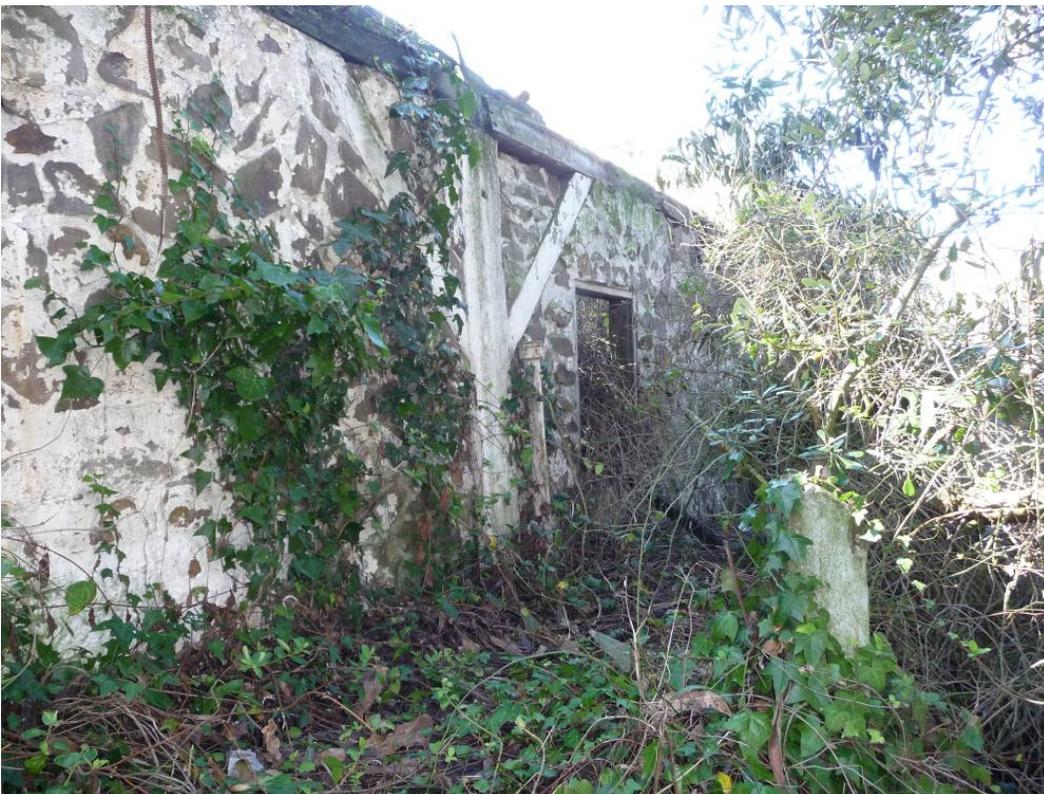
Figure 3 - 323. Officers' Quarters 72 and 73. Remnant stone foundation walls and debris. (MBD P1020862.JPG, MBD P1020858.JPG)

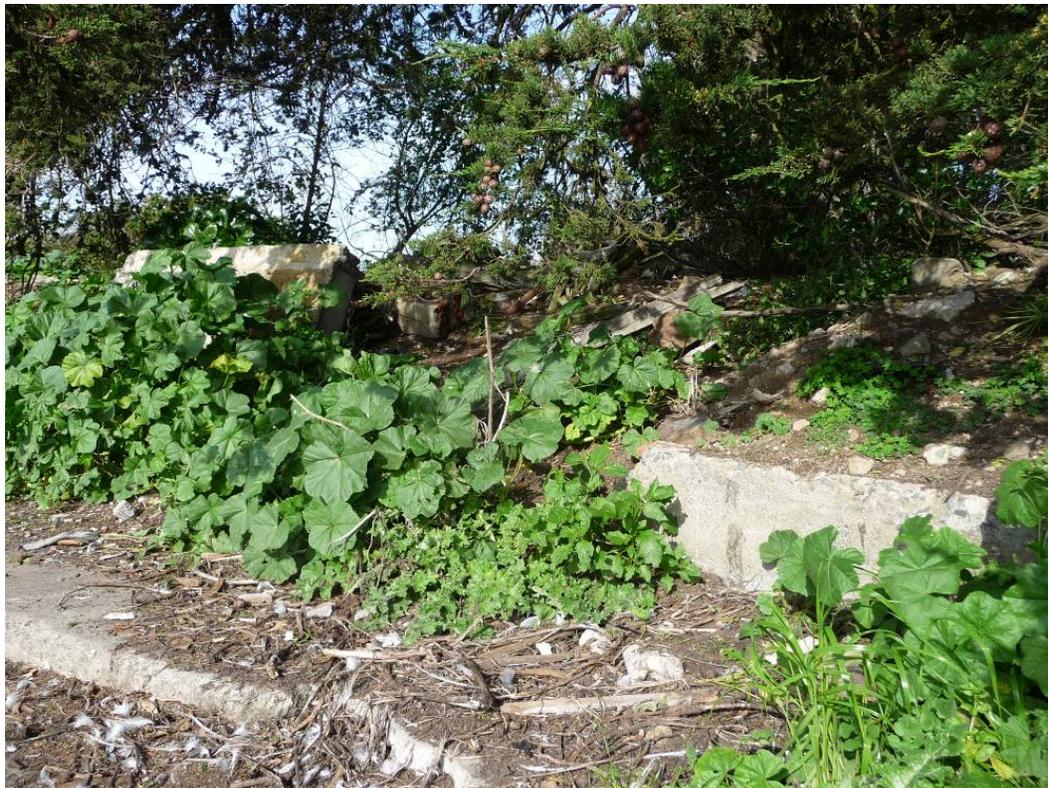
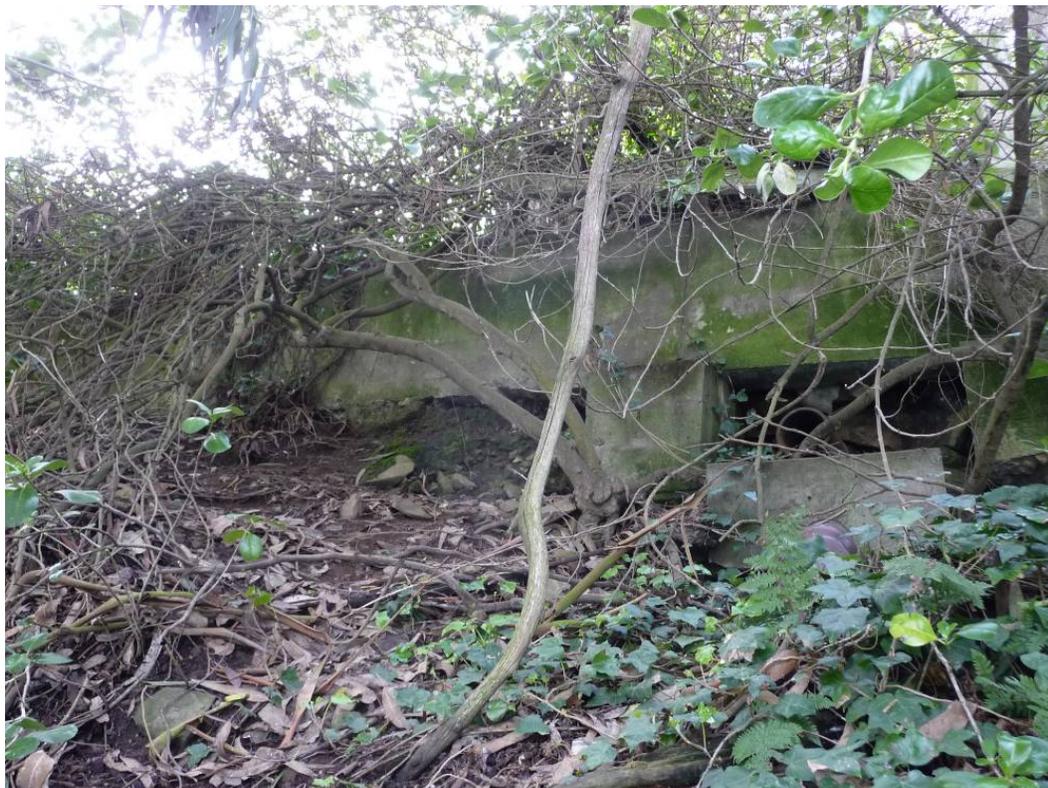
Figure 3 - 324. Officers' Quarters 74 and 75. Remnant concrete foundation walls. (MBD P1040233.JPG, MBD P1040280.JPG)

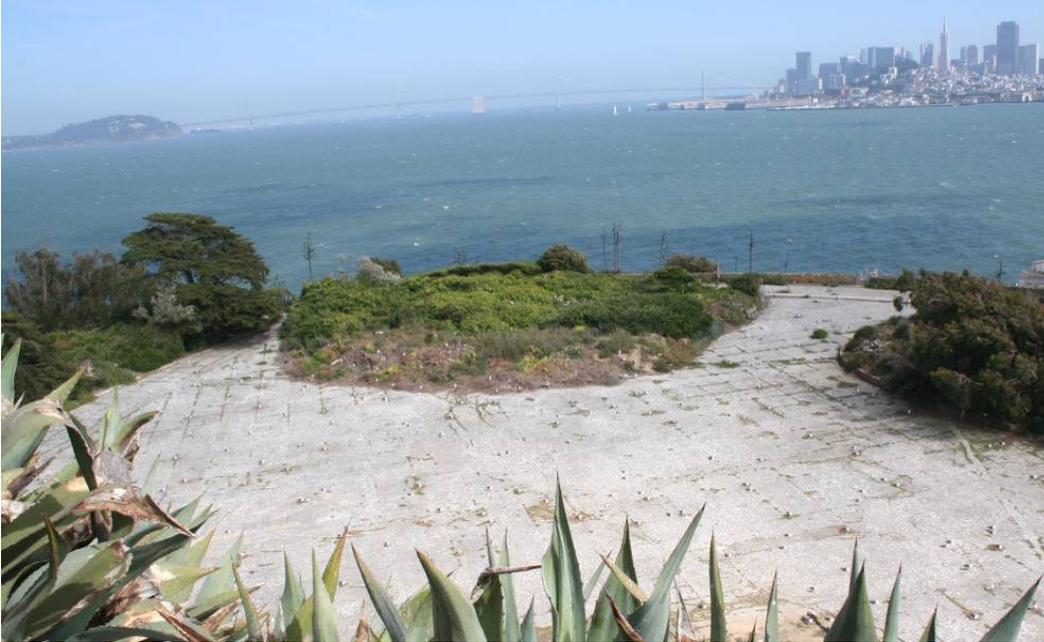
Figure 3 - 325. Officers' Quarters – Duplex (Building 83) remnant, Officers' Quarters 72-75 at left, view from above; San Francisco and Bay Bridge in background (MBD IMG_2906.JPG)

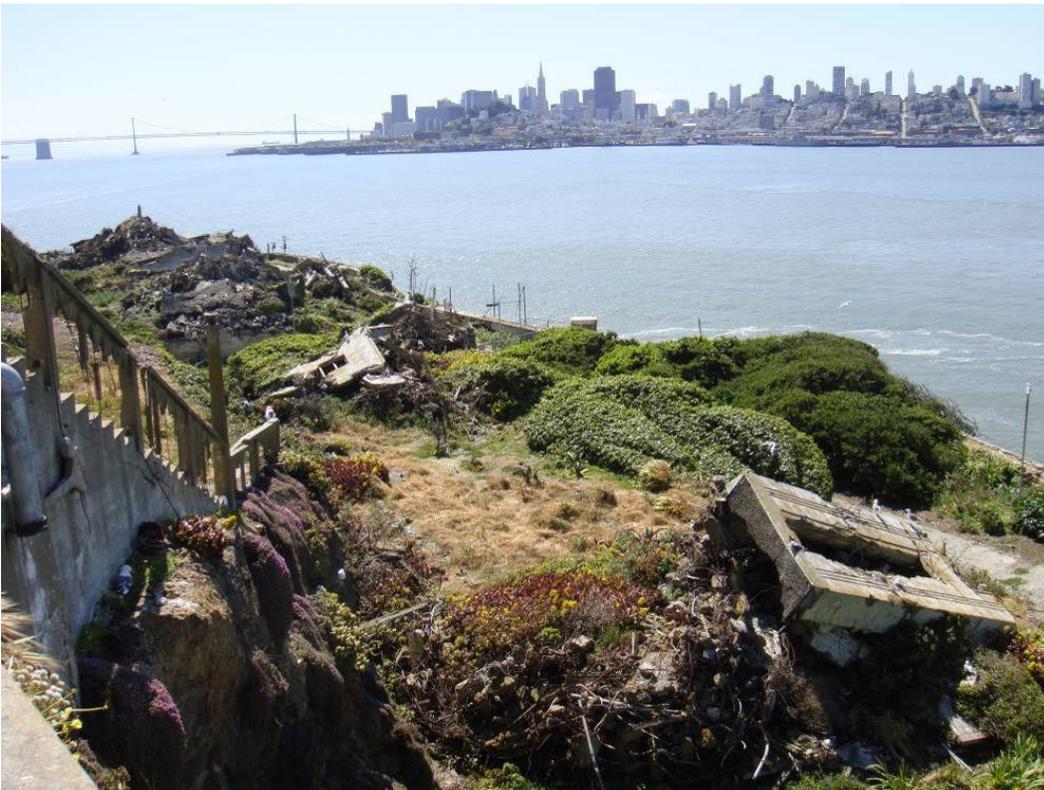
Figure 3 - 326. Apartments 'A' (foreground), 'B', and 'C' remnants, and view to San Francisco and Bay Bridge (MBD DSC00194.JPG)

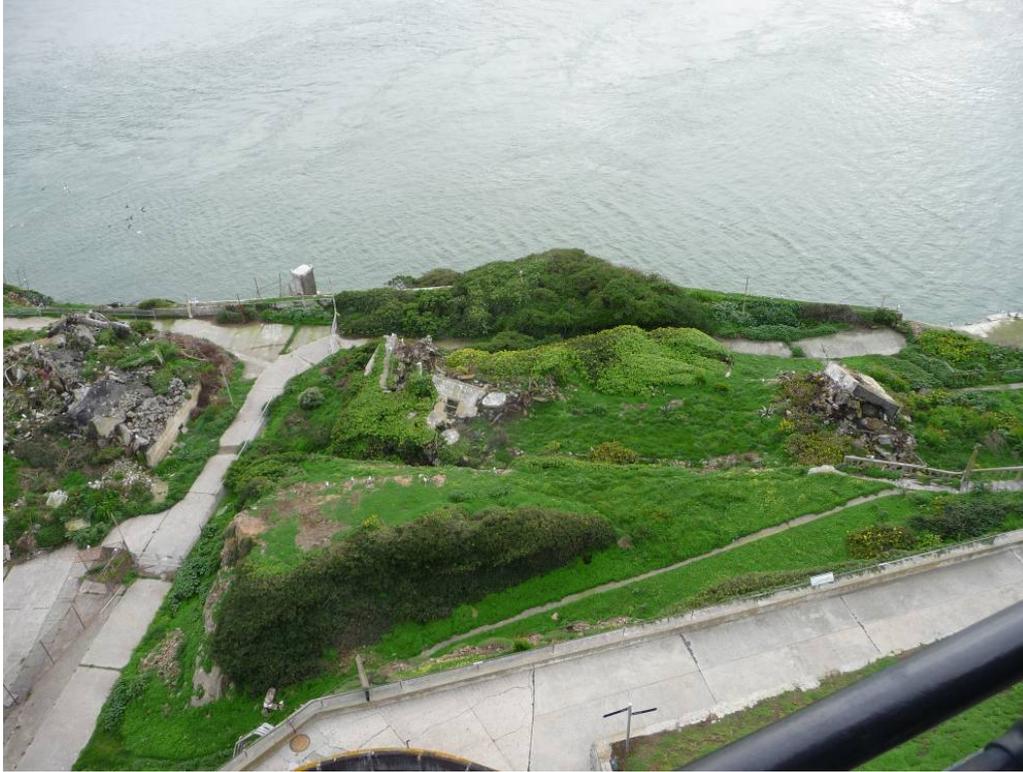
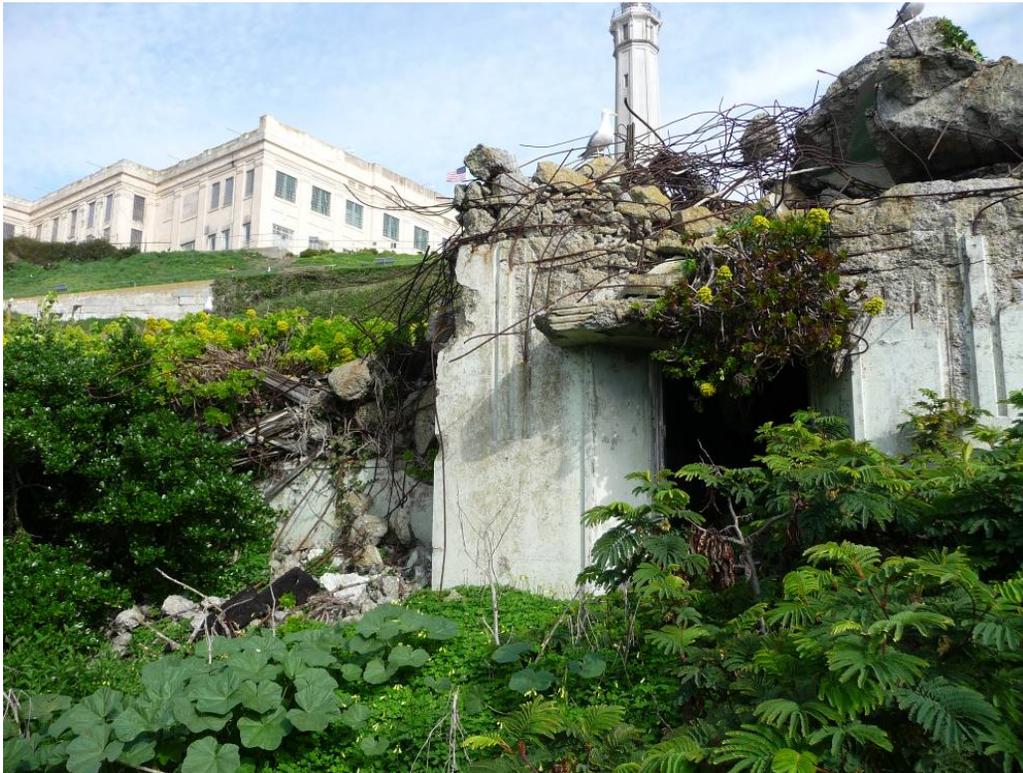
Figure 3 - 327. Apartment 'A' remnant materials (MBD P1030921.JPG, MBD P1040031.JPG)

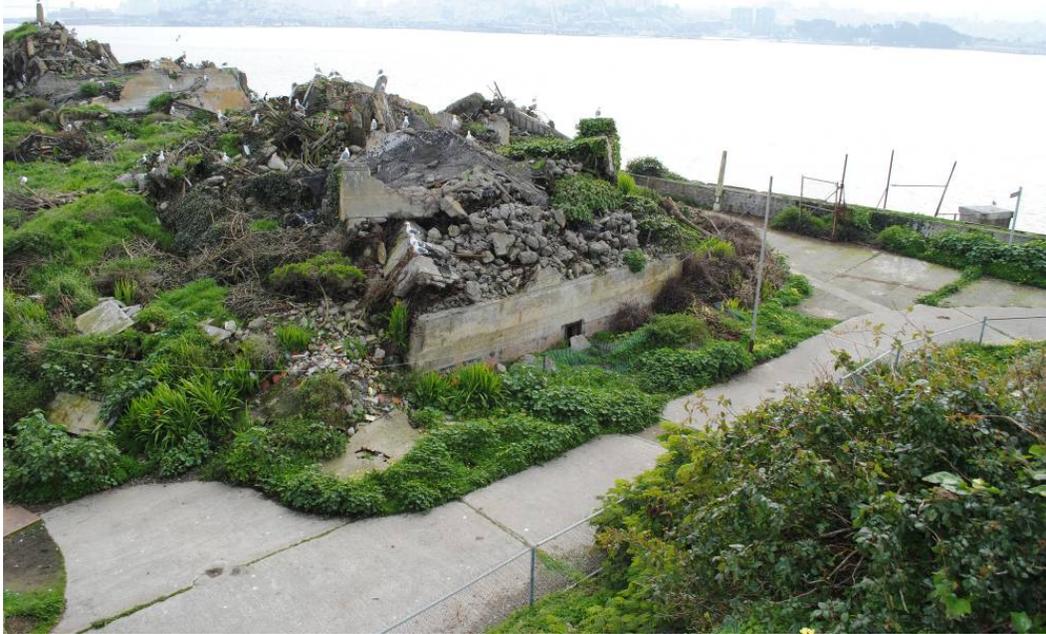
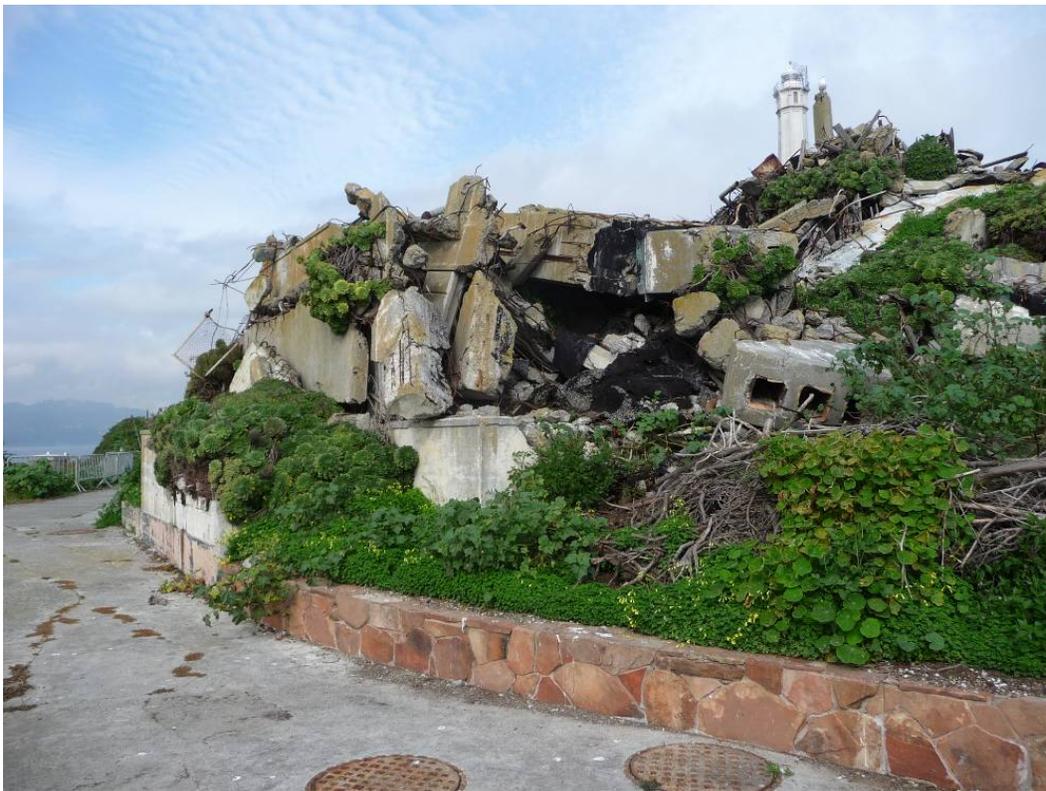
Apartment B Remnant	B	3-326 3-328	The west concrete edge of Apartment B is intact along with most of the original south and west concrete landscape walls. The southwest building entrance is noticeably surrounded by large pieces of concrete debris. Vegetation is interspersed within concrete rubble. Demolished 1971.	Poor

Figure 3 - 328. Apartment 'B' remnant materials. Southern portion of Apartment 'C' remnant materials are visible in top image at bottom right of photo. Flagstone seatwall added by NPS in foreground of lower image. (MBD DSC_0327.JPG, MBD P1040021.JPG)

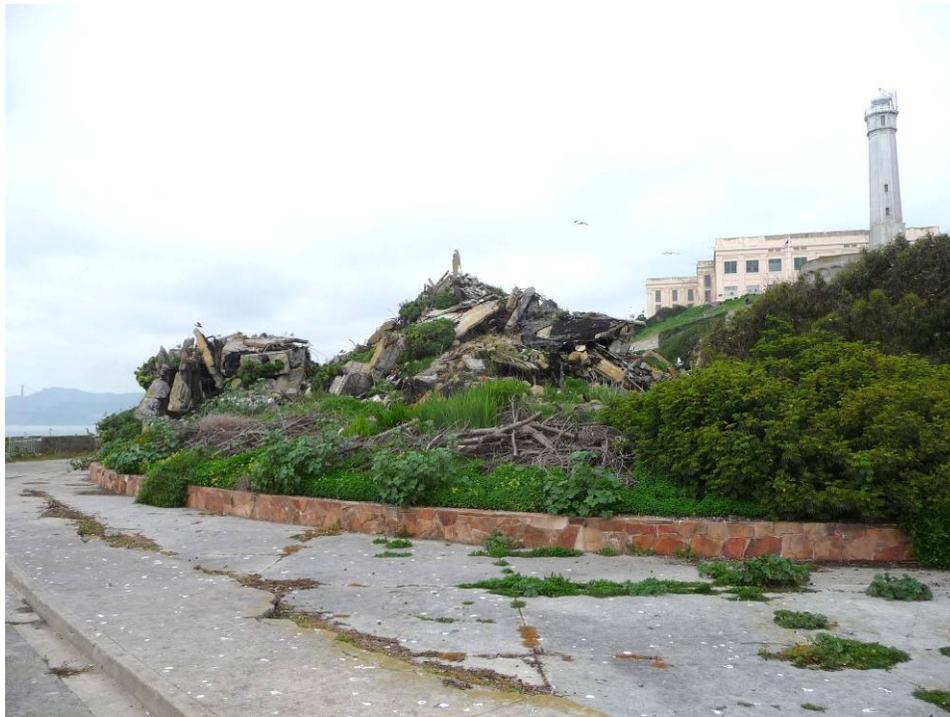
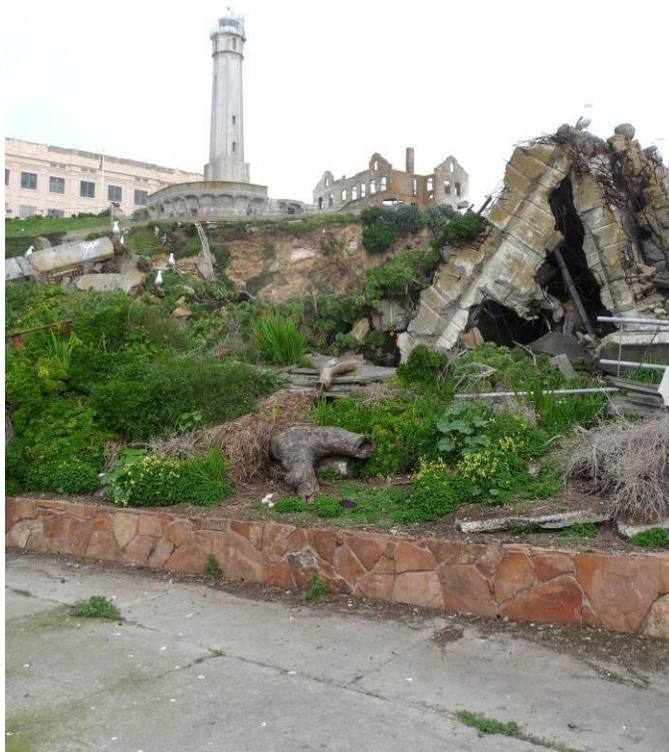
<i>Feature (Type)</i>	<i>Bldg #</i>	<i>Figure #</i>	<i>Description</i>	<i>Condition</i>
Apartment C Remnant	C	3-326 3-329	The collapsed opening to the southwest building entrance marks the western edge of Building C rubble mound. Sandstone walls (not original) define the edges. Portions of the original building landscape walls are extant. Vegetation and escaped vegetation is interspersed within the concrete rubble. Demolished 1971.	Poor
Gymnasium	31	3-330	Concrete foundations of Gymnasium, Playground/Sandbox, and Handball Court at base of Escarpment slope	Poor
Playground		3-330	Concrete curb outlines playground	Poor

Figure 3 - 329. Apartment ‘C’ remnant materials. Flagstone seatwall added by NPS at base (MBD P1030994.JPG, MBD P1040001.JPG)

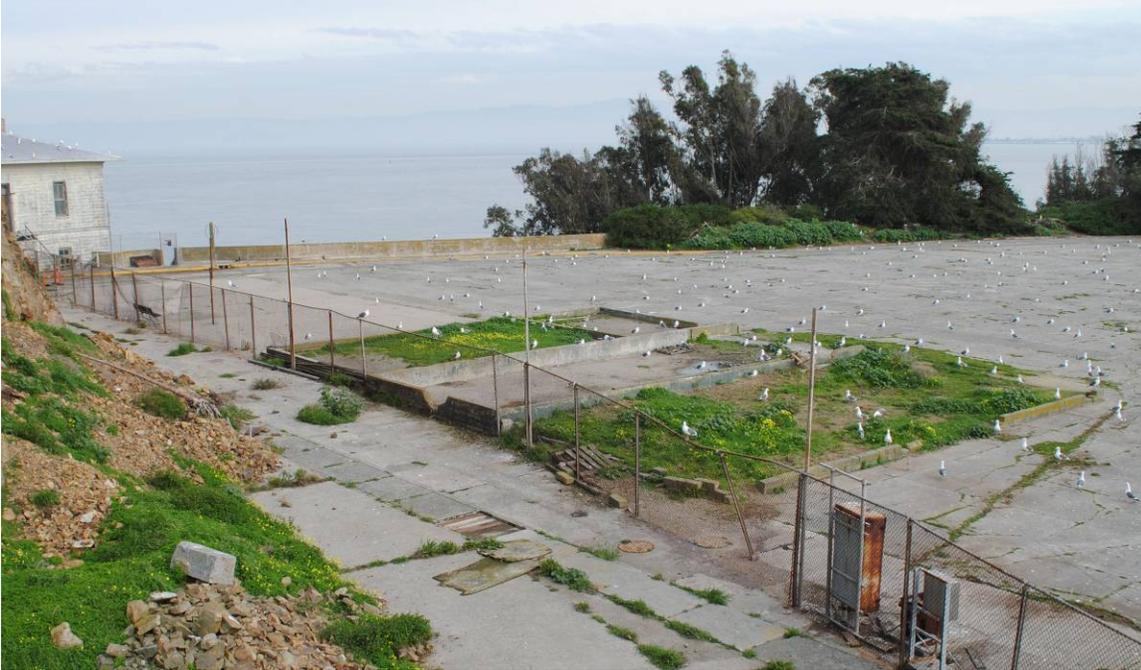
Figure 3 - 330. Playground and Gymnasium foundations (foreground) and Officers' Quarters 72-75 remnants (background) South edge of Building 64 at left. (MBD DSC-0326.JPG)

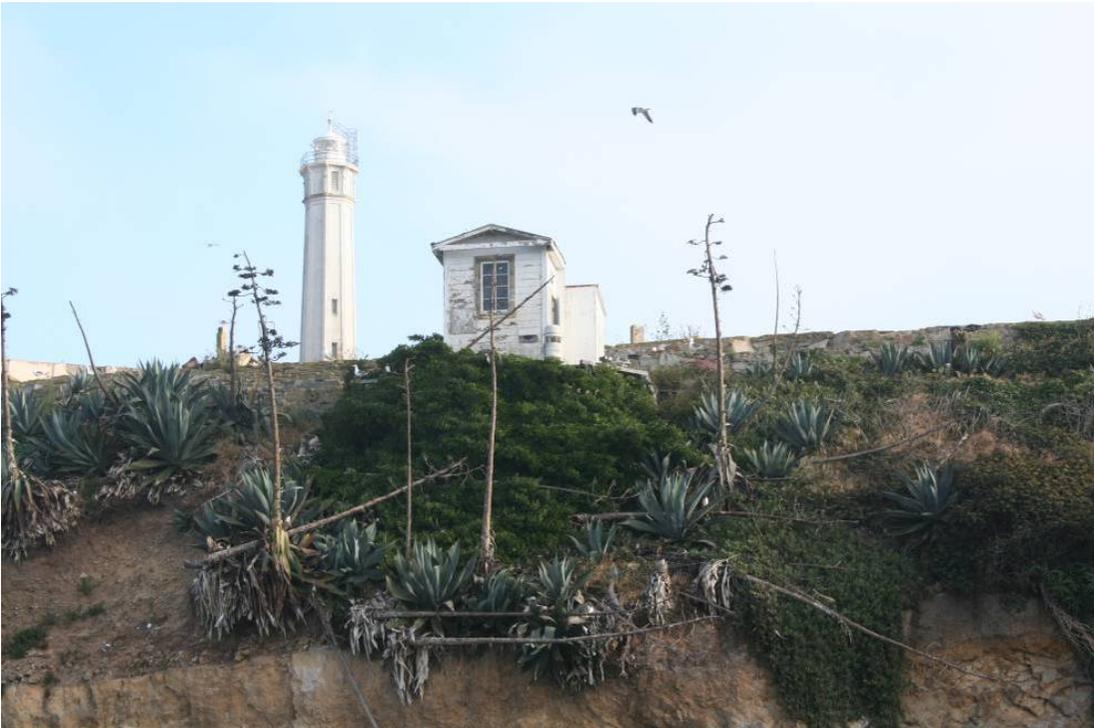
<i>Feature (Type)</i>	<i>Bldg #</i>	<i>Figure #</i>	<i>Description</i>	<i>Condition</i>
Firebox #2		3-331	Located at base of slope to Summit, directly under the Warden's House	Fair
Foghorn South and Fogbell (1867)		3-332	(1867 Map; Thompson 1979; Barker 2009) Located west of the Agave Walk	Fair
South Battery - 1870s (structure collapse)		3-333 3-334	<ul style="list-style-type: none"> brickwork curb for earthwork frontal slope - Portions of the brickwork curbing added to hold the angle of repose of earthen fill placed in front of the sandstone wall of 1850s South Battery in the 1870s collapsed off the bluff edge in early 2005. A discovery assessment was made by Leo Barker, park archeologist, with the assistance of John Martini, historian. Other parts of the brickwork remain. Annual monitoring of the material lying on the rocky bay shoreline will be conducted to examine the eroding brickwork, and an island wide shoreline survey has been planned to identified additional vulnerable sites and structures. (Barker, Cantwell, Merkle 2005) 	Fair

Figure 3 - 332. Foghorn South, viewed from water; Lighthouse tower in background (MBD IMG_2712.JPG)

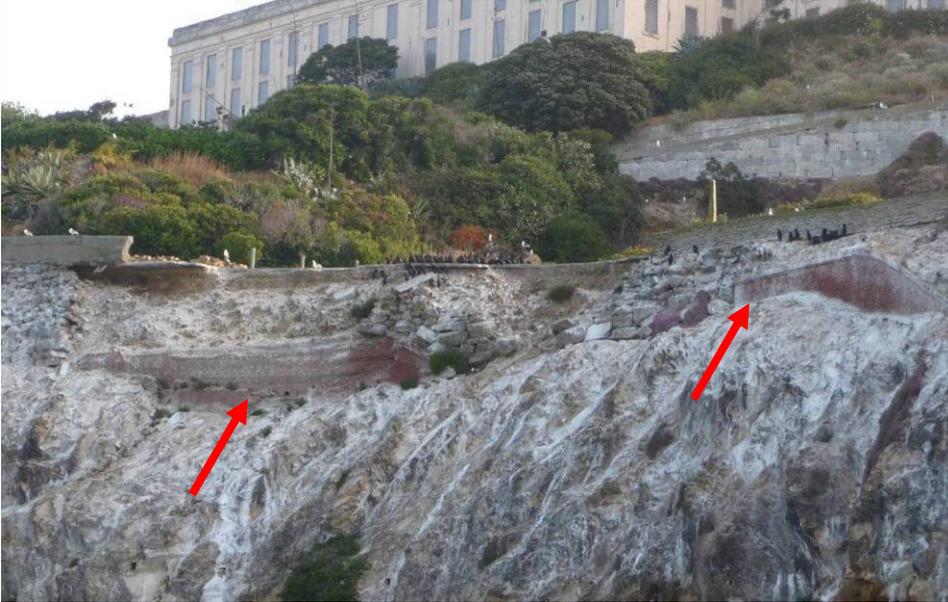
Figure 3 - 333. South Battery (Fortification Wall) (MBD P1000961.JPG)

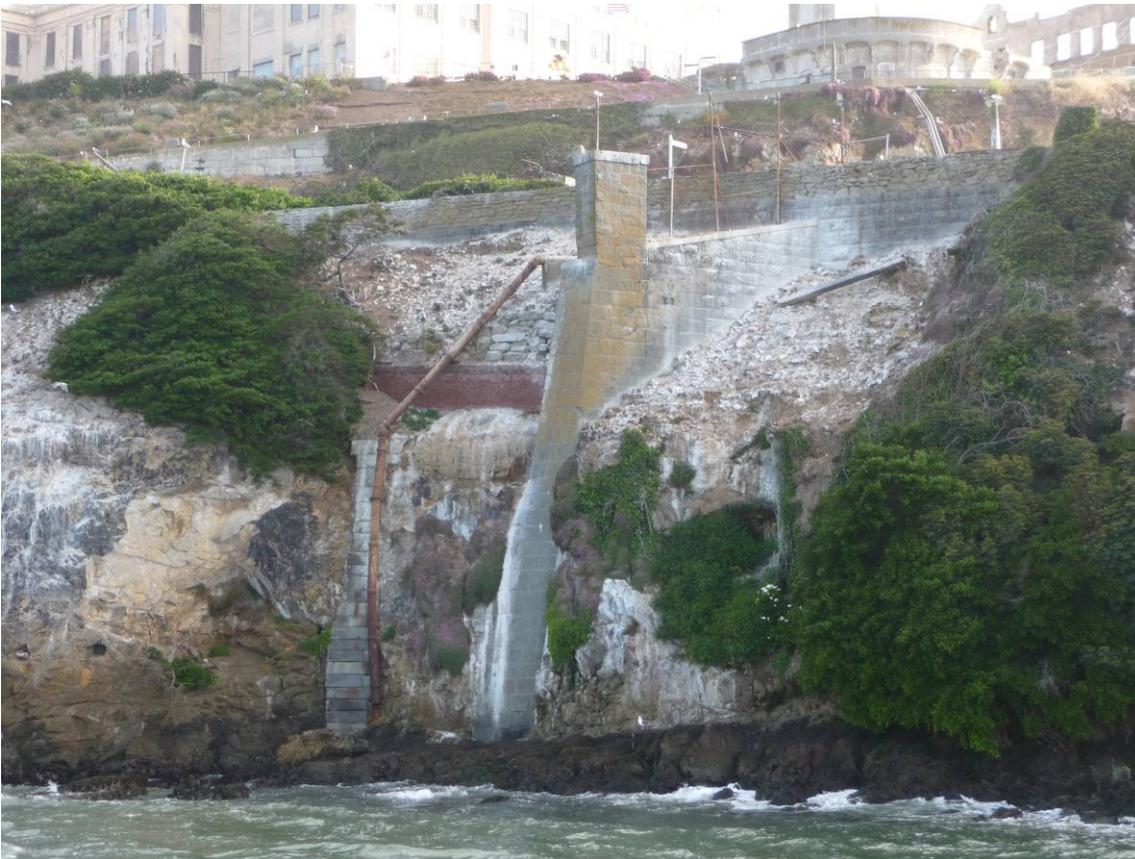
Buttress		3-334	Sandstone wall nearly perpendicular to Fortification Wall	Fair
Sewer Chase		3-334	Concrete block chase emptying at shoreline next to Buttress below Fortification Wall	Fair
Buttresses at Wharf		3-335	2 Concrete block Buttresses south of Building 64	Good

Figure 3 - 334. Left to right: Sewer Chase, South Battery (red brick), Sandstone Buttress, and Seawall Planter along top of shoreline (MBD PI000957.JPG)

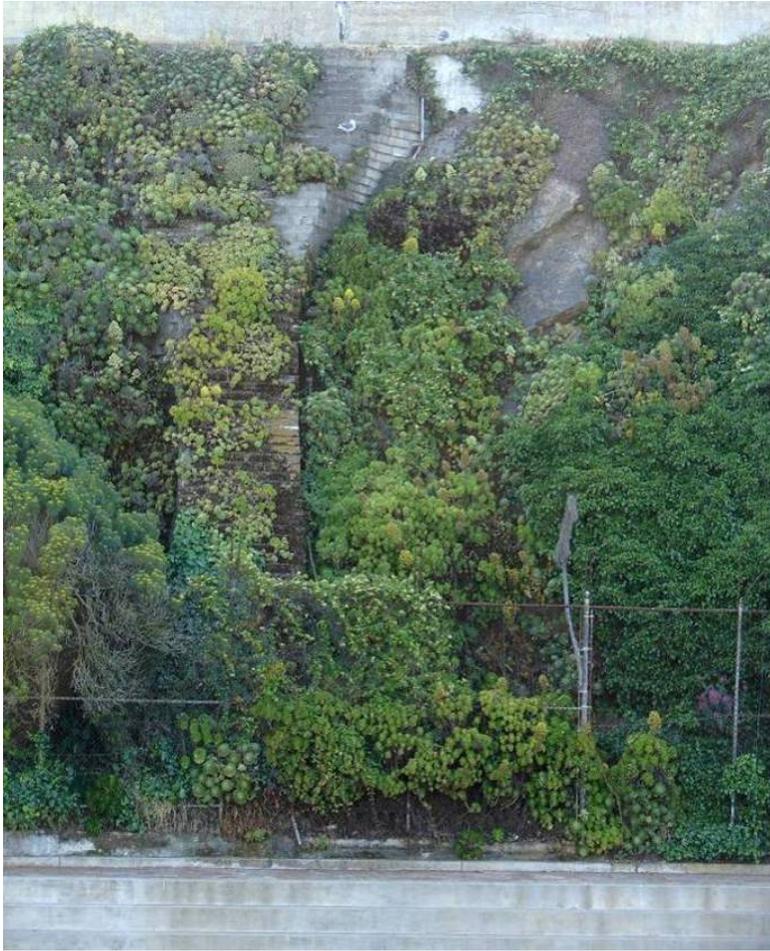
Figure 3 - 335. Buttresses at Wharf; Wharf Terraced Steps and SF2 in foreground (MBD DSC02661.JPG)

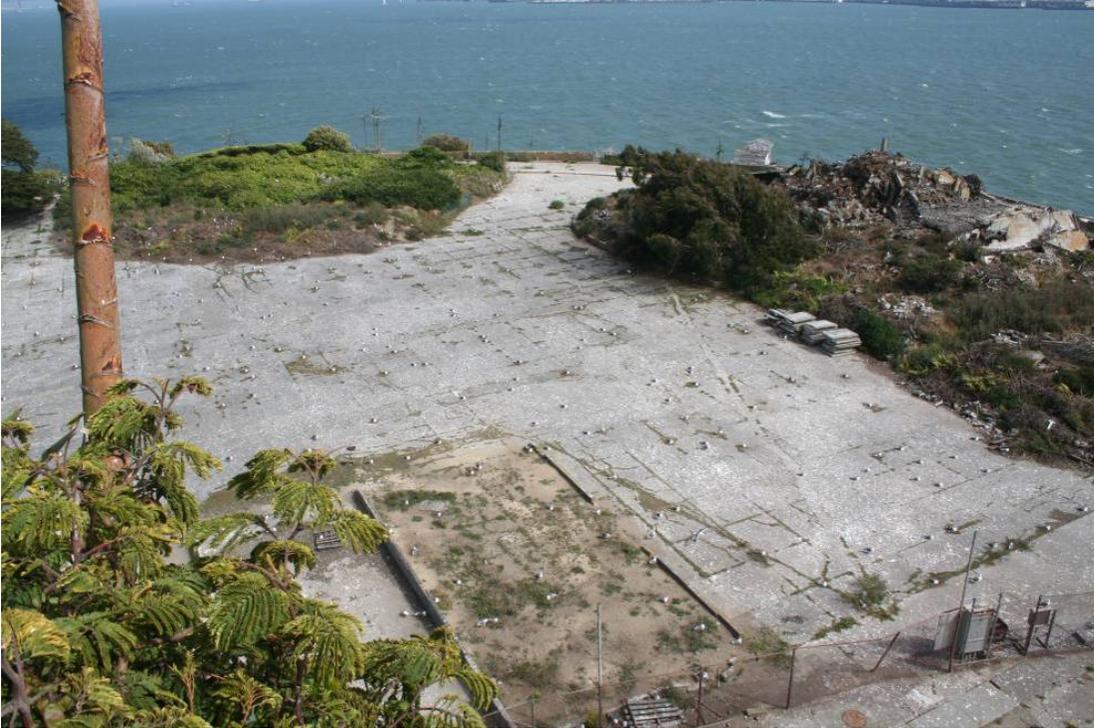
<i>Feature (Type)</i>	<i>Bldg #</i>	<i>Figure #</i>	<i>Description</i>	<i>Condition</i>
Road to Parade Ground		3-336	Concrete road surface, extending from connection at main road around the perimeter	Good
Parade Ground Paving		3-337	Concrete paving on excavated terrace, circa 1930; in distinct geometric pattern	Fair
Parade Ground Road and Parade Ground Sidewalk and Curb		3-338	Concrete surface perimeter road <ul style="list-style-type: none"> • Concrete walk adjacent to Parade Ground Road; follows road for most of its length • Concrete curb 	Road: Fair Sidewalk/ Curb: Good
Flagstone Seawall	B,C	3-339	Concrete wall with sandstone veneer	Good
Agave Walk with SR3		3-340 3-341 3-342	<ul style="list-style-type: none"> • Paving: crushed aggregate • Retaining walls: cast in place concrete • Stairs: cast in place concrete with sandstone veneer • SR3: Steel pipe railing on seawall, NPS 1995 	Good
'Warning' Sign on Agave Walk		3-343	<ul style="list-style-type: none"> • Painted lettering on plywood sign mounted on wood posts • Sign has been rebuilt extensively and repainted by NPS Staff c1980s. 	Fair

Figure 3 - 337. Parade Ground paving, and playground at lower center. Officers' Quarters-Duplex at upper center and Apartment B and C remnants at upper right. (MBD IMG_2908.JPG)

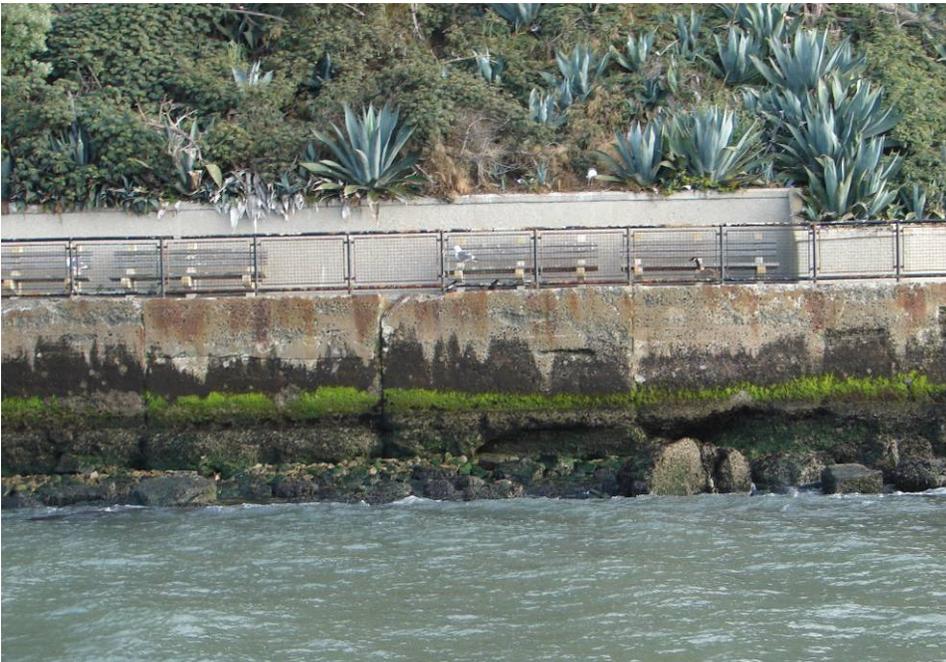
Southeast Seawall		3-344	Concrete seawall with replacement steel guardrail (built by NPS) from Wharf to western terminus of Agave Walk	Fair to Poor
Windy Gulch Trail		3-345	Path from Upper West Road to Parade Ground	Fair
Staircase to Apartments with SR65	A	3-346	Concrete stairs with concrete wall below; near Apartment 'A' <ul style="list-style-type: none"> • SR65: Decorative concrete railing, circa 1920 	Stairs: Poor SR65: Poor

Figure 3 - 344. Southeast Seawall at low tide (MBD DSC02926.JPG)

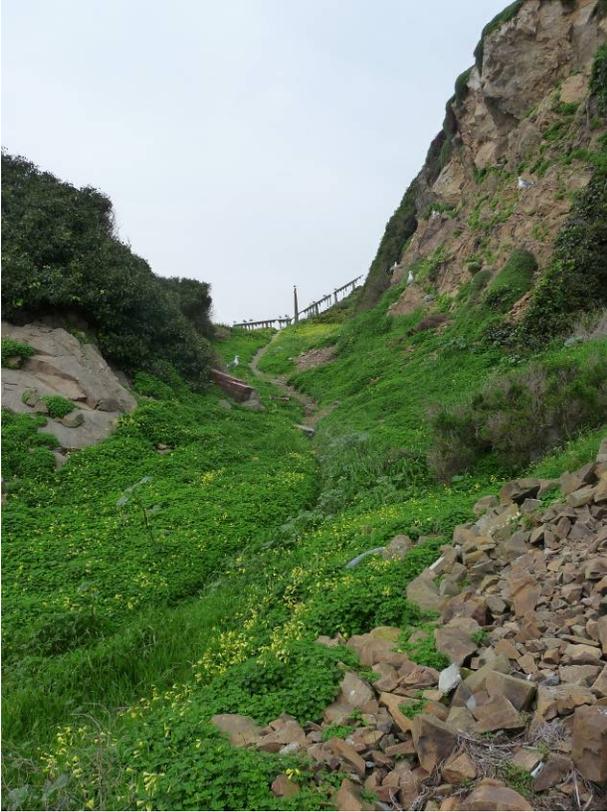
Figure 3 - 345. Windy Gulch Trail, viewed from Parade Ground (MBD P1030797.JPG)

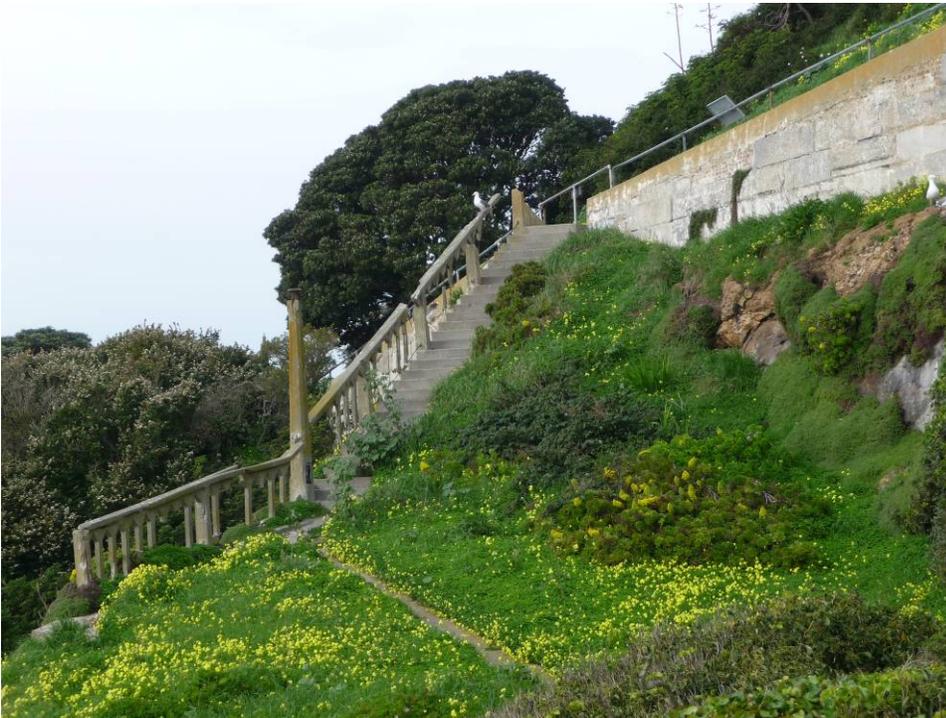
Figure 3 - 346. Staircase to Apartments, viewed from area west of Windy Gulch Trail. (MBD P1030636.JPG)

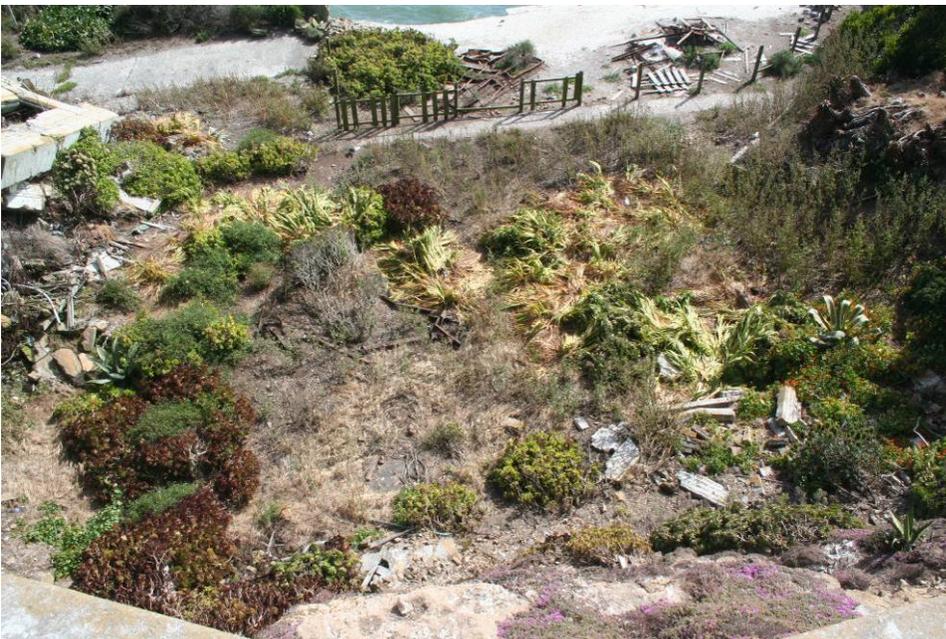
Wood slate fence near Apartment A		3-352	Constructed by NPS in 1980s as safety measure around collapsing road section	Poor
SR67		3-325	NPS chainlink fence to prevent visitor access	Good
SR68		3-330, 3-331	Federal Penitentiary period Security Fence at base of Escarpment Slope	Poor
Pipe railing at Seawall Planter			NPS metal pipe railing in area of collapsing Seawall Planter on west side of Parade Ground	Good
Concrete Light Standards along Seawall Planter		3-338	Five remnant concrete lights along Seawall Planter	Poor
High Security Lighting along SR58 of Gym Foundations		3-330, 3-331	Remnant Federal Penitentiary security lighting on SR68.	Poor

Figure 3 - 352. Pre-1940 Playground and Wood slate fence near Apartment 'A', viewed from Upper West Road (MBD IMG_2916.JPG)

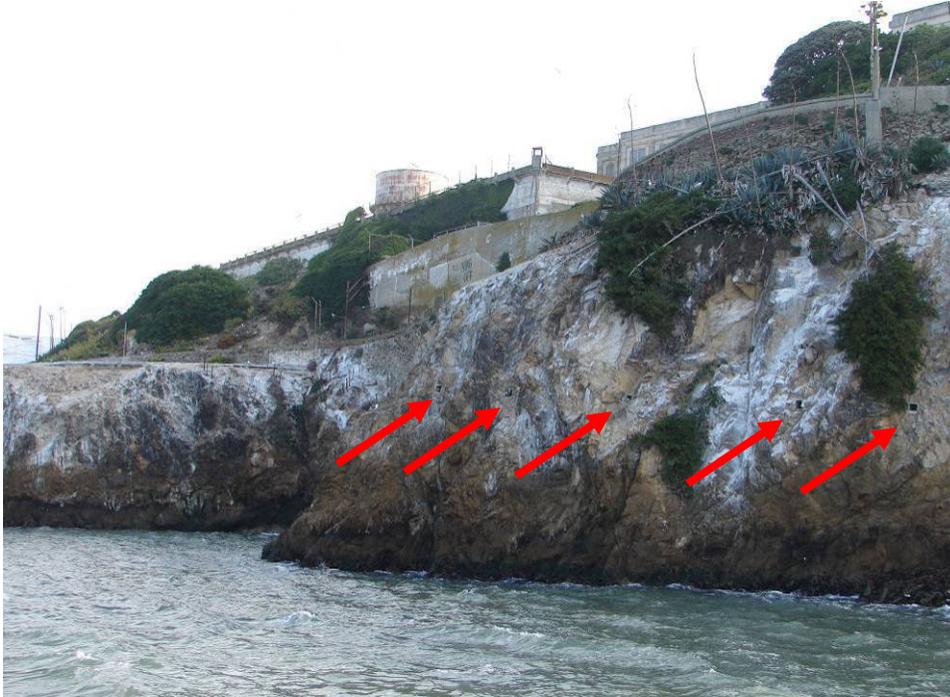
<i>Feature (Type)</i>	<i>Bldg #</i>	<i>Figure #</i>	<i>Description</i>	<i>Condition</i>
Sentry Catwalk Foundations - Southwest Side		3-353	<ul style="list-style-type: none"> • Recesses chiseled in face of cliff to support sentry catwalk on southwest side of island; catwalk gone. • Cut rock and mortises on southwest cliff - circa 10' apart and 10' above tidepools - supported with stone, brick and concrete in mortises (Kelly 1976:68) - 1928 map may show the alignment of the catwalk - begins around incinerator and ends below location of Officers' Quarters 75. (Kelly 1976:68, 1928 Alcatraz Map, Barker 2009) 	Poor
Children's Names above Garden Plots			At least one child's name "Prudence McCreay" is painted on Seawall Planter across from Building C near Foghorn South.	Poor

Figure 3 - 353. Southwest Sentry Catwalk - sockets in cliff for support beams (MBD DSC02946.JPG)
