PART II: TREATMENT AND WORK RECOMMENDATIONS

GULF OF THE FARALLONES NATIONAL MARINE SANCTUARY, FORT POINT COAST GUARD STATION REHABILITATION OF THE MAIN BOATHOUSE/LIFE SAVING STATION (PE1903)

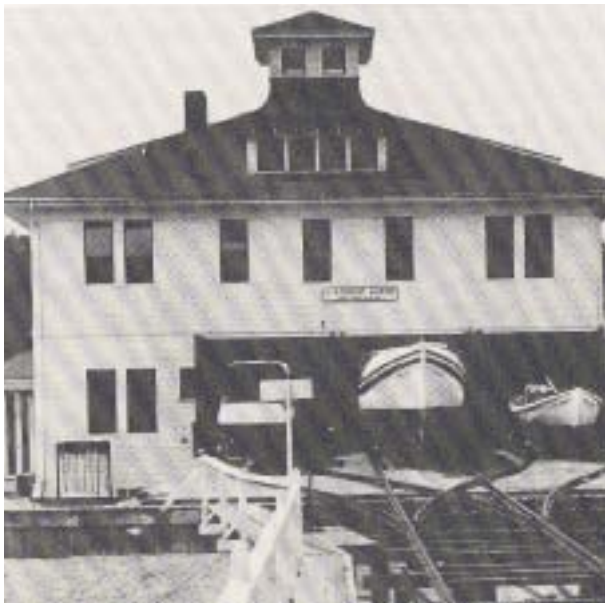
Fig. 37 : North elevation, the original window configuration of the Life Safety Station, 1919.

At the Main Boathouse/Life Saving Station (PE1903), in particular, the proposed rehabilitation project will open the northern wall at the first floor to its original three bay configuration. While reversing changes that diminished the Main Boathouse's relationship to the waters edge, it creates a weak or "soft" story condition for lack of shear bracing. The interior space of the boat storage bays is also part of the building's historic character and should be preserved. This may be accomplished by adding steel plates to existing wooden posts, and the new opening could have a steel shear framed mounted on the interior, which could be cased to be less obtrusive.

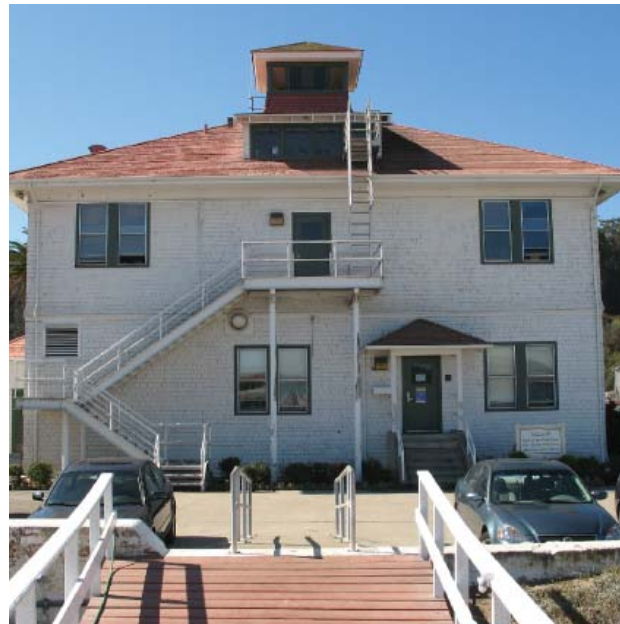
Fig. 38 :North elevation, the current window configuration of the Life Safety Station.

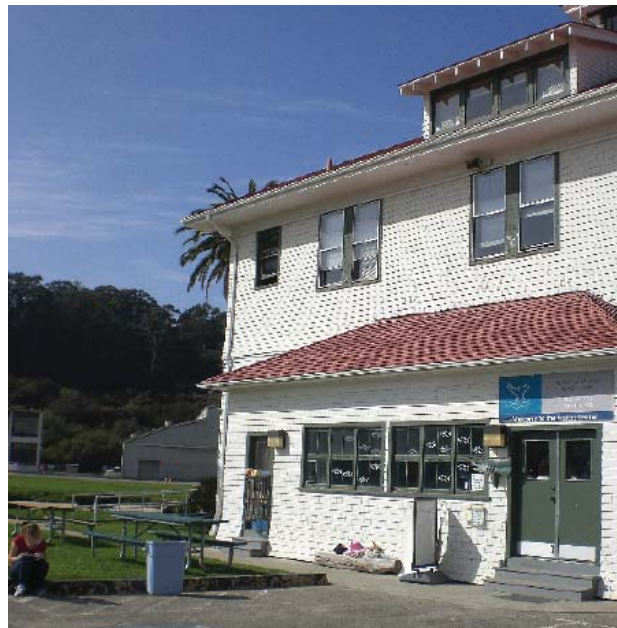
Condition: At the Main Boathouse, the enclosed area of the south porch has been completely reconfigured. The enclosed area of the eastern porch is in fair condition; however, the exterior windows are in relatively poor condition. Water has infiltrated the interiors, around the window sash and on the floors. The open front porch of the Officer in Charge Quarters is in poor condition, the platforms and stairs are deteriorated and unsafe, mud swallows are nesting in the eaves, and the painted finishes are severely deteriorated.

Fig. 42 : East elevation, enclosed porch of the Main Boat-house

Recommendations: Reopen the eastern porch at the Main Boathouse. Repair wooden elements at the Officer in Charge Quarters porch. Refinish all porches with historically appropriate colors.

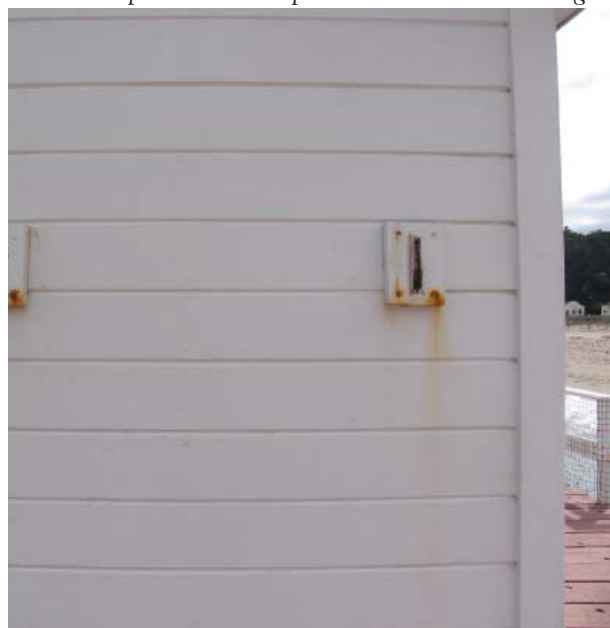
Fig. 43: Corrosion staining from embedded hardware at the Buoy Shack

Condition: The cladding is in fair condition. Deterioration includes delamination and general deterioration of the paint, water damage, dirt build-up, and biological growth. Rust staining occurs at metal attachments (see figure 43).

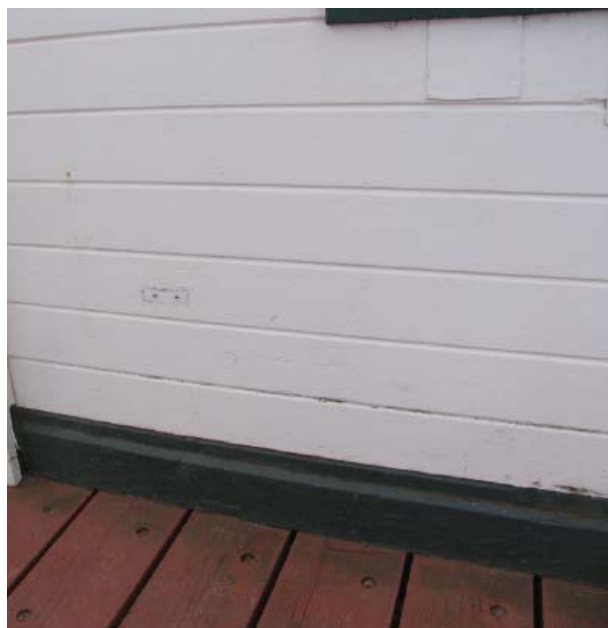
Fig. 44: Inappropriate patching on clapboard wall at the Buoy Shack..

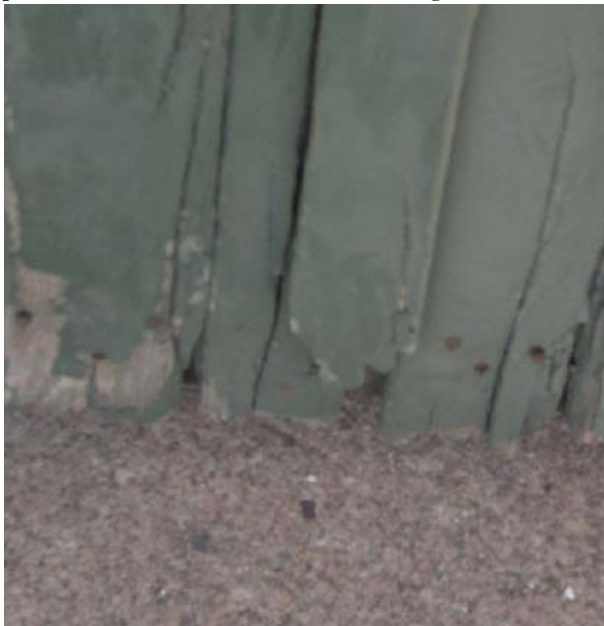
Fig. 45: Mechanical deterioration of doors of the Shop & Garage associated with cross-grain dragging.

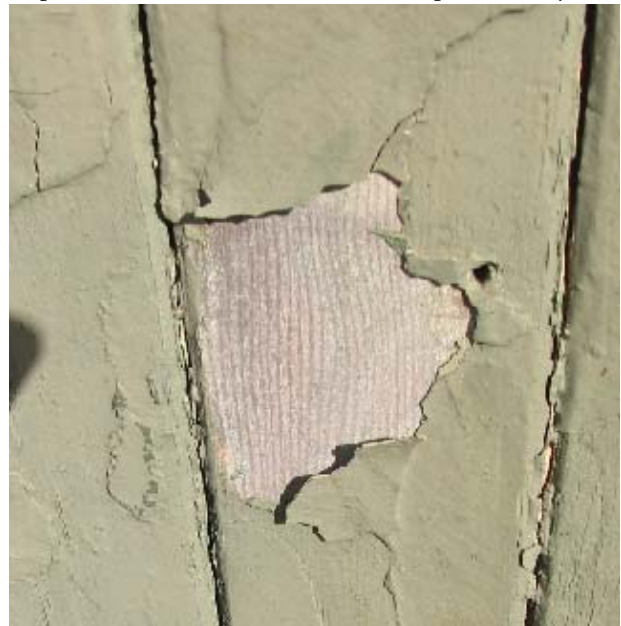
Fig. 46: Paint failure on the doors of the Shop & Garage.

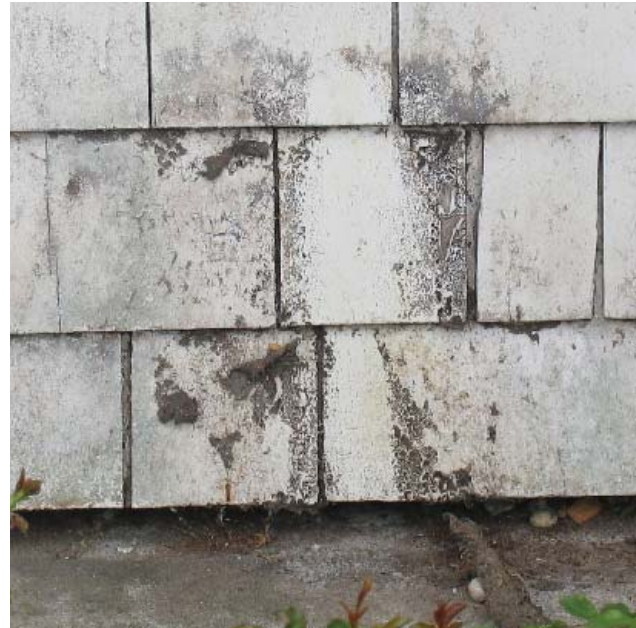
Fig. 50: Shingle soiling and deterioration at the Main Boathouse.

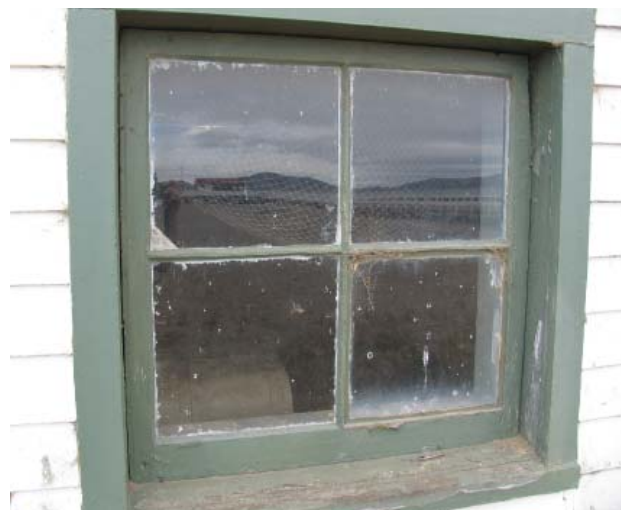
Condition: The paint has deteriorated, and is alligatored, peeling, or missing over the majority of all five structures primarily on the window elements (see figure 52).

Fig. 52: Four-lite awning window at the Shop & Garage.

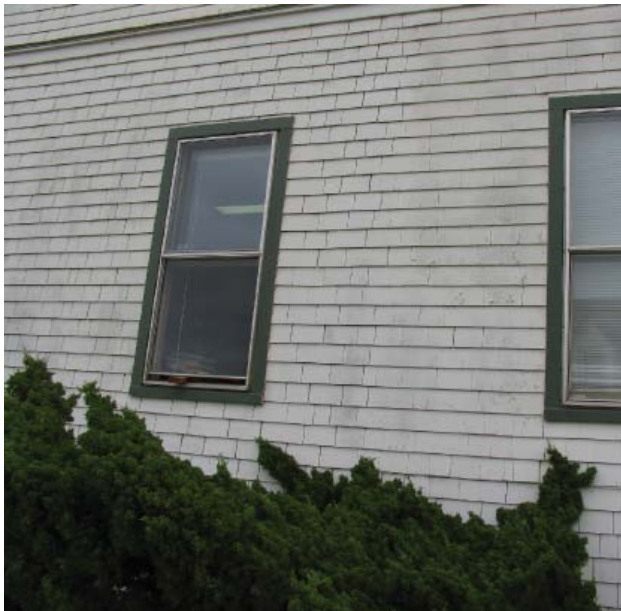
Fig. 55: Vegetation at the south wall of the Main Boathouse.

Recommendations: Cut back trees and bushes in contact with the buildings. Swinging tree branches could cause impact damage. Roots can damage building foundations, underground building services and drainage systems. Additionally, vegetation can hold moisture against the buildings, providing an ideal climate for biological growth. Proposed landscape plans should use historic landscaping as a guide.

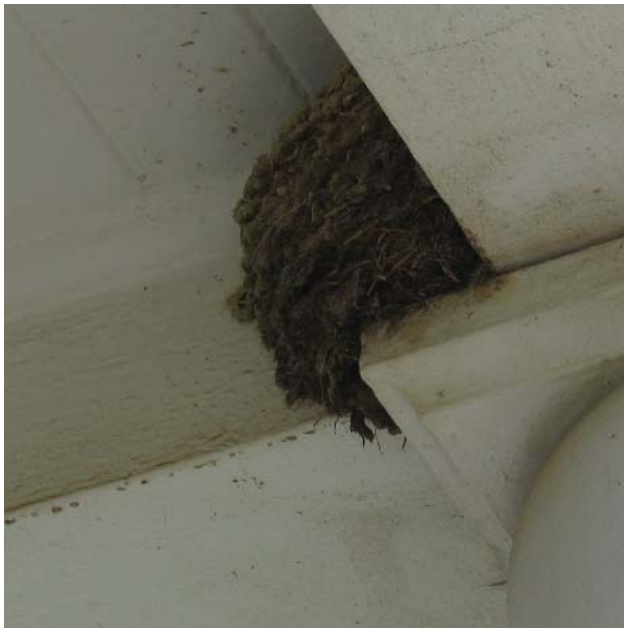
Fig. 57: Mud Swallow nests at the front porch of the Officer in Charge Quarters.

Recommendations: For general pests, determine how the pests are accessing the structures and then, once they are removed, block the access points in an architecturally acceptable manner. Follow legal and ethical procedures for the removal of these pests.

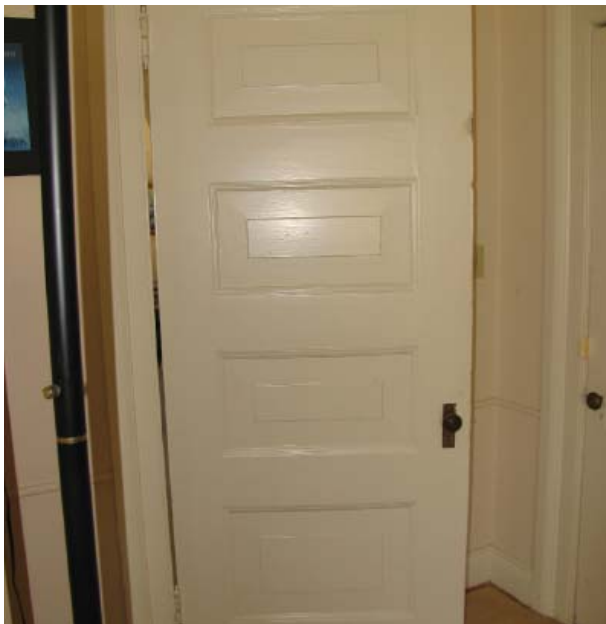
Fig. 67 : Most of the doors appear to be in good condition, with only minor repairs needed.
