SAN FRANCISCO
PORT OF EMBARKATION
HISTORIC STRUCTURE REPORT

Golden Gate National Recreation Area
National Park Service

ARCHITECTURAL RESOURCES GROUP

February 1991

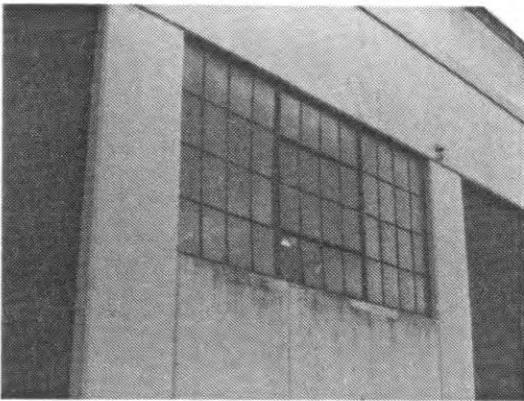
Factory sash in Pier Shed 3 with a bowed frame.

Missing muntins, sashes and frames should be replaced and matched to original.

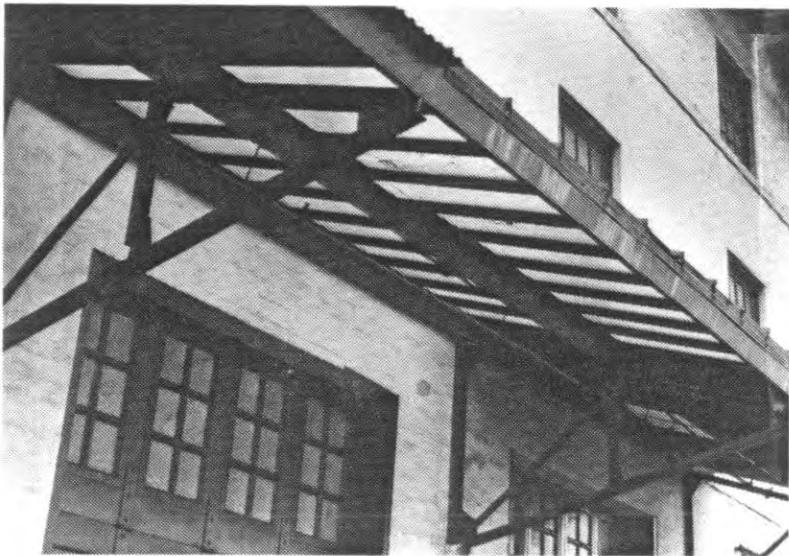
Damaged awning on Building 314

1. Repair or replace deformed awning components.
2. Scrape loose or flaking paint and remove all corrosion from metal by wire brush.
3. Prime bare metal and paint all metal using appropriate coating of the same system for use on exterior ferrous metals. Finish coat color should match existing.
4. Check all metal biannually for any areas of corrosion. Remove corrosion and re-coated surface.
5. Areas where birds roost should be covered with specially manufactured bird netting sensitively installed.

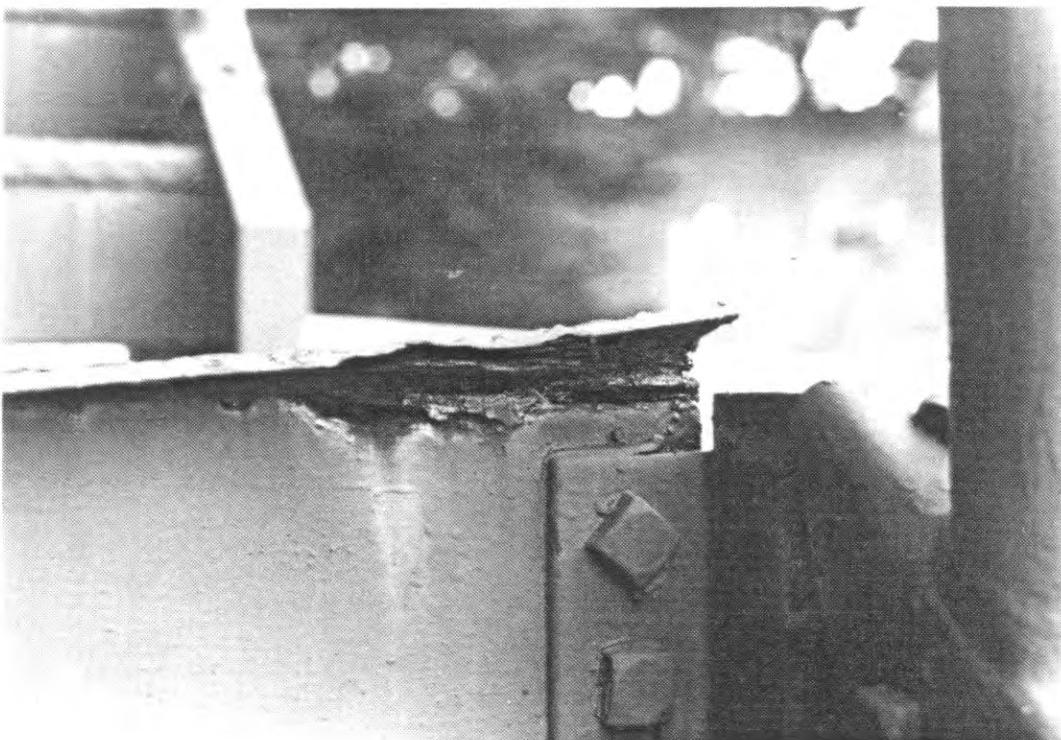
Corroded section of exterior stair landing.

Fire escape stairways should be surveyed immediately and severely corroded portions repaired. This will involve removing steel that has lost more than 25% of its original dimension and replacing it with new steel welded into place. In some cases it may be more economical to replace entire stair runs. New steel and portions affected by repairs should be coated as described below.

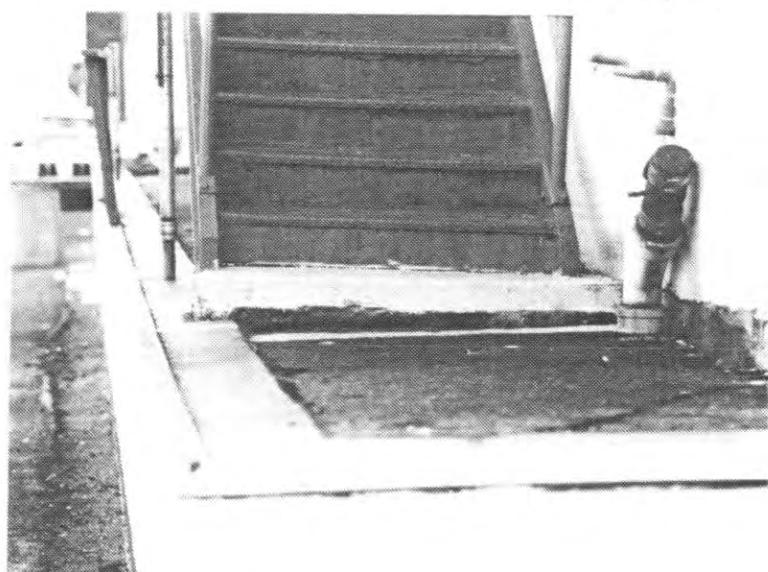
Settling on a loading dock caused by the 1989 earthquake.

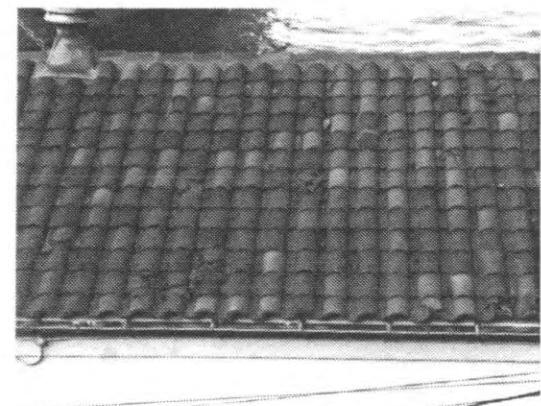
Tiles which no longer retain their original form due to cracking and displacement.

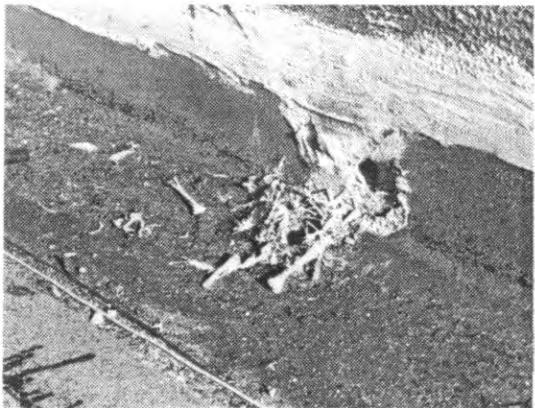
Drains in which debris restricts or stops normal rain water flow are designated as obstructed. Typical obstructions were feathers, bones, and pigeon droppings.

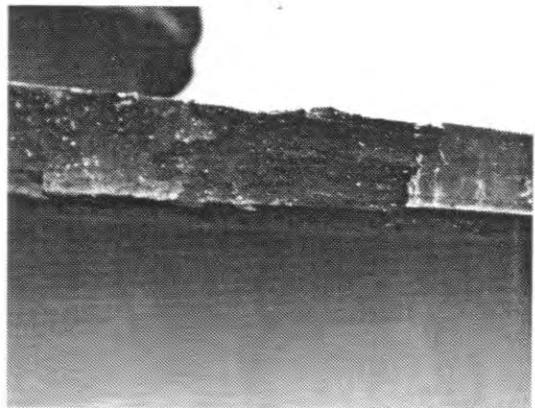
Failed Membrane

Failed Membranes are identified by bubbles, cracks, and areas of loose material.

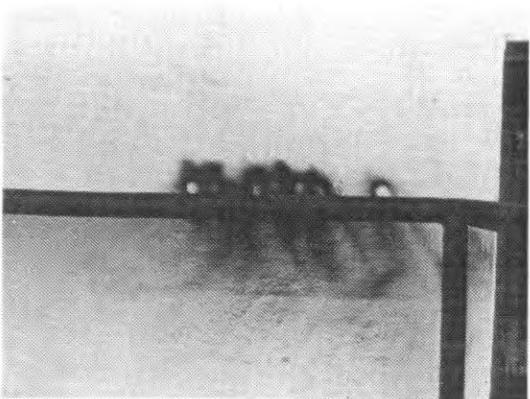
Deteriorated Flashing

Flashing which is corroded due to oxidation of the metal is termed deteriorated.

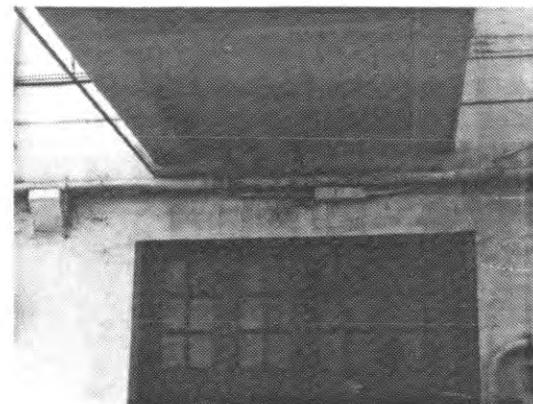
Bird debris is defined as any material which has produced soiling on adjacent materials due to the presence of pigeons. This may include, but is not limited to nests, bones, feathers, and pigeon droppings.

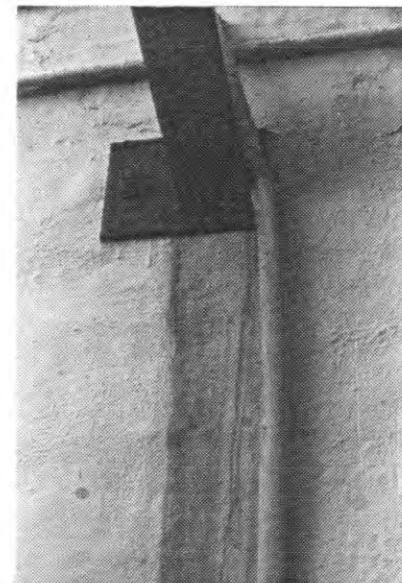
Biological Staining

Biological growths producing dark green to black stains on the concrete.

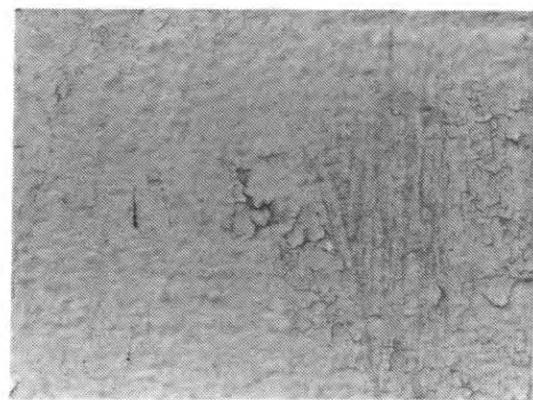
Ferrous Staining

Ferrous staining is staining of the concrete surface due to the oxidation of ferrous metal adjacent to, or imbedded in the concrete.

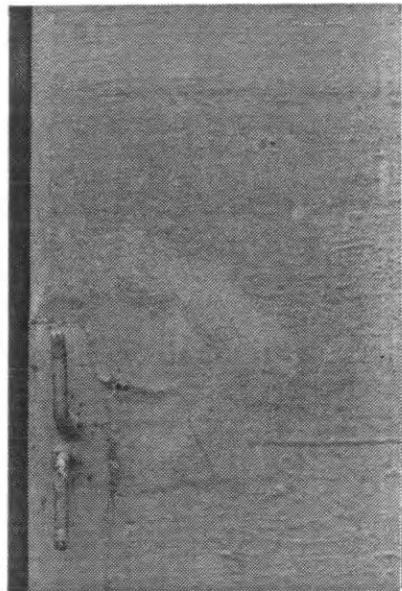
Failed Paint Coatings

Failed paint coatings are characterized by flaking and loss of adhesion.

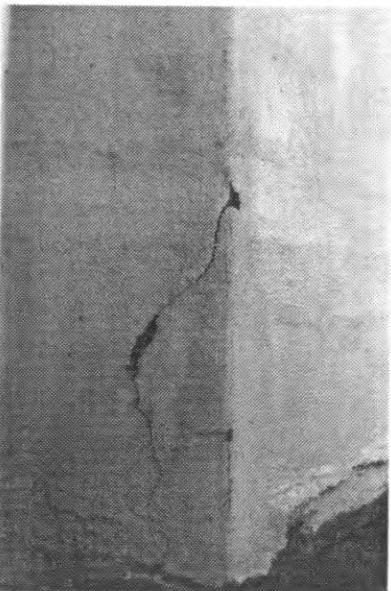
Cementitious Patches

Patches which are of a plastic consistency when applied, and are composed of a cementitious material together with aggregate and a liquid are termed cementitious patches.

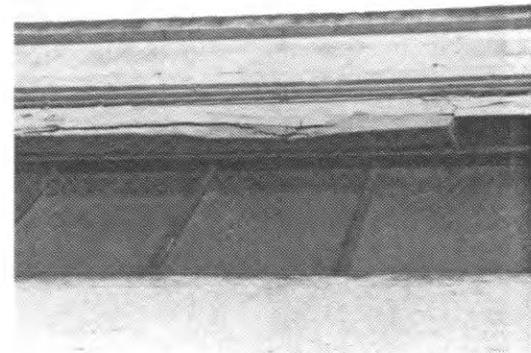
CRACKS, INCIPIENT SPALLS AND SPALLS are three conditions typically caused by corrosion jacking of reinforcing bars or imbedded steel anchors. Corrosion jacking is the increase in dimension that ferrous metals undergo during oxidation due to the presence of moisture. Iron oxide (rust) may expand up to eight times the thickness of the original metal. The increase in size exerts great pressure, leading to the rupture of the surrounding materials.

Incipient spalls were noted on all elevations of the pier buildings, and at random locations on other structures primarily at window and door openings.

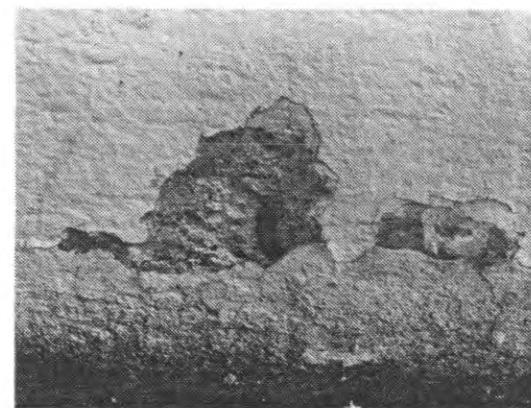
Spalls are losses in the concrete surface. Frequently, exposed reinforcing bars are visible in the spall area. Although spalls were observed on all elevations of the buildings, the most severely affected area was on the west elevation of Building 319.

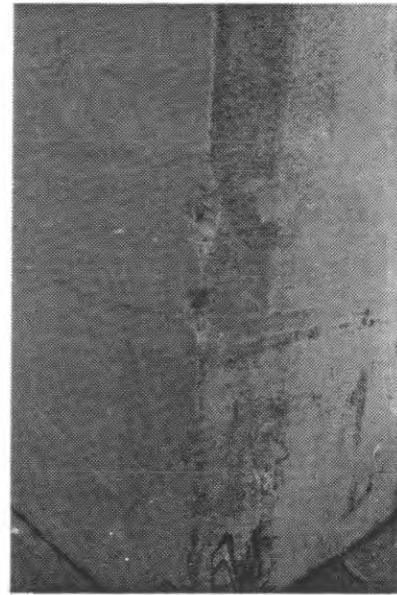
Impact Losses

Losses due to objects striking building, primarily at corners.

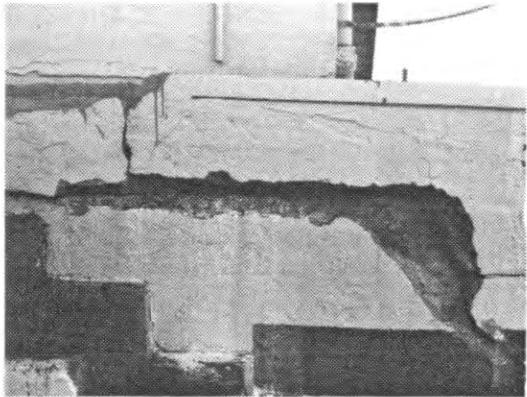
Displacement

Large cracks with corresponding displacement of walls and sinking of decks were noted in the porch walls. This damage may have been caused or exacerbated by the October 1989 earthquake.

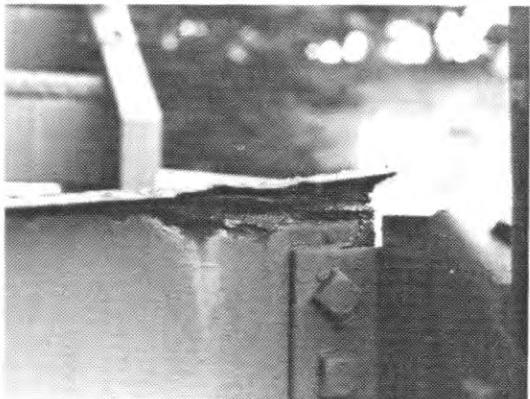
The deterioration of metal by chemical or electrochemical reaction resulting from exposure to moisture, chemicals or other agents.

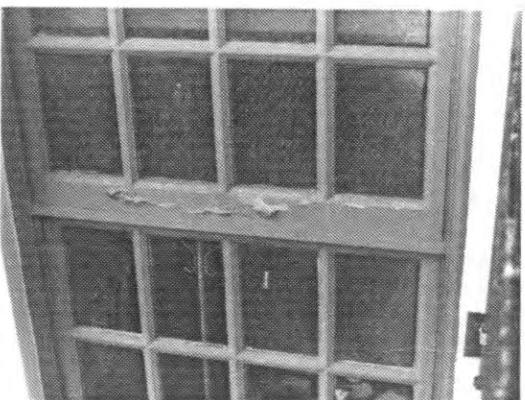
Failed Paint Coatings

Failed paint coatings are characterized by flaking and loss of adhesion.

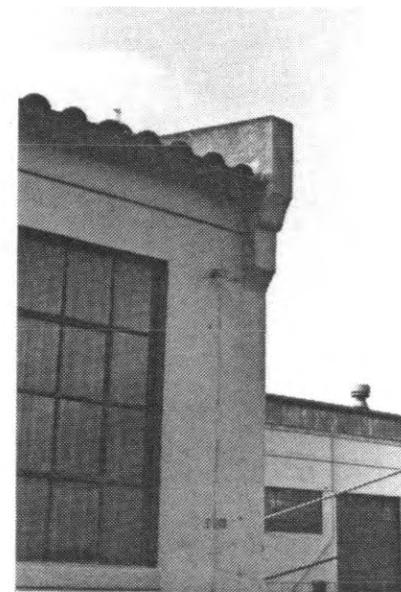
MISSING
FEATURES

Absence of original features as judged by incompleteness of form or decoration.
