Golden Gate Dairy (Lopes Brothers Dairy, Ranch M)

Cultural Resource Reports and Site Treatments: Cultural Landscape Report Historic Structure Reports Archeological Assessment and Treatment Report

June 10, 2013
United States National Park Service,
Golden Gate National Recreation Area
Division of Cultural Resources

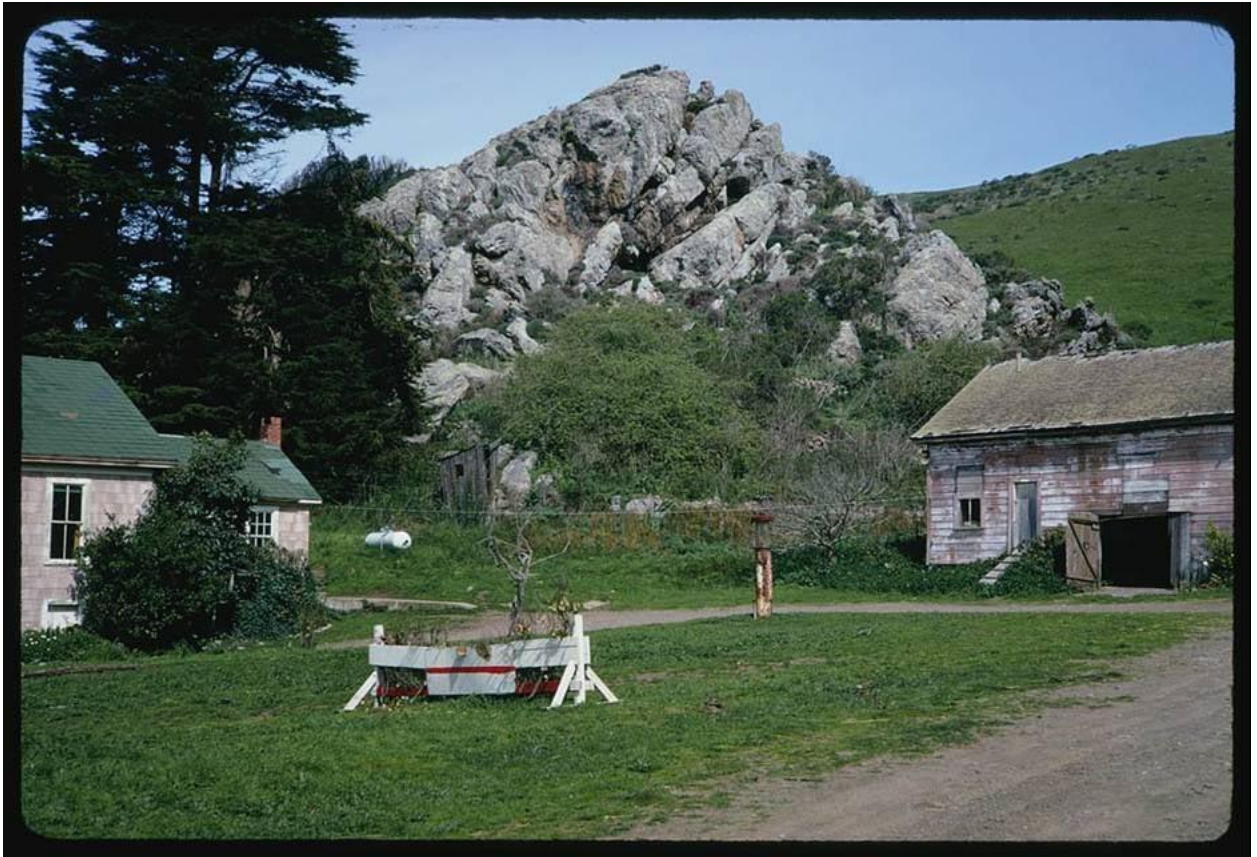
Recommendations include removing structures from the central core. This photograph from 1968 shows the internal road encircling an area free of structures. The Main House is to the left and the Creamery is to the right.

- Restore the central open space to its historic condition.
 - Remove all non-historic structures within this area, including horse stalls and sheds.
 - If possible, retain the use of the central, open area as a single space, with only a perimeter fence and no interior divisions.

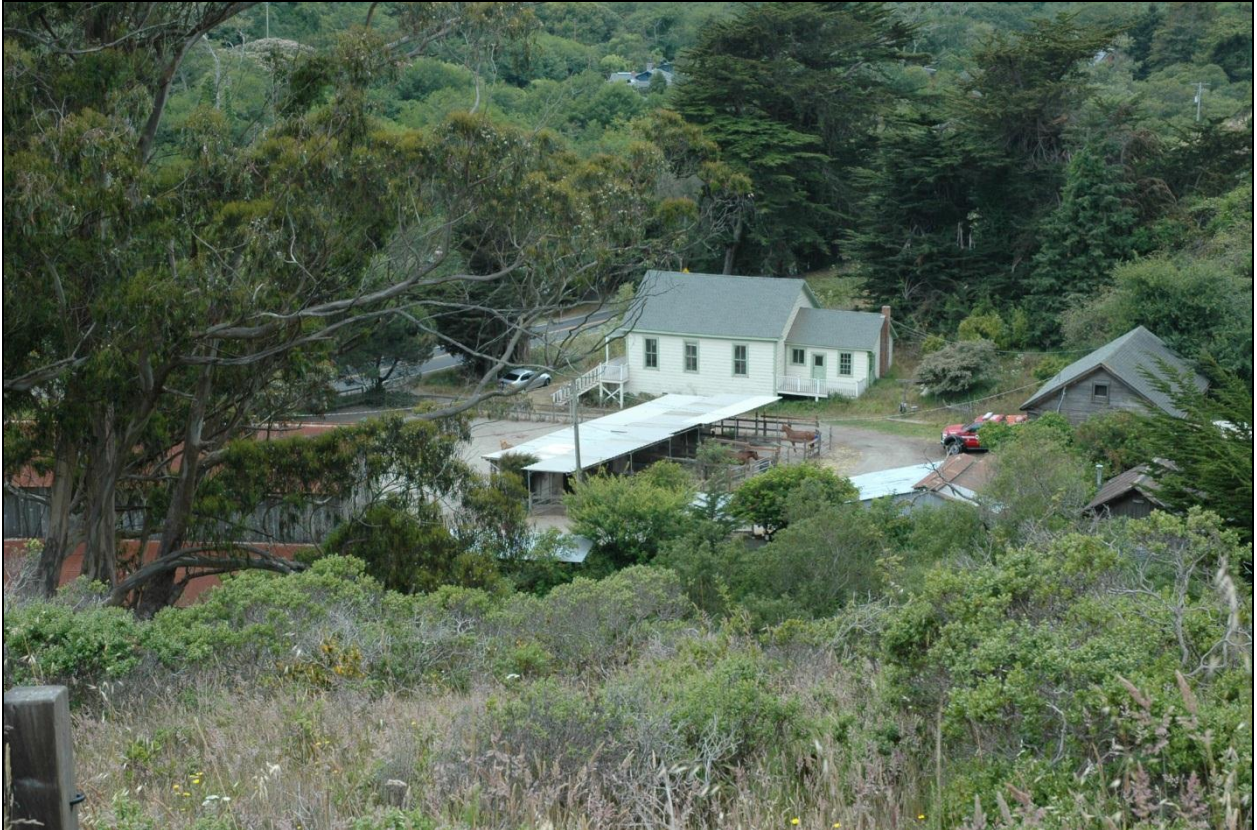
With the cessation of grazing, vegetation surrounding the core building area has evolved from grassland to coastal scrub.

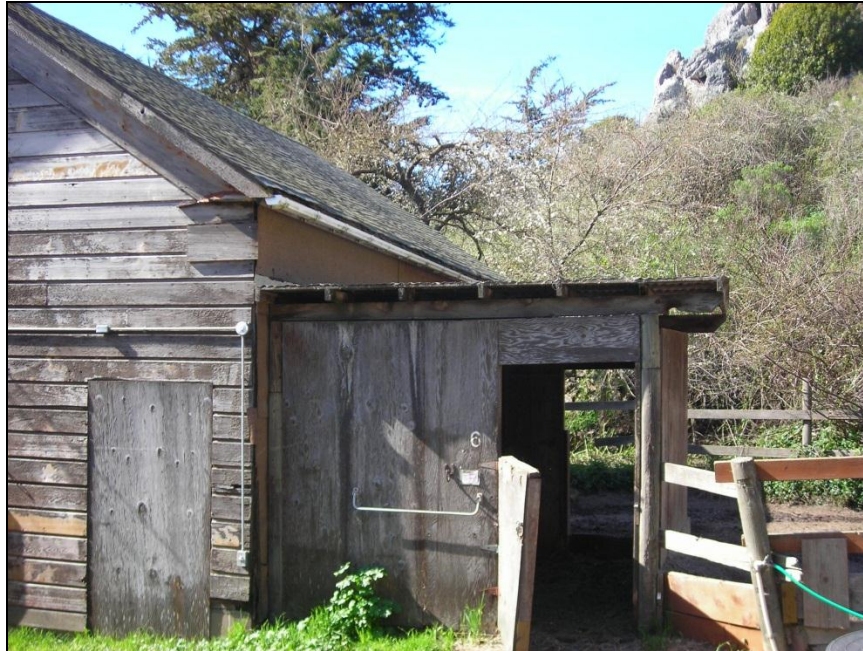
Recommendations include removal of non-historic attachments to historic buildings, such as this plywood stall behind the Creamery.

- Remove all non-historic additions to the historic buildings, including the outhouse on the south side of the Sanitary Barn.
 - Plywood stalls in the will be removed. Stalls outside of the historic core maybe replaced in the same general location, with an emphasis on organization of the space available. This may result in a less than one for one replacement.

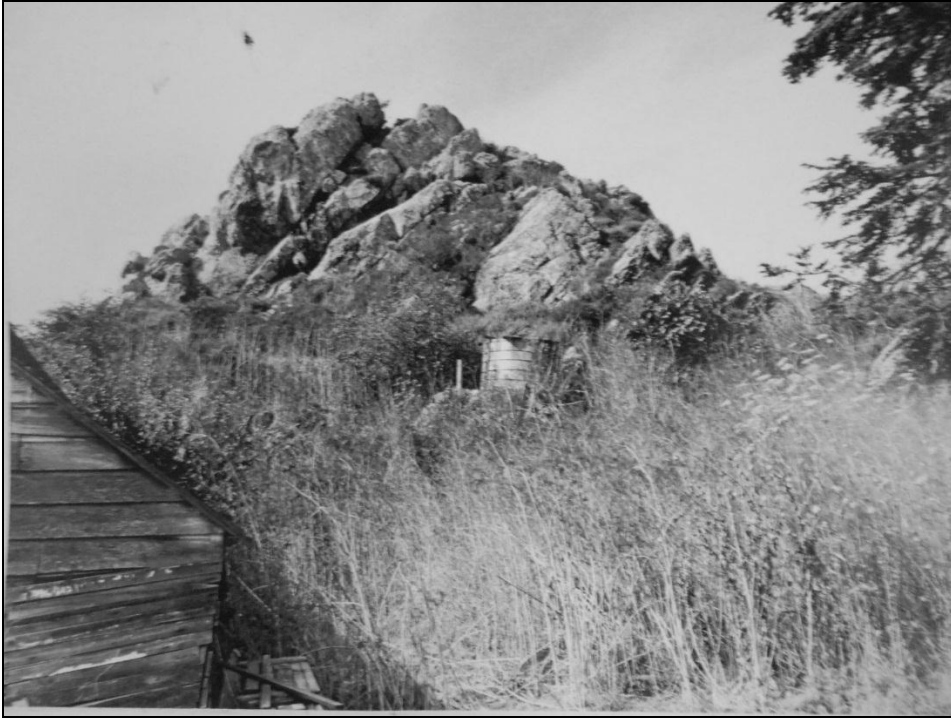
Watertank visible below the rock outcrop, north east of the Main House. Consideration should be given to locating a new watertank in this location, if at all feasible.

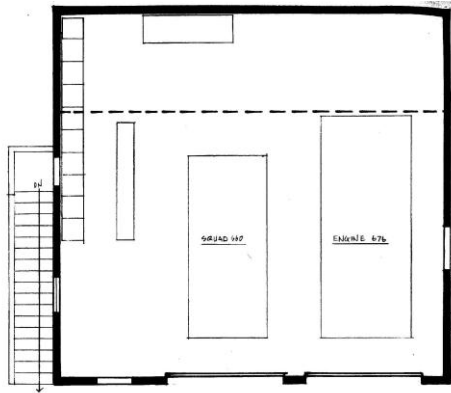
MBVFD Barn Remodel Concept Floor Plan

Not Recommended: Changing the building form and shape by adding a stair on the west where there was not one historically; altering the original footprint with an addition along the whole of the north wall, modifying the roofline.

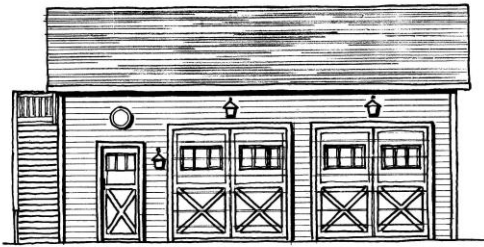
MBVFD Barn Remodel Concept Front (South) Elevation

Not Recommended: Changing the building form and shape by adding a stair on the west where there was not one historically; changing the character of the main façade by the addition of contrasting stylistic treatments and appurtenances; altering important elements of the building style (rake boards and corner returns).

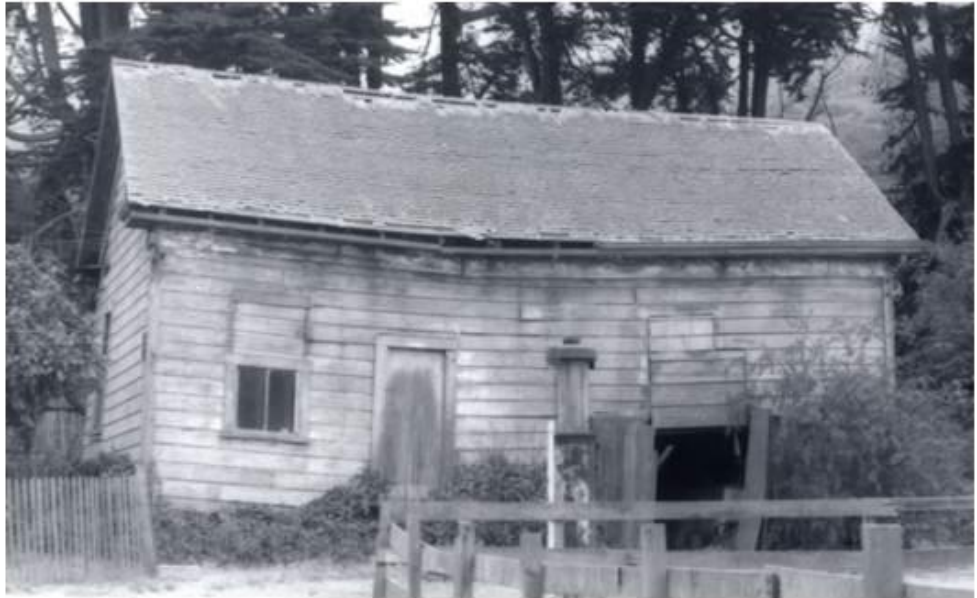
Golden Gate Dairy Creamery Building South Façade ca. 1970

Note the window penetration on the west, the in-filled window penetrations on the south, and the door penetrations. There is no exterior porch. The window at photo left matches windows extant on the Main House. Object in foreground is believed to be a gasoline pump.

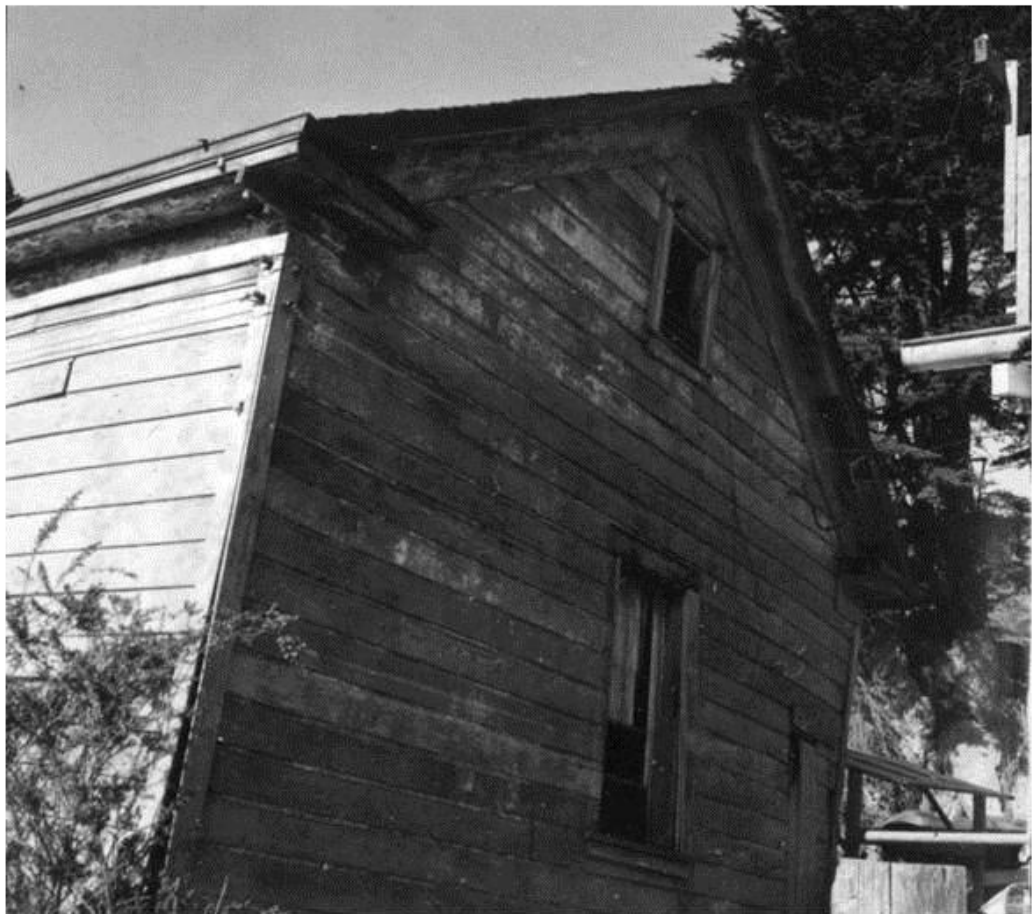
Two Views of the Golden Gate Dairy Creamery Building East Façade 1970

Note the window that appears to have been closed off but has shelves on the interior. Note also the lack of (or extreme foreshortening) of the door penetration in this location.

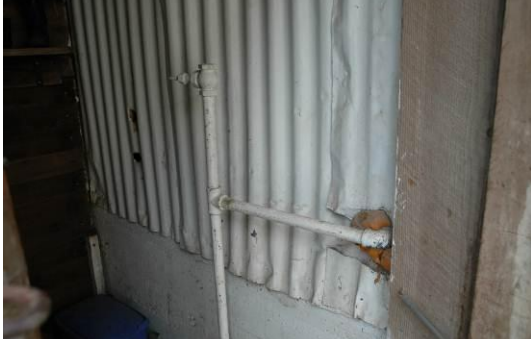
| <p>Northeast corner inside outhouse; abandoned water piping possibly from boiler or heater on opposite side; north room (NPS Photo, 2012)</p> | | <p>Capped ridge vent detail (NPS Photo, 2012)</p> |
