**FINAL REPORT  
BUILDING 0679  
ASBESTOS MATERIALS RE-SURVEY AND LEAD-BASED PAINT INVESTIGATION  
EAST FORT BAKER  
SAUSALITO, CALIFORNIA**

**CONTRACT NUMBER DACA05-87-C-0188  
MODIFICATION P00008**

**U.S. ARMY CORPS OF ENGINEERS  
SACRAMENTO DISTRICT  
1325 J STREET  
SACRAMENTO, CALIFORNIA 95814-2922**

March 8, 1996

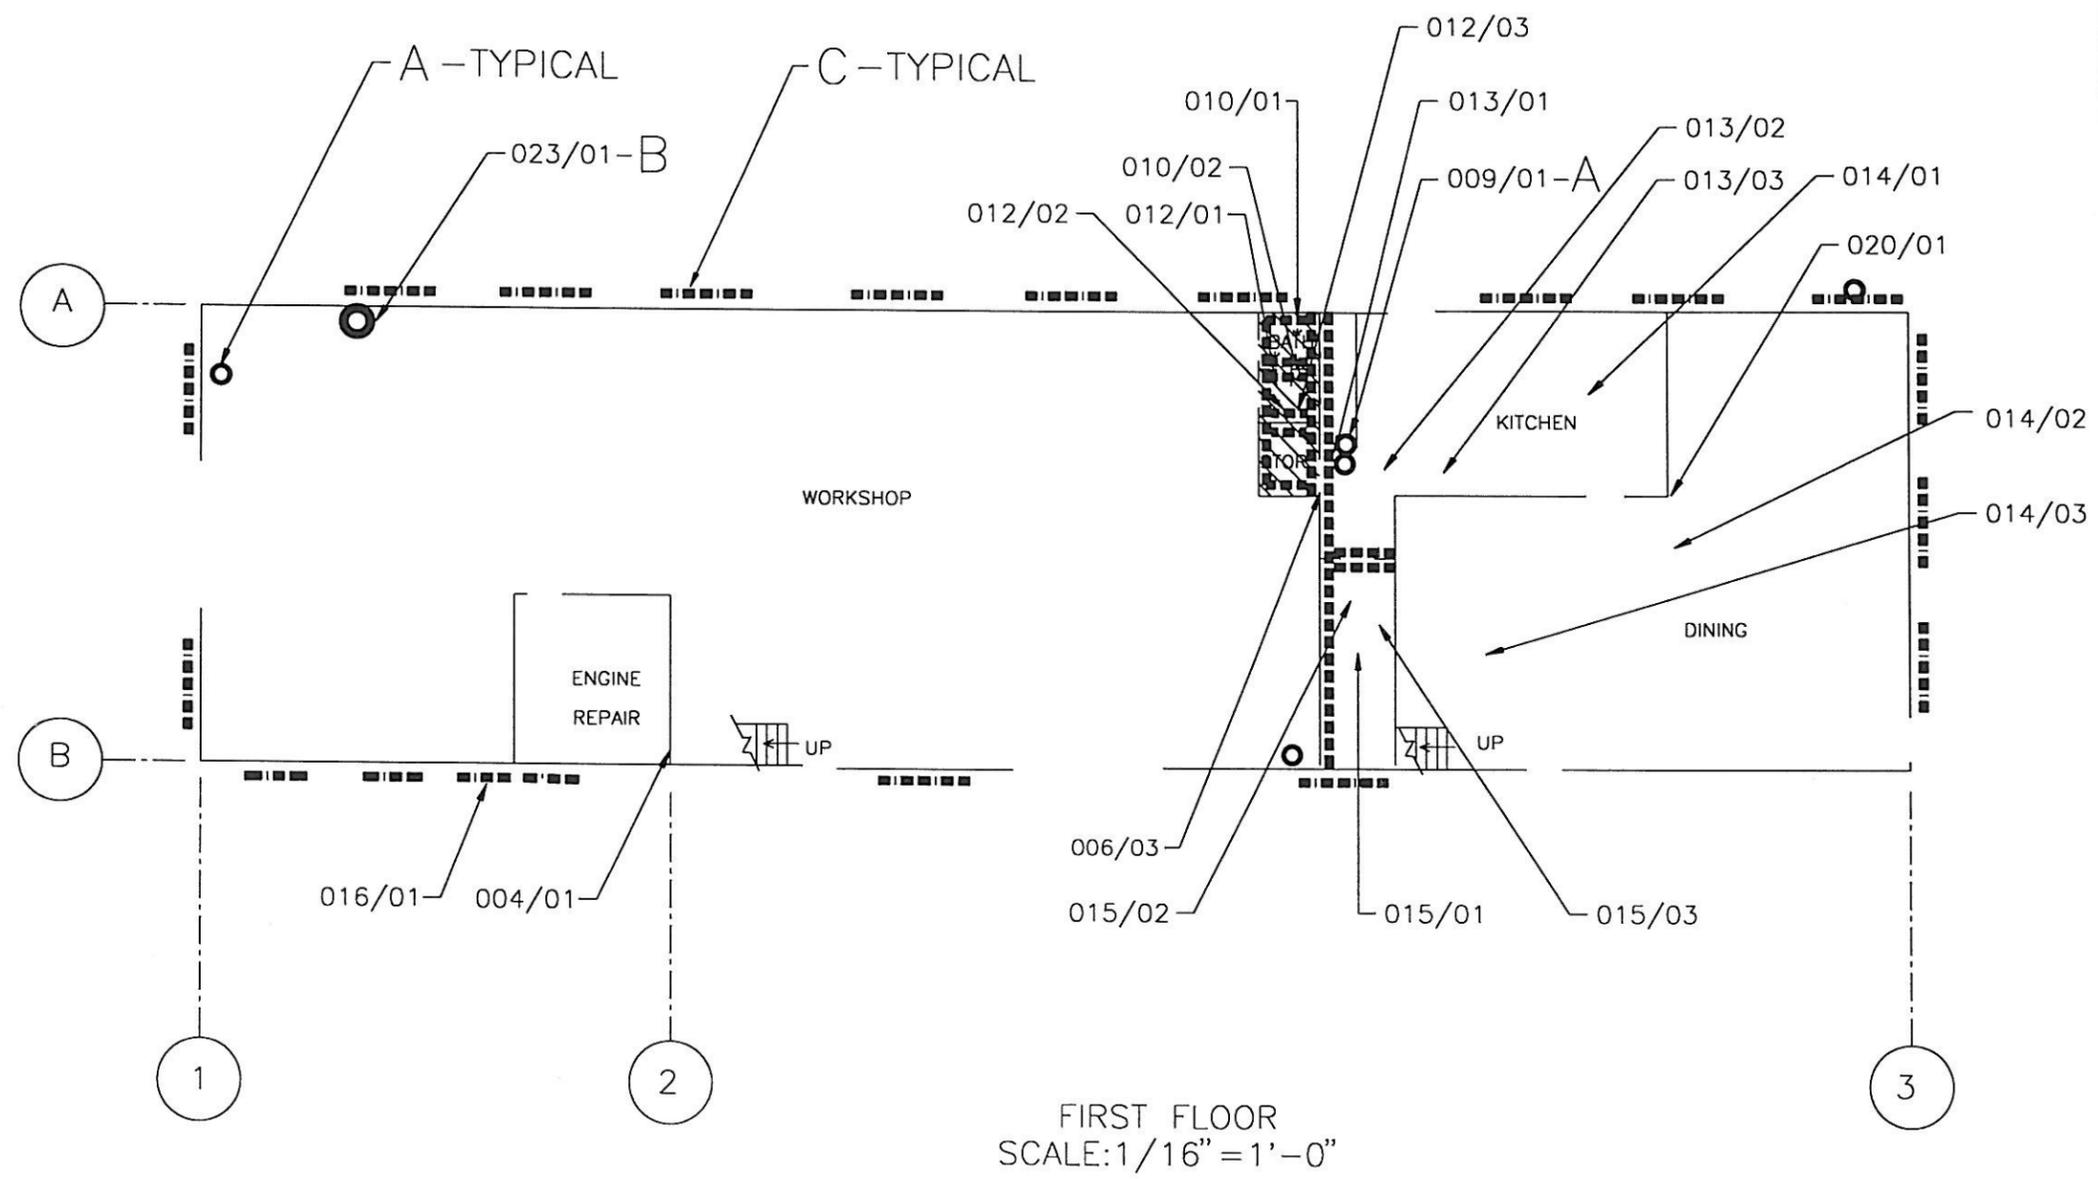
The asbestos-containing asbestos concrete flue located throughout the building is assigned a friability rating of "nonfriable" and a damage rating of "none." Bulk samples of this material were collected and found to contain 8 percent chrysotile and 1 percent

The asbestos-containing window putty located around windows is assigned a friability rating of "nonfriable" and a damage rating of "low." Bulk samples of this material were collected and found to contain 1 percent chrysotile asbestos. This material is located on the exterior of the building; therefore, a hazard rank is not applicable. Versar recommends incorporating the material into an O&M Program for proper management.

The asbestos-containing transite located on the first floor is assigned a friability rating of "nonfriable" and a damage rating of "none." Bulk samples of this material were collected and found to contain 20 percent chrysotile asbestos. This material has a hazard rank of 5. Versar recommends conducting periodic inspections of this material as part of an O&M Program for proper management.

- A. TRANSITE FLUE
- B. TRANSITE SHEET-LOOSE
- C. WINDOW PUTTY

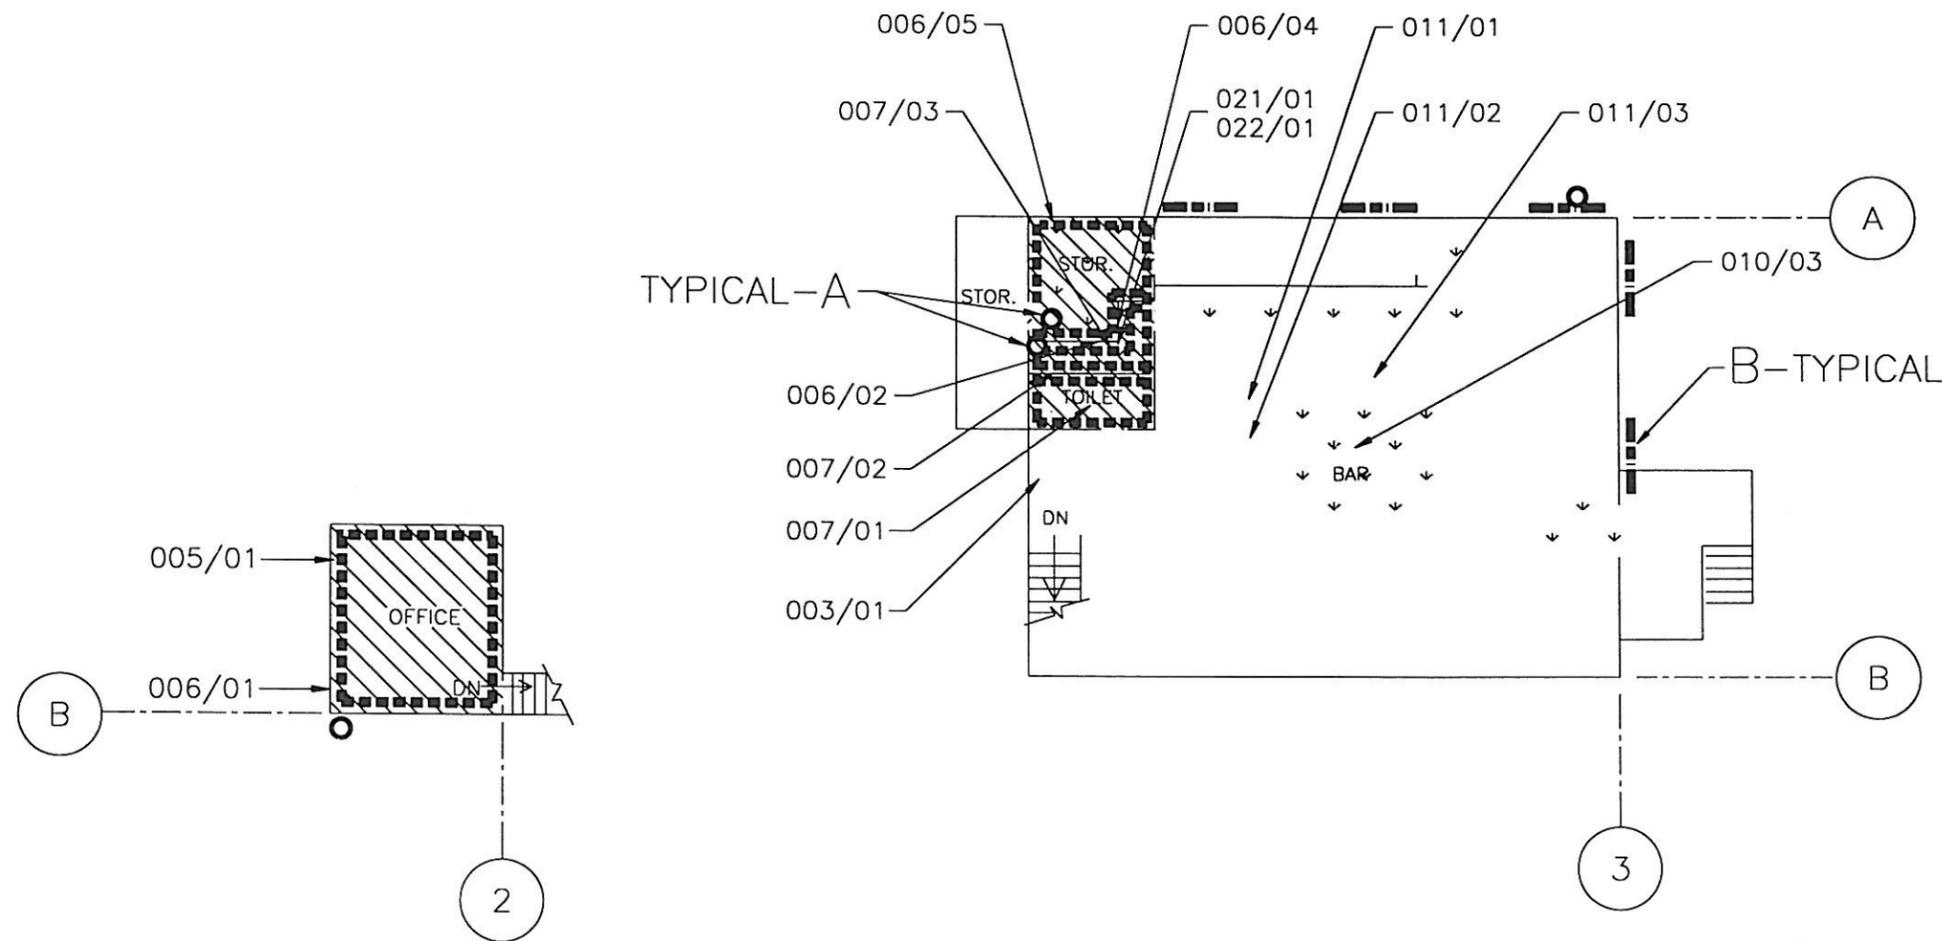
SECOND FLOOR  
SCALE: 1/16" = 1'-0"

found to contain 2 percent chrysotile asbestos. This material has a hazard rank of 6. Versar recommends incorporating the material into an O&M Program for proper management. Versar further recommends that individuals in these areas be instructed to refrain from any activity which could disturb the asbestos-containing gypsum board joint compound. This includes drilling holes, installing nails or picture hangers, or any other activity having the potential to disturb the material.

The asbestos-containing gypsum board wall texture located in second floor bathrooms is assigned a friability rating of "nonfriable" and a damage rating of "none." Bulk samples of this material were collected and found to contain 1 percent chrysotile asbestos. This material has a hazard rank of 5. Versar recommends conducting periodic inspections of this material as part of an O&M Program for proper management. Versar further recommends that individuals in these areas be instructed to refrain from any activity which could disturb the asbestos-containing gypsum board wall texture. This includes drilling holes, installing nails or picture hangers, or any other activity having the potential to disturb the material.

- WALL TEXTURE ASSOCIATED WITH TAPING COMPOUND LOCATED THROUGHOUT THE WALLS AND ON CEILING IN THE TOILETS

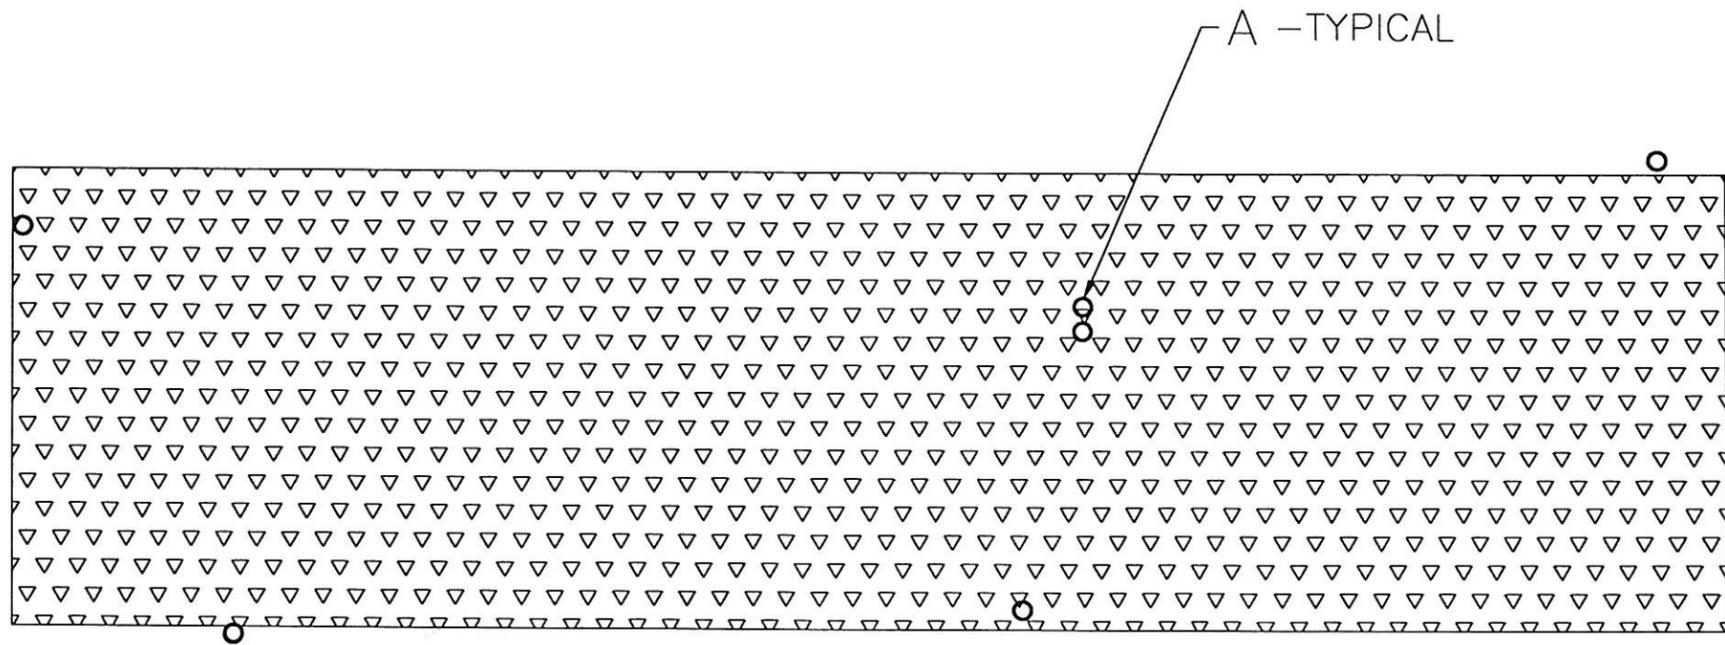
ROOF  
SCALE: 1/16" = 1'-0"

The asbestos-containing asphalt shingles located over the entire roof are assigned a friability rating of "low" and a damage rating of "none." Although no bulk samples of this material were collected, the material is assumed to contain asbestos. This material is located on the exterior of the building; therefore, a hazard rank is not applicable. Versar recommends incorporating the material into an O&M Program for proper management. In addition, Versar recommends that sampling be performed to confirm the presence or absence of asbestos prior to any renovation or demolition that would disturb this material.

The asbestos-containing felt paper located under asphalt shingles is assigned a friability rating of "low" and a damage rating of "none." Although no bulk samples of this material were collected, the material is assumed to contain asbestos. This material is located on the exterior of the building; therefore, a hazard rank is not applicable. Versar recommends incorporating the material into an O&M Program for proper management. In addition, Versar recommends that sampling be performed to confirm the presence or absence of asbestos prior to any renovation or demolition that would disturb this material.

The asbestos-containing mineral roll roofing located over asphalt shingles on one quarter of the roof is assigned a friability rating of "low" and a damage rating of "none." Although no bulk samples of this material were collected, the material is assumed to contain asbestos. This material is located on the exterior of the building; therefore, a hazard rank is not applicable. Versar recommends incorporating the material into an O&M Program for proper management. In addition, Versar recommends that sampling be performed to confirm

ASSUMED ROOFING MATERIAL

NOTES:  
A. TRANSITE FLUE
