Project Completion Report

Fiscal Year 2008

Chapel of the
Transfiguration Window
Repair

Grand Teton National Park

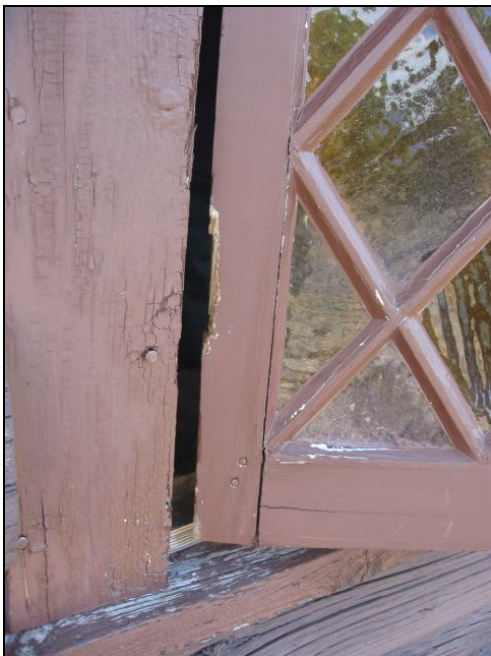
Figure 2: Missing hardware that was causing further damage to framing and sills.

The third phase of the project consisted of the re-installment of the window sashes in the Chapel of the Transfiguration. Part of the goal of phase one of the project was to repair the windows in such a way that would permit the half-lap joint to work effectively and properly again, precluding the need for astragals. In order to do this, the WCHP shimmed and trimmed the window jams in a way that allowed the windows to hang correctly. One hinge was replaced to match historic hinges.

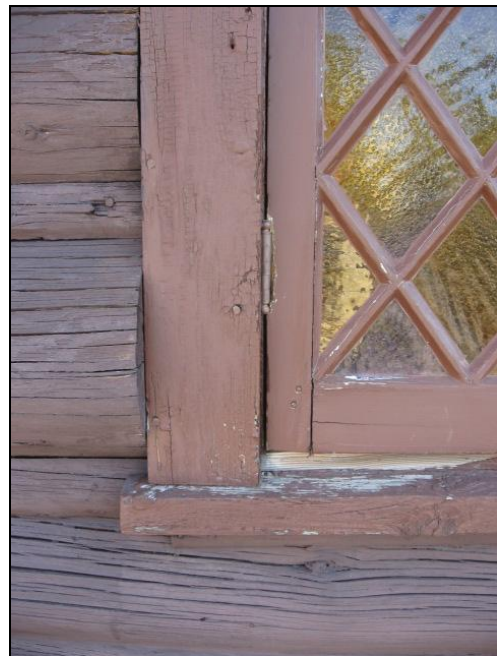
Figure 3: Unpainted, cracked, and rotting sills and framework.

The second phase of the project on the Chapel of the Transfiguration included repairs to the exterior framing and sill repair work. The WCHP worked on one window sill at a time while replacing the plywood at night in order to secure the building. Any split or severely damaged wood was replaced-in-kind. Most framing and sills were repaired using epoxy and/or dutchman repairs. Again, the woodwork completed during this portion of the repair work was then only primed in an effort to allow St. John's Episcopal to utilize more cost-effective options for the repainting of the windows. Continuing on in the second phase of the project, the jambs and casings were replaced for the stained glass windows. St. John's Episcopal was also responsible for the replacement of the protective screens on the exterior of the stained glass windows.

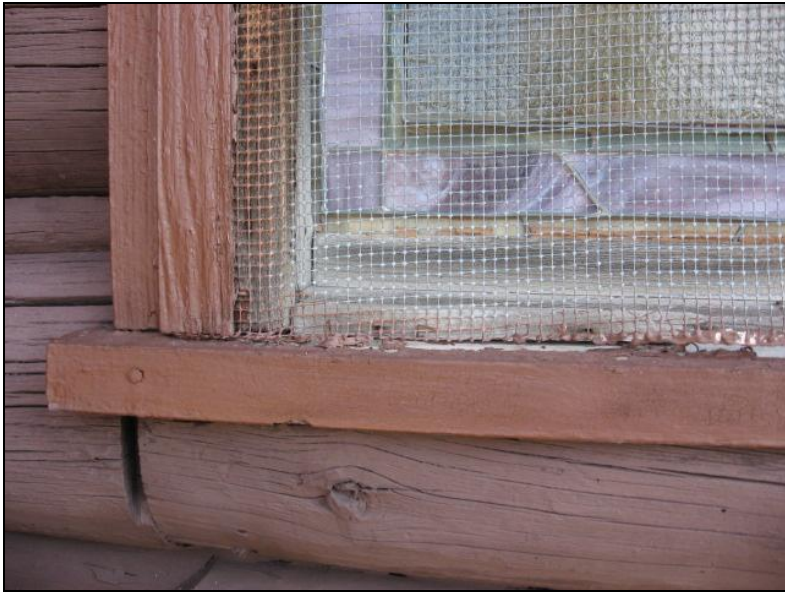
Figure 4: Insufficient mesh & distressed sill.

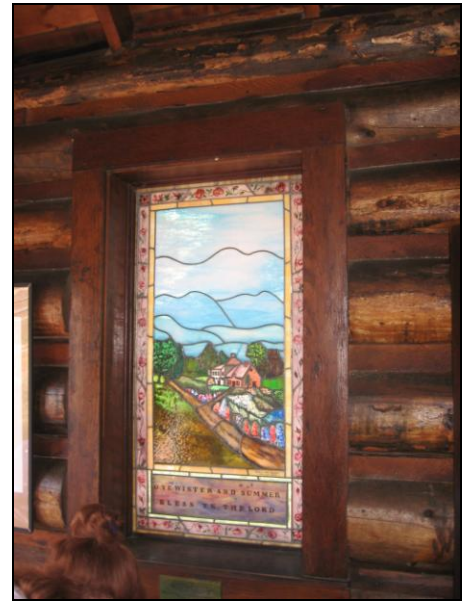
Figure 5: Stained glass window before repairs.

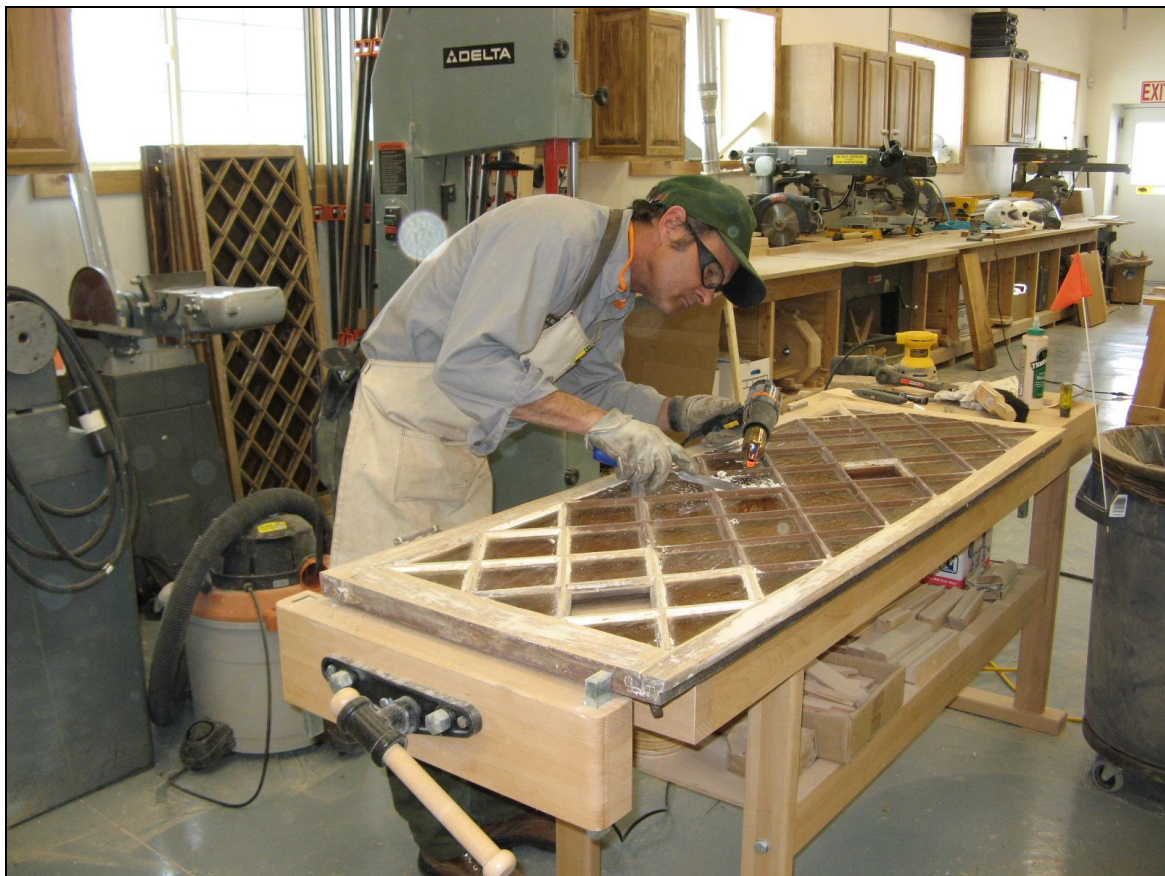
Figure 6: Al Williams, WCHP, stripping existing paint from windows.

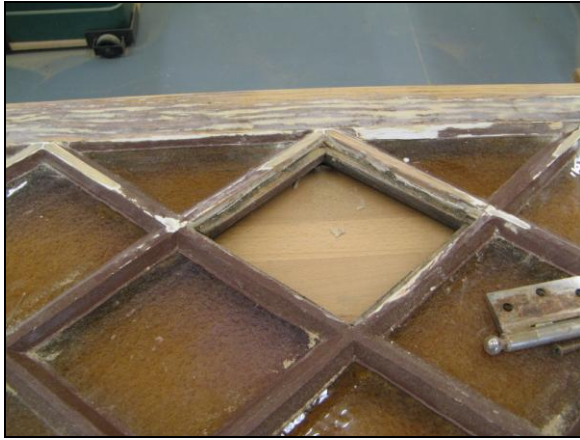
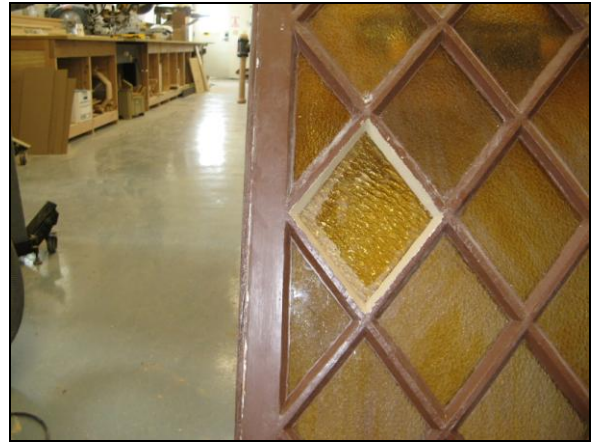
Figures 7 & 8: Replacement and reglazing of similarly colored glass pane.

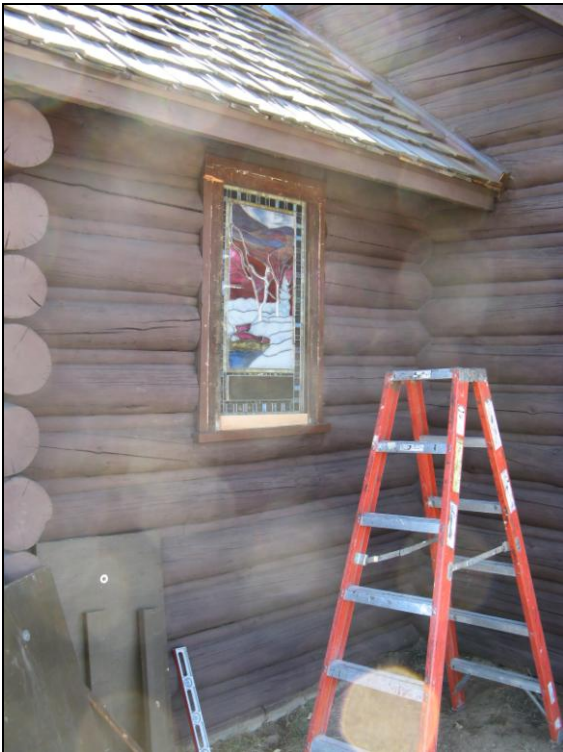
Figure 9: Repaired stained glass window before painting of exterior.

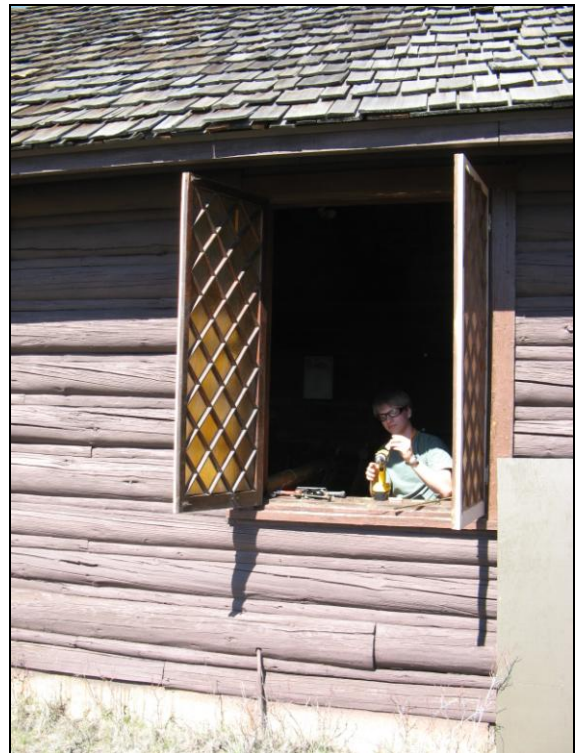
Figure 10: David Stubbs, WCHP, reinstalling paned window sashes into their framing.
