Scope of Work for Highlands Community Center

Date: July 5, 2009

Introduction:

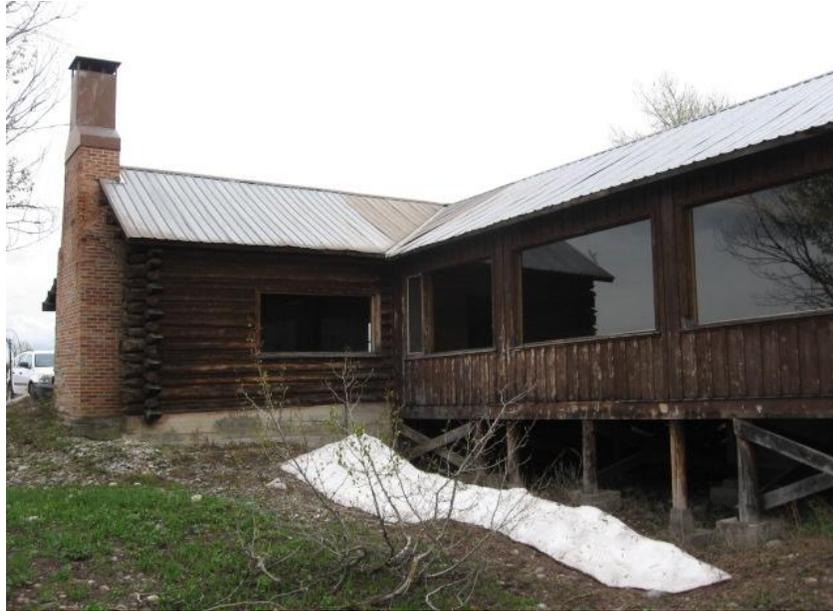
#1 Foundation Replacement Area from Chimney to The Right Ending at Pier Area and Slope West Elevation

- **General Site Work:** Pictures numbered 1 and 2
 - The project site will require excavation of an existing downhill grade in order to form and pour the new footer and stem wall. After the new foundation has cured sufficiently the area will need to be backfilled and graded with a slope that allows at least 3 feet of soil over the new footers. See specification sheet.
 -

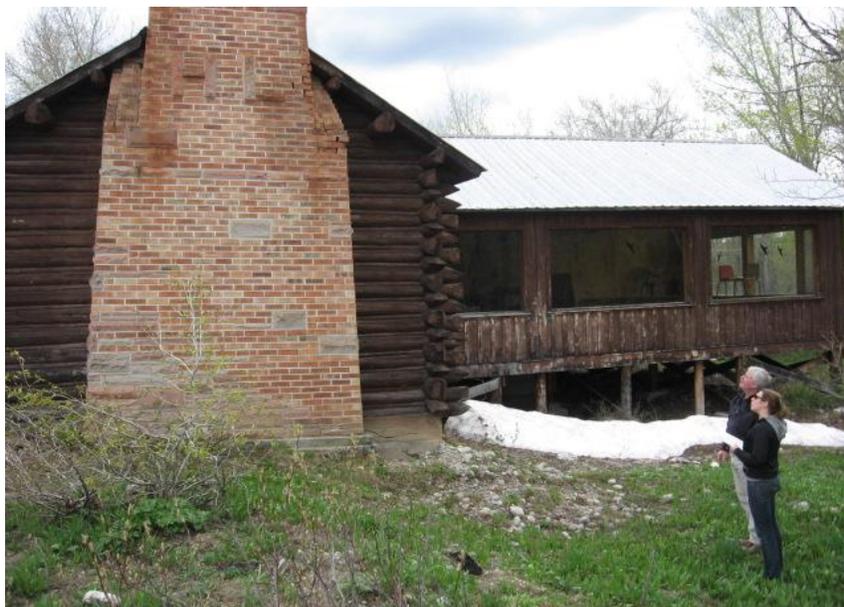
#2 Chimney at North End of Structure Grade from Right Of Chimney around Corner Down slope

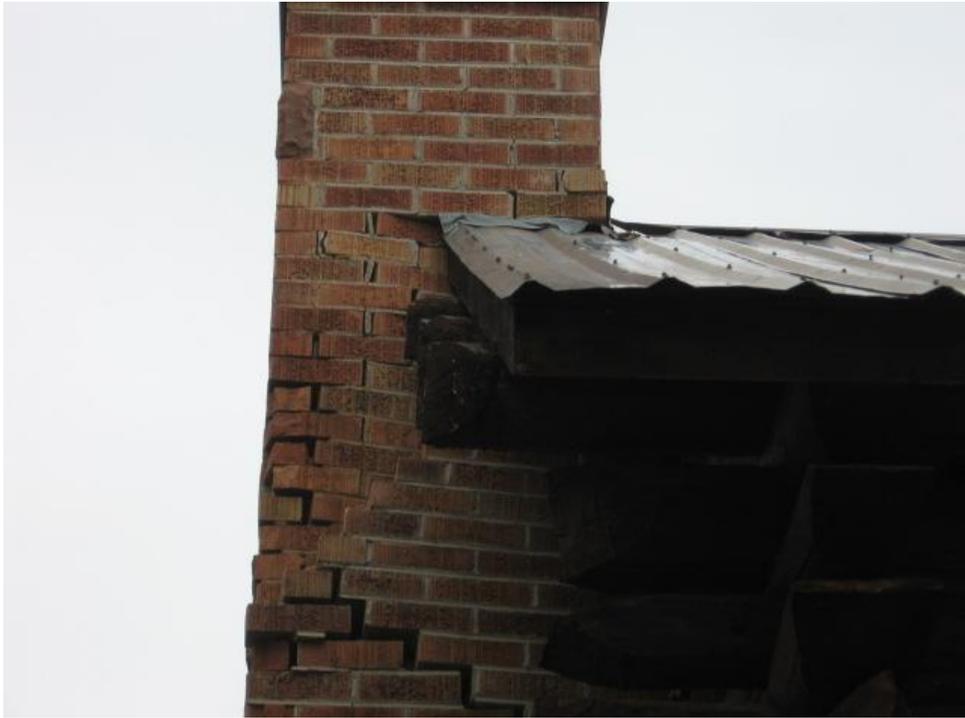
#3 West Side of Chimney Stress Cracks from Settling and Straightening

- **Exterior and Interior Chimney Work:** Pictures numbered 3-8
 - The exterior of the chimney requires dismantling the chimney from the top to below the stress cracks approximately 8 feet. Reconstructing the chimney using the original bricks in their original positions where possible and obtaining matching bricks for use where the original have been damaged beyond reusability. This work requires the removal and replacement of the chimney cap. The interior of the chimney will require resetting of the flagstone with new mortar, resetting the mantle and replacing the existing chinking immediately above the mantle. The mortar should match the existing as near as possible as to color and material.

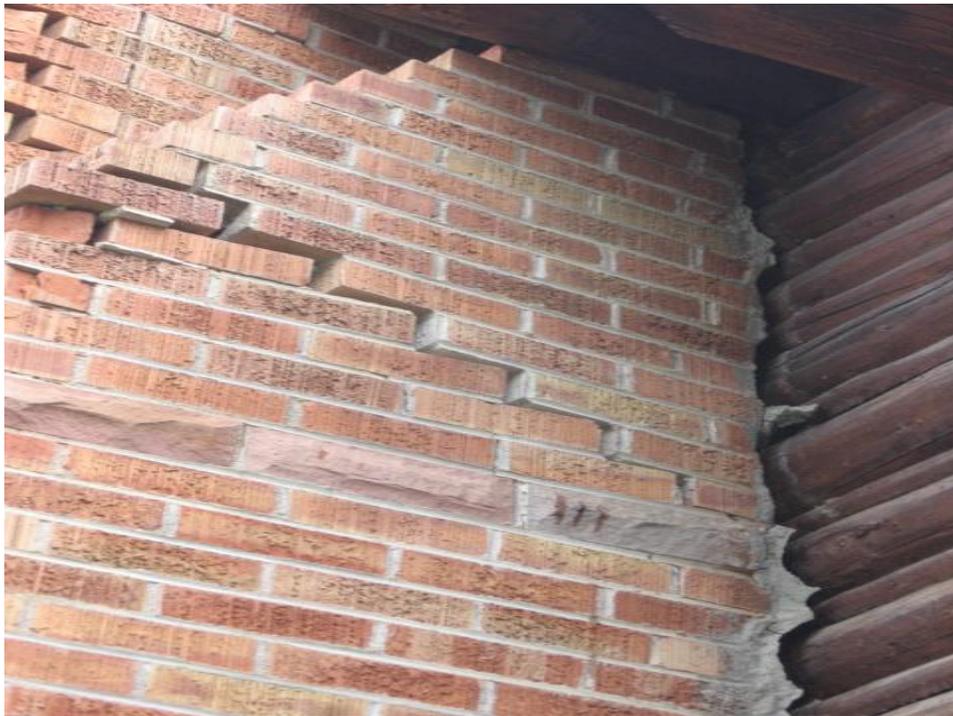
#4 Close Up Of Above Picture

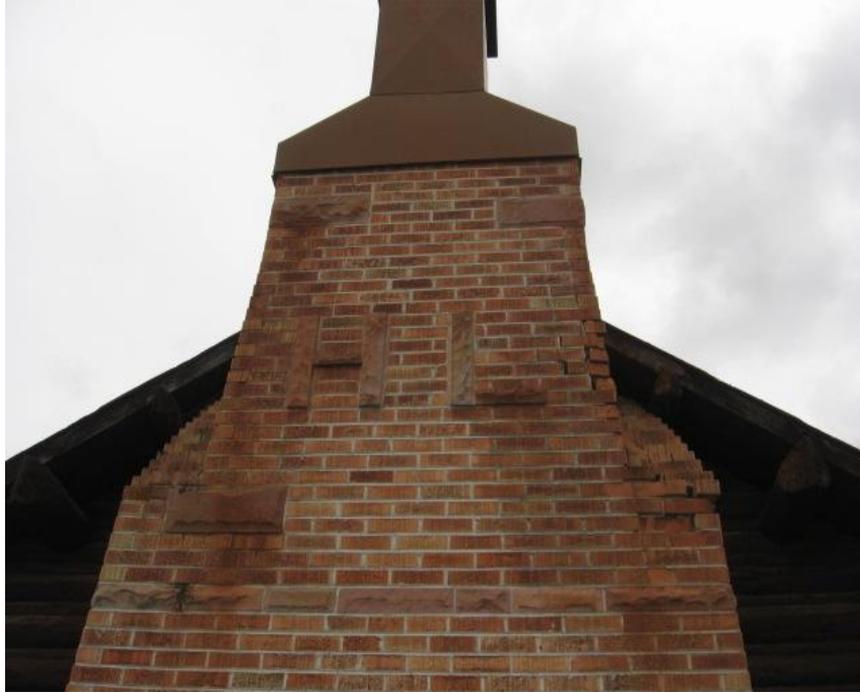
#4 Front of Chimney Showing Lowest Level of Stress Damage Visible on Right Edge

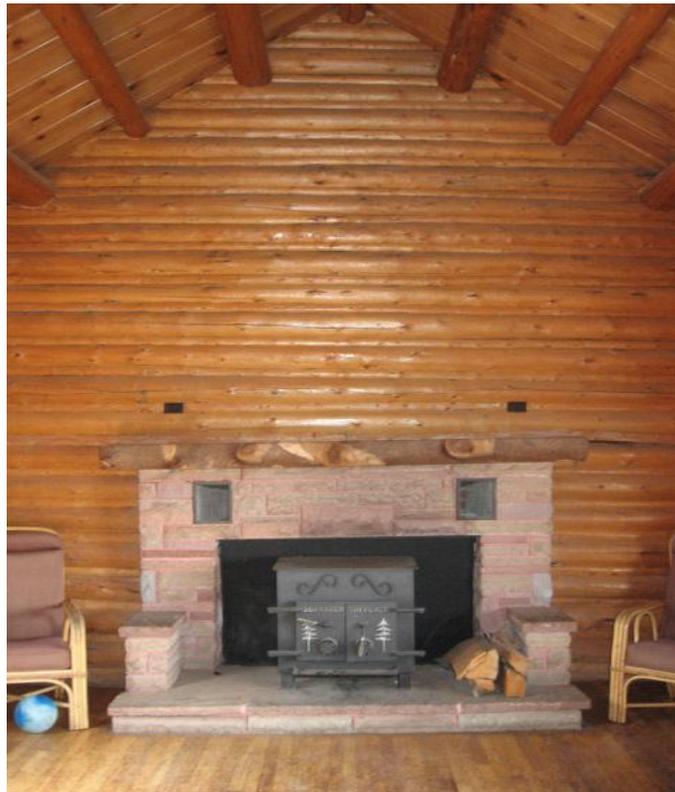
#5 Interior View before Plumbing and Leveling Of Chimney in 2008

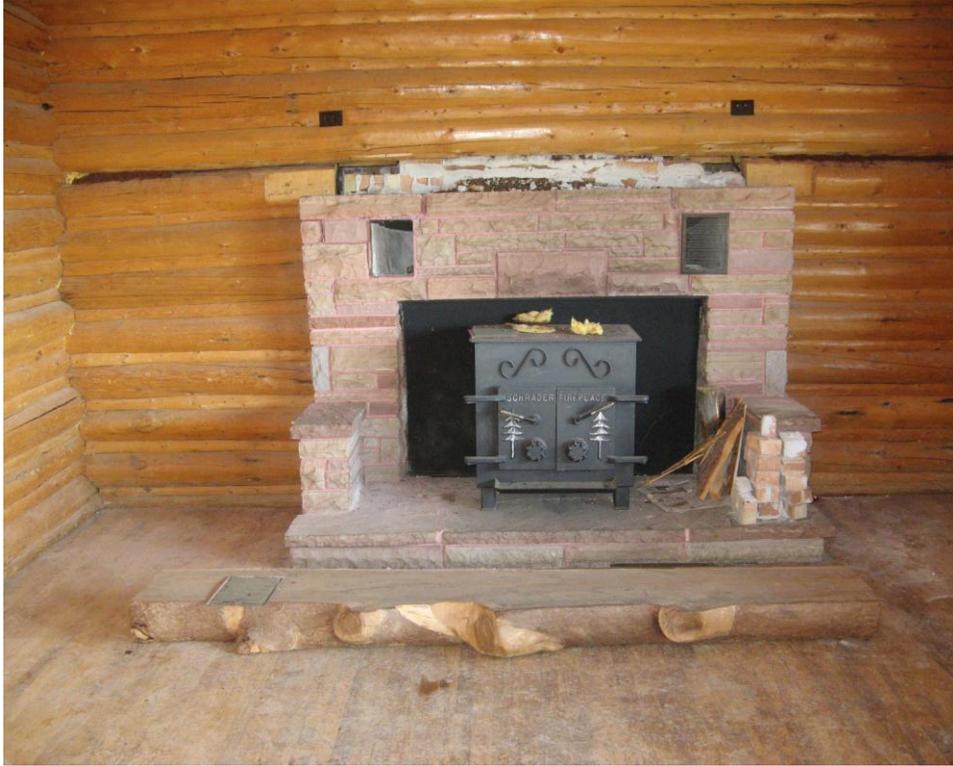
#6 Current View of Interior Chimney with Mantel on Floor

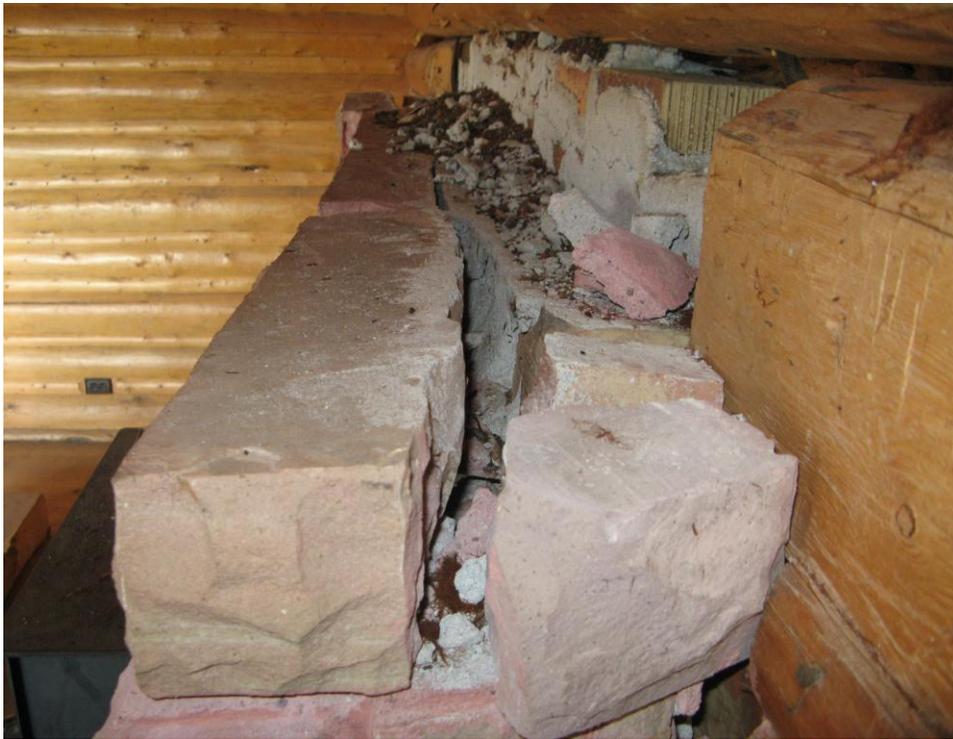
#7 Current View of Interior Chimney Flagstone Separated from Wall East Elevation

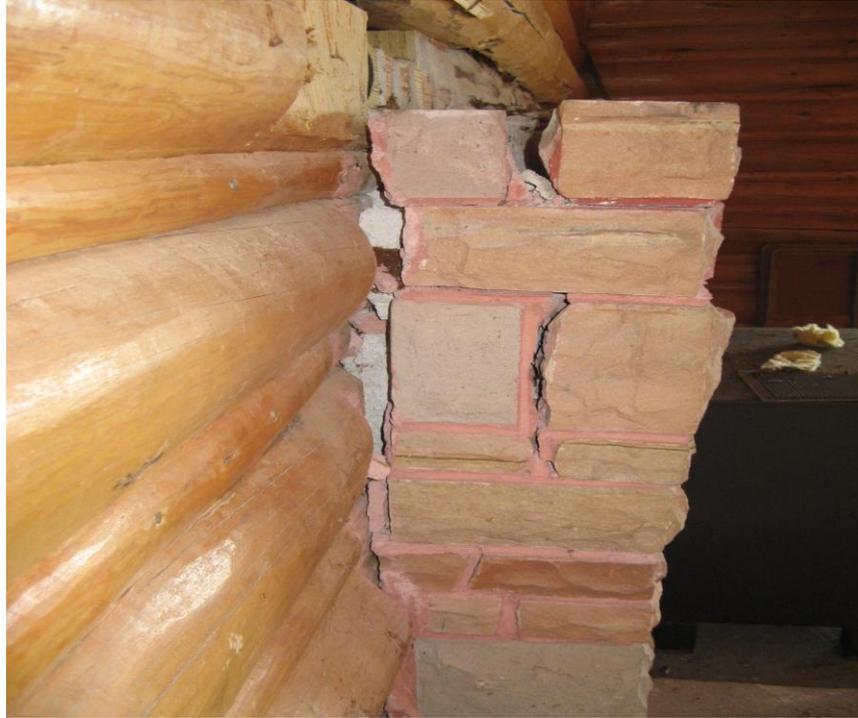
#8 Chimney Interior West Elevation Flagstone Separation From Wall

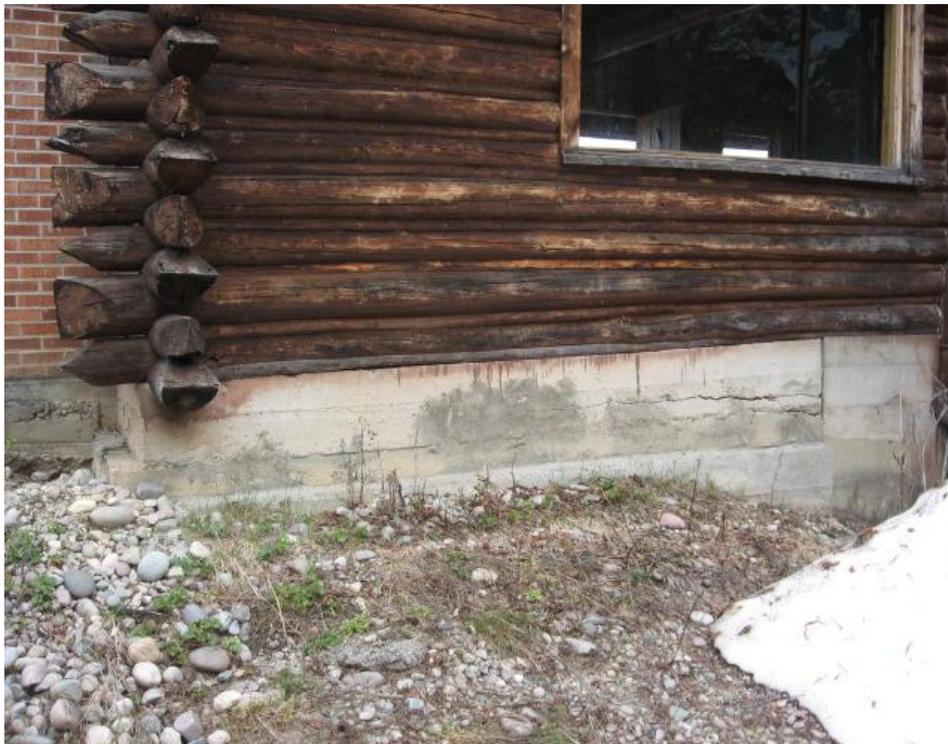
#9 Foundation Area to be removed from Chimney Corner on Left to Vertical Crack under Right Side of Window

- **New Foundation:** Pictures numbered 9-11
 - The new foundation should match the existing in size and configuration to that under the main part of the structure. The new foundation will have #4 rebar steel reinforcement as shown or described in the specifications. The new foundation should match the existing under the main part of the structure. Cold joints will be

attached to existing with rebar epoxied to the existing concrete and extending into the new foundation including the footer according to specifications.

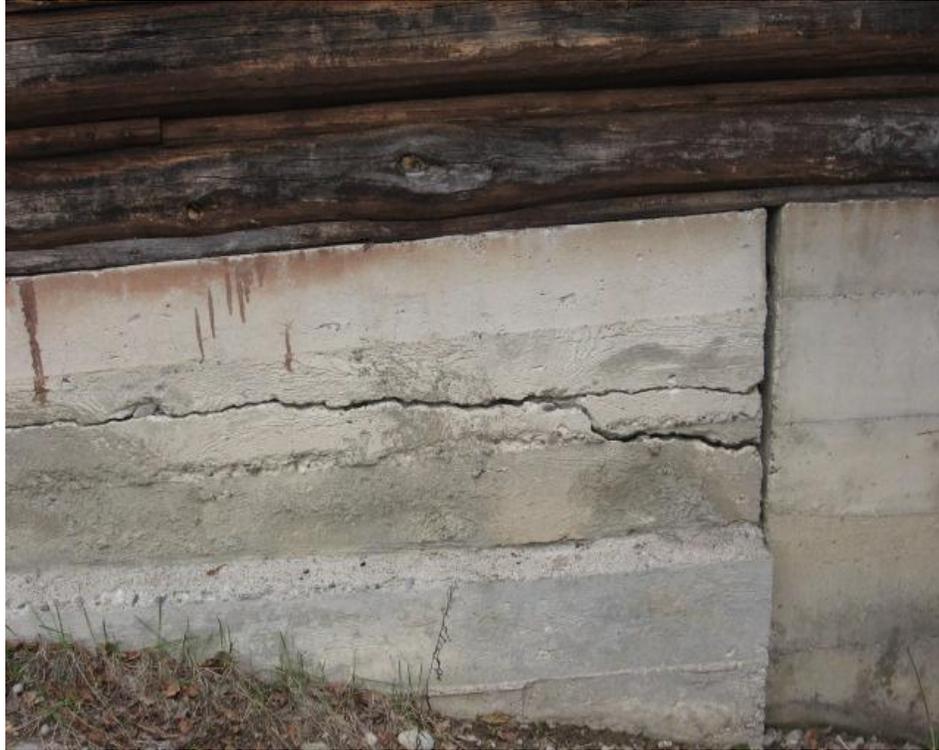
#10 Close Up of Vertical Crack under Window

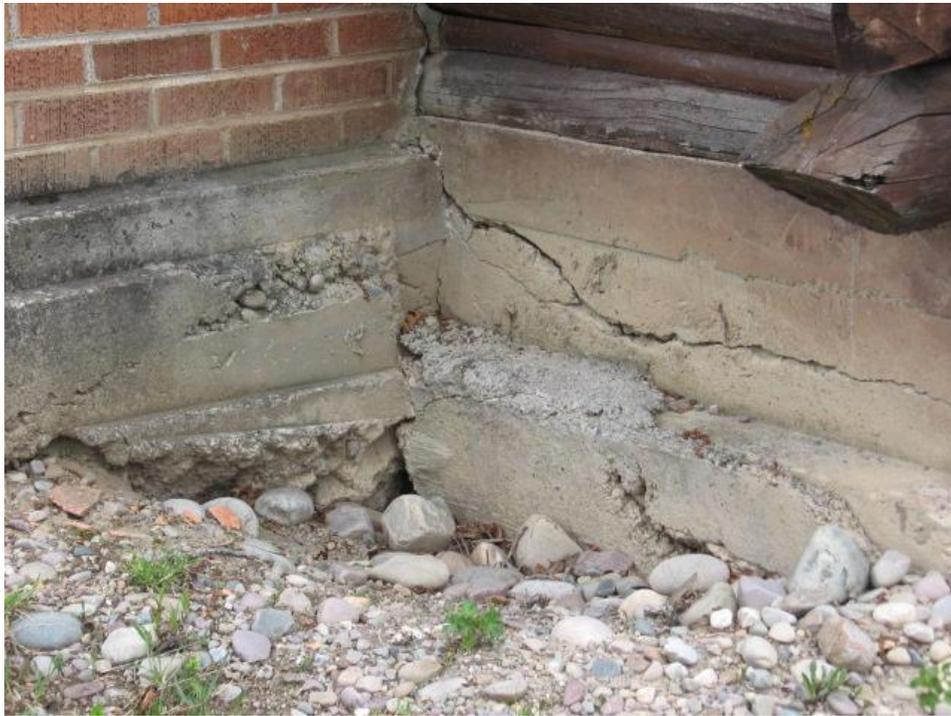
#11 Close Up of Corner at Chimney
