## Leigh Lake Patrol Cabin Completion Report

**Start Date:** June 30, 2008

**Completion Date:** July 30, 2008

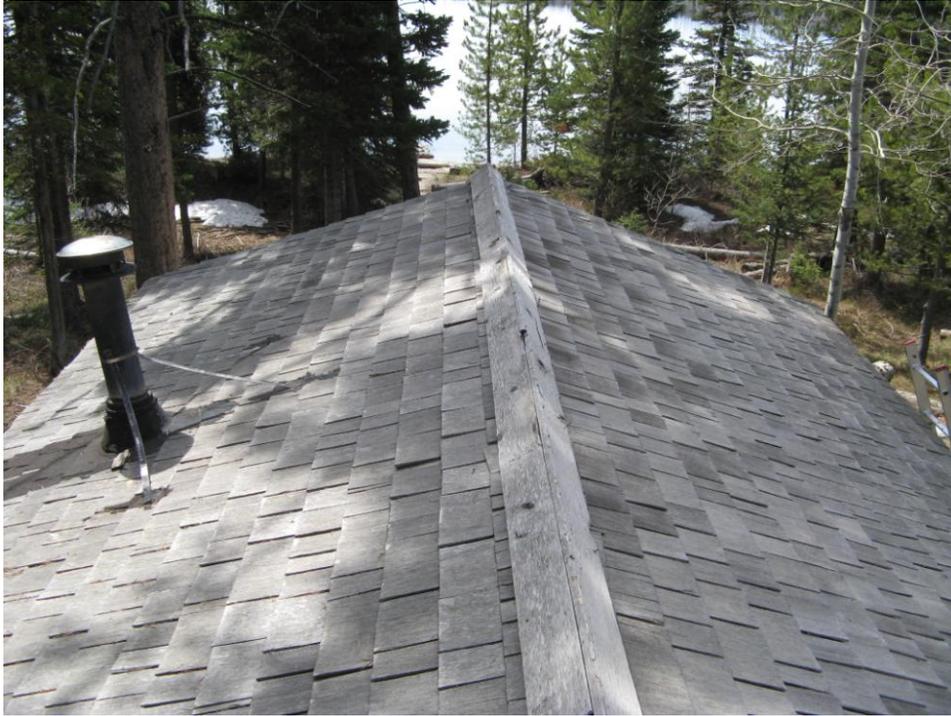
Roof prior to replacement.

The WCHP preservation crew removed the existing wood shingle roofing material and replaced it with #1 Chemco treated wood shingle of similar size and shape. The new treated shingle is fire retardant, which is important to preservation of the cabin because of the remote location and fire danger. Rotted roof sheathing board was replaced as needed.

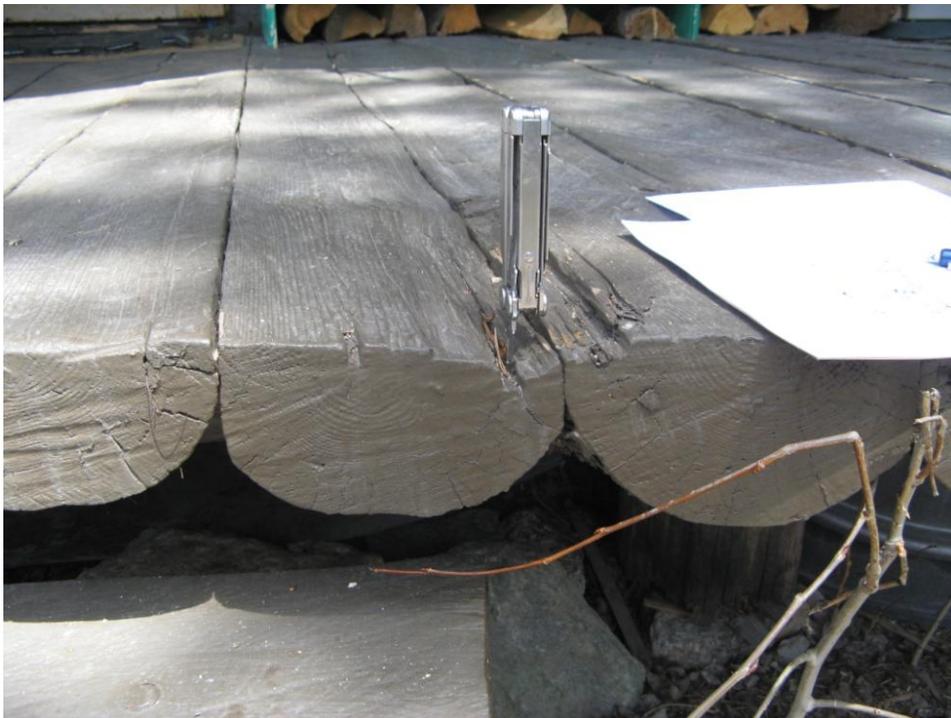
Decayed half-log deck ends.

Several under-porch support posts, wall logs along the side of the porch, and half-logs in the porch decking were decayed. These logs and posts were removed and replaced in-kind. The porch was repainted to match the rest of the cabin.

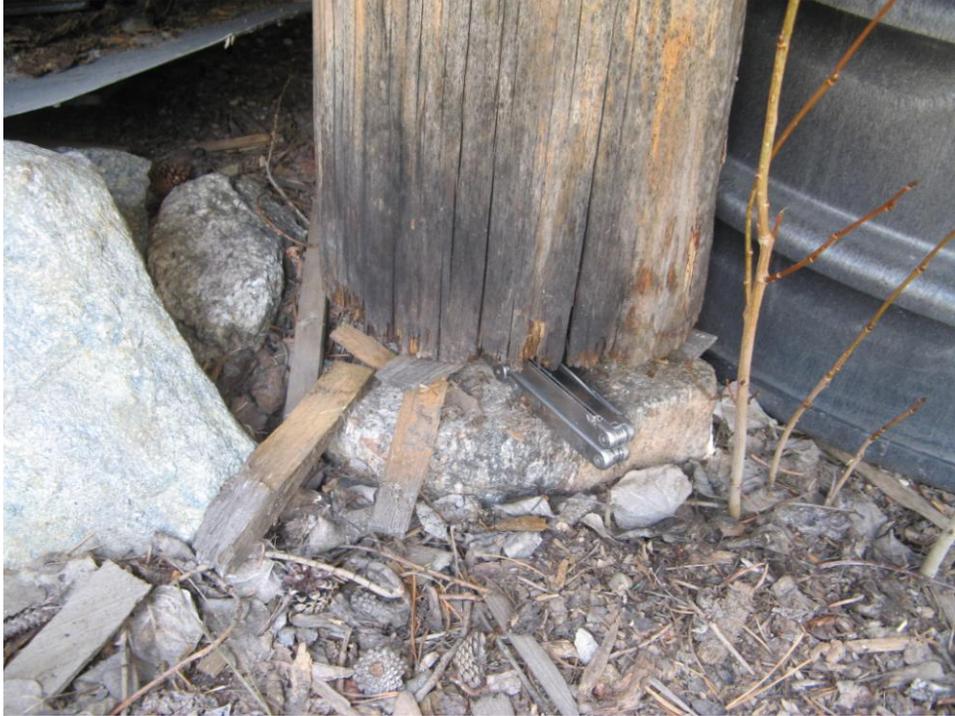
Decayed under-porch support post.

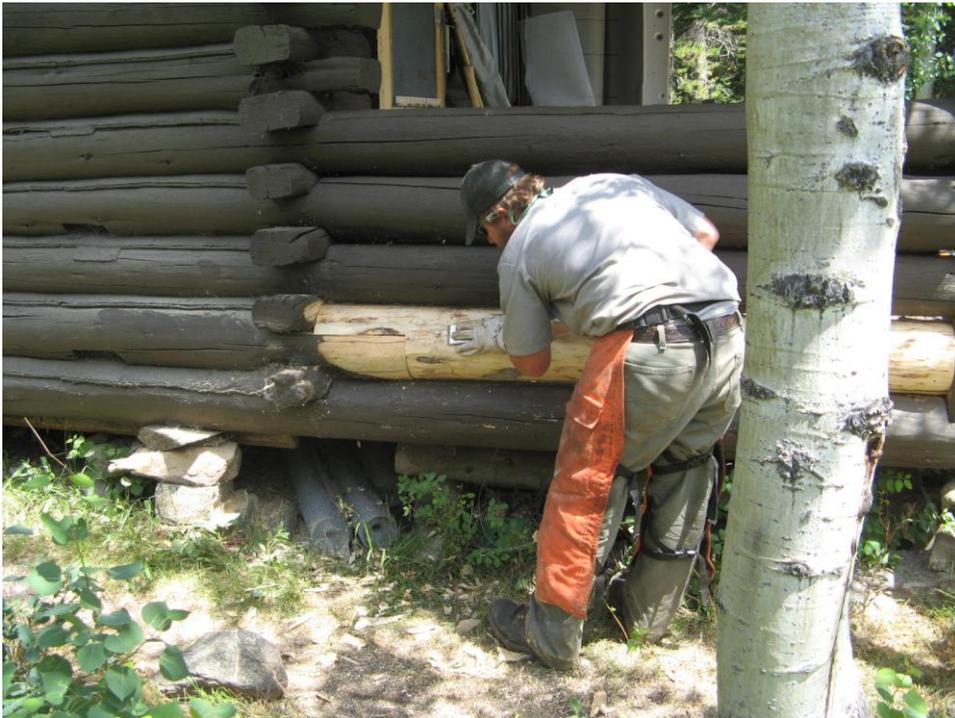
Final fitting of west side porch log replacement.

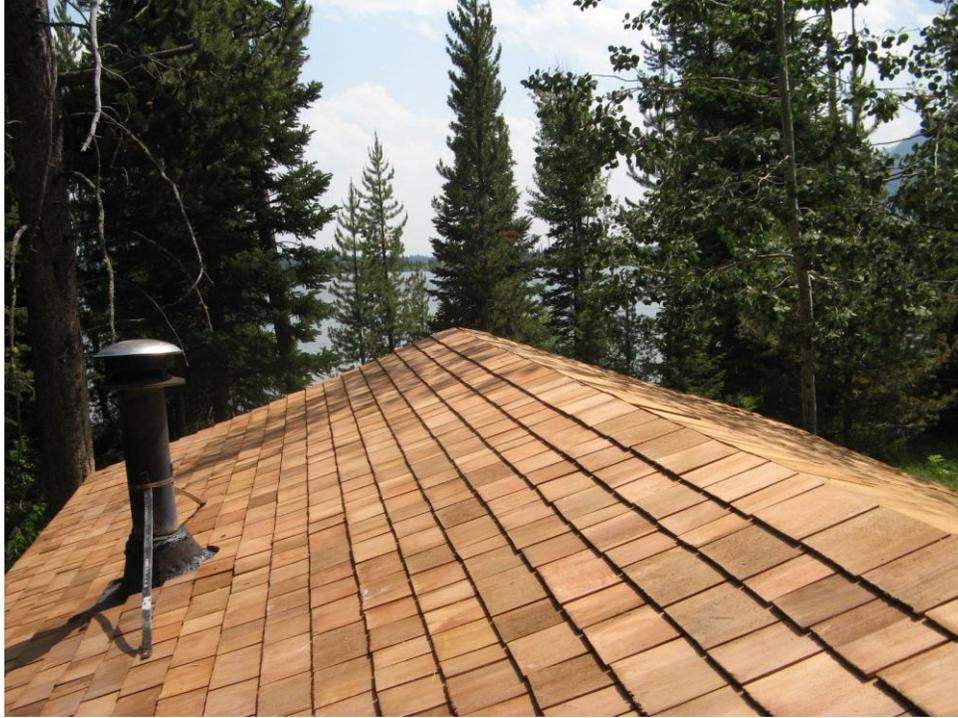
New fire retardant shingle ready for ridge boards.

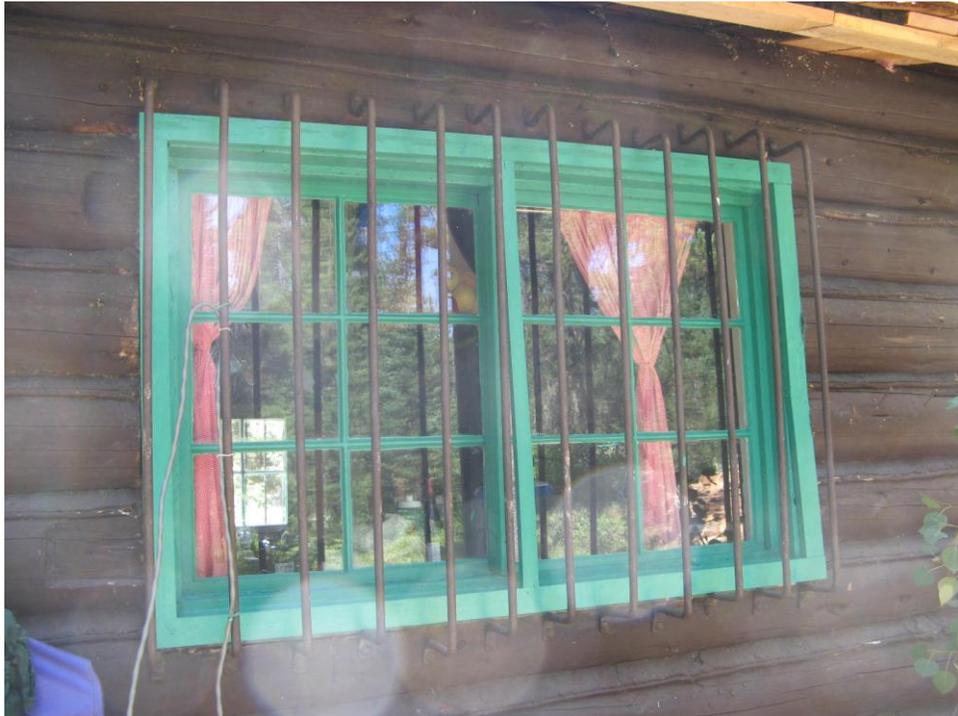
East side window completed.

Window work included repairing and painting window sash. Broken window glass was repaired and glazed onsite.

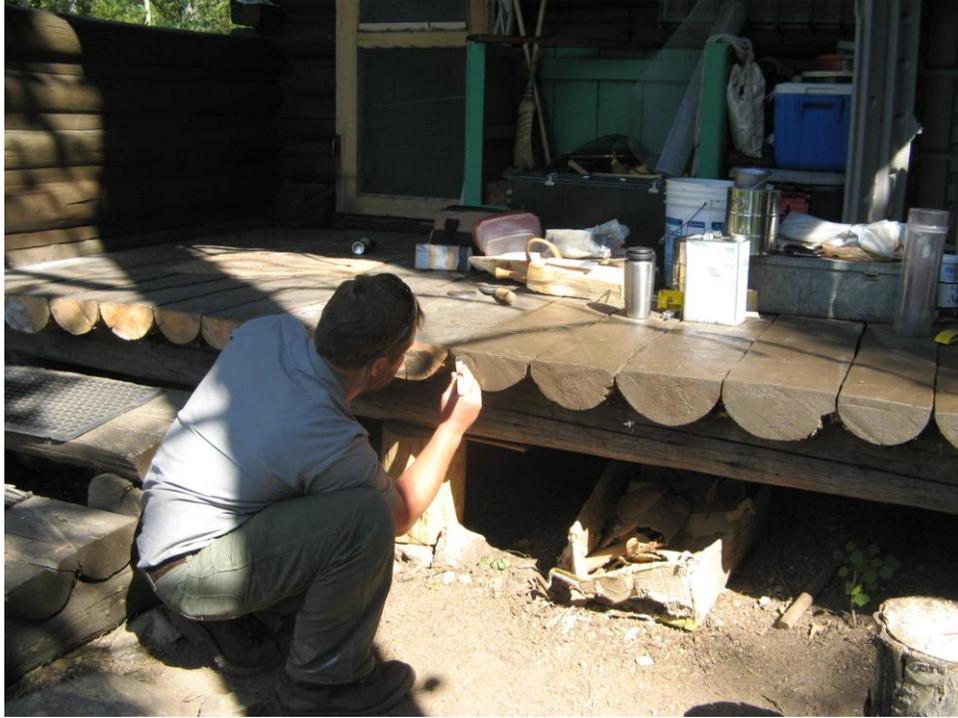
Painting deck log ends after repair.

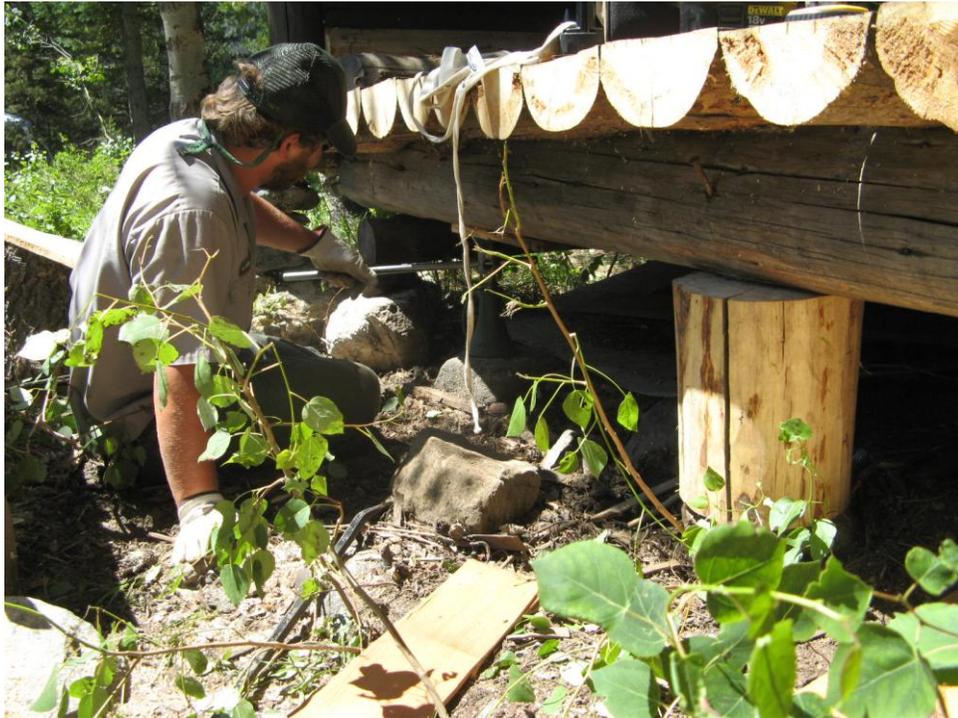
Replacing under-porch support post.
