Historic Structure Report

1872 Neosho Colored School

639 Young Street
Neosho, Missouri

July 17, 2012
NPS PMIS # 174533

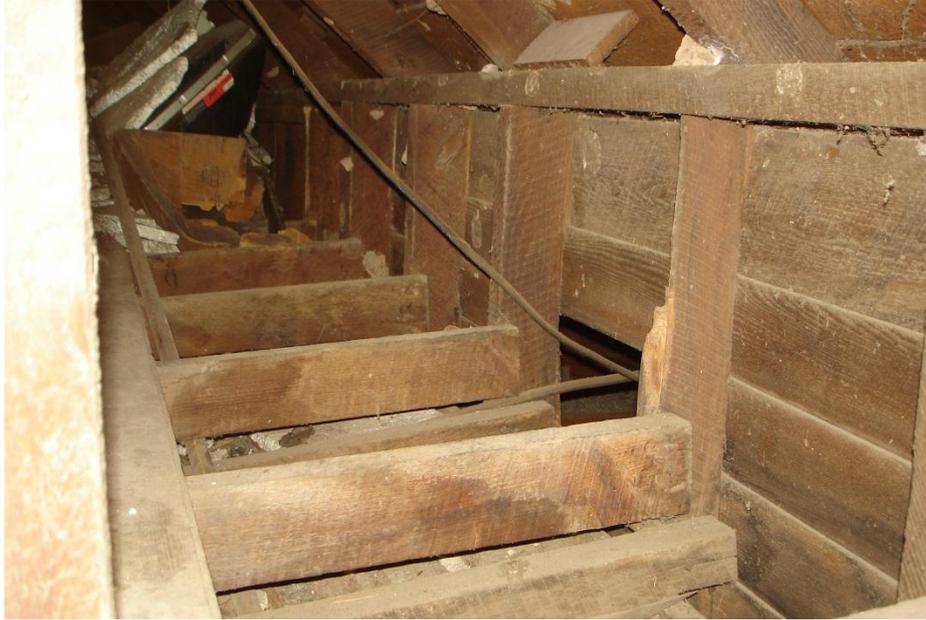
Figure 27. West side of attic space, looking north. The top layer of joists appears to have been added in the late 19th to early 20th century. The bottom joists, which support only the ceiling below, are original. (DS 2011)

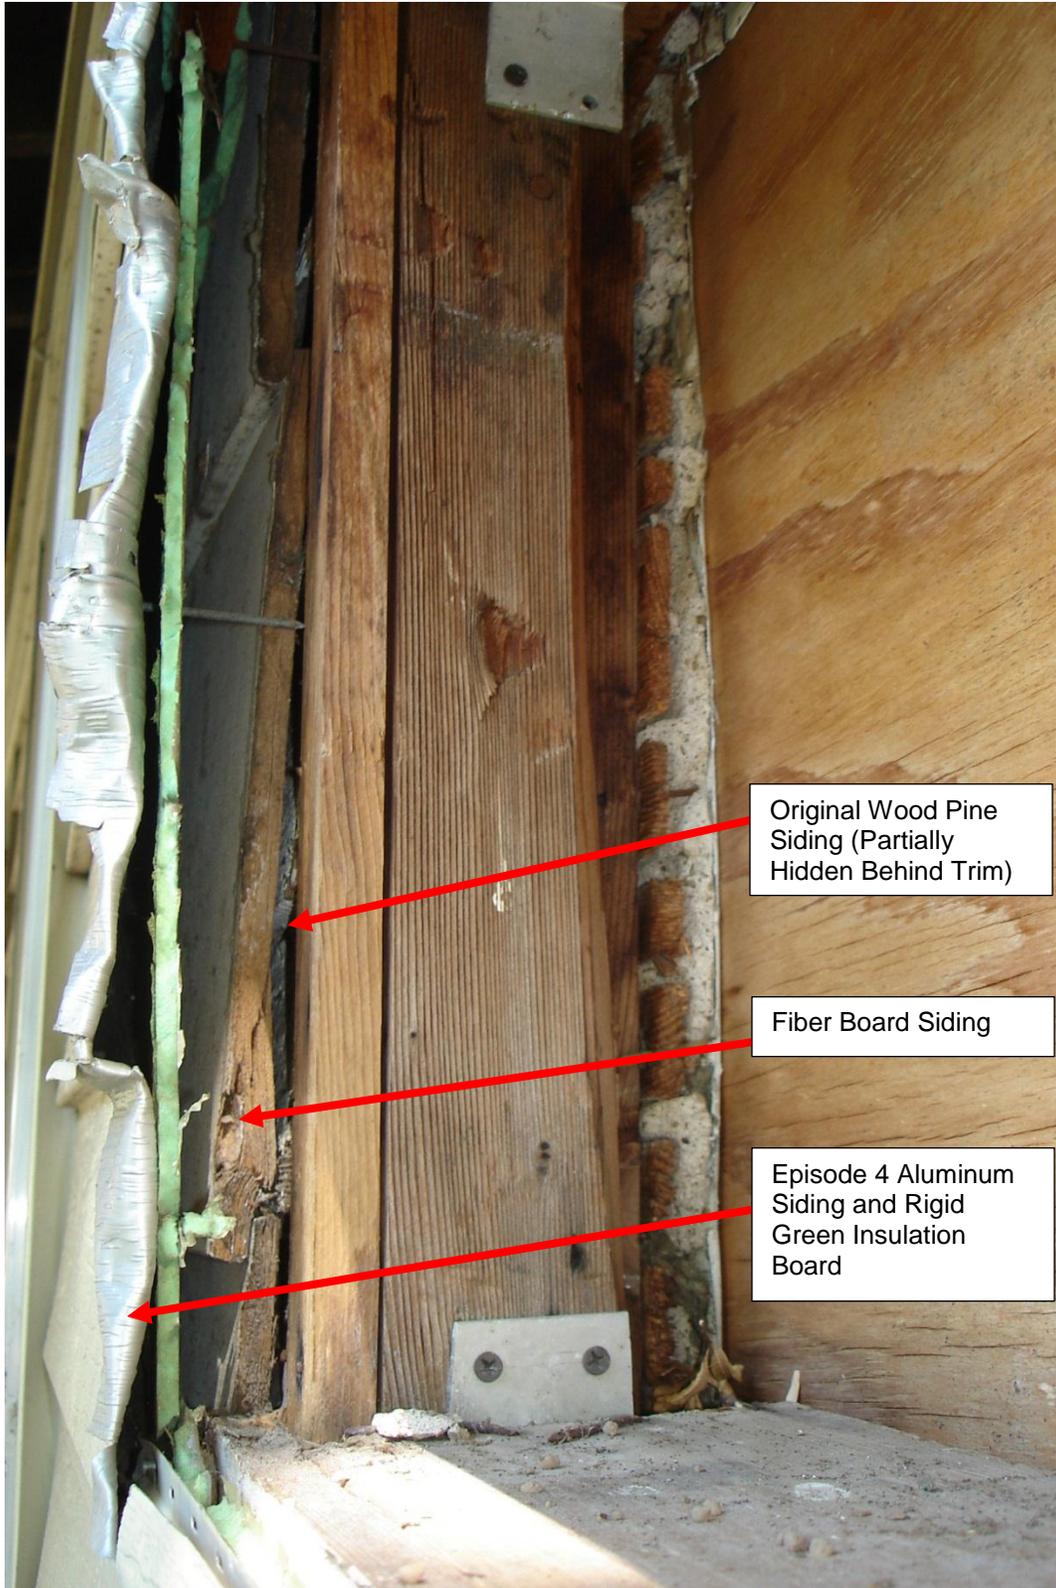
Figure 43. West exterior wall, modern opening for through-wall air conditioning unit, allows observation of layers of siding materials. (DS 2011)

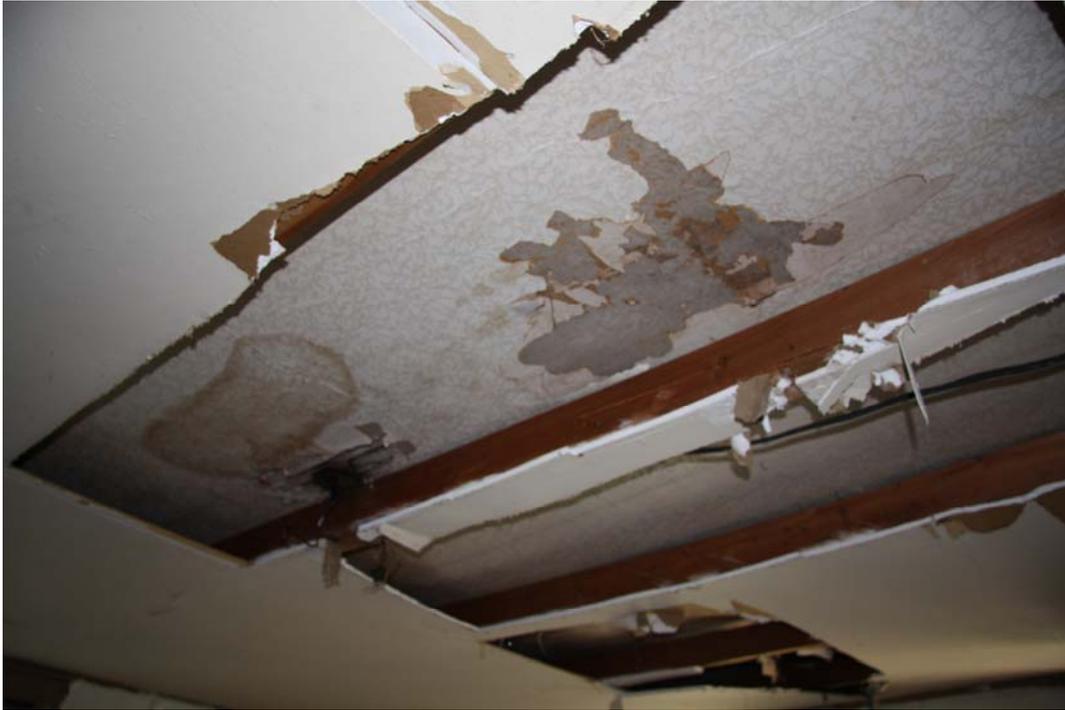
Figure 52. Detail of modern framing at ceiling in Room 101 with papered plaster ceiling visible above. (SRJA 2011)

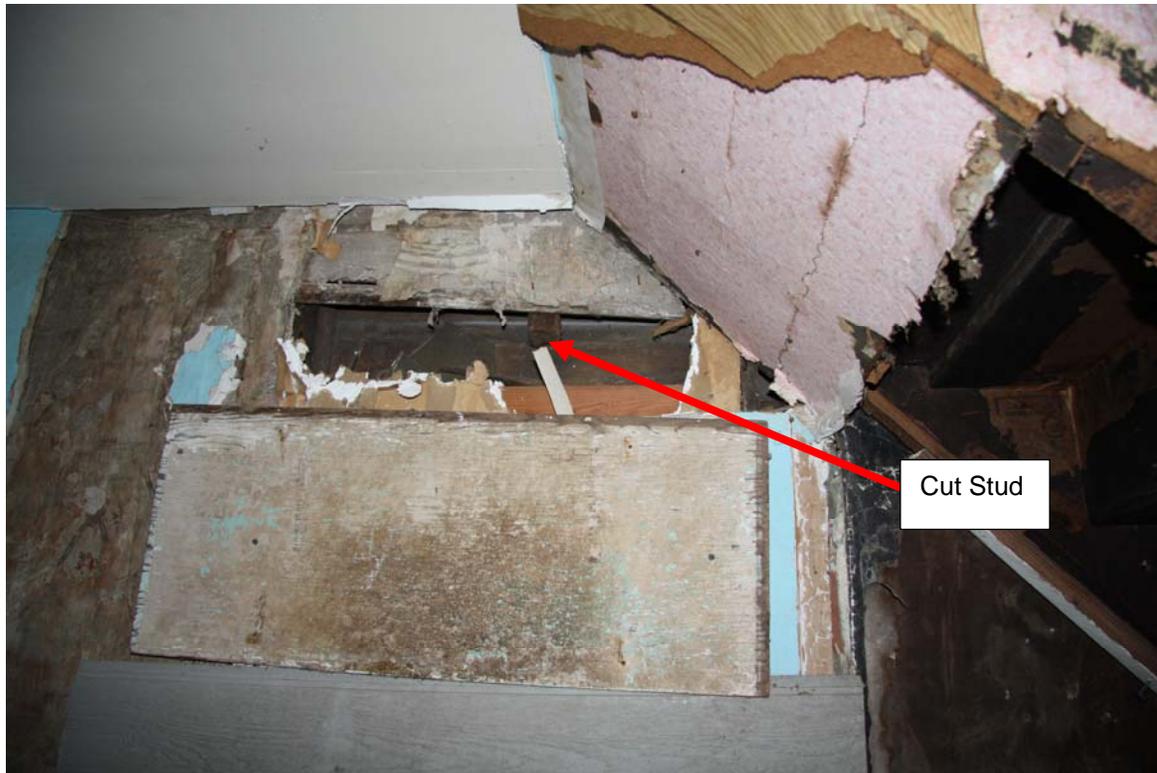
Figure 55. Detail head of Window 103, covered with plywood, Room 102, looking north. (SRJA 2011)

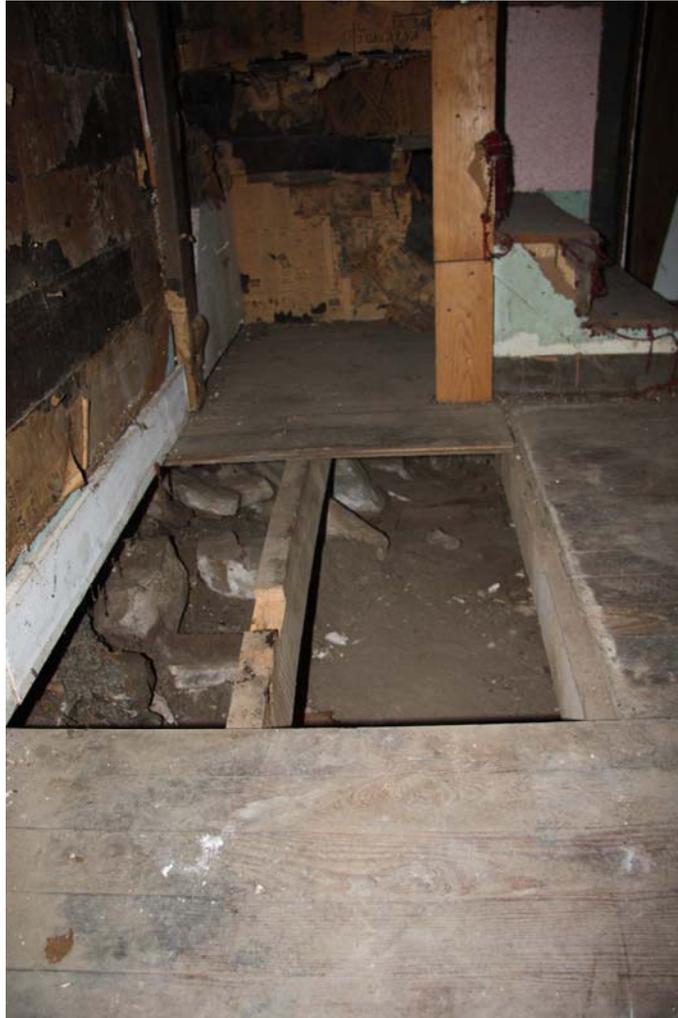
Figure 58. Opening in floor along north wall, Room 102, looking east. (SRJA 2011)

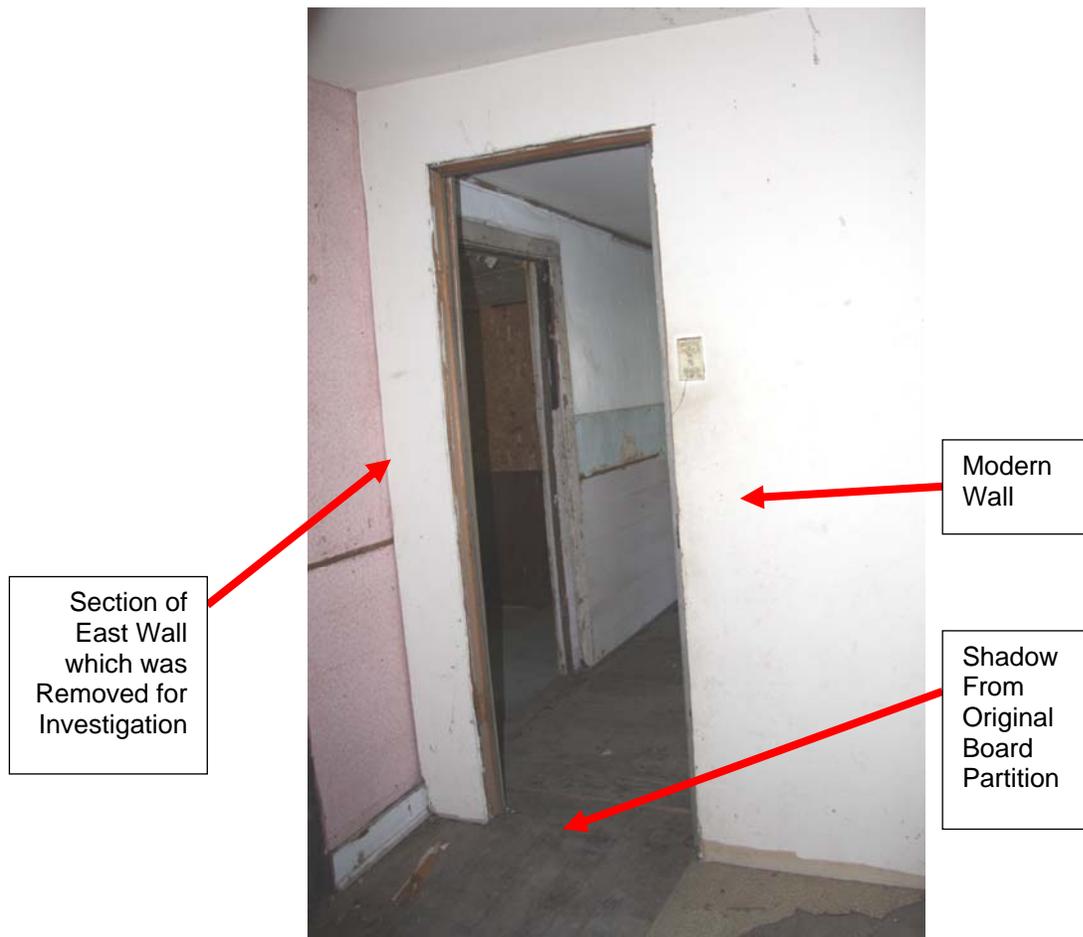
Figure 61. Modern wall between Room 102 and Room 101, shadow in wood floor of original wood board partition location. (SRJA 2011)

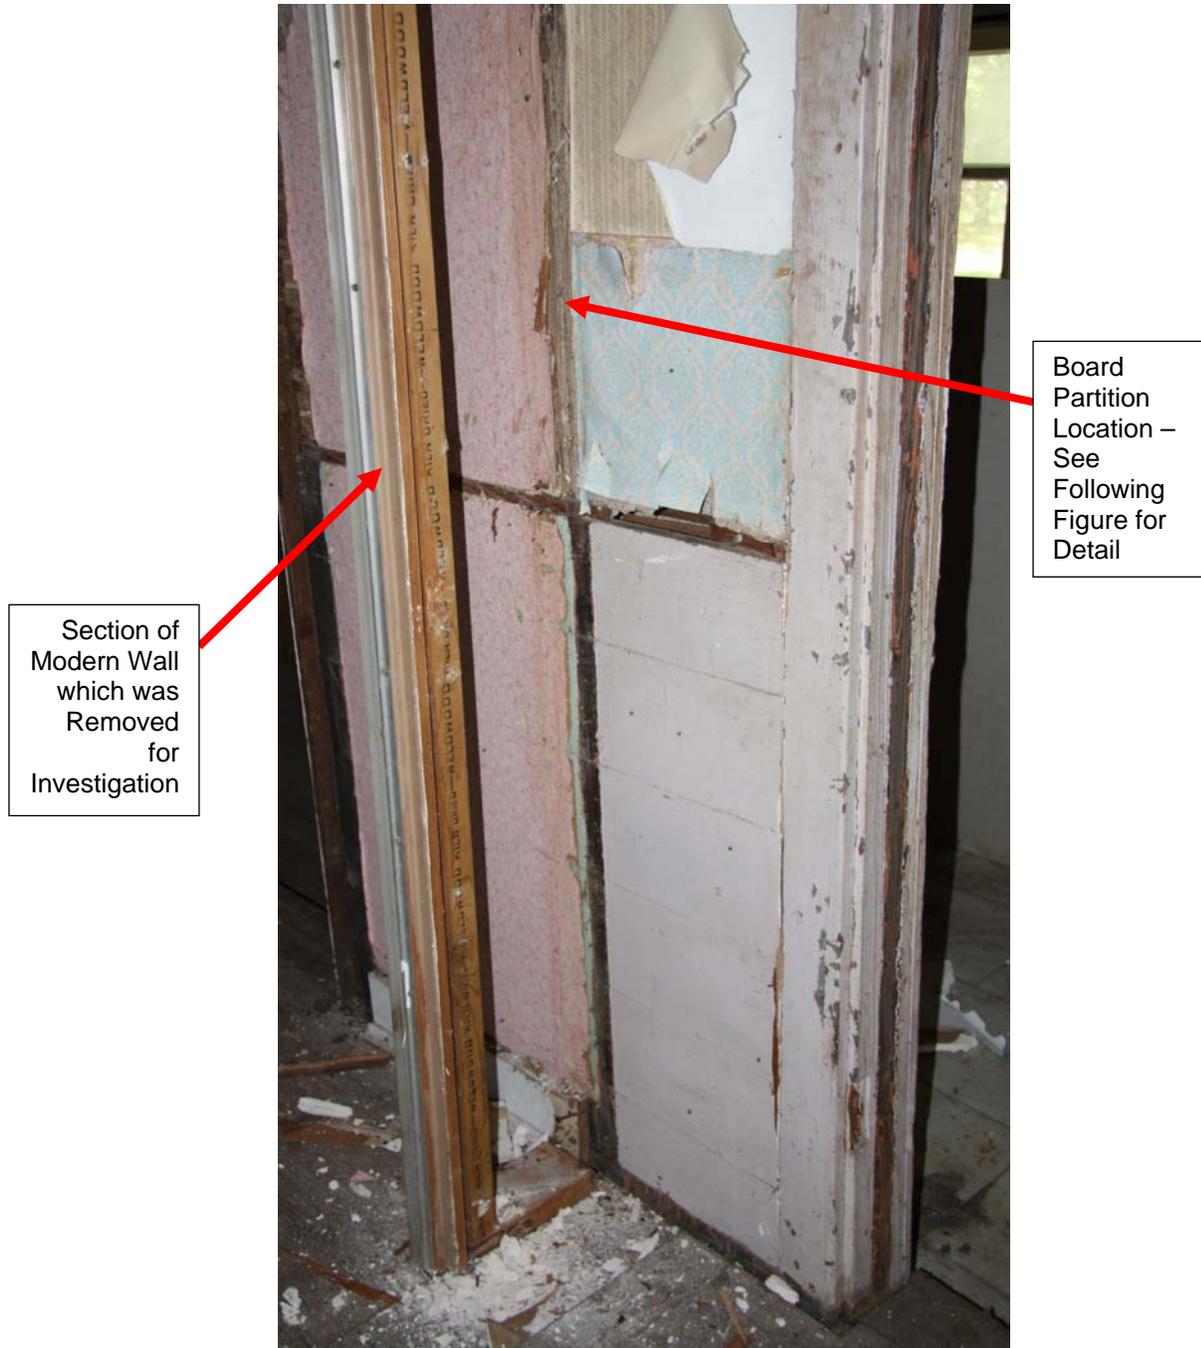
Figure 62. Section of demolished partition wall between Rooms 101 and 102, Right hand arrow points to location of original wood board partition on east wall. (SRJA 2011)

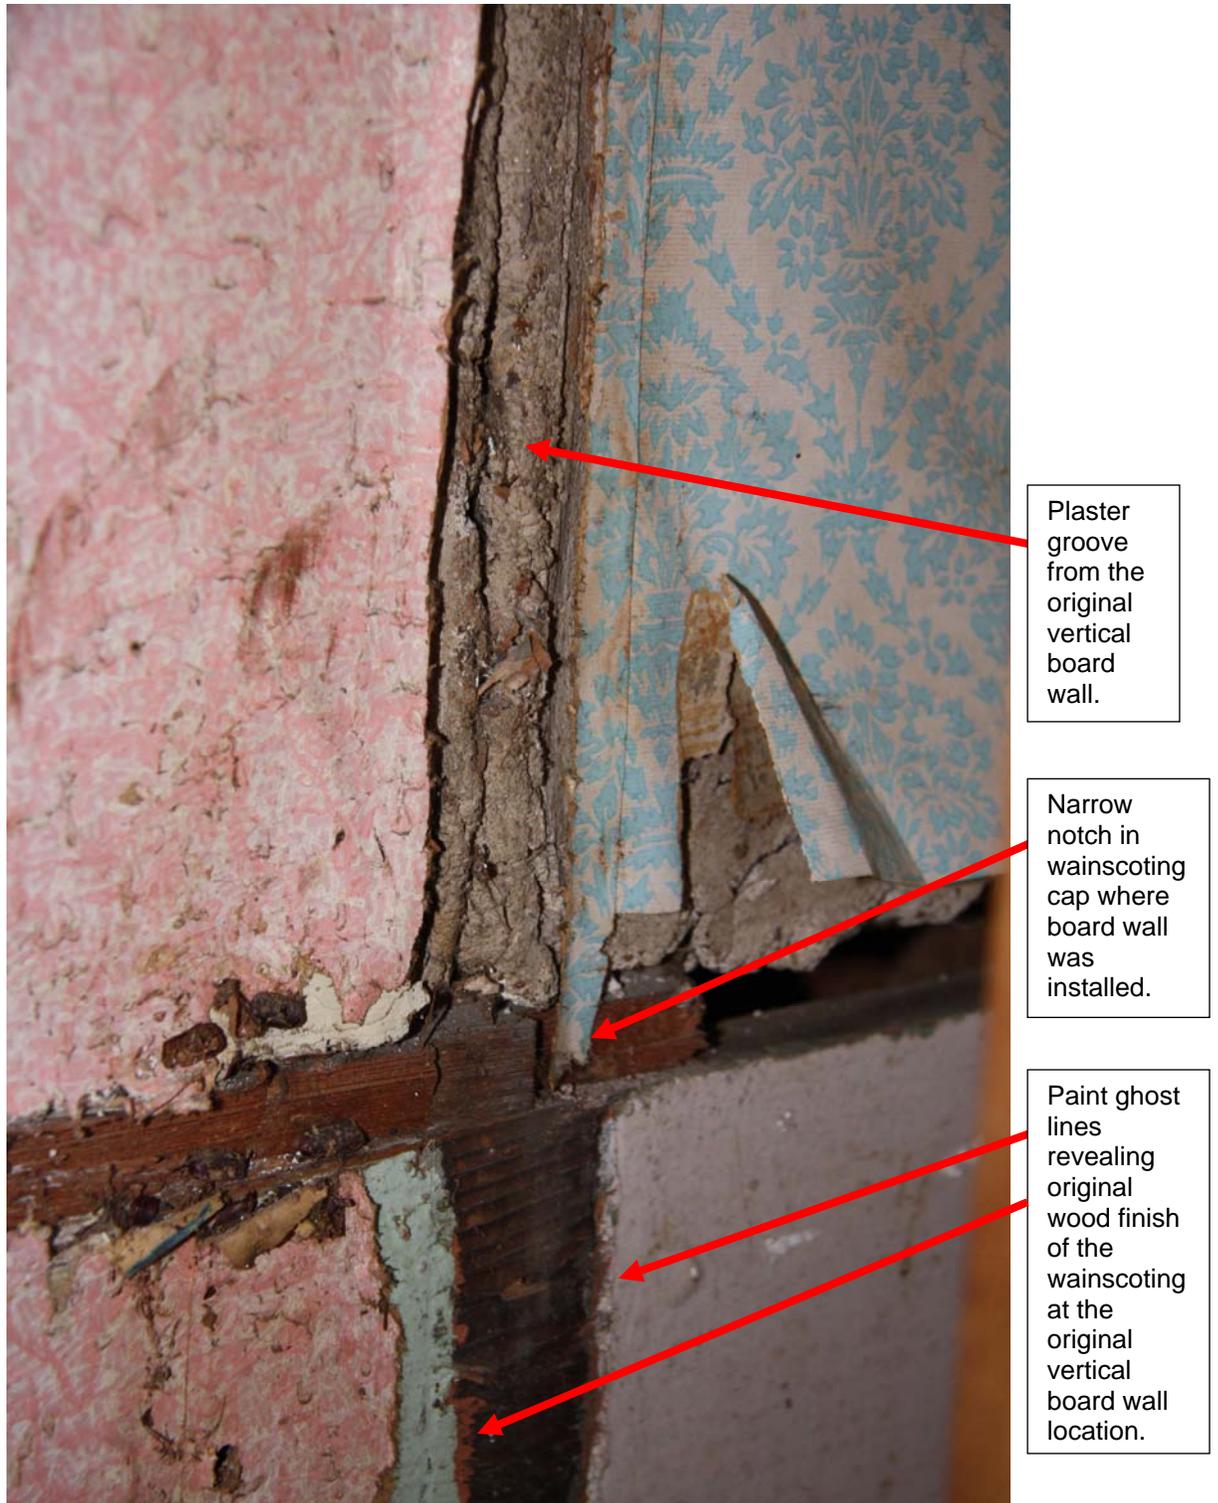
Figure 63. Detail of east wall at the original board partition wall location, indicating impression of old board groove in the unfinished plaster. Note that paint also stops at the board partition wall location. (SRJA 2011)

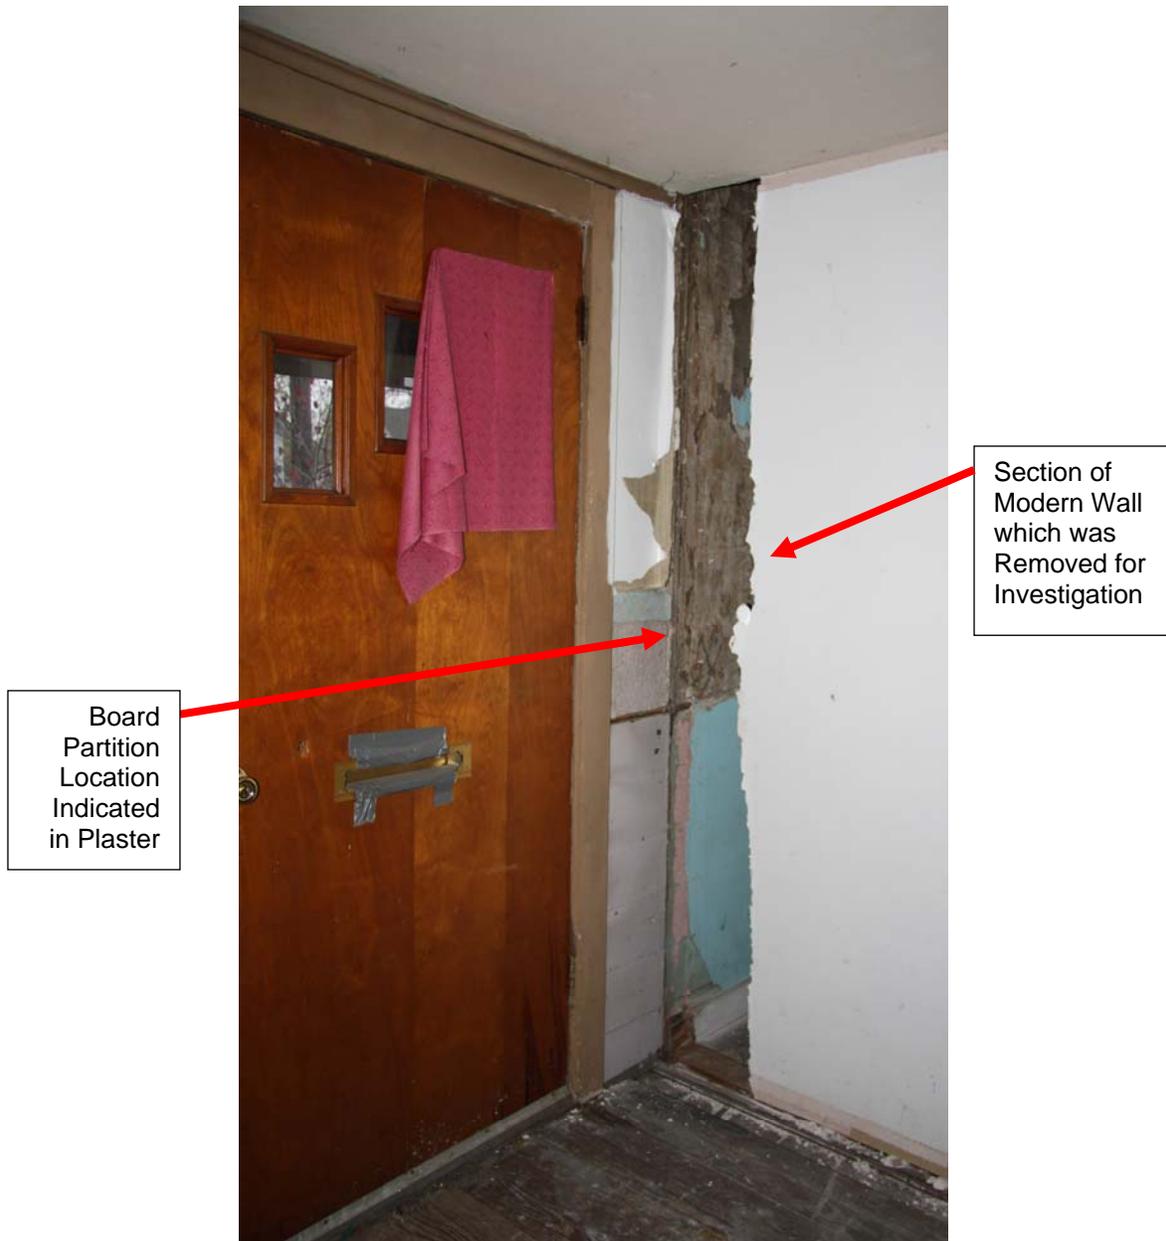
Figure 64. Section of demolished partition wall between Rooms 101 and 102, Left hand arrow points to location of original wood board partition on west wall. (SRJA 2011)

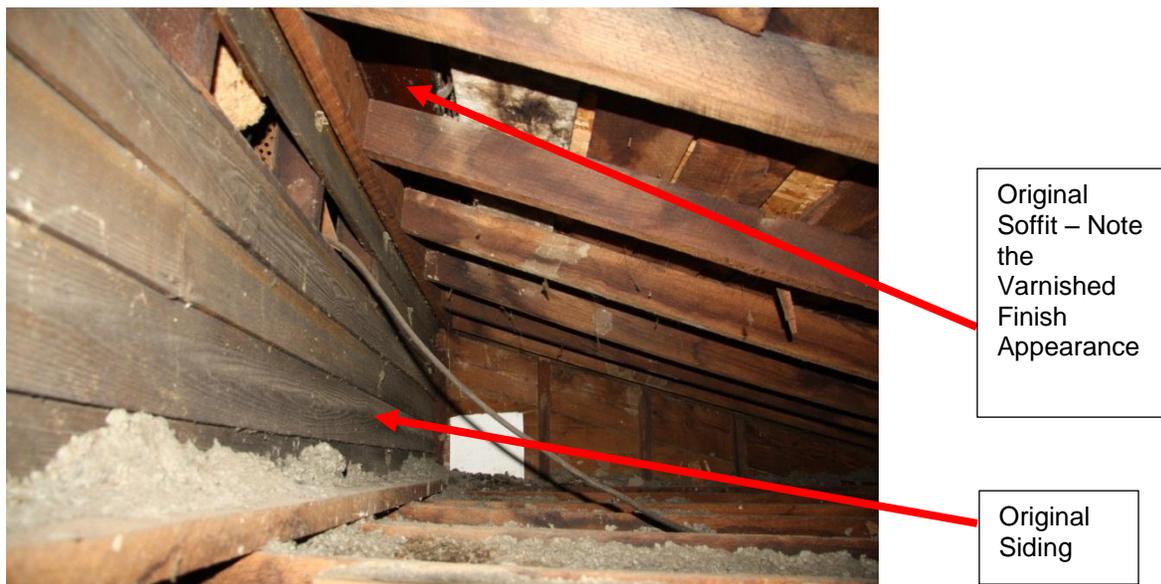
Figure 82. Ceiling and roof framing over Room 103, looking north. Note the original exterior siding in the left side of the photograph, as well as the original soffit board. (SRJA 2011)

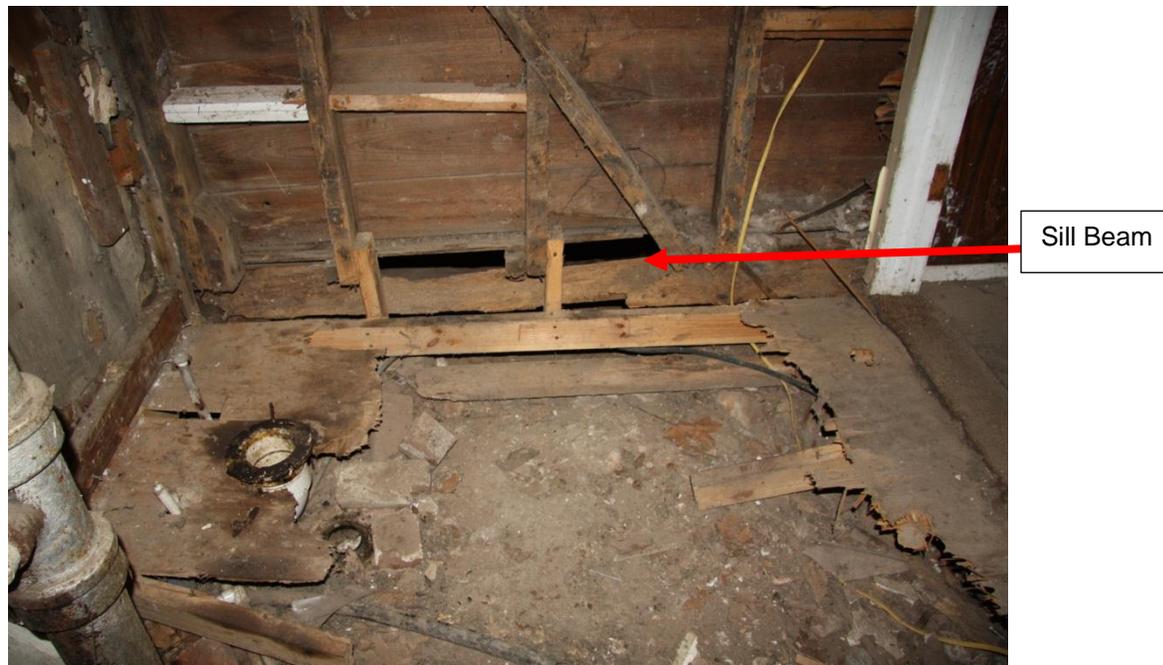
Deteriorated Original
Sill Beam

Figure 88. Deteriorated 5 ½ x 5 ½ original sill beam and original wall studs, partially supported by modern framing. (SRJA 2011)

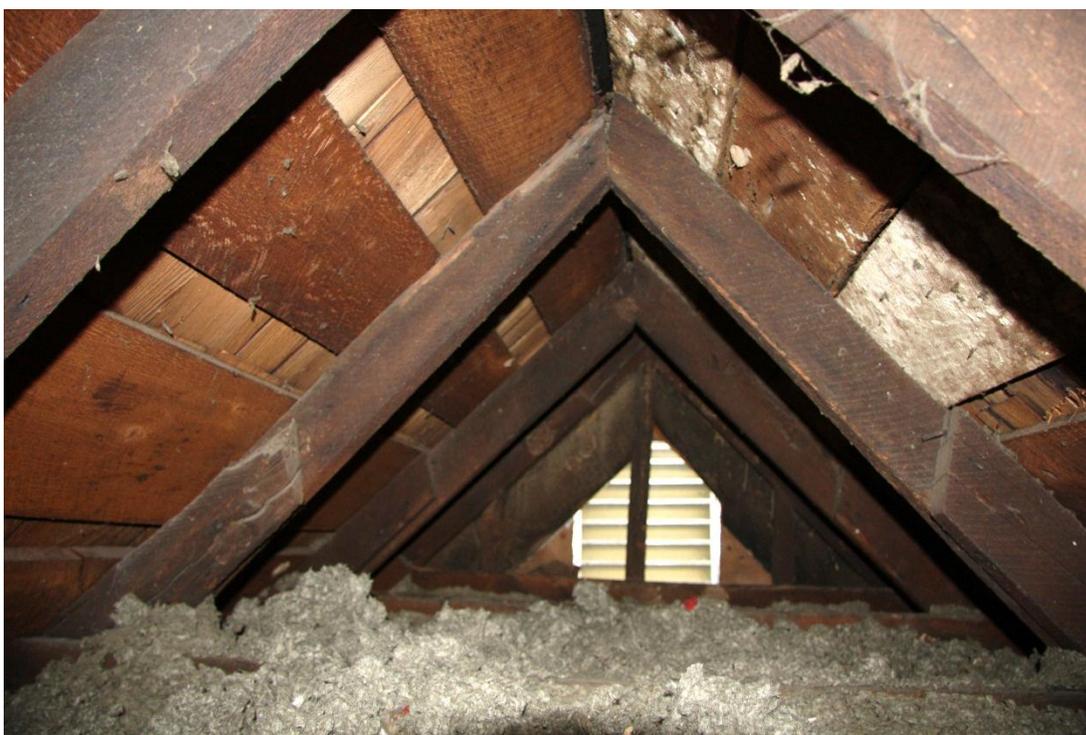
Figure 95. Attic rafters – note angled, sistered rafters. (SRJA 2011)

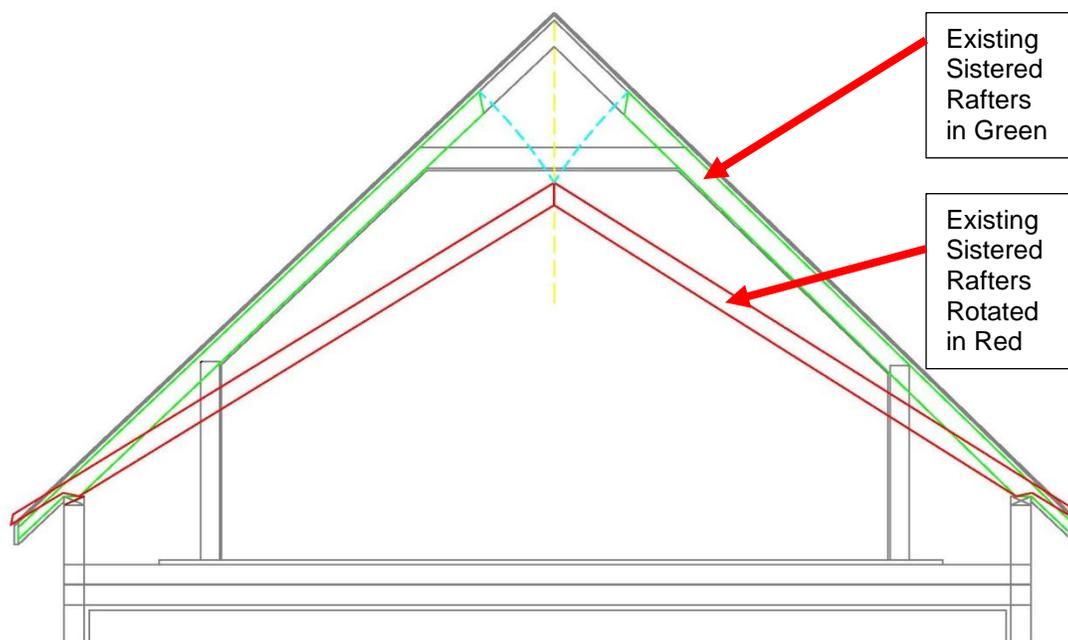
Figure 96. Attic rafters – sistered rafters rotated to meet in the middle. (SRJA 2012)

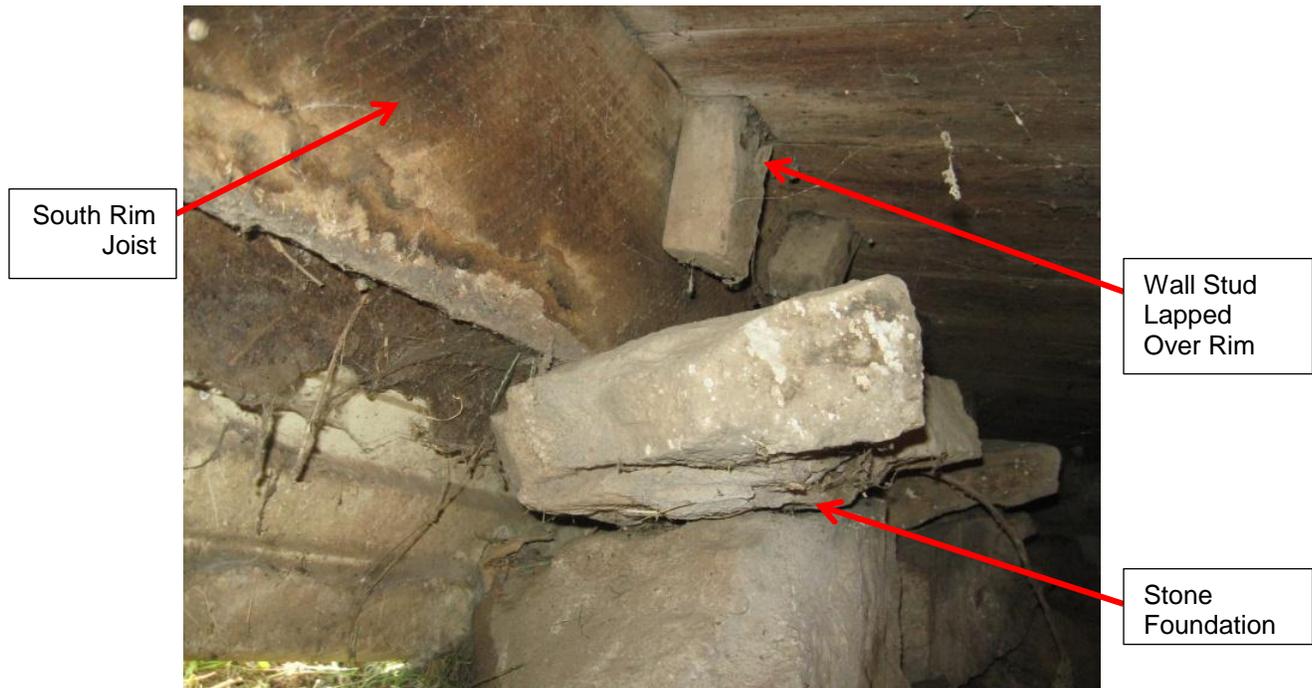
Figure 99. South crawlspace, southern rim joist detail with studs lapped on interior face, looking south. (SEA 2011)

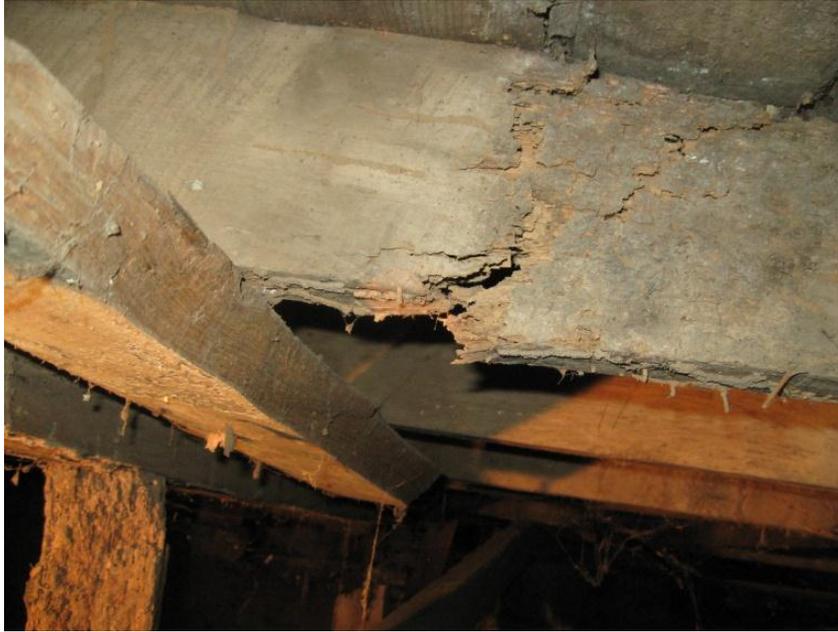
Figure 102. South crawlspace, failed joist at the center span, looking north. (SEA 2011)

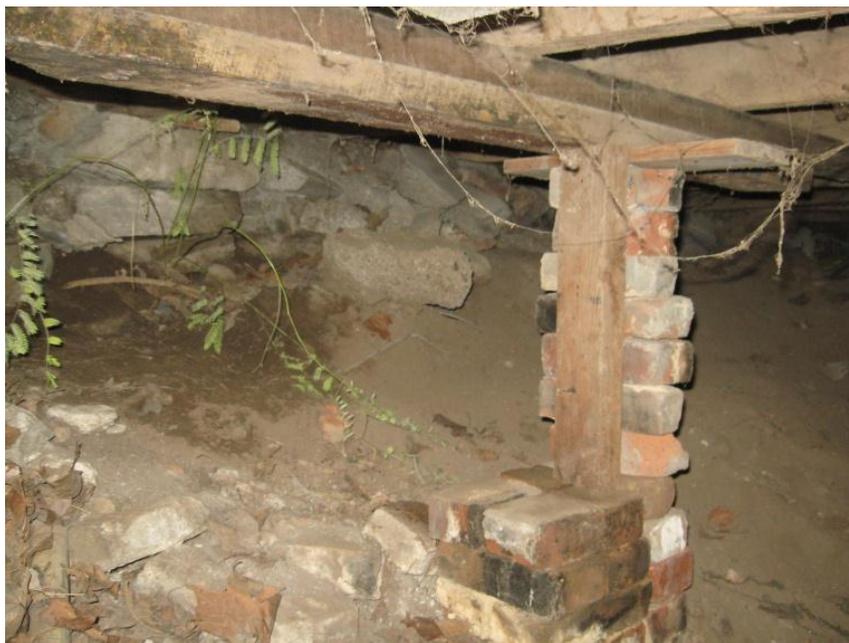
Figure 103. South crawlspace, additional support of floor joists, looking northwest. (SEA 2011)

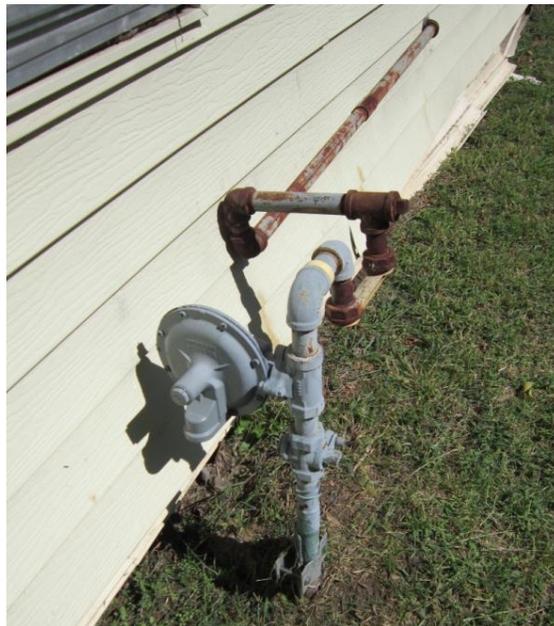
Figure 97. Gas entrance on south side of building. (HEI 2011)

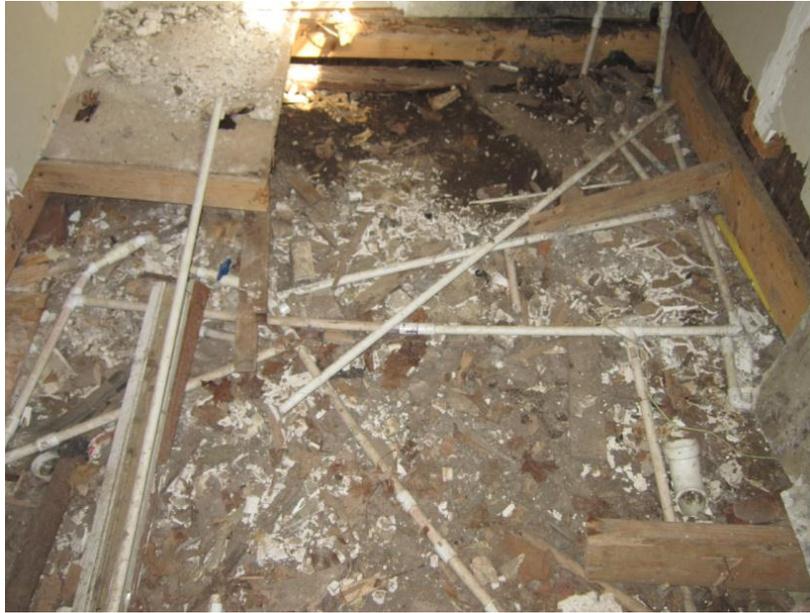
Figure 98. Water piping in bathroom, Room 104, looking east. (HEI 2011)

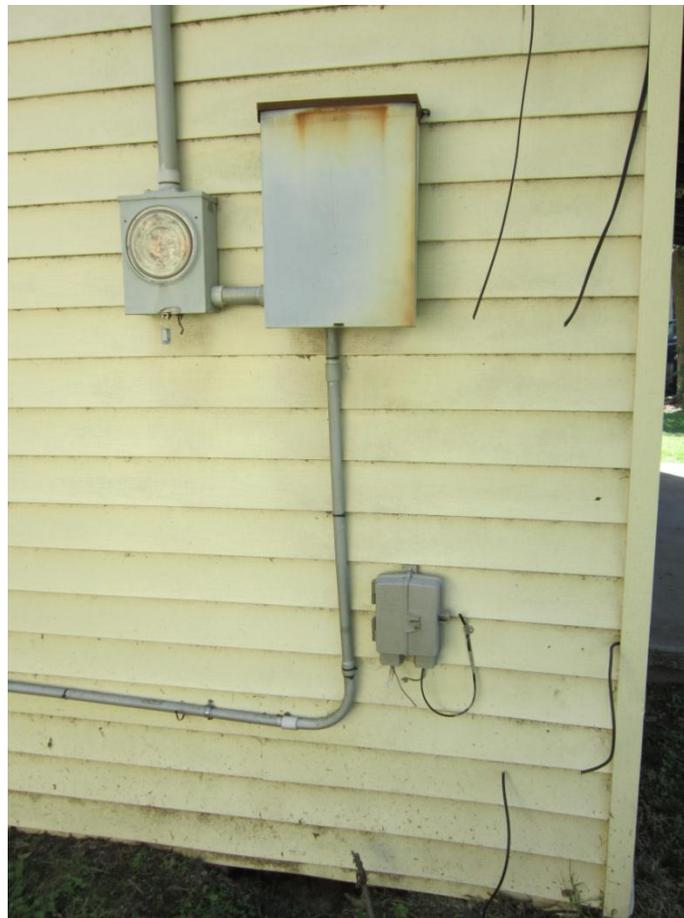
Figure 99. Electrical service entrance, north exterior wall. (HEI 2011)
