## **Hamilton Grange Restoration Update – October 7, 2008**

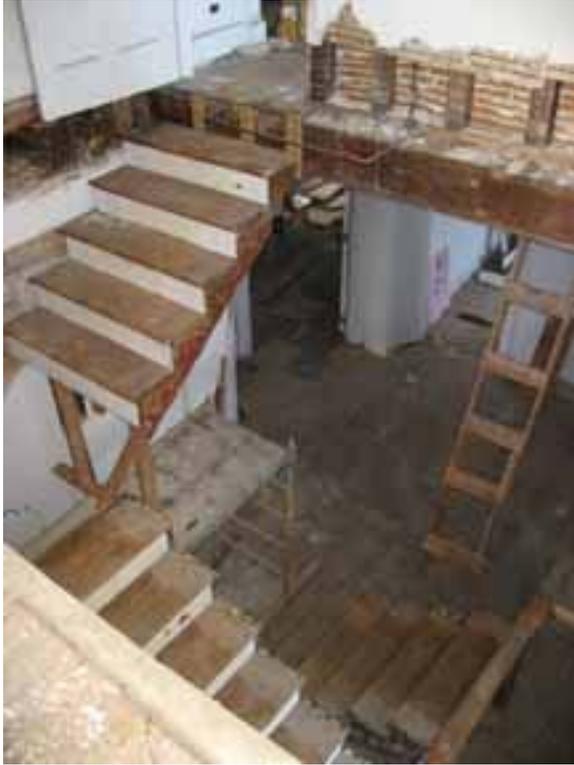
landings. Last week we “temporarily” reconstructed the original stairs, in order to determine the extent of missing pieces, and verified that the re-used landing was in fact the original.
