National Park Service Cultural Landscape Inventory 2006

Kilauea Administration and Employee Housing Historic District Hawaii Volcanoes National Park

CONDITION ASSESSMENT: Good

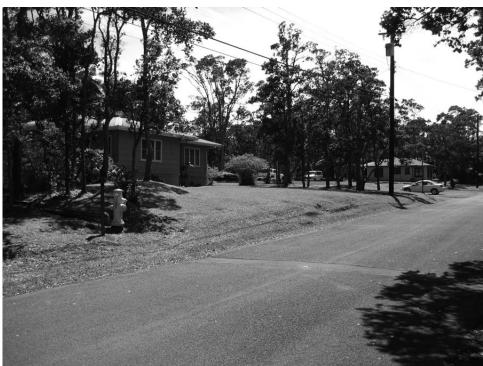
Figure 3. Lots were graded to create boundaries between the units—Employee Quarters No. 19 (PWR Staff—2005).

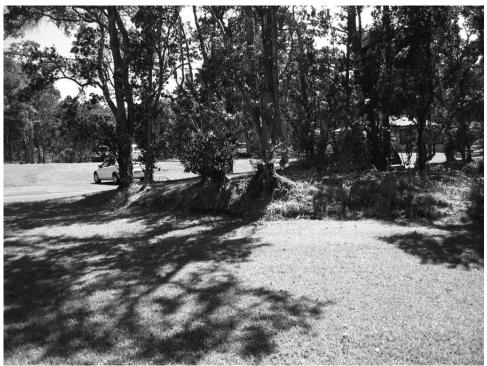
Figure 4. Change in elevation between two residences. The grading and lot boundaries are further accentuated with vegetative screening (PWR Staff—2005).

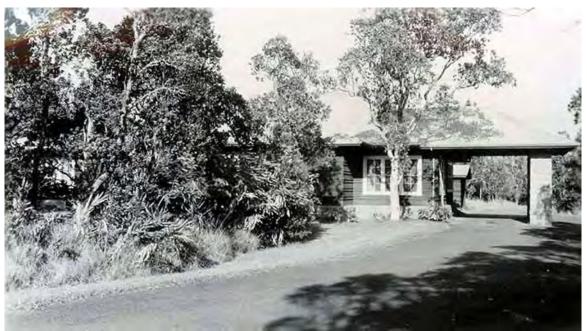
Figure 4. Employee Quarters No.17, Superintendent's Residence (PWR Staff-2005).

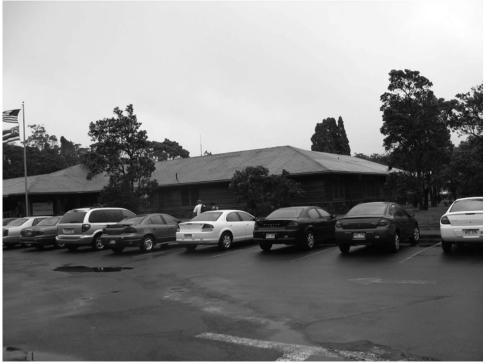
Figure 6. Current view of Administration Building (PWR Staff-2005).

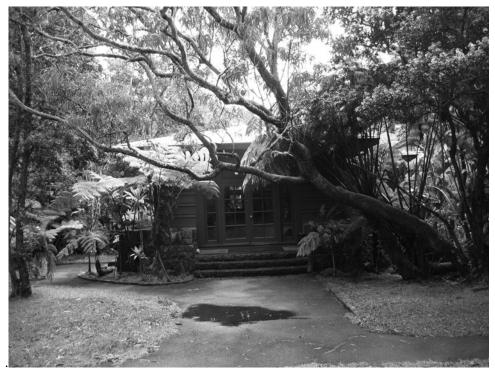
Figure 7. South entrance of the Ohia Wing (PWR Staff—2005).

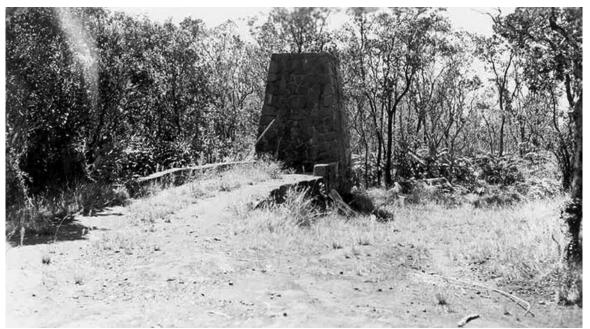
Figure 9. Abandoned incinerator located between CCC camp and NPS employee housing area. (PWR Staff—2005).

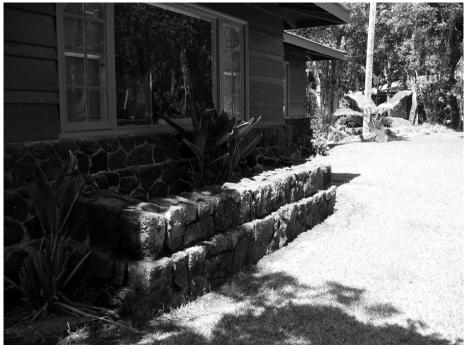
Figure 1. Example of a mortared lava-rock planter in employee housing area (PWR Staff-2005).

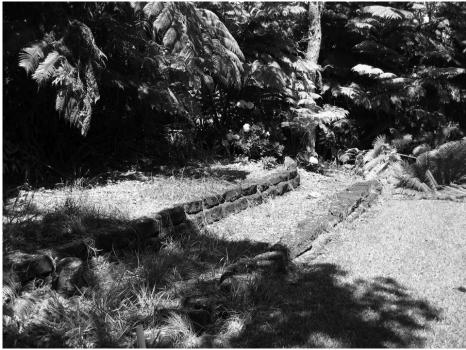
Figure 2. Example of a dry-lay, lava-rock, terraced planting bed in employee housing area (PWR Staff—2005).

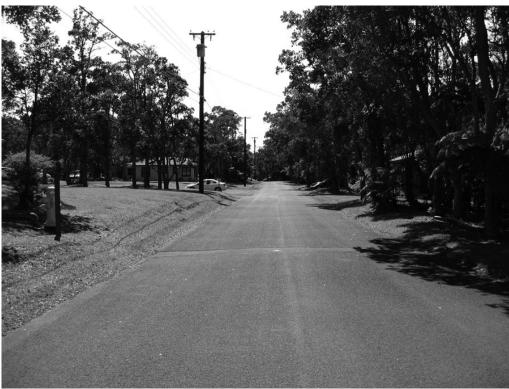
Figure 3. Existing conditions of main residential road facing northeast (PWR Staff—2005).

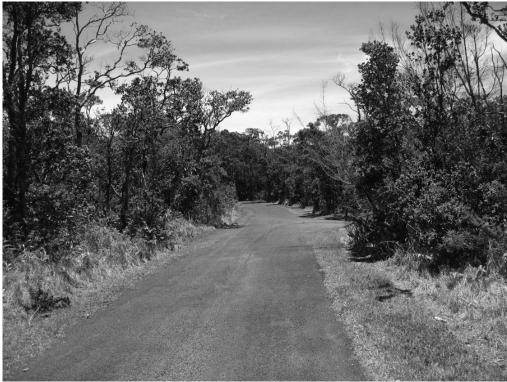
Figure 4. Existing conditions of residential loop road (PWR Staff—2005).

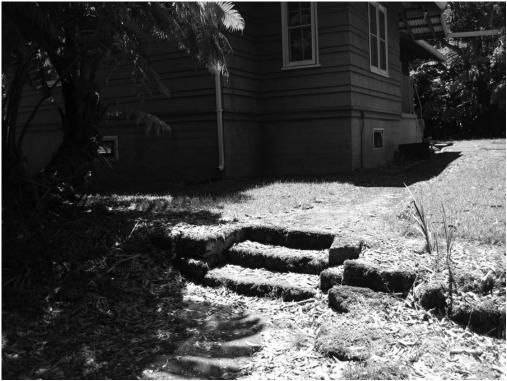
Figure 5. Example of mortared lava stairs and footpath leading from carport to backdoor of residence (PWR Staff—2005).

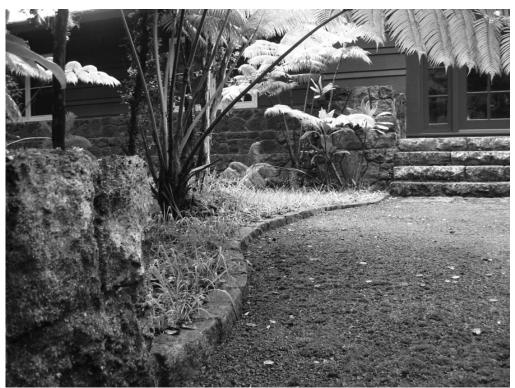
Figure 6. Stone curbing, wall and stairs at north entrance of the Ohia Wing (PWR Staff—2005).

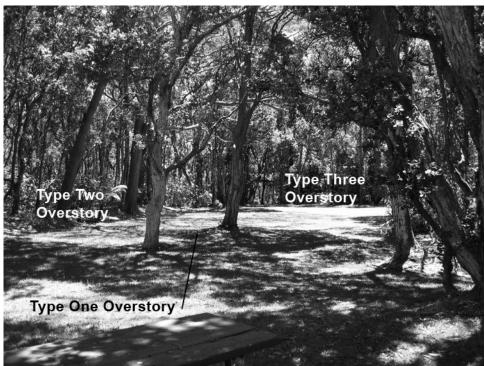
Figure 4. View of three types of overstory vegetation; photograph taken in backyard of Employee Quarters No.17, Superintendent's Residence (PWR Staff—2005).
