Update on the Independence Hall Tower Restoration Project

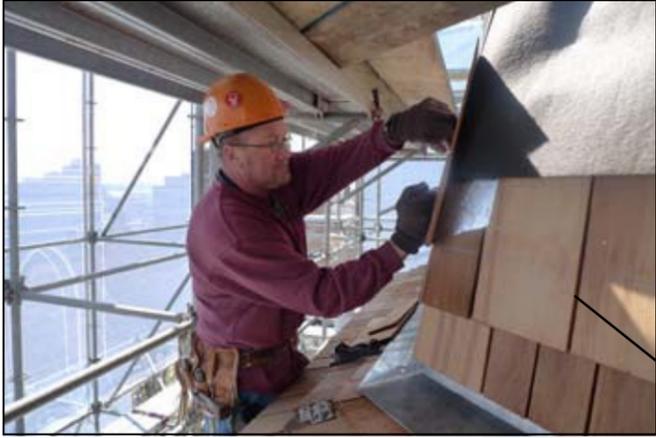
Carpenter installing wood shake roof

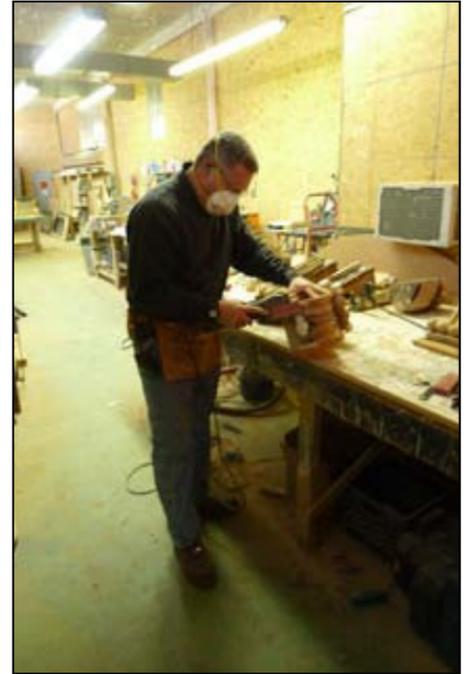
Woodcrafter restoring a Level wood bracket

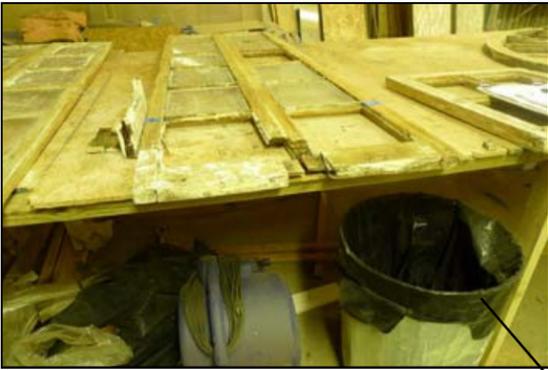
Many repairs have been over the years to the Level 3 south window. It has been disassembled and incompatible repairs will be removed and the window restored.

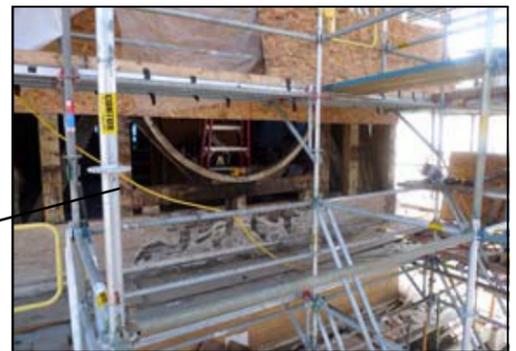
Most of Level 5 cladding has been removed. This has revealed the wood framing of the clock face.

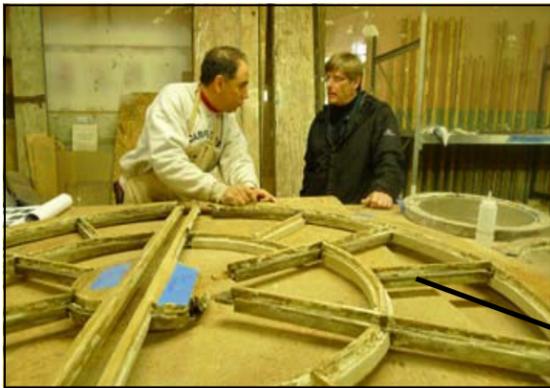
The Level 2 round windows have been disassembled and each member is being reviewed to see what work is required to conserve the window.

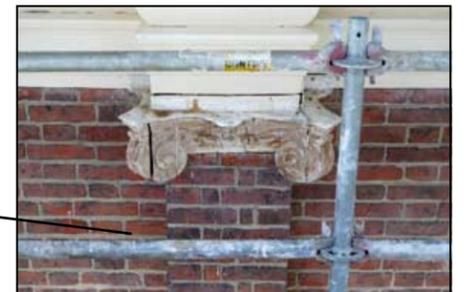
A close inspection of the carved pilaster capitals after paint removal has revealed that they will need to be

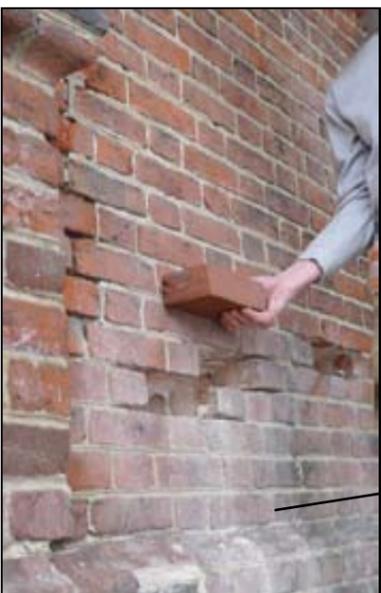
Construction team is checking the match of handmade bricks to the existing masonry.

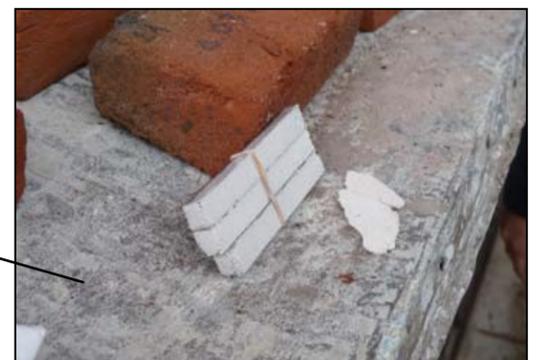
The mason submitted mortar samples in the tubes that were rejected. They were grayer than the original mortar used to construct the tower.
