# **Jefferson National Expansion Memorial Old Courthouse**

St. Louis, Missouri

## **Historic Structure Report Special Issues**

July 2013

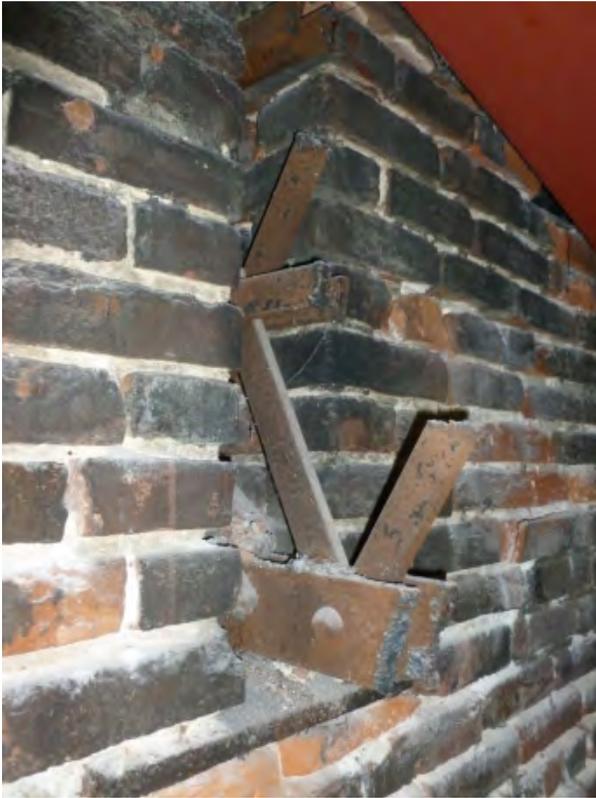
**FIGURE 59.** Remaining portion of wrought iron lattice beam in the attic of the south wing. The lattice beam was cut where it bears on the masonry wall. The bar stock for all elements was rolled and the connections are riveted (photo by S. Kelley, 2011).

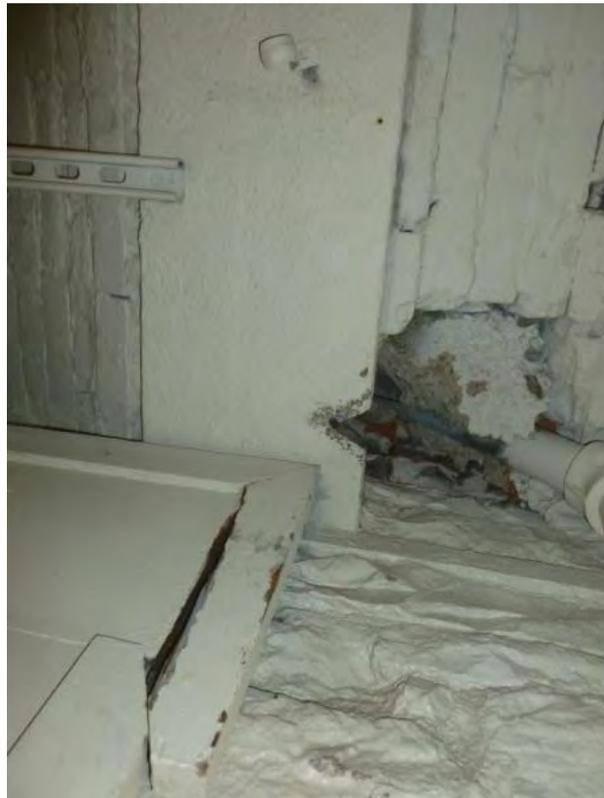
**FIGURE 98.** View from below of cast iron beam section at inspection opening no. 1 (north wing - first floor) (photo by S. Kelley, 2011).

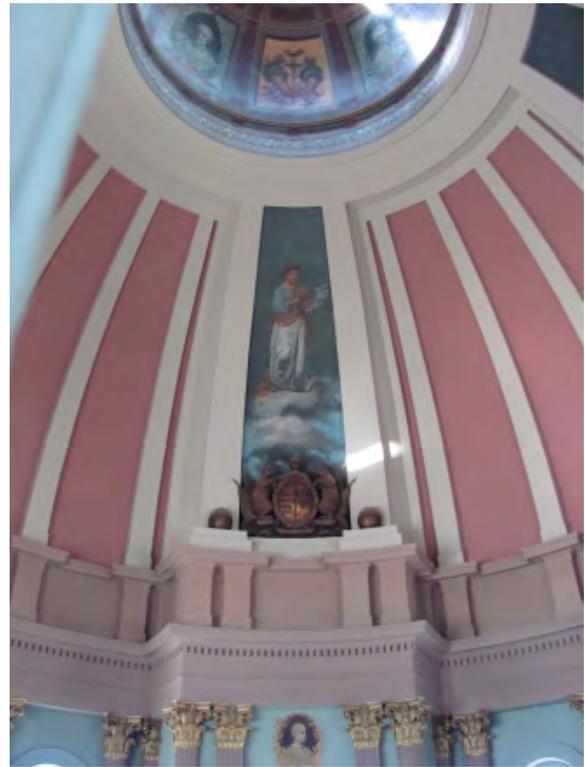
A limited visual assessment of the plaster ceiling in the rotunda was performed from the interior of the dome and attic above the dome. No scaffolding or lifts were available during the inspection. The upper drum walls, currently painted green, and entablature, currently painted mauve, are plaster on wood lath likely dating to the period of original construction in 1861. The dome ribs, currently painted off-white, are plaster on expanded metal lath and were replaced in 1985 during restoration of the dome plaster. The coffers of the dome, currently painted pink, are plaster on wood lath and likely date to the period of original construction in 1861. The allegorical figures at the four quadrants of the dome are plaster on wood lath. The existing plaster and lath likely date to the period of construction in 1861, while the allegorical figures are part of the 1880 decorative scheme (Figure 189). The upper dome plaster is currently decoratively painted on canvas, which is installed on plaster applied to metal lath. The canvas was installed during the 1955–1956 restoration and is decoratively painted as a re-creation of the 1880 decorative scheme (Figure 190). The plaster of the upper dome was completely replaced as part of the 1950s work, so no physical evidence of the original painted decoration survives. The plaster at the lantern was most recently repaired and partially replaced in 1979–1980 and is painted in a re-creation of the 1880 decorative scheme.

**FIGURE 189.** Overview of the dome interior. Photograph by WJE, October 20, 2011.

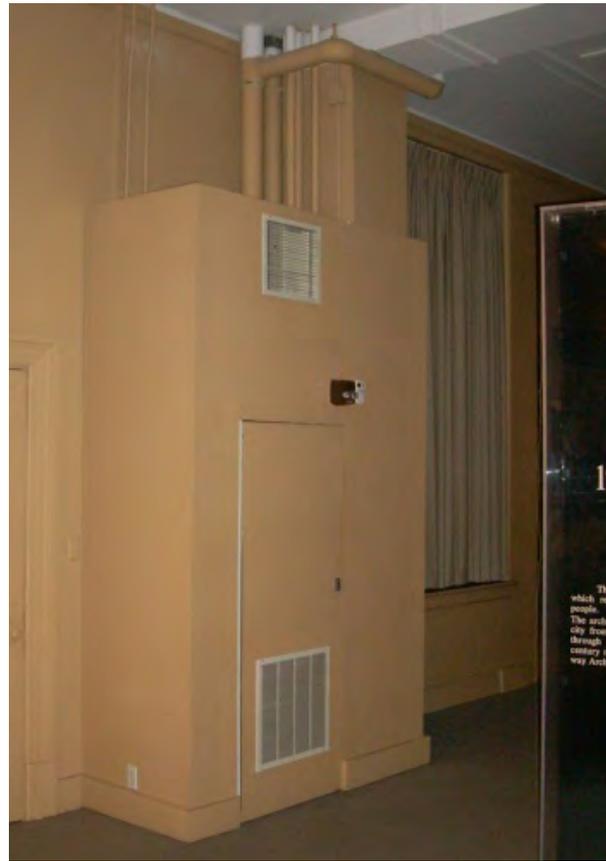
**FIGURE 201.** Indoor part of typical gallery split cooling system. Source: Alvine and Associates, 2011

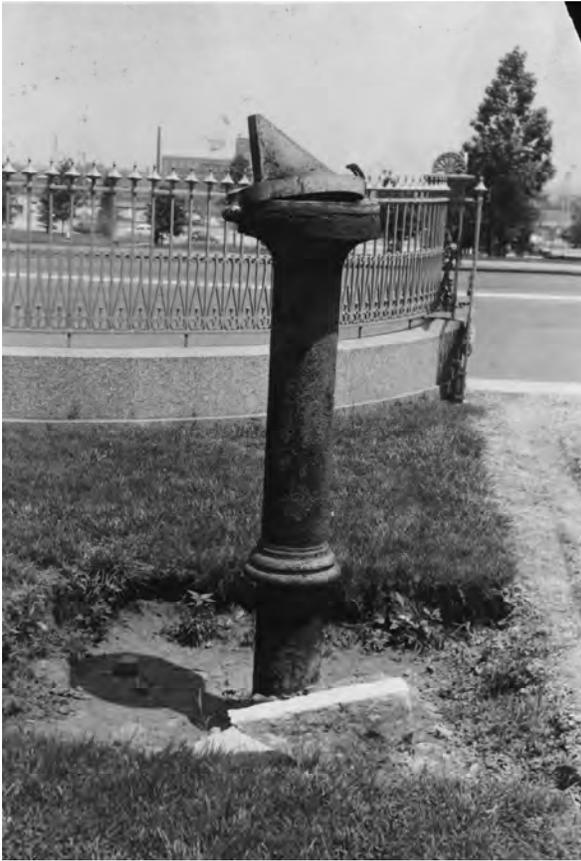
**FIGURE 206.** The sundial, circa 1955. At the time of the restoration, the sundial, the only element to survive from the original courthouse square design, was in poor condition and in need of repair. Replacement parts were manufactured at a local foundry. Source: JNEM Visual Reference collection, reference (VPRI-003925) HSR3925. Data sheet indicates “Sundial prior to restoration, looking northeast.”

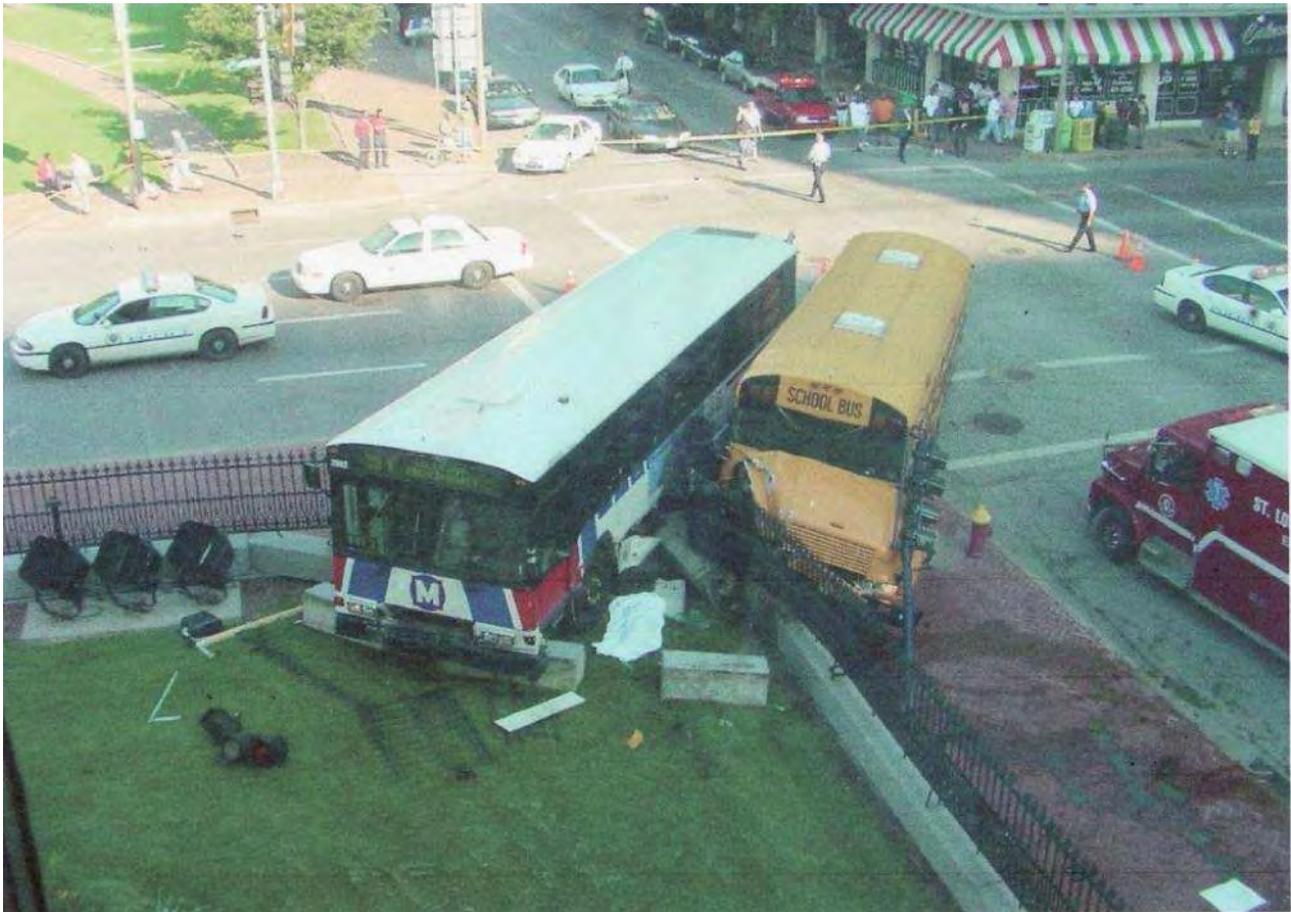
**FIGURE 207.** View of bus accident resulting in damage to the courthouse wall and fence, 2004. The perimeter fence and wall has been damaged several times by vehicles, including the damage shown in this image. Source: National Park Service files. Bus accident.

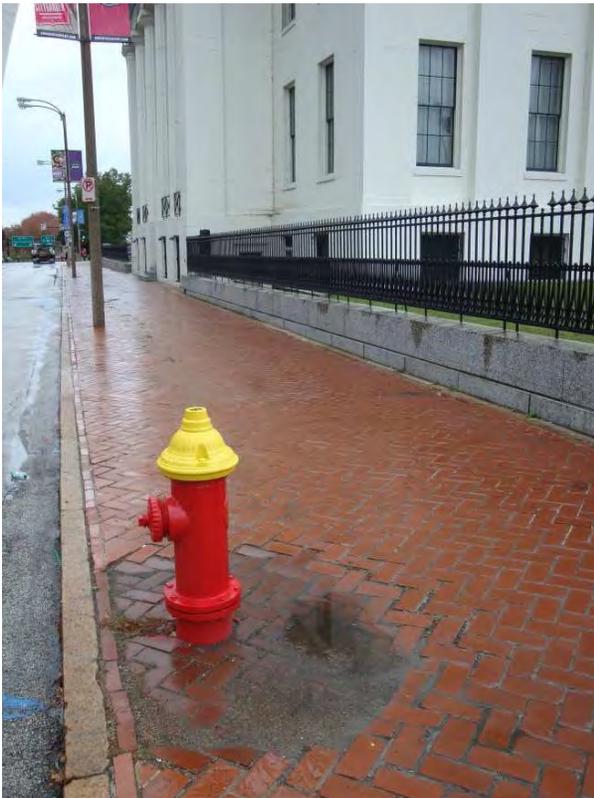
**FIGURE 218.** View of ponding and dislodged bricks associated with the perimeter brick sidewalk around the Old Courthouse grounds. Photograph by JMA, 2011.

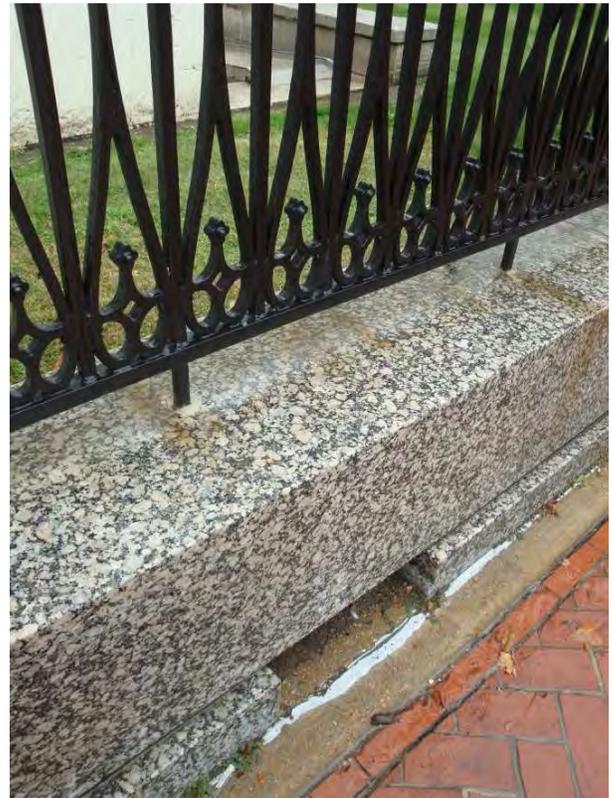
**FIGURE 219.** Example of staining caused by corrosion of the wrought-iron fence. Photograph by JMA, 2011.
