ACCESSIBILITY SELF-EVALUATION AND TRANSITION PLAN

LAKE ROOSEVELT

NATIONAL RECREATION AREA | WASHINGTON

AUGUST 2018

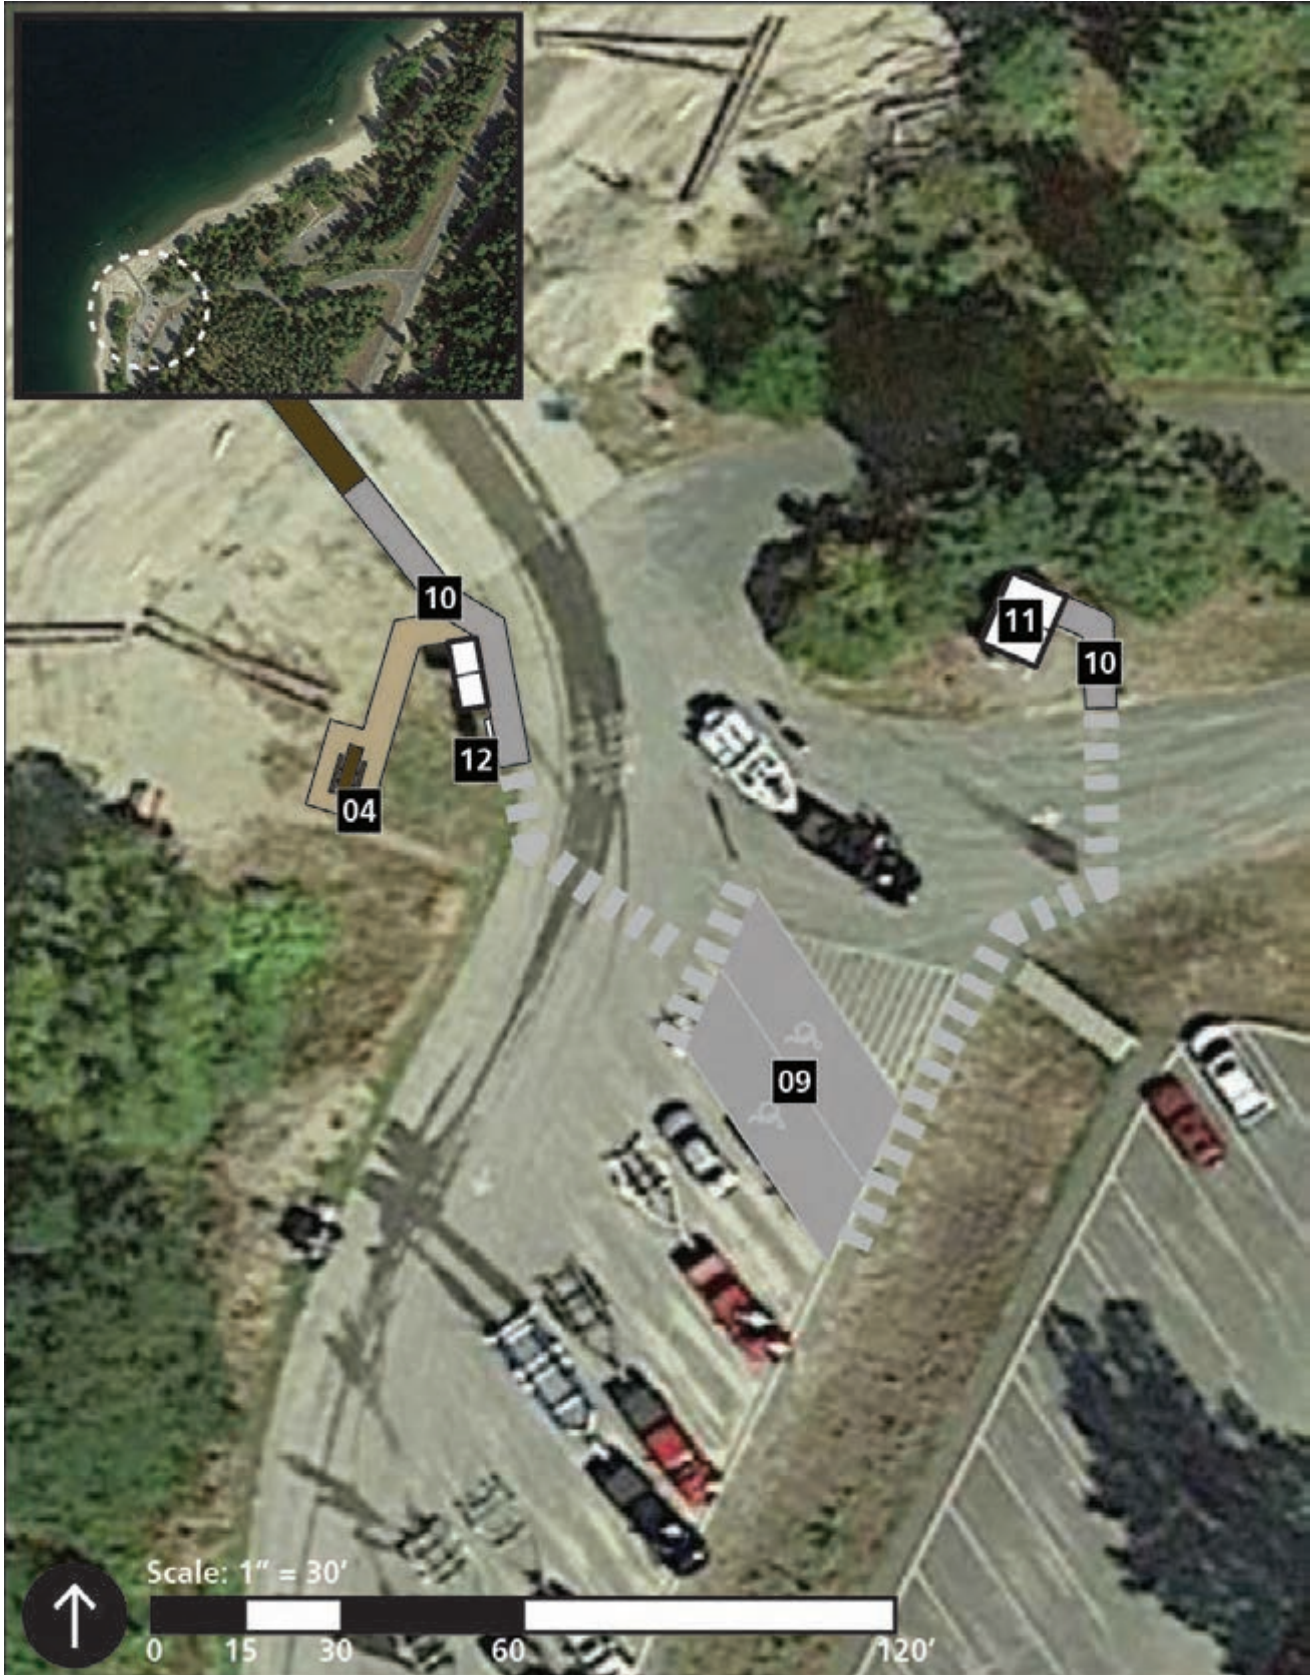
**Bradbury Beach
South Site Plan**

Restrooms (at south parking lot)	3	The restroom has high grab bars and a high coat hook. Tactile signage is missing adjacent to the restroom door.	1) Lower the coat hook to be no more than 48" above the ground. 2) Lower the grab bars so that the top of the gripping surfaces are between 33" and 36" above the ground. 3) Provide tactile signage adjacent to the latch side of the restroom door with the bases of the lowest tactile	ABAAS 603, 609, and 703	Retrofit all restrooms to conform to ABAAS	N/A	Y	N	N	N	Day Labor	Kettle Falls Maintenance Mechanic Supervisor	Short-term	Refer to Appendix E, "Actions Taken by the Park" form identification no.____ when actions are taken.

- 1) Relocate trash and recycling receptacles to accessible locations, with firm and stable approaches, 30" by 48" minimum from a forward approach at a 2% maximum slope in all directions.
- 2) To the extent practicable, improve or replace at least two trash and recycling receptacles so that they are operable with a closed fist and 5 pounds of force or less.

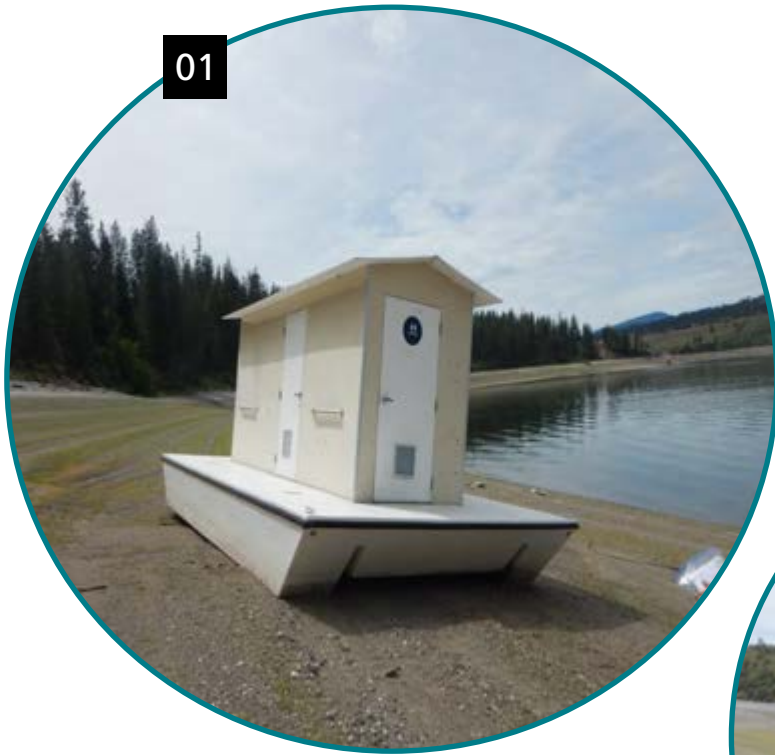
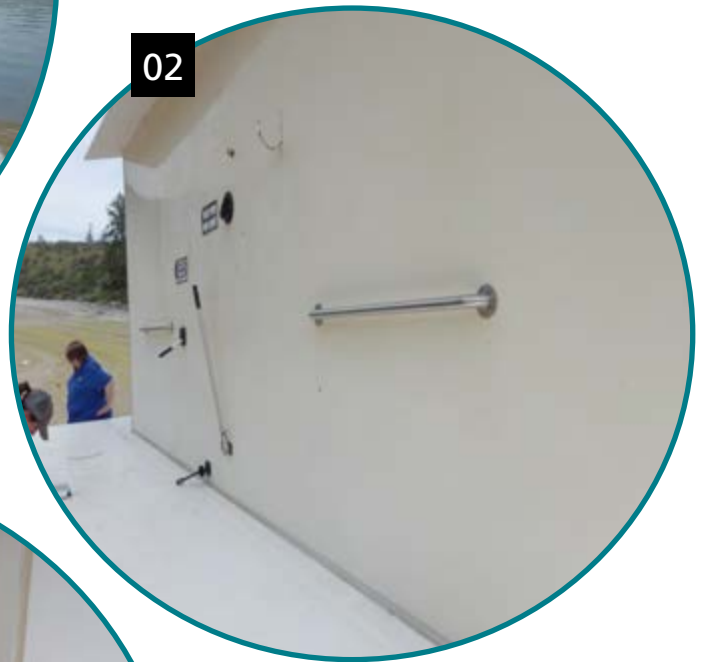
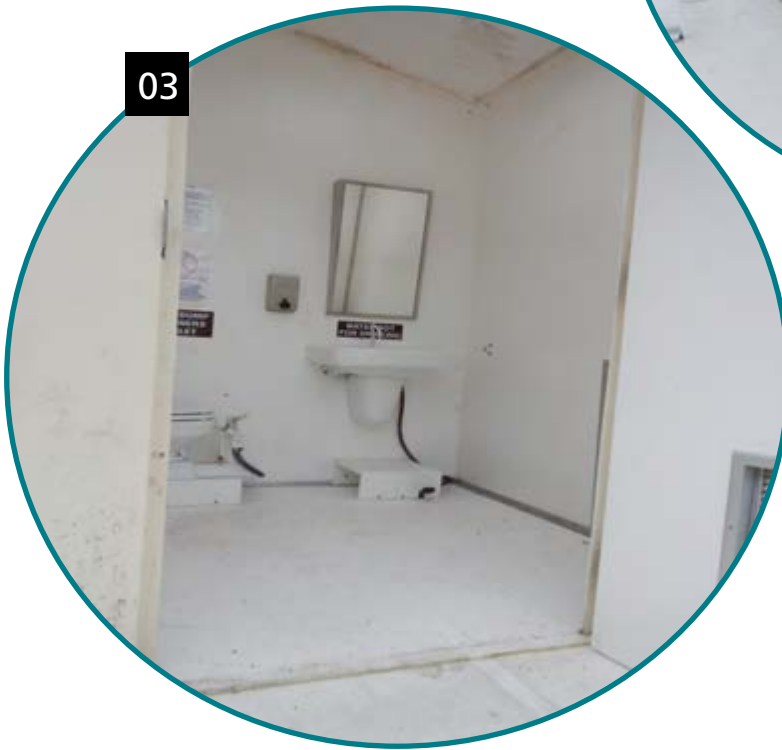
Site Features

The Crystal Cove – Floating Pump-out Station is connected to one key park experience: distinct geographic provinces. Several floating pump-out station/restrooms are located within the lake and provide essential on-lake restroom and pump-out facilities for boaters. Some stations are grounded during low water and would be inaccessible during this time. The stations are pre-fabricated; however, opportunities for improving accessibility exist.
