Beyond Basic Preservation: RESTORATION

CASE STUDY: Restoration of the Cape May Lighthouse

CASE STUDY: Restoration of Cape Hatteras Lighthouse

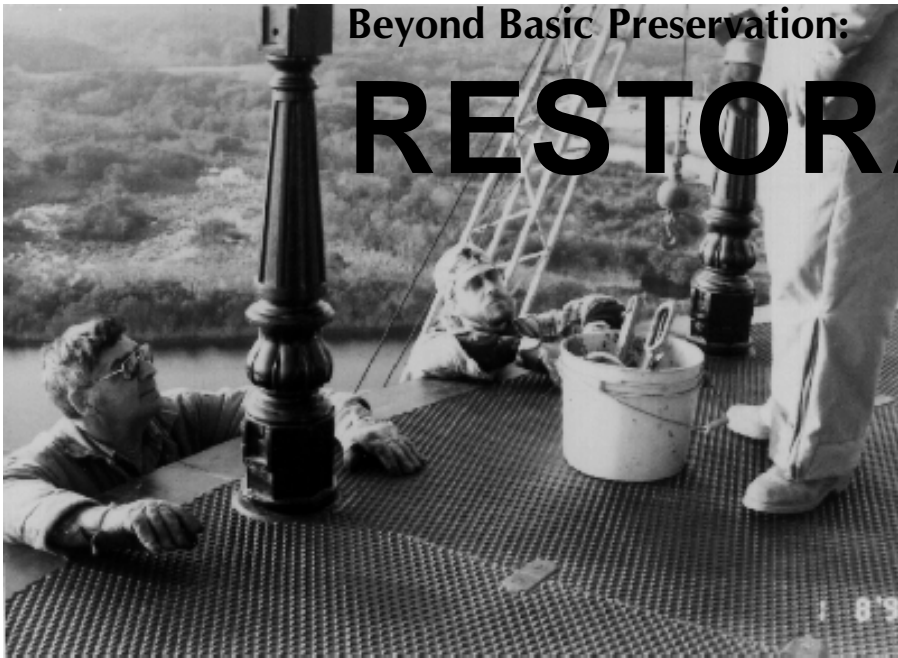
Figure 1. New ornate cast-iron handrail posts were recast and installed on the new gallery deck as part of a restoration at Cape Hatteras Lighthouse, Buxton, North Carolina.

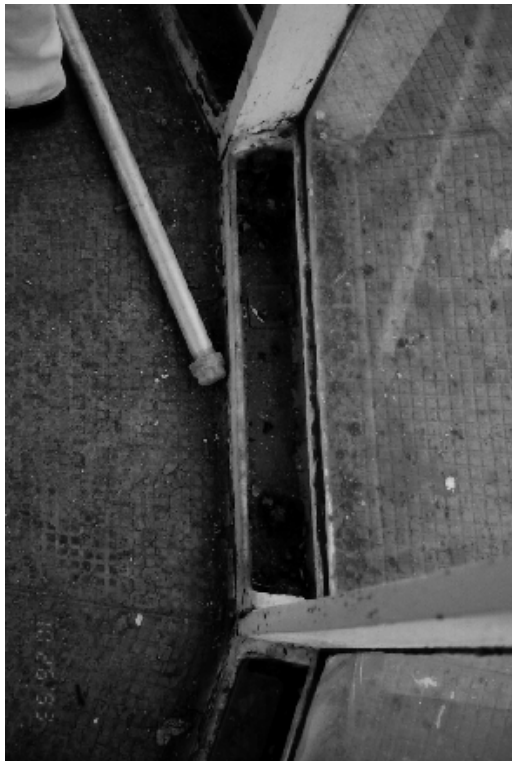
Figure 2 (left). Condition of the bronze sill sitting on the lantern deck inside the lantern room. The sill is wedged between two vertical cast-iron stiles, which are anchored into the masonry below.

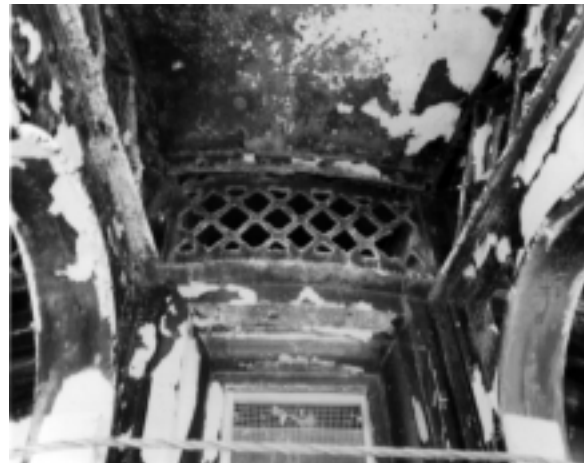
Figure 3 (above). Horizontal mullions run in between the stiles and serve to keep the stiles straight and frame the individual pieces of glass. Before restoration, the mullions and sills had been bolted in place over 140 years.

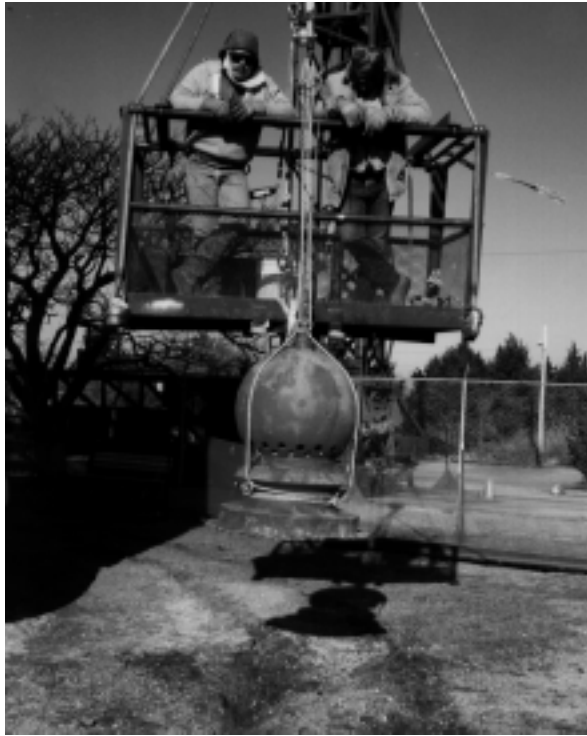
Figure 4. The first step in removing the roof was to take off the vent ball. The vent ball not only serves as a lightning rod but also provides ventilation to the glass in the lantern room, limiting condensation.

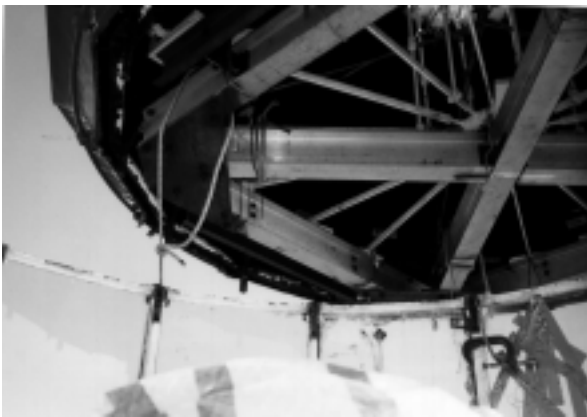
Figure 5. As the roof is being removed from the lighthouse, the tie rod system, supported by ICC's aluminum roofing frame, is visible. This frame was designed to fully support the roof and alleviate any stress or strain on the roof during the lift. Protruding down from the roof are the ends of the rafters which connect to the top of the stiles.

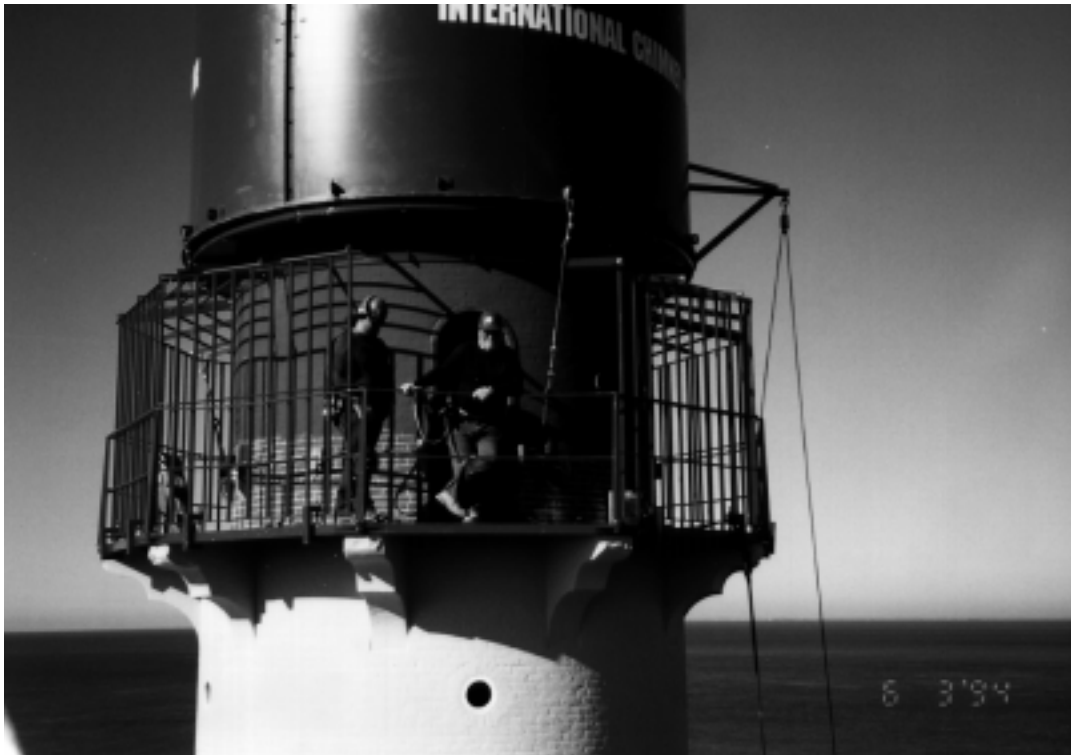
Figure 6. During the restoration, this ‘Campbell Soup Can’ was installed over the lantern room in order to protect restoration efforts from the environment.

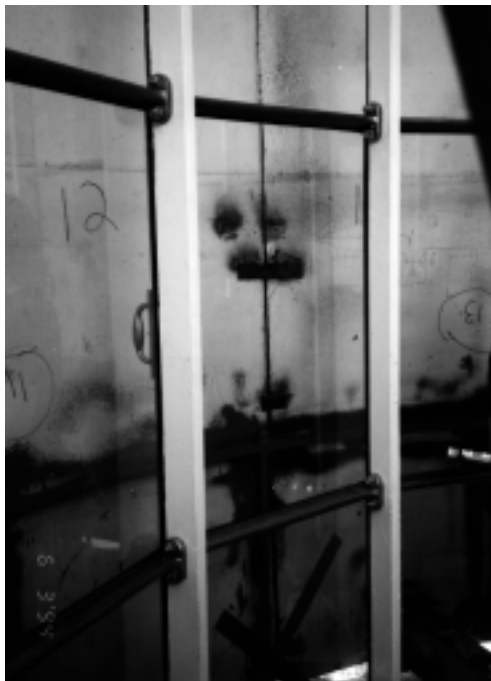
Figure 7. Inside the lantern room, the mullions have been reworked and reattached to the stiles. New stainless steel bolts have been used to prevent corrosion and teflon tape has been used as a gasket between the bronze and the cast iron. Teflon washers also separate the bronze from the stainless steel bolt.

In June 1994, all preparations were complete for reassembly of the lantern room and roof system. The matched, marked pieces were carefully refitted with new stainless-steel hardware and teflon tape which acts as an isolator between the dissimilar bronze and cast-iron metals. In the 19th century, little was known about the chemical reaction between dissimilar metals. When a copper-based metal is placed in contact with a ferrous-based metal, an anode-cathode reaction occurs, similar to a battery. This changes the molecular structure of the ferrous metal, causing corrosion.

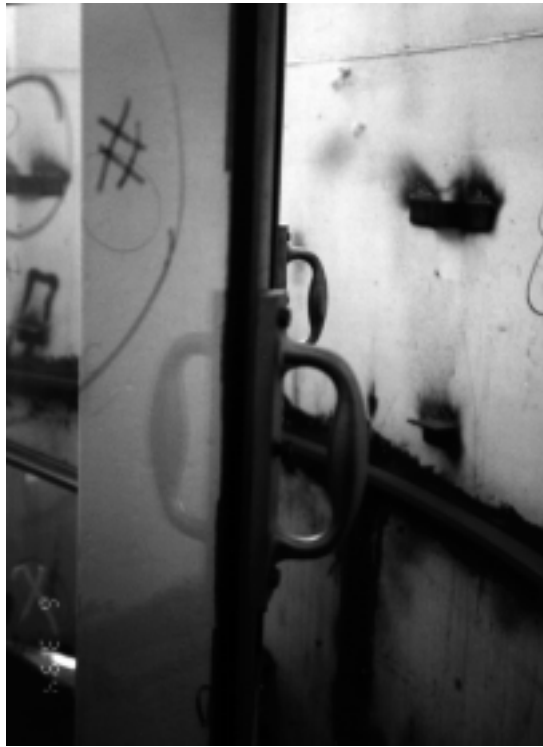
Figure 8. New hand holds were replicated to replace missing pieces. These exactly match the originals.

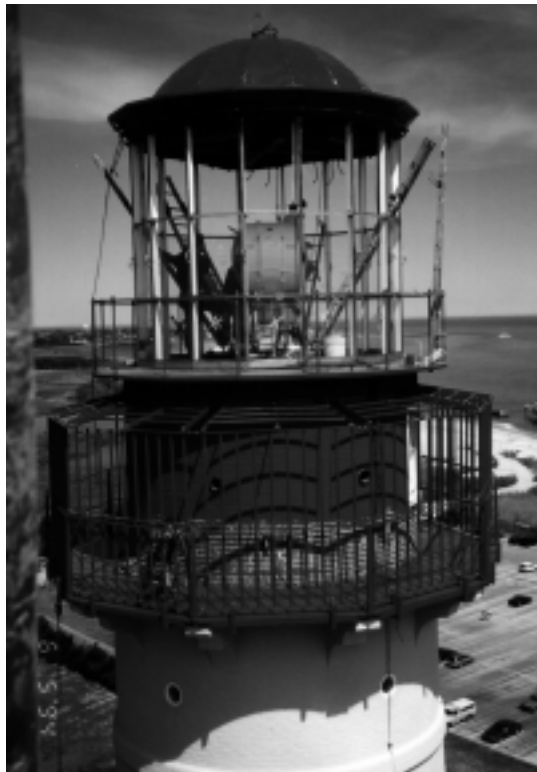
Figure 9. The refurbished roof is replaced on the lantern room. The fit is almost exact.

Meticulous preparations were made on the ground and in the air for the lift. The refurbished roof was centered as close as possible to the center line of the lighthouse and turned to allow for the proper fit in its original position. ICC's craftsmen were perched on ladders waiting for the roof to be hoisted. When all was ready, the signal was given and the lift began. The roof was centered above the window wall and began its descent. The result was anticlimactic. The roof came down exactly into position as if sucked in by a giant magnet. The major portion of the restoration was complete.

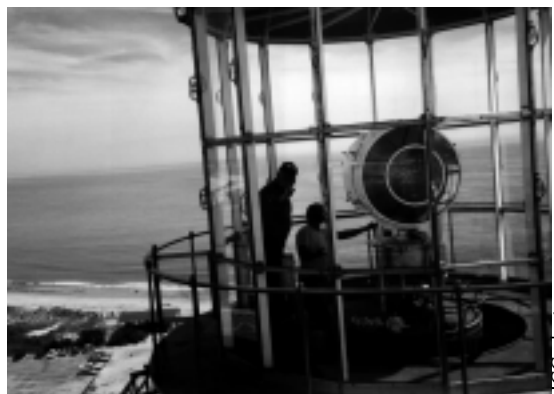
Figure 10. All glass is now in place and final preparations are made for the reopening.

New safety glass was installed on the window wall system, and the 'soup can' was no longer needed. A relatively calm wind would be required to remove the enclosure and set down the newly refurbished roof. On the June 4, 1994, conditions appeared favorable. The enclosure was lifted and, for the first time in five months, the efforts of the craftsmen were revealed. The newly lacquered bronze mullions, glazing bars, and sills gleamed in the bright early summer sun.

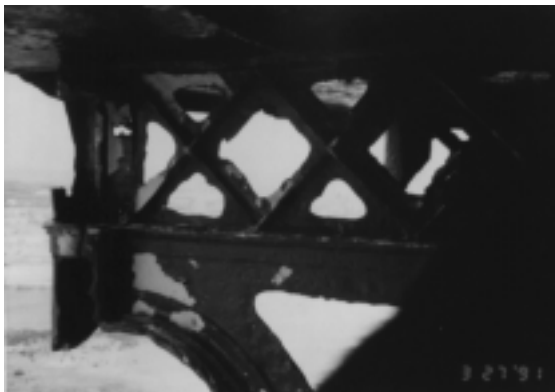
Figure 12. Some brackets were so deteriorated that they were totally exposed to the elements.

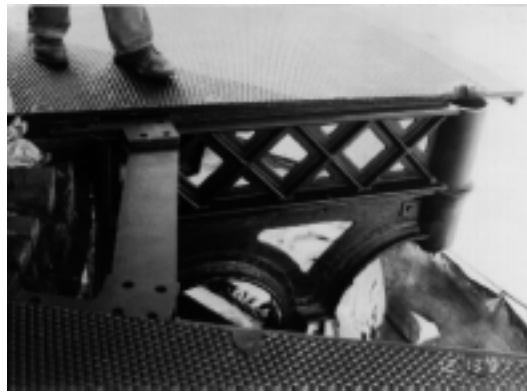
Figure 13. After the most severely deteriorated portion of the brackets were removed, new cast-iron pieces were made and installed; and new deck plates installed.

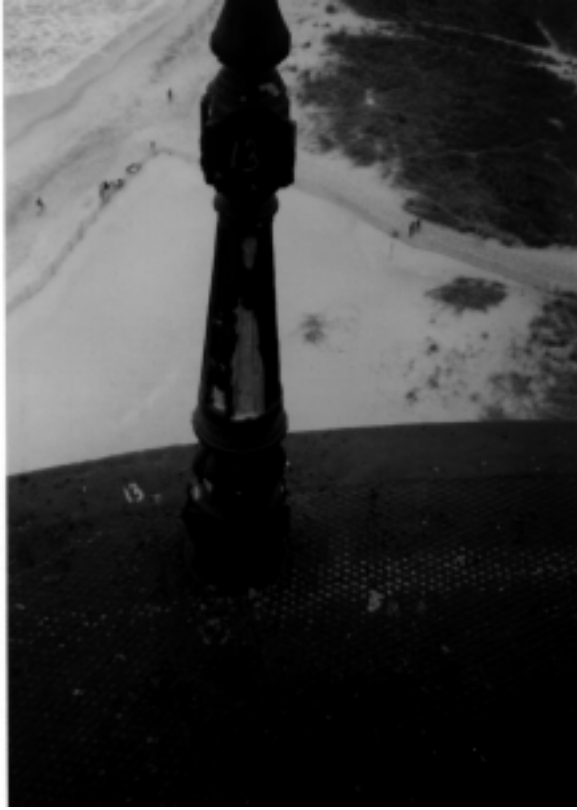
Figure 14. The handrail assembly has been removed and the ornate cast-iron post is ready for removal.

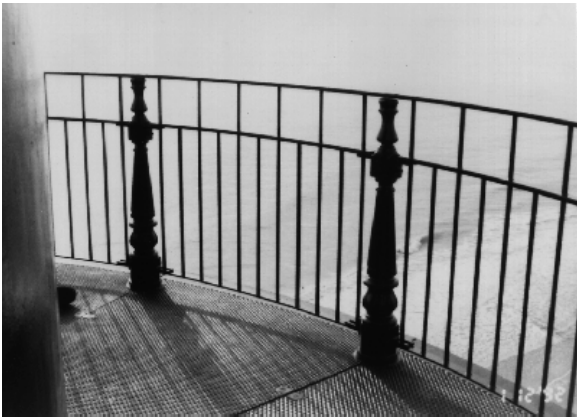
Figure 15. A replica handrail is installed.

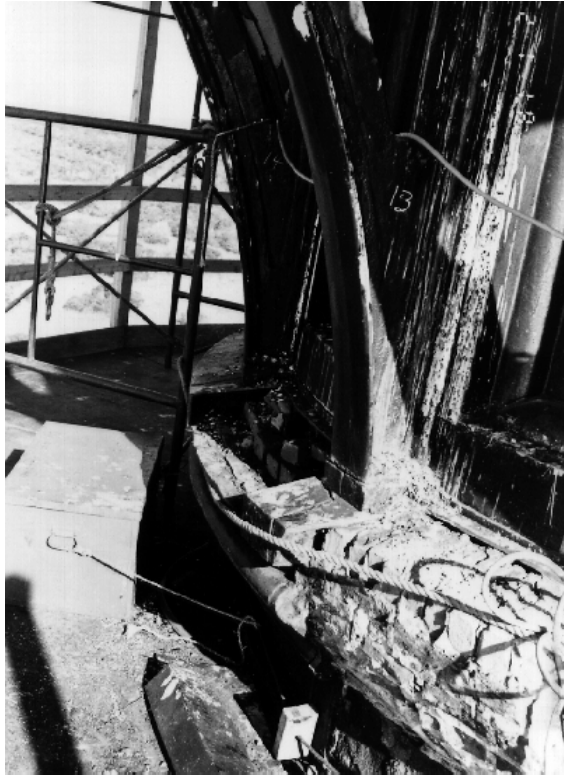
Figure 16. At the base of the brackets, the cast-iron belt course is removed, exposing deteriorated masonry below.

When repairs were completed to the Bonner Bridge, exterior work could begin. A 7-foot-wide, circular work deck was placed below the large gallery deck. This afforded access to the complete hand rail system and deck plates. The hand rail components were carefully removed, as were the deck plates. The surviving pieces of deck plate were so deteriorated that accurate measurements could not be made. The deck was recalculated and a template made of the theoretical size and shape of the new deck plates. This was custom-fitted to each individual bracket, revealing that the lighthouse was slightly out of round. Measurements were taken for each individual section, which required custom casting, machining, and fitting of each individual section of plate. The brackets supporting the plate were reworked, and individual components recast. The belt course holding the brackets together below was removed, the masonry underneath repinned, and the cast belt course reinstalled. Deteriorated masonry was carefully cut out and repainted, as was the granite pedestal at the base.

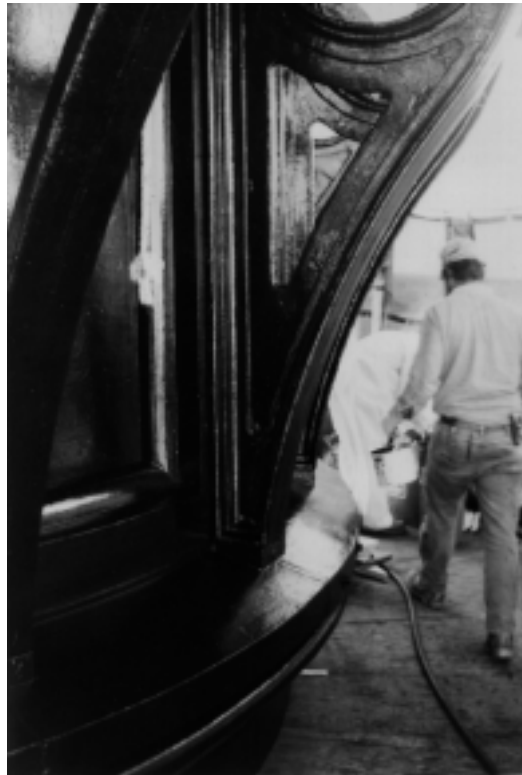
Figure 17. The cast-iron belt courses are repinned to new masonry beneath.
