Nicodemus National Historic Site

Nicodemus, Kansas

Historic Structures Report Update

May 2010

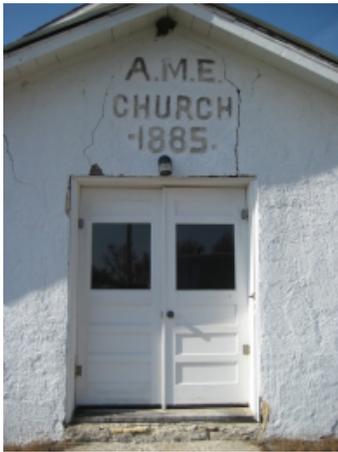
1
2 *Figure 1. The restored doors at the east elevation of the*
3 *A.M.E. Church. Compare to Photo A-19 in the 2002*
4 *HSR. Photo by BVH, 2009.*

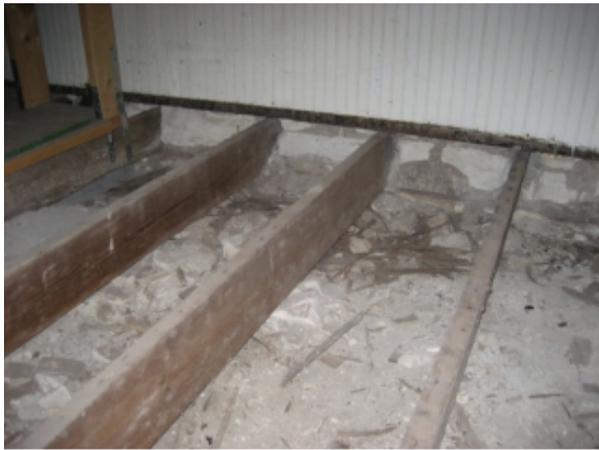
1
 2 *Figure 23. Detail at southeast corner of sanctuary*
 3 *showing portion of flooring removed to allow*
 4 *repointing and repairs to stone wall/foundation. Photo*
 5 *by BVH, 2009.*

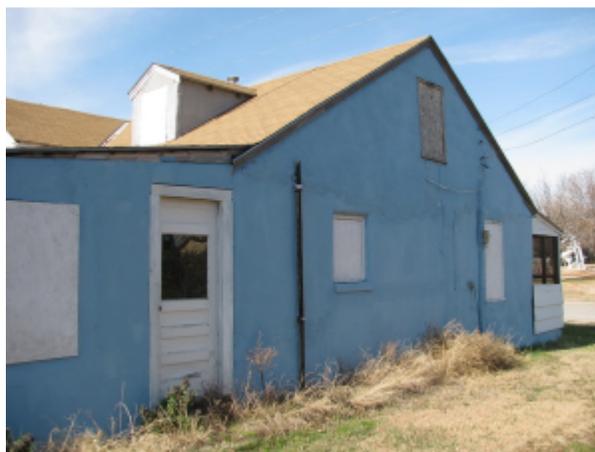
40
41 *Figure 27. View of the east elevation showing stucco*
42 *repairs and repainting of exterior stucco and wood*
43 *trim. Photo by WJE, 2009.*

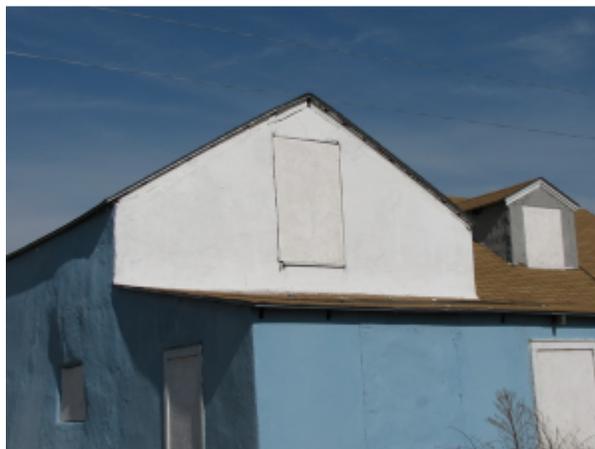
44
45 *Figure 28. View of the southwest corner of the building,*
46 *showing flashing repair between the second floor wall*
47 *and shed roof. Compare to Photo F-18 in the 2002*
48 *HSR. Photo by WJE, 2009.*

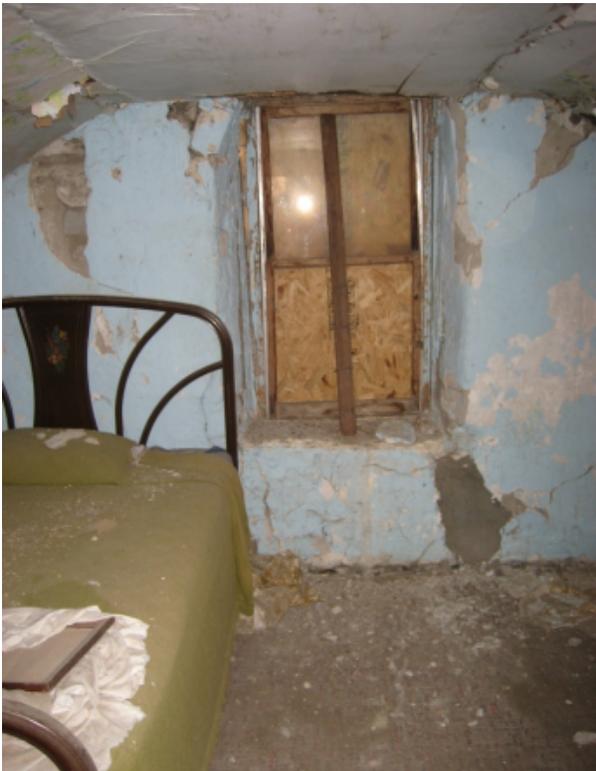
4
5 *Figure 30. The second floor bedroom has been cleaned*
6 *out since 2002 and contains few items. The south*
7 *window has been covered but large gaps around the*
8 *frame allow moisture to penetrate into the building and*
9 *wall system. Photo by BVH, 2009.*

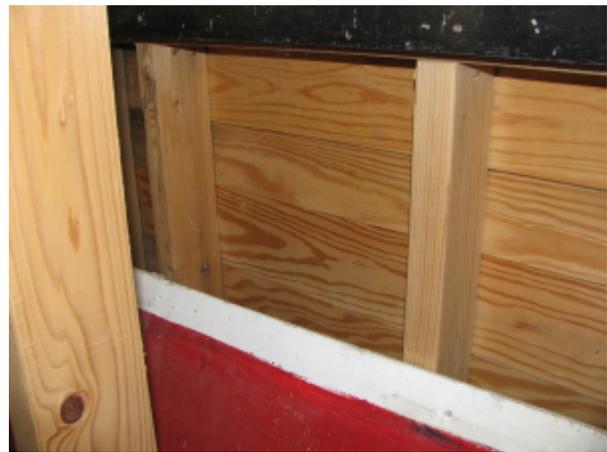
6 Between August and October 2005, repairs were
7 performed at the north wall to address
8 displacement that had occurred due to previous
9 water leakage (Figure 31). Interior wood shoring
10 was constructed to support the roof structure.
11 Although the drawings for this work indicated
12 that concrete piers were to be built in the crawl
13 space to support the shoring wall, as
14 implemented the shoring wall bears on the floor
15 framing of the schoolhouse. Cellulose insulation
16 was removed from the wall cavity. A new 2x4
17 sill plate, new 2x4 wall framing, new plywood
18 sheathing, and new painted wood exterior siding
19 was installed at the north wall below the
20 window sill. The original siding was found to be
21 too deteriorated for reuse.¹⁰

42
43 *Figure 31. Detail of new stud framing and exterior*
44 *sheathing below the windows of the north wall. Photo*
45 *by WJE, 2009.*

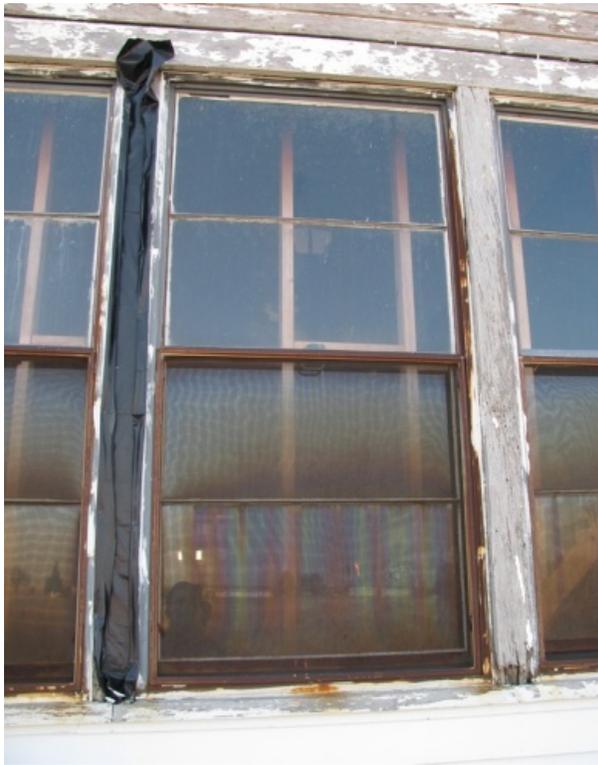
1
2 *Figure 33. Some exterior wood window trim was*
3 *removed and not replaced. Note temporary plastic*
4 *sheeting at left window jamb. Photo by WJE, 2009.*

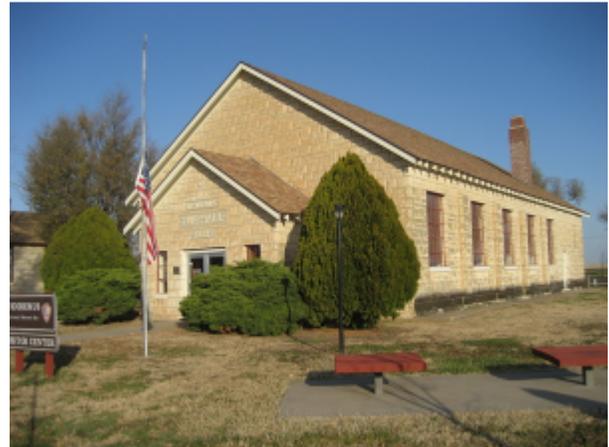
46
47 *Figure 38. View from the southeast of the Township*
48 *Hall, showing new asphalt shingle roofing, painted*
49 *wood trim, and repointed brick masonry chimney.*
50 *Photo by BVH, 2009.*

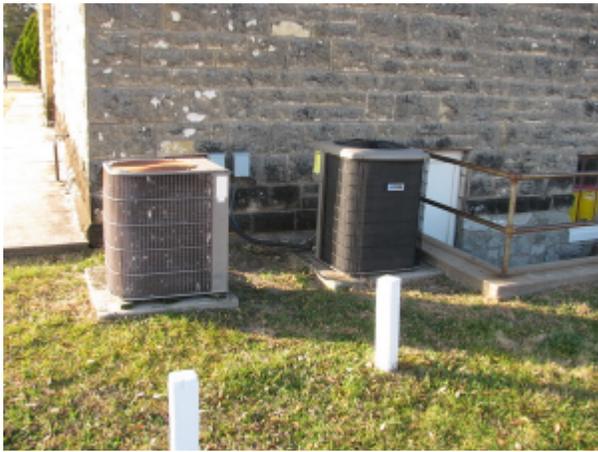
1
2 *Figure 40. The new York air conditioning condenser is*
3 *at right. Photo by WJE, 2009.*

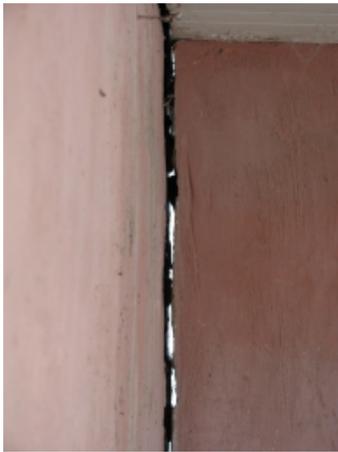
Figure 46. View inside the vestibule. There is a continuous open joint (note visible daylight) between the main sanctuary wall and the vestibule walls at the north and south sides of the vestibule. Photo by WJE, 2009.

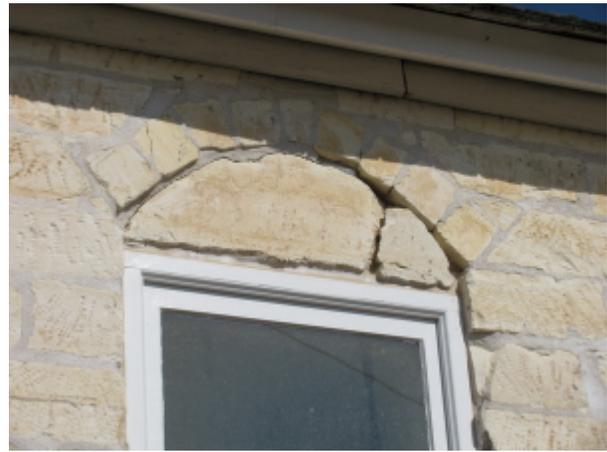
Figure 49. Cracked lunette stone over one window on the south elevation. Photo by WJE, 2009.

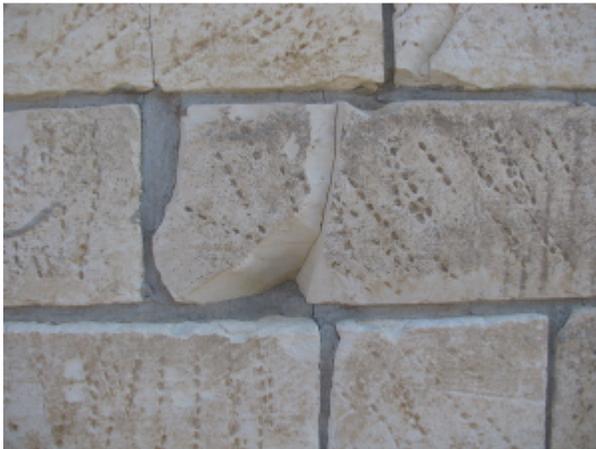
Figure 47. Cracking of recently repointed mortar joints and stone at the west elevation. Photo by WJE, 2009.

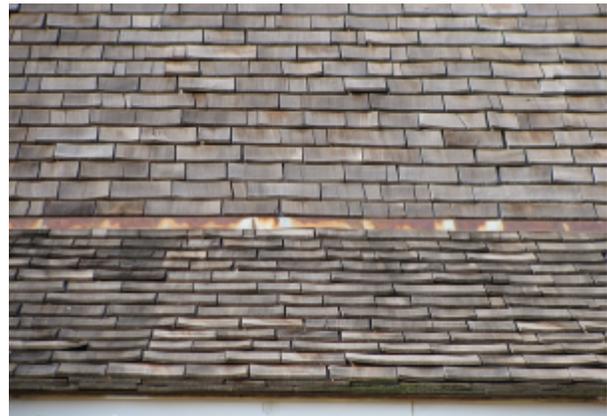
Figure 51. Minor cupping of the cedar shingles and corrosion of the sheet metal flashing have occurred as the new roof system has weathered. Photo by WJE, 2009.

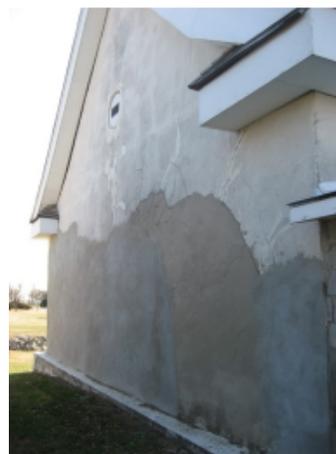
Figure 52. The newly installed stucco at the north elevation and elsewhere is uncoated. Photo by BVH, 2009.

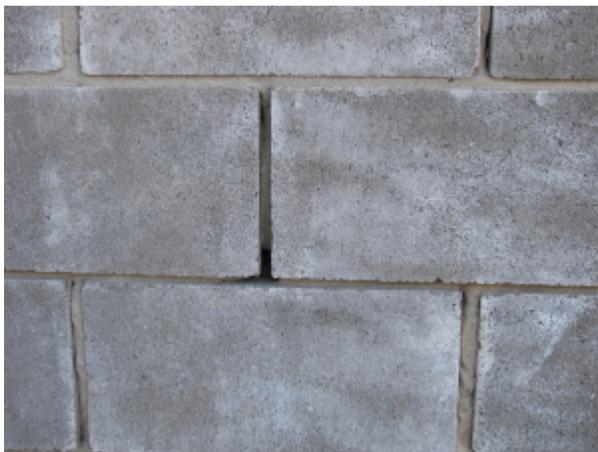
Figure 55. The concrete masonry walls of the northwest addition are significantly deteriorated, with eroded and open mortar joints and efflorescence. Photo by WJE, 2009.

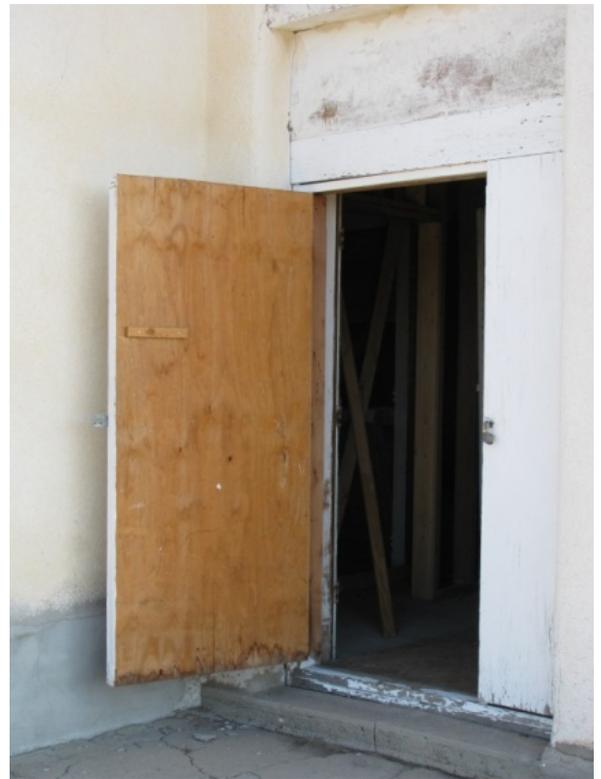
Figure 57. Entry doors removed and replaced with temporary plywood door and side panel. Photo by WJE, 2009.

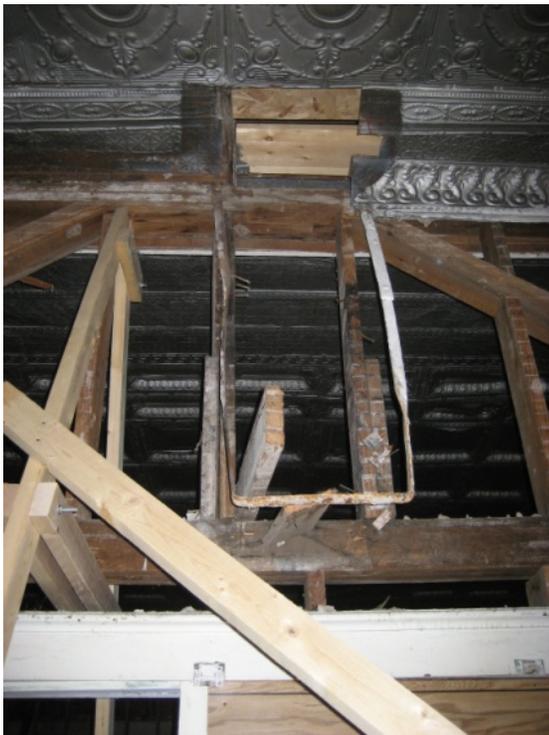
Figure 58. Chimney flue removed. Note metal strap that suspended flue masonry. Photo by BVH, 2009.

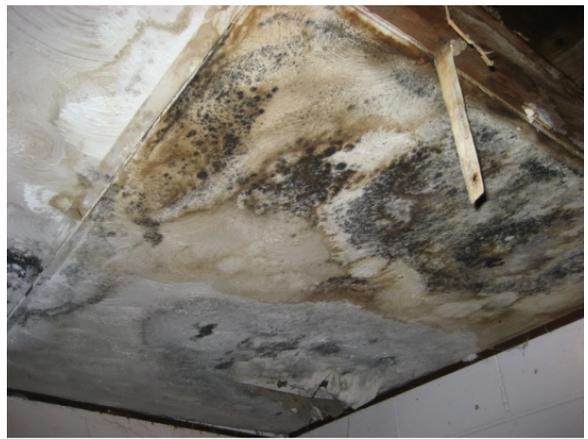
Figure 60. Ceiling in study exhibiting severe deterioration and apparent biological growth. Photo by BVH, 2009.

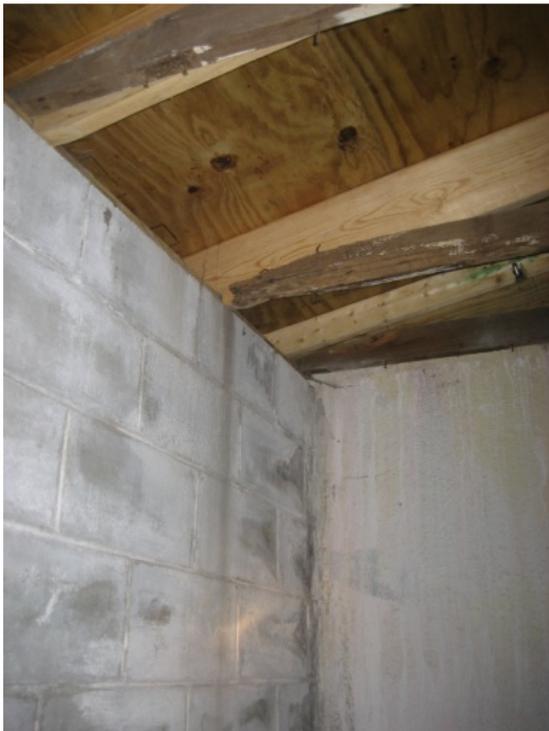
Figure 59. Ceiling in study that has either fallen down or been removed since 2002. Photo by BVH, 2009.

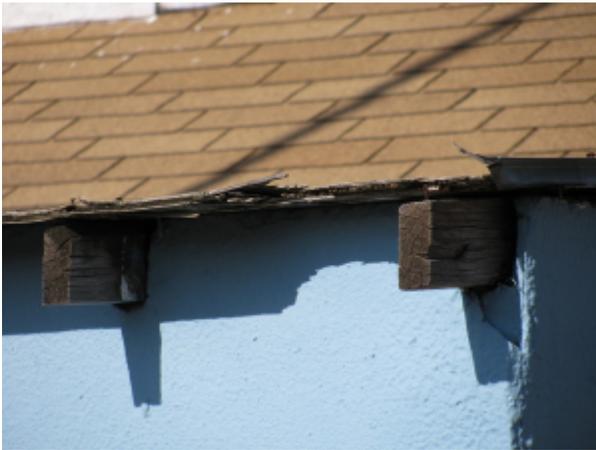
Figure 61. Deterioration of the wood roof overhang, south elevation. Photo by WJE, 2009.

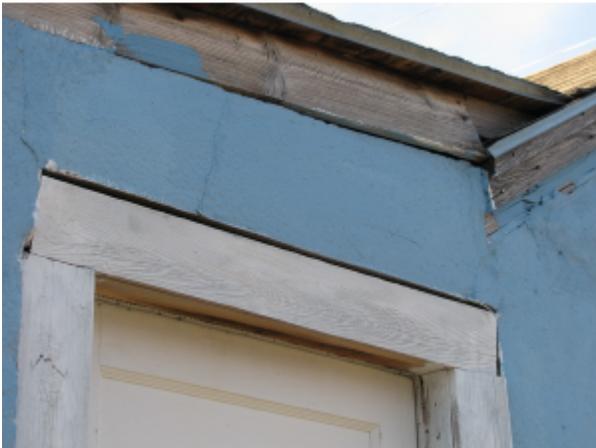
Figure 62. Unpainted wood eave trim and unsealed gaps between stucco and wood trim. Photo by WJE, 2009.

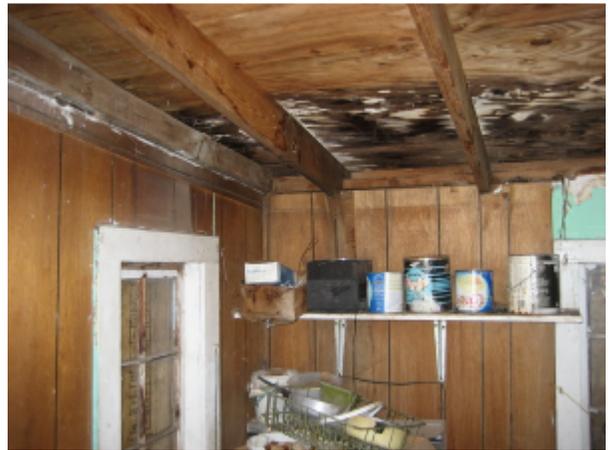
Figure 64. Previous or active water leakage has damaged the plywood roof deck and wood rafters at the southeast corner of the first floor. Photo by BVH, 2009.

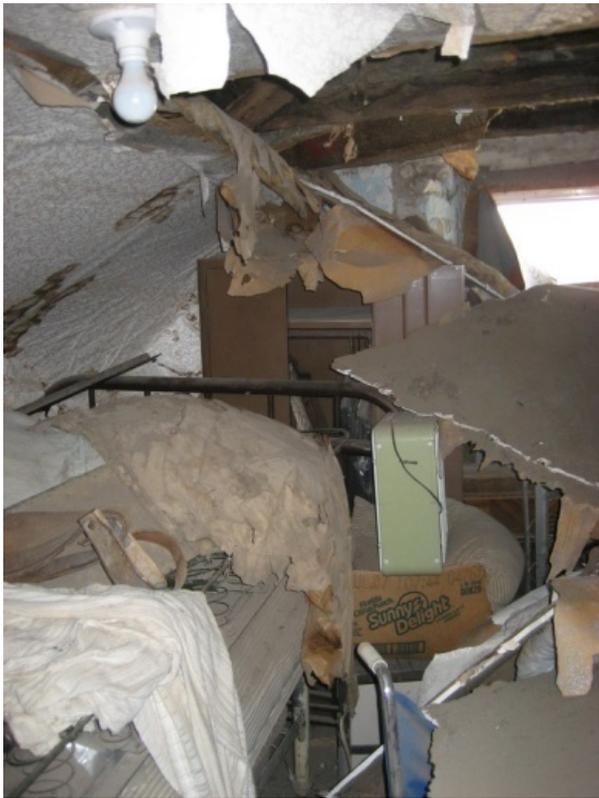
Figure 65. Previous or active water leakage has resulted in the collapse of gypsum wallboard and ceiling finishes at the second floor. Photo by BVH, 2009.

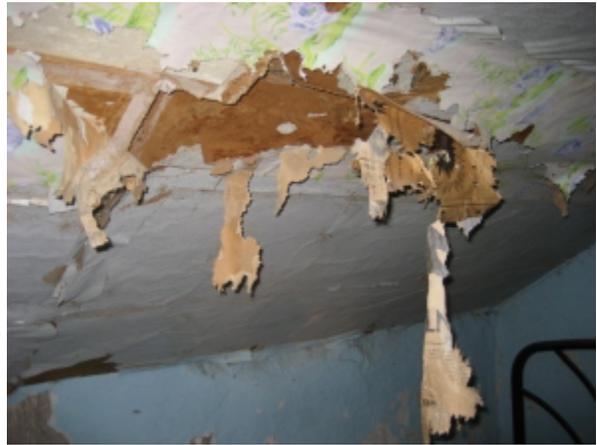
Figure 67. Gypsum board ceiling deterioration. Photo by BVH, 2009.

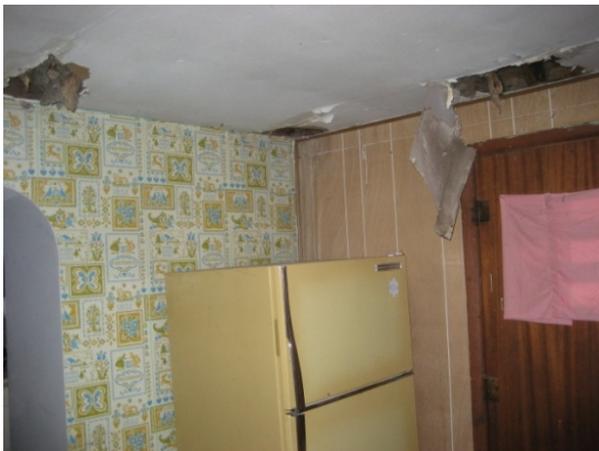
Figure 66. Access/inspection holes broken into the living room ceiling by unknown party at unknown date. Photo by BVH, 2009.

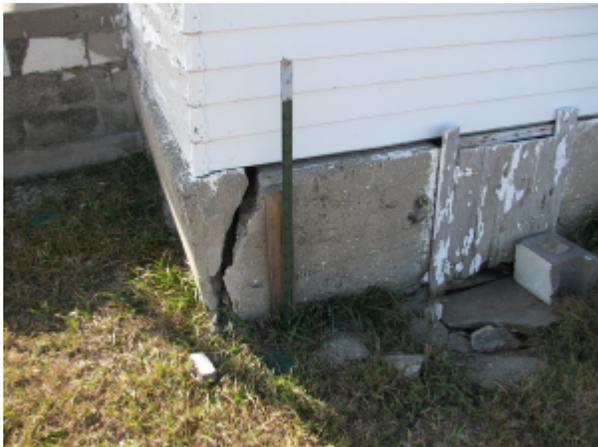
Figure 68. Crack at the northeast corner of the foundation. Photo by WJE, 2009.

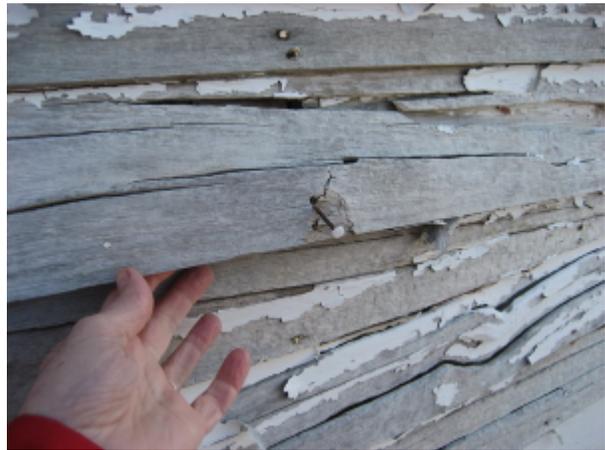
Figure 69. Deterioration of the existing wood siding at the west elevation. Photo by BVH, 2009.

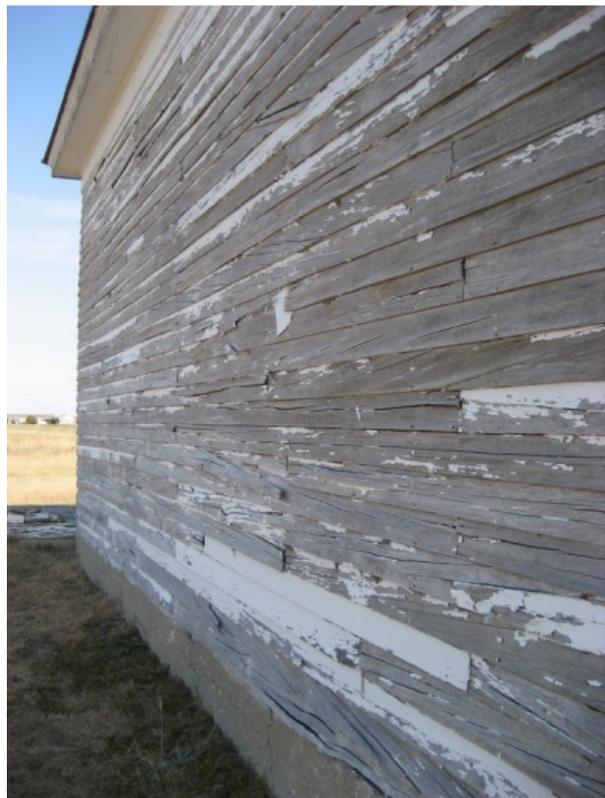
Figure 70. Deterioration of the existing wood siding at the west elevation. Photo by BVH, 2009.

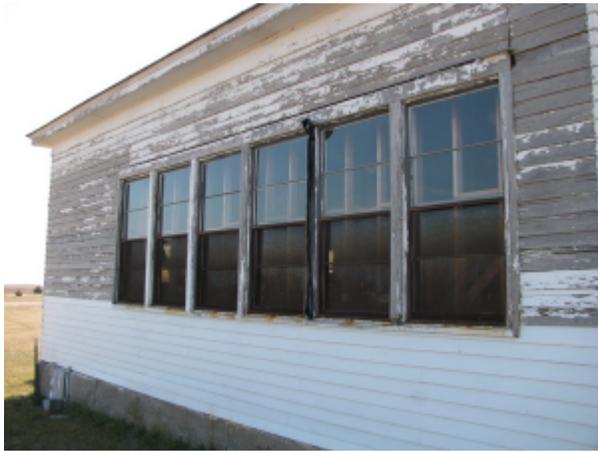
Figure 71. View of the north elevation showing newly installed wood siding. Photo by WJE, 2009.

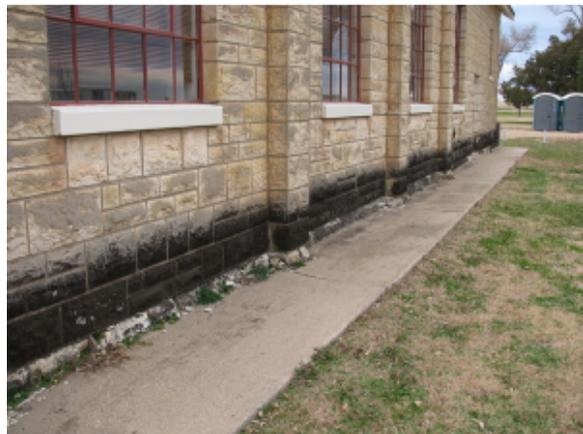
Figure 76. Staining and stone distress near grade and the concrete paving along the east elevation. Photo by WJE, 2009.

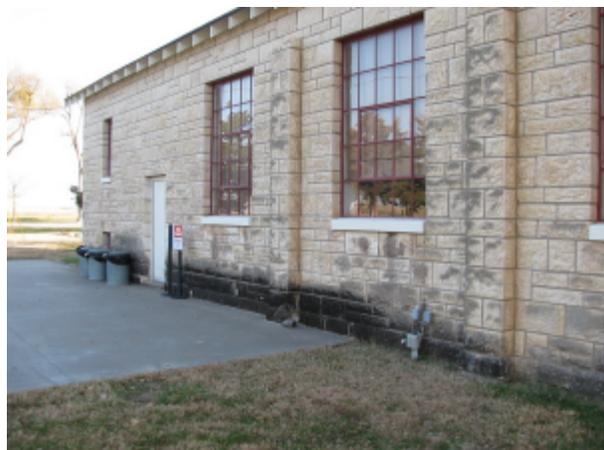
Figure 77. Concrete terrace at the north half of the west elevation. Note the concentration of staining and masonry distress at the areas adjacent to the concrete paving. Photo by WJE, 2009.

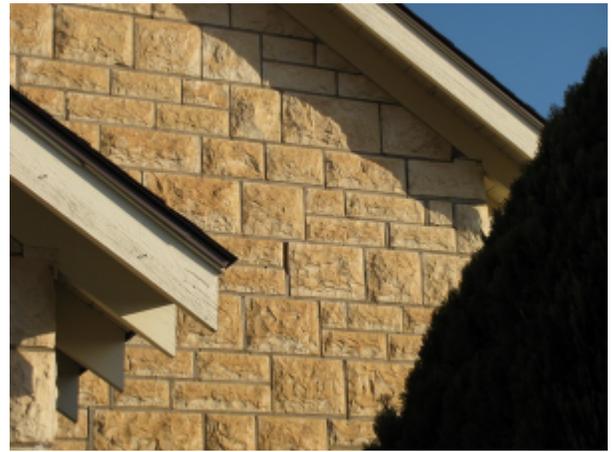
Figure 81. Step cracking at the south gable wall. Photo by WJE, 2009.

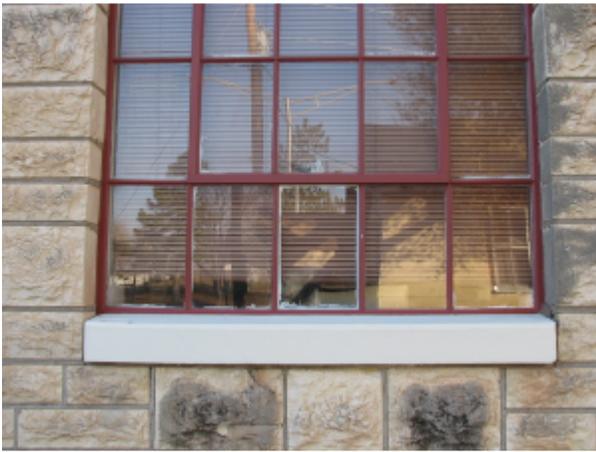
Figure 79. Reglazing of individual lights with sealant is visible as a light-colored perimeter (for example, center bottom light). Photo by WJE, 2009.

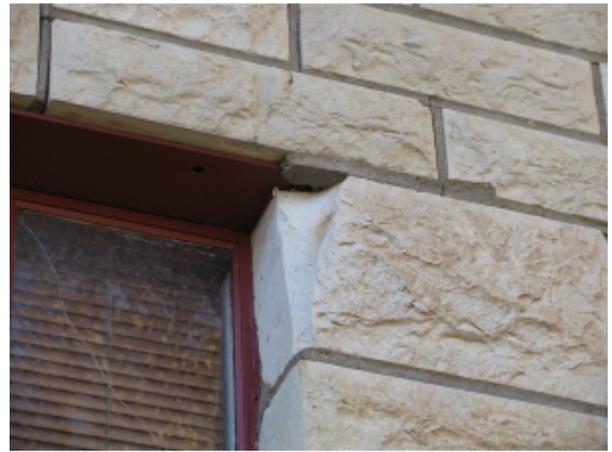
Figure 82. Spalling of stone at the bearing point of a window lintel. Photo by WJE, 2009.

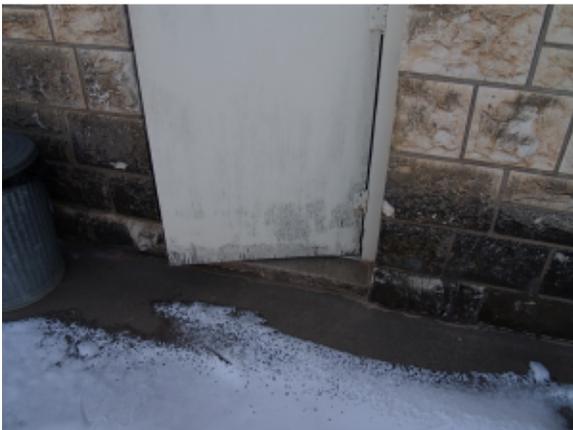
Figure 80. The west side entrance door has paint loss and wood deterioration. Photo by NPS, 2009.

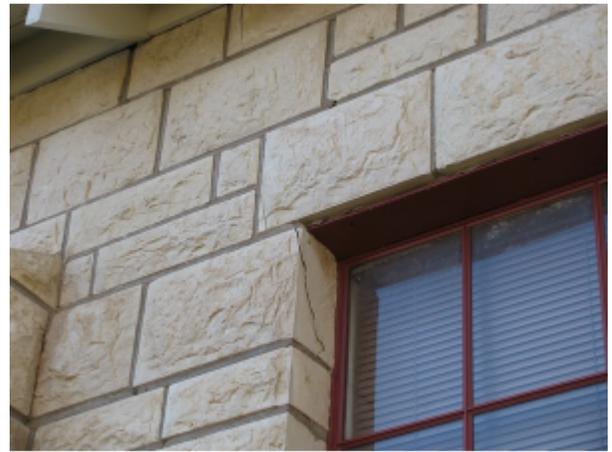
Figure 83. Cracking of stone at the bearing point of a window lintel. Photo by WJE, 2009.

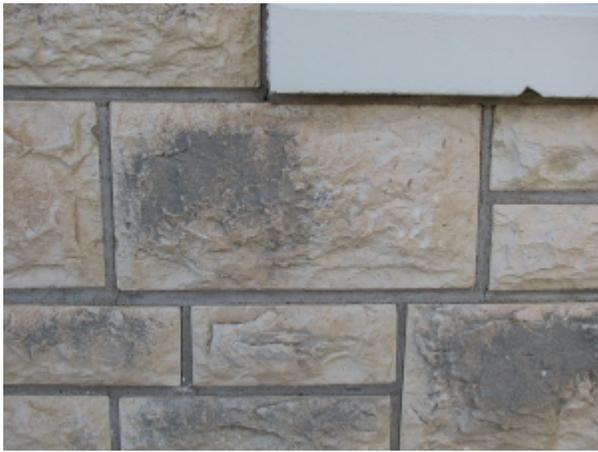
Figure 84. Cracking of mortar joints. Photo by WJE, 2009.

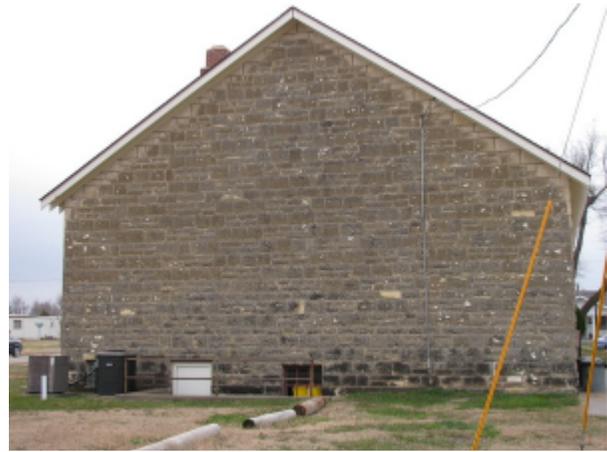
Figure 87. Intermittent impact damaged stone without organic growth gives the north elevation a speckled appearance. Photo by WJE, 2009.

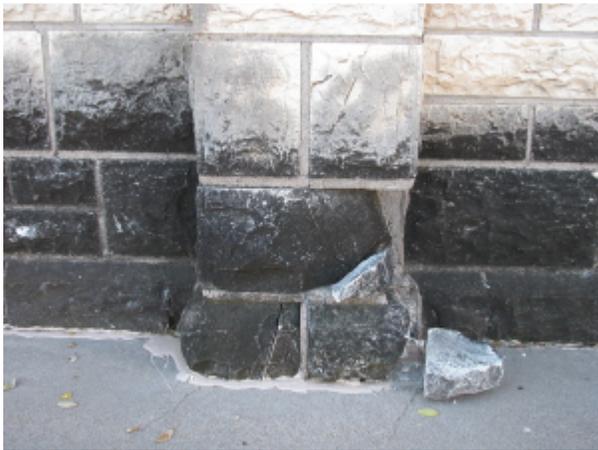
Figure 85. Heavy staining and spalling of stone, concentrated at grade near the concrete paving. Photo by WJE, 2009.

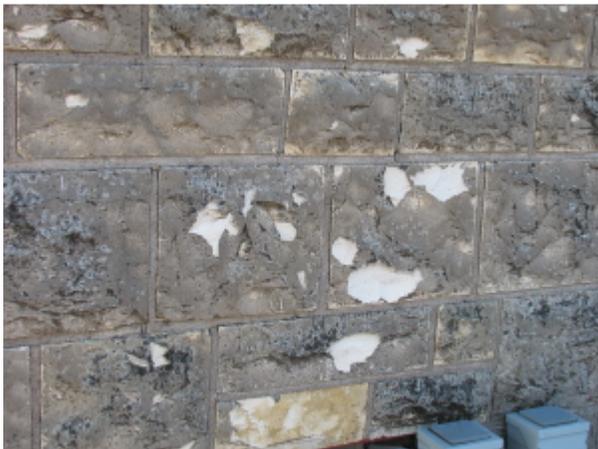
Figure 86. Spalled stone units at the north elevation due to impact damage. Photo by WJE, 2009.

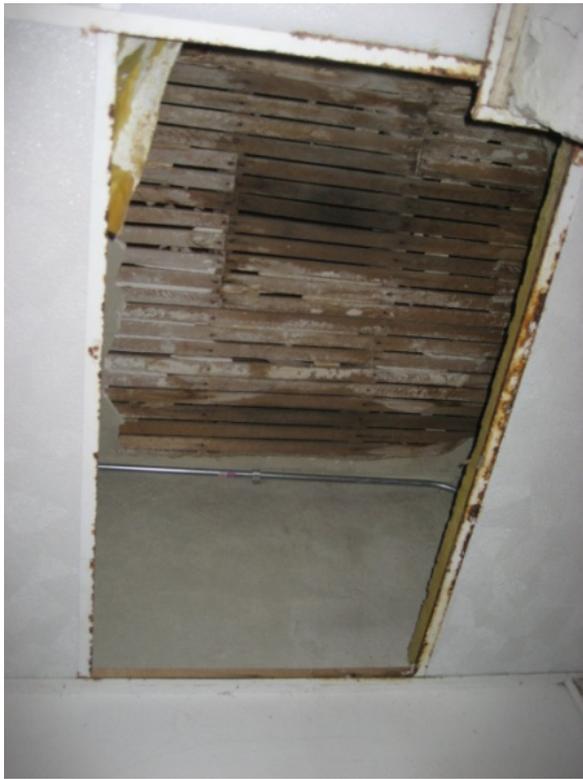
Figure 89. Location of missing ceiling tile, revealing removed plaster with lath remaining. Note corrosion on metal frame for ceiling tile. Photo by BVH, 2009.
