PROPERTY NAME: Hoyt-Barnum House

District/Property Name Hoyt-Barnum House
Address (For individual nomination) 713 Bedford Street
(Proposed relocation to 1508 High Ridge Road)

HOYT BARNUM HOUSE RELOCATION

713 BEDFORD STREET,
STAMFORD, CONNECTICUT
TO
1508 HIGH RIDGE ROAD,
STAMFORD, CONNECTICUT

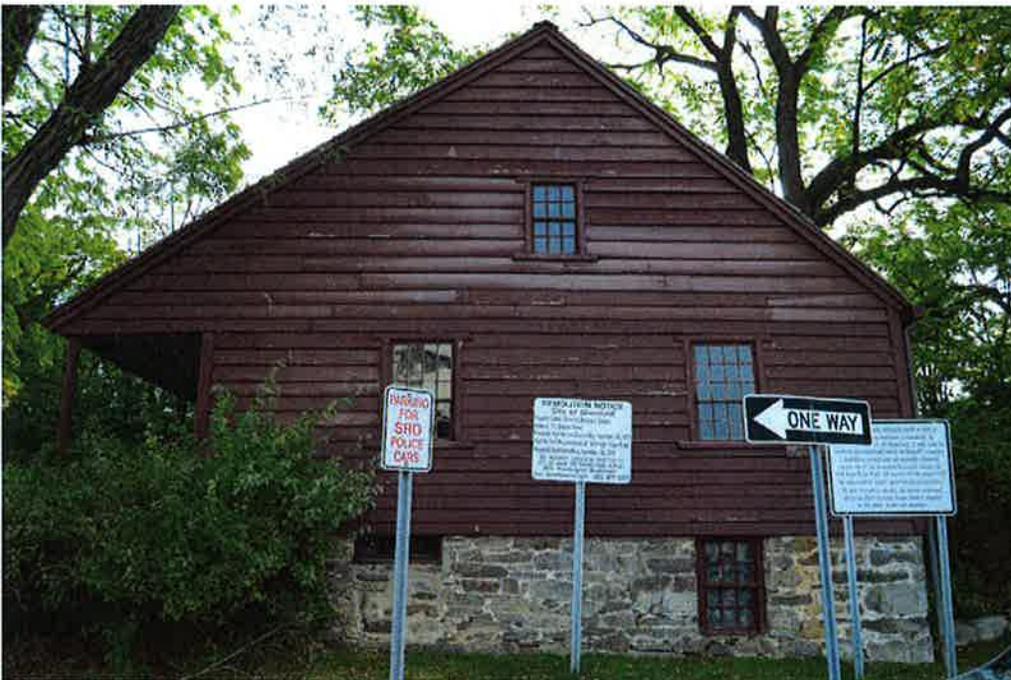
Photo 5. South and west elevations with original cellar access door at the west side of the south elevation within the at-grade fieldstone foundation, looking northeast from the Bedford Street sidewalk.

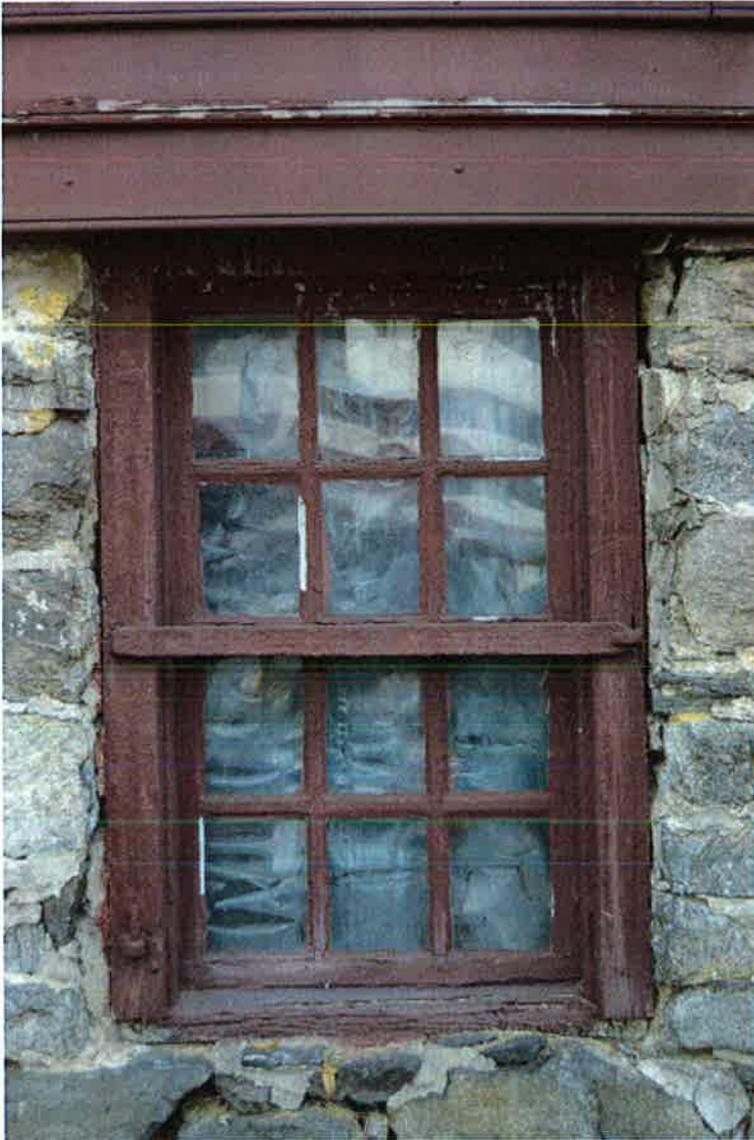
Photo 6. West elevation of the Hoyt-Barnum House, looking east from the Bedford Street sidewalk. The ghost marks for the former full-size window at the north side of the foundation are visible.

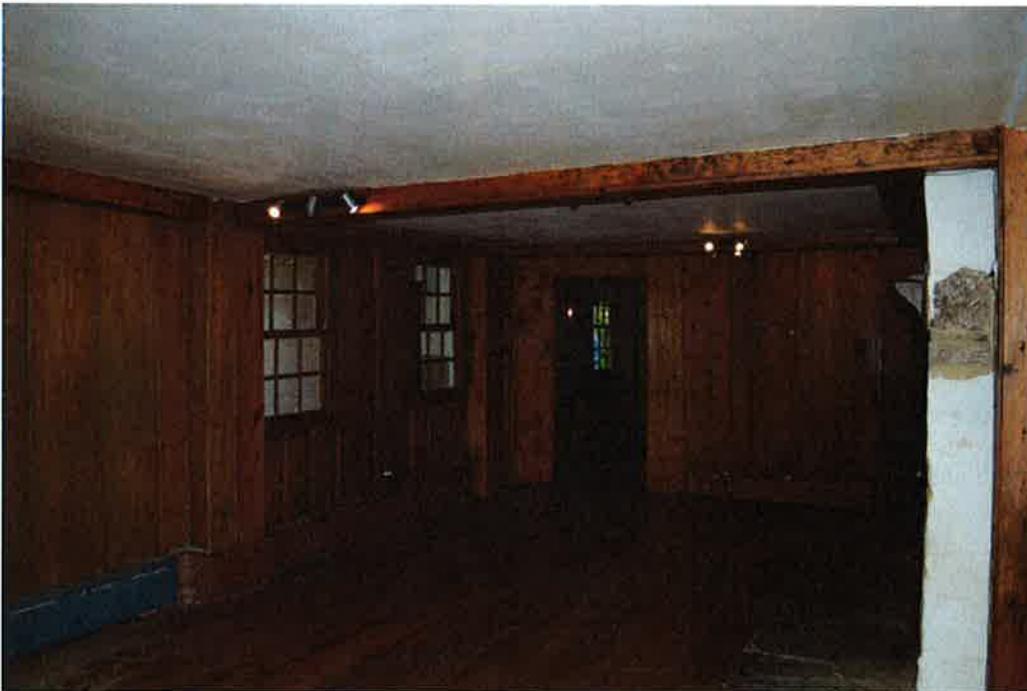
Photo 18. Keeping Room looking southwest towards the West Room. The fireplace with bread oven has an original hearthstone. The Keeping Room paneling is historic; the floorboards are replacement.

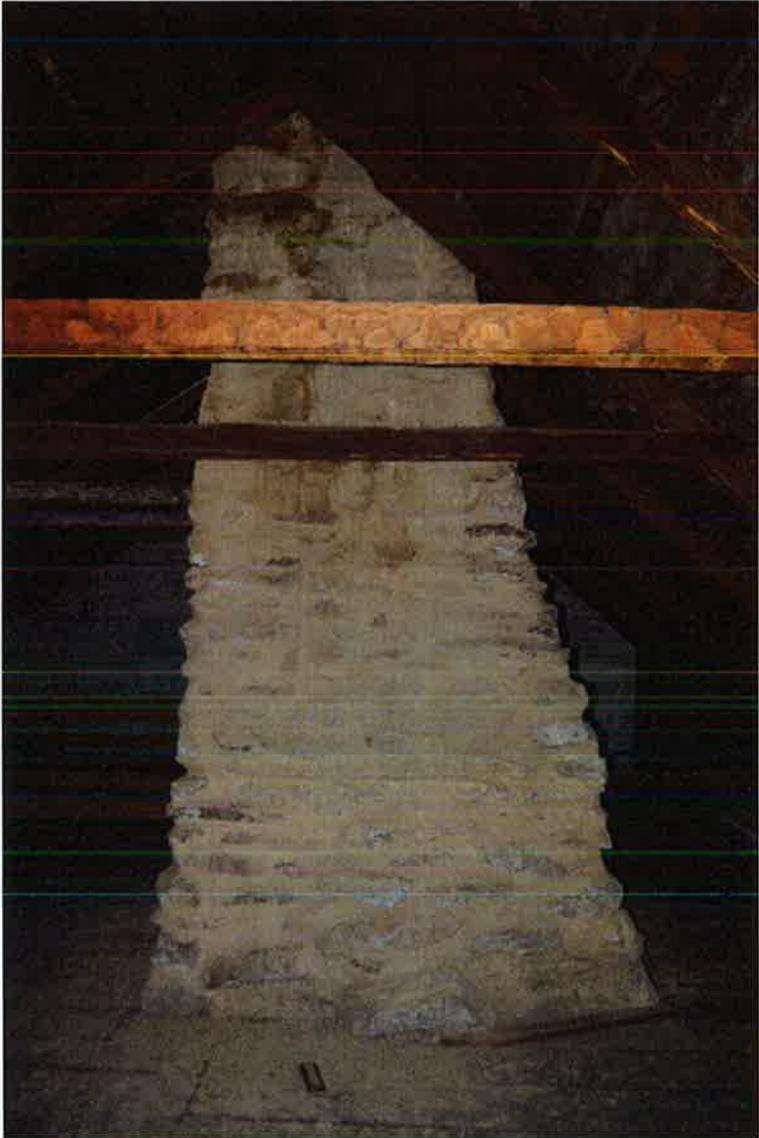
Photo 24. Attic looking southwest towards the west attic wall. Ghost marks of a nineteenth-century window are visible north of window, and the two collar beams to the west of the chimney are replacements.

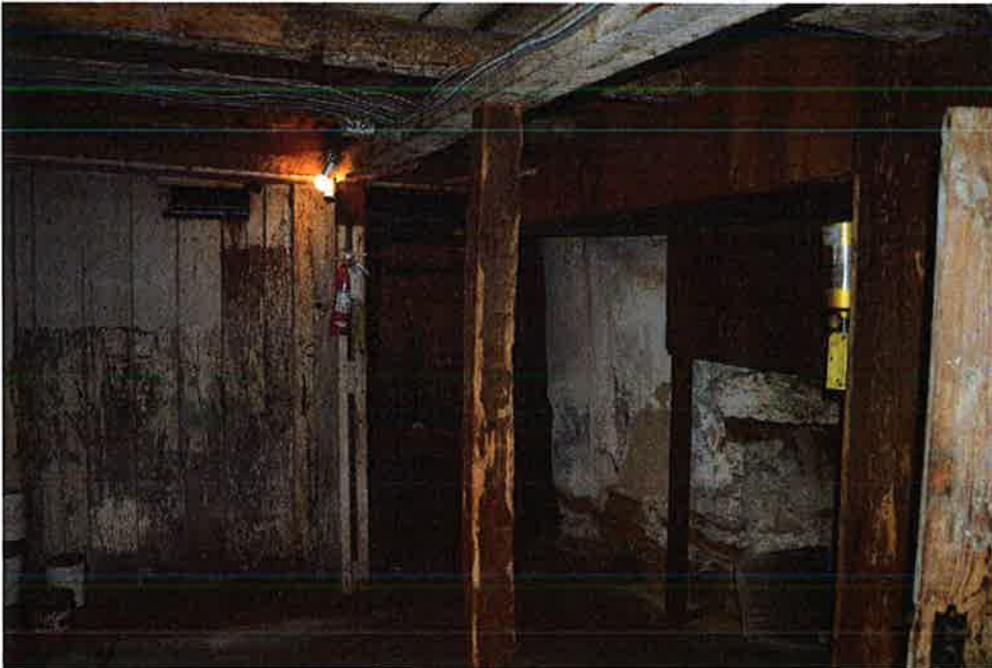
Photo 27. Cellar looking northwest, showing the west and north fieldstone foundation walls, floor joists, square wood posts installed in late twentieth or twenty-first century, and the five-light transom, where a full-size window at the north side of the foundation was once located.

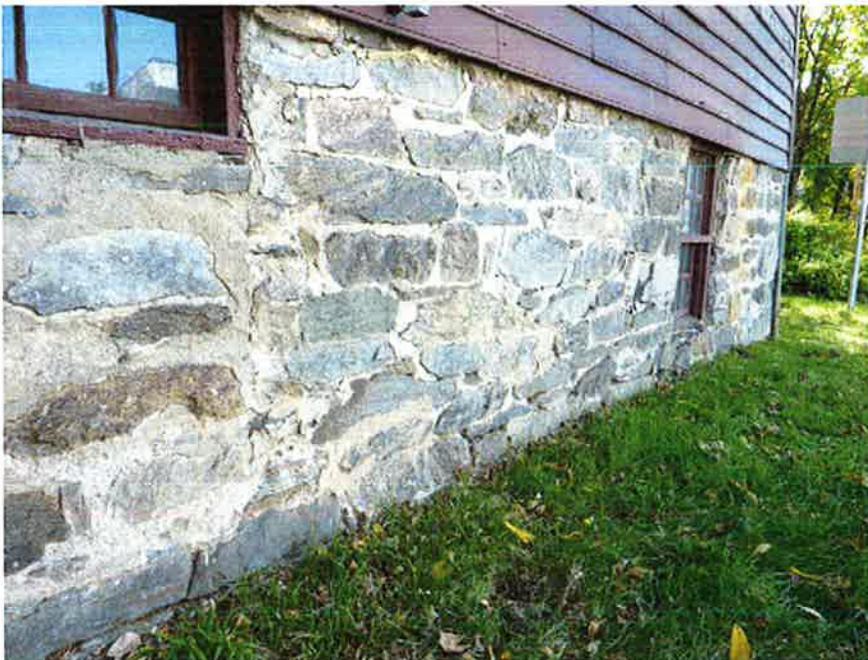
Photo 3 - Cement rich pointing mortar at Southeast corner of North elevation at removed porch

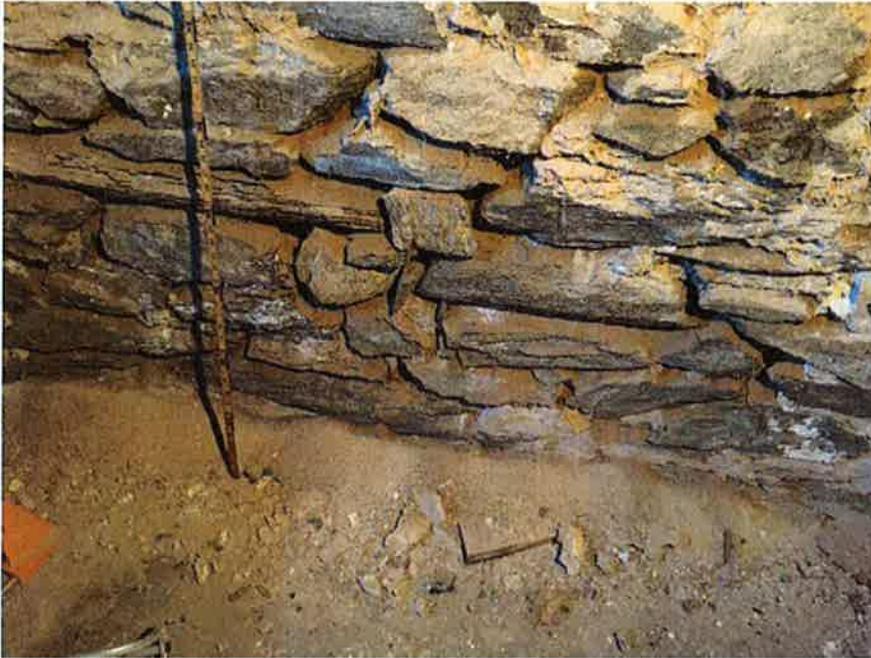
Photo 3a – West foundation. Infilled original window, variety of mortars and pointing techniques

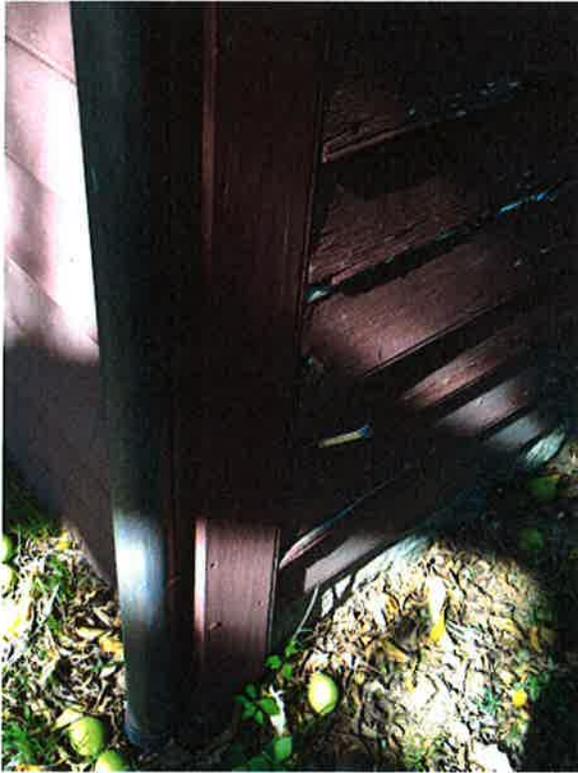
Photo 9b - Siding curling away from East attic window

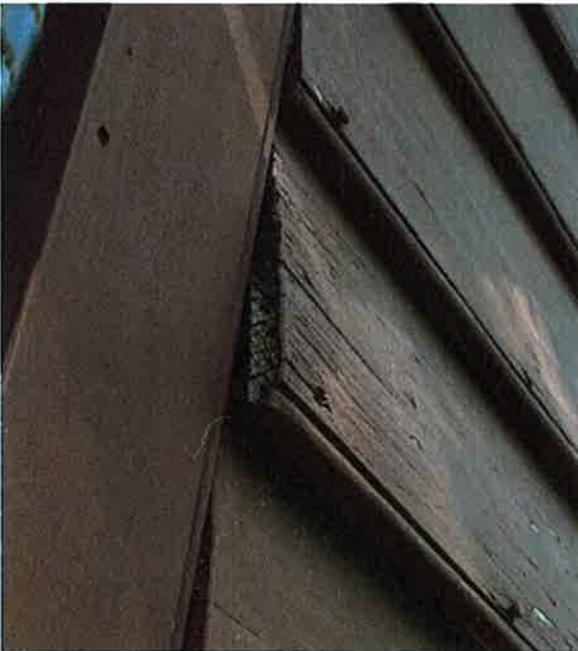
Photo 10 - Probing indicates localized decay; easy knife penetration to 3" depth, SE corner

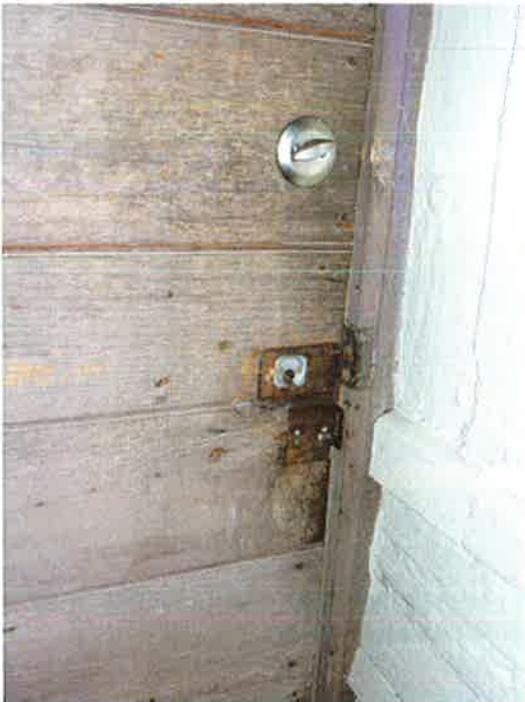
Photo 15c - Kitchen exterior entrance latch, a later interpretive product.

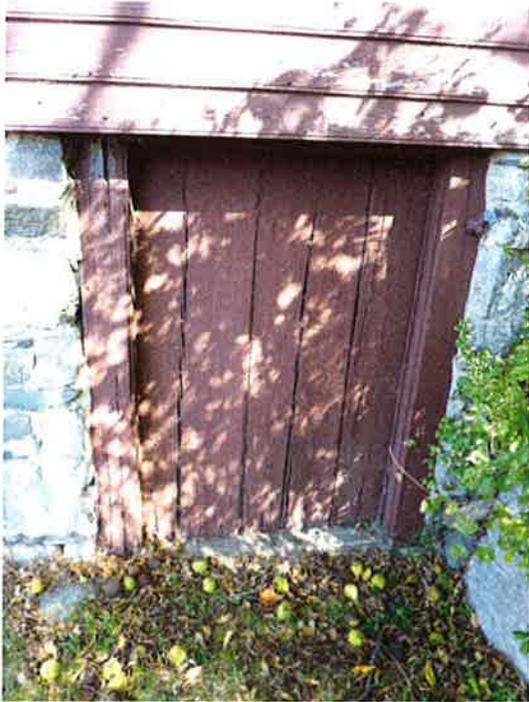
Photo 15d - No surviving interior latch; rim lock replaced by deadbolt

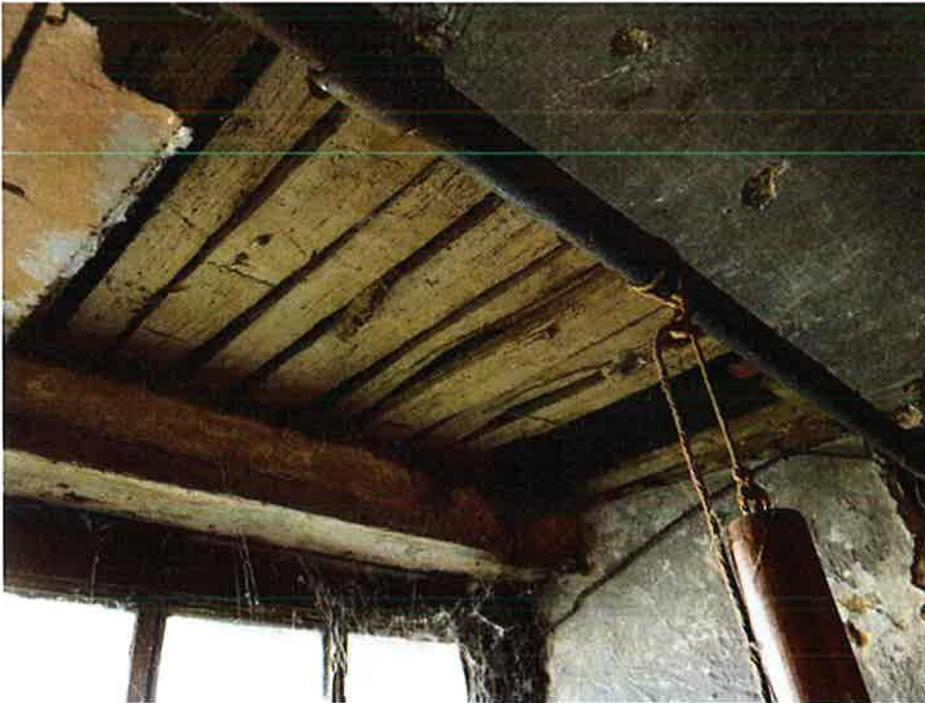
Photo 31 - Chimney cant through attic. Note mortar-wash stain at upper extent.
