Submerged Cultural Resources Site Report

NOQUEBAY

APOSTLE ISLANDS NATIONAL LAKESHORE

**SUBMERGED CULTURAL RESOURCES SITE REPORT:
NOQUEBAY**

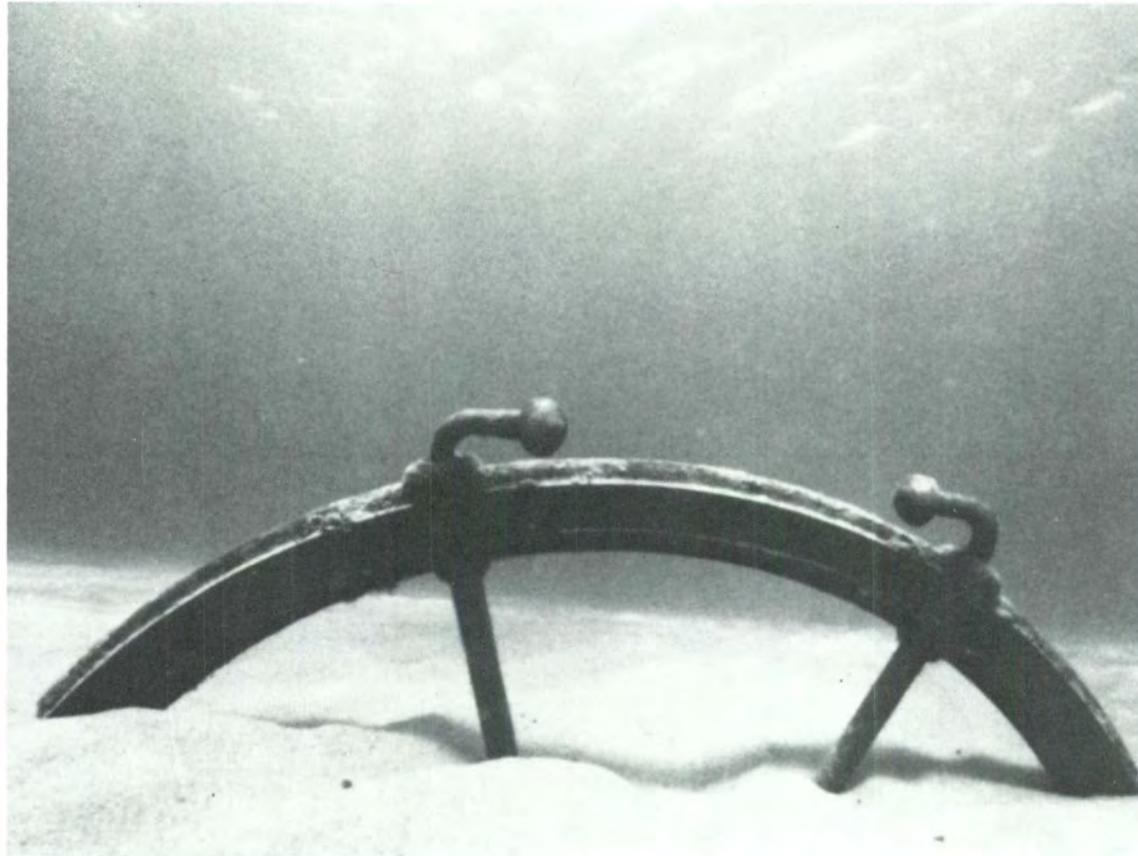
The wheel is in remarkably good condition, the only obvious attrition being the deterioration of the wood on the handgrip spokes, bending of the three exposed outside handgrip spokes or handgrips and a crack in the rim. The diameter of

Plate 6: NOQUEBAY's wheel, partially exposed in the deep sand, was located during a submerged cultural resources training course. The manufacturer's name, Coffin and Woodward, are embossed on the wheel's rim. Photo Joe Strykowski.

Following the mapping, photo, and video documentation of this feature, it was reburied. This was done to protect the wheel from winter storms, ice action, and possible vandalism.

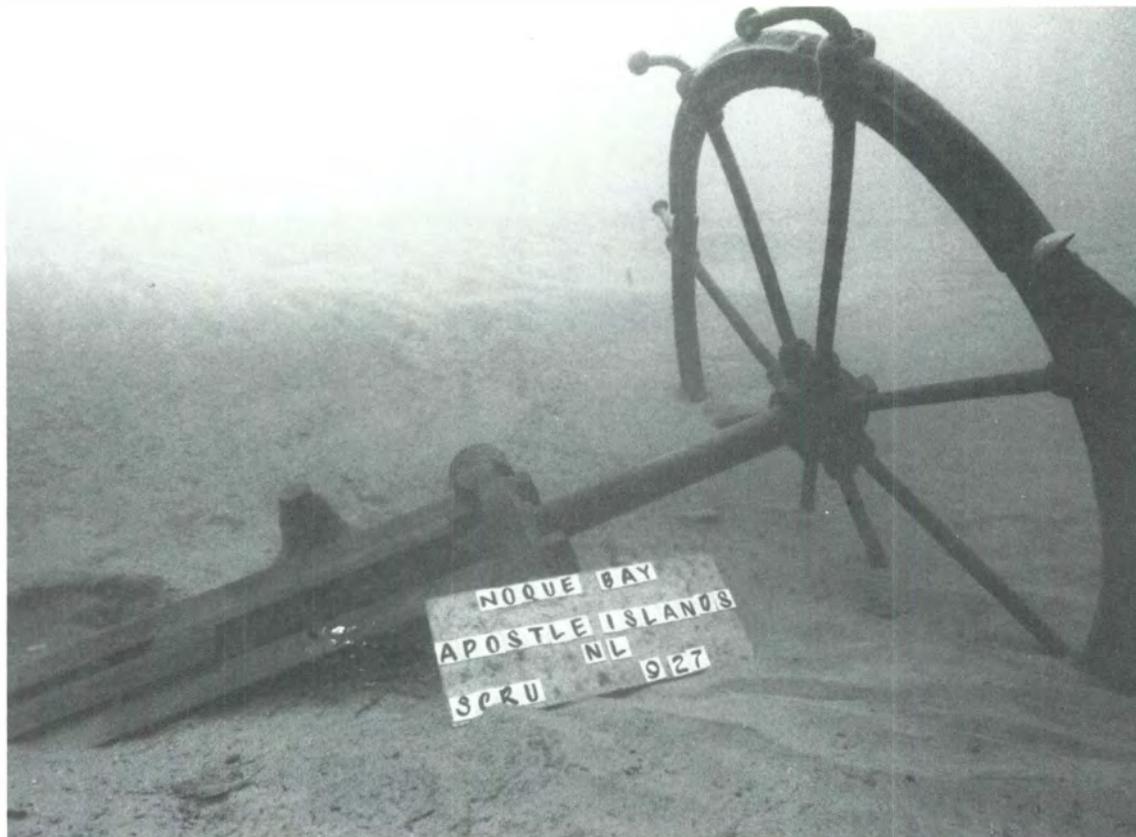
Plate 7: After excavation, the entire wheel and steering assembly were exposed. The mechanical, or "patent steering gear," came into use in the latter half of the 1800s. The wheel and worm gear are in an excellent state of preservation.

The mechanical steering gear and spindle (Figure 8), also called worm gear or screw gear, are made of steel or iron and are in an excellent state of preservation. The guide rods are in place as is the yoke and yoke bolt. The coupling rods are missing; however, the traverse nuts are in place. Only the cross head top plate was present. The spindle is 34-1/2 inches long, with 15 exposed right-left spindle threads at 1 per inch, and 8 exposed right-left spindle threads at 1 per 3 inches. The steering wheel spindle is 2-1/4 inches in diameter and it is 4 feet 4-1/2 inches long to the wheel. The overall length of the steering mechanism, including the wheel is 5 feet.

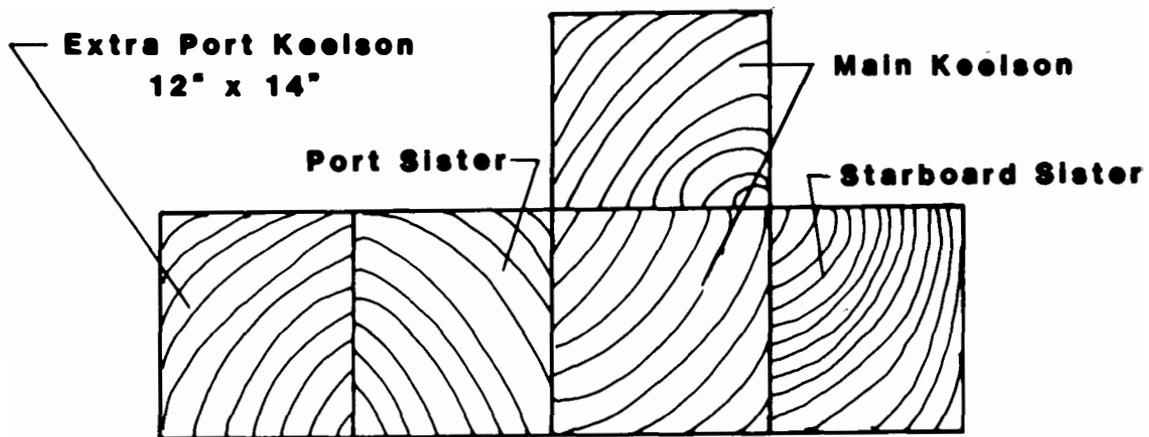
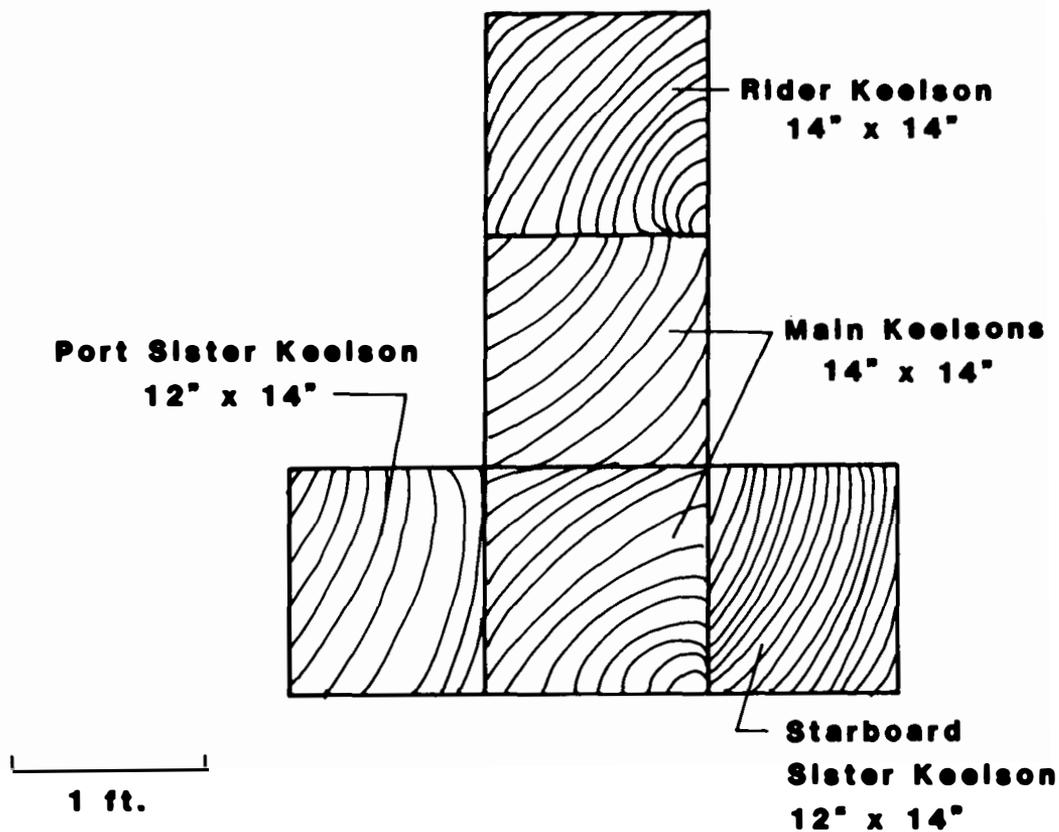
Figure 9: Centerline Keelsons Cross Section

The main keelson is composed of two stacked timbers, each 14 inches by 14 inches. The main keelson broke at a point of weakness, at the scarp in the stern. The scarp joint used on all of the keelsons is the same type, a hooked scarp. The scarps found on the vessel are a uniform 5 feet in length. This followed the ship building rule of the era which called for making the keelson scarps "equal to at least two frame intervals, that is double the room and space" (Desmond 1919:55).

The rider keelson, resting atop the main keelson timbers, is also 14 by 14 inches. A rider keelson is usually added to provide additional longitudinal strength. Its extant length on the vessel is 28 feet 6 inches. When the main keelson gave way, the rider apparently failed with it.

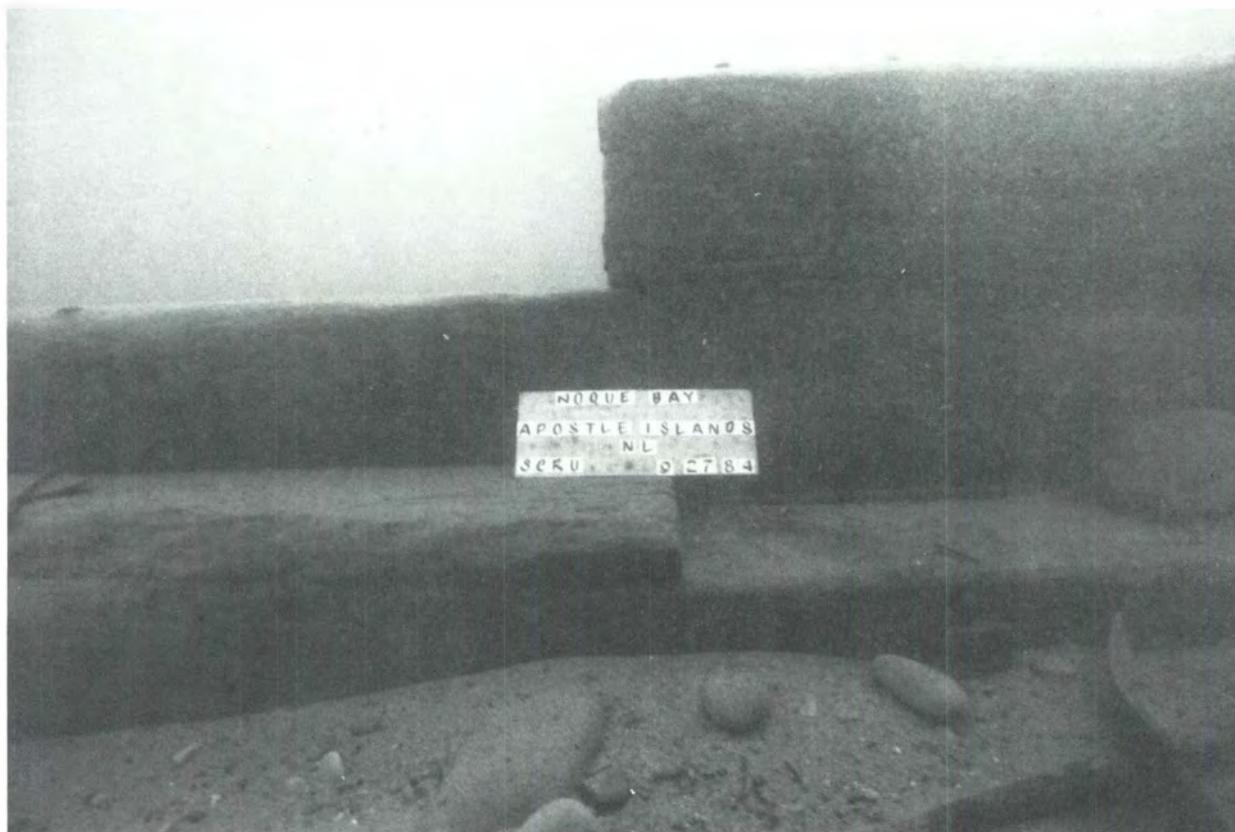
The rider keelson ends at base line point 100. It is not broken or removed, at this point it steps down to the main keelson (Plate 8).

Plate 8: The rider keelson, added to provide longitudinal strength, rests atop the main keelsons. It steps down to meet the main keelsons at base line point 100. A keelson cap and the port sister keelson are visible under the photo board. A small portion of truss rod with a protective plate is present in the lower right of the photo.

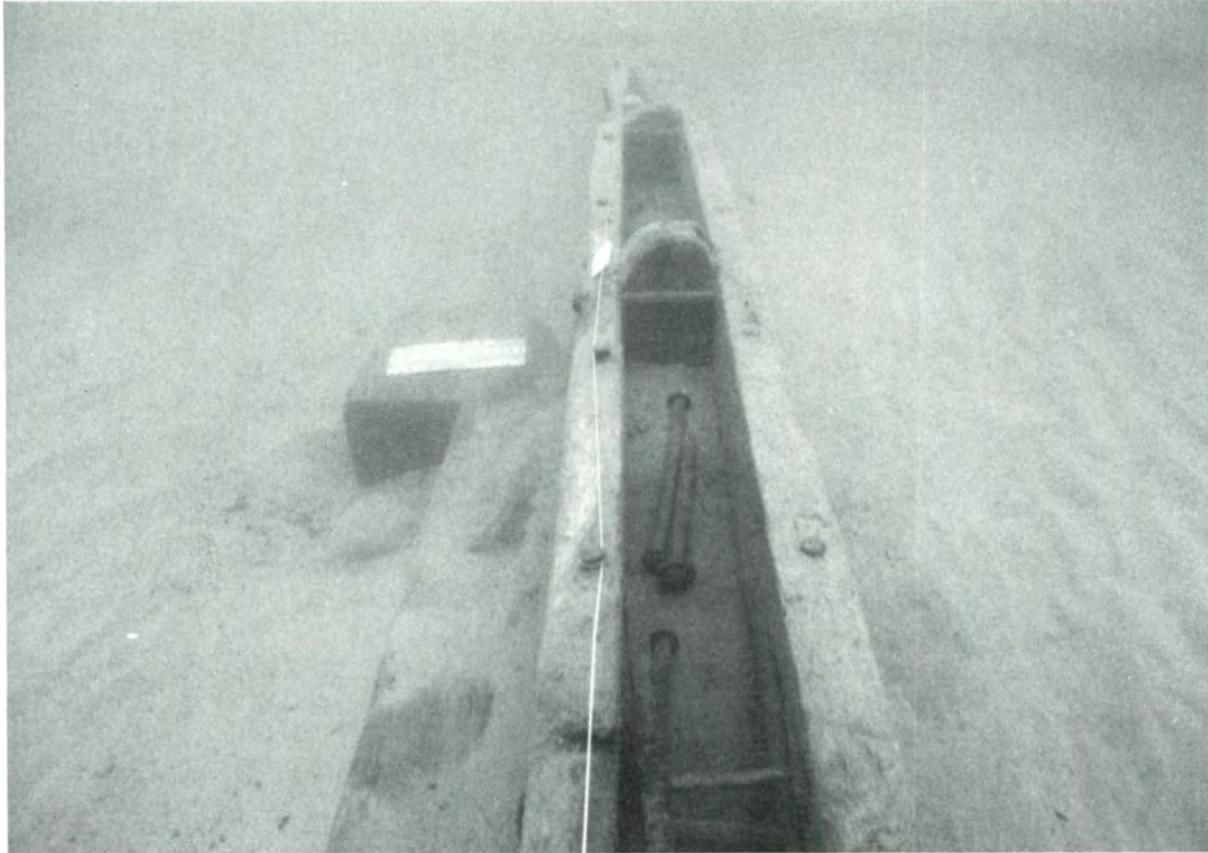
Plate 9: The centerline stanchion-post remnants at base line points 149 and 153, measured 6 by 6 inches. The extant longitudinals at this point were just over 11 feet in length. The additional port sister keelson, presumably in the area of the centerboard, appears on the left of the photo.

base line points 149 and 153. They measure 6 by 6 inches and stand approximately 1 foot high. The longitudinals and stanchions show evidence of rounding and rubbing, possibly from sand abrasion or from ice shelving. Three sections of longitudinals were identified in all; each had remains of stanchion-posts. Portions of four posts remain in place on the site. The spacing between two posts, which appear to be in their original locations, is 4 feet on center.

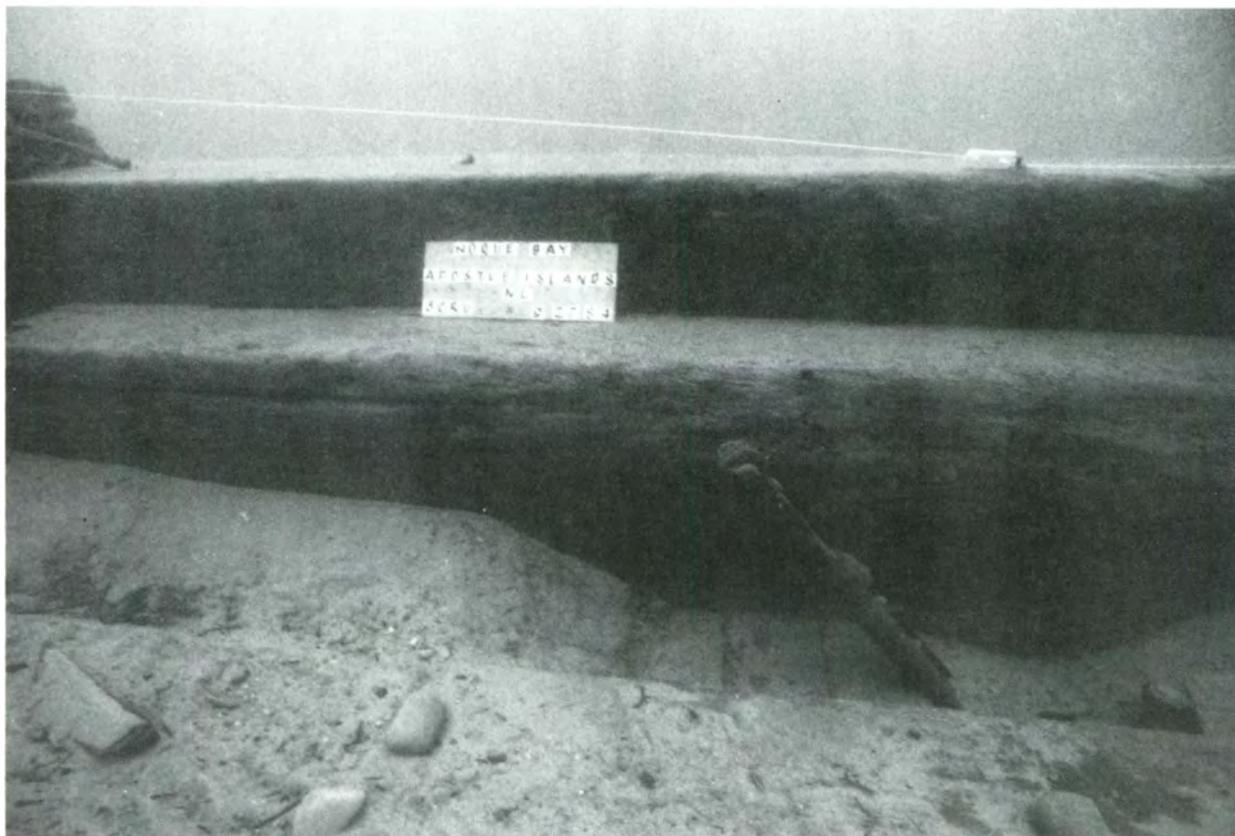
Plate 10: An anomalous feature located along the port side of the centerline keelson is this rod and shackle. This feature may have been used in conjunction with the centerboard. One of the two exposed sets of triple frames can be seen immediately in front of the rod.

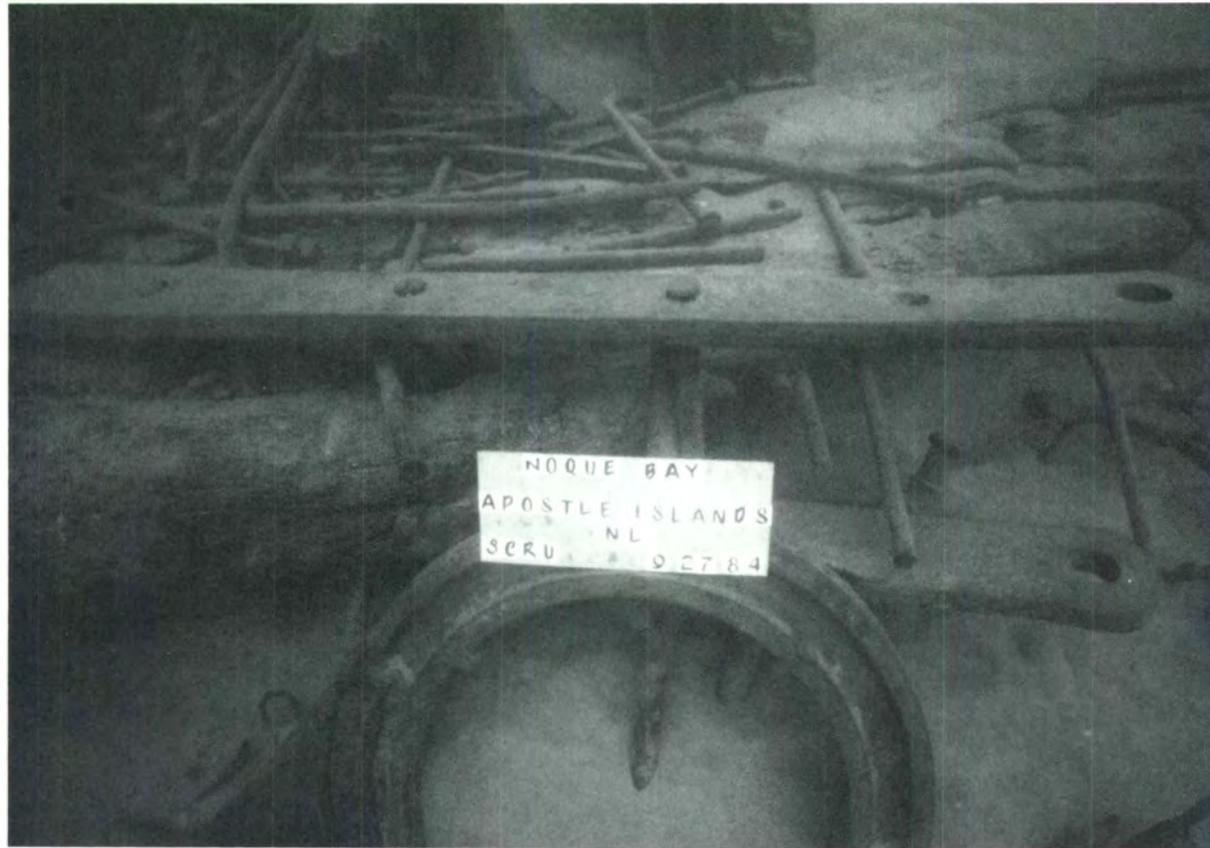
Plate 12: The bow deadwood, constructed of 4 stacked timbers each 16 by 14 inches, has two flat straps which straddle the timbers. These straps would have articulated with the truss rods as part of the vessel's hogging system. The driving wheel from the windlass is leaning up against the deadwood strap.

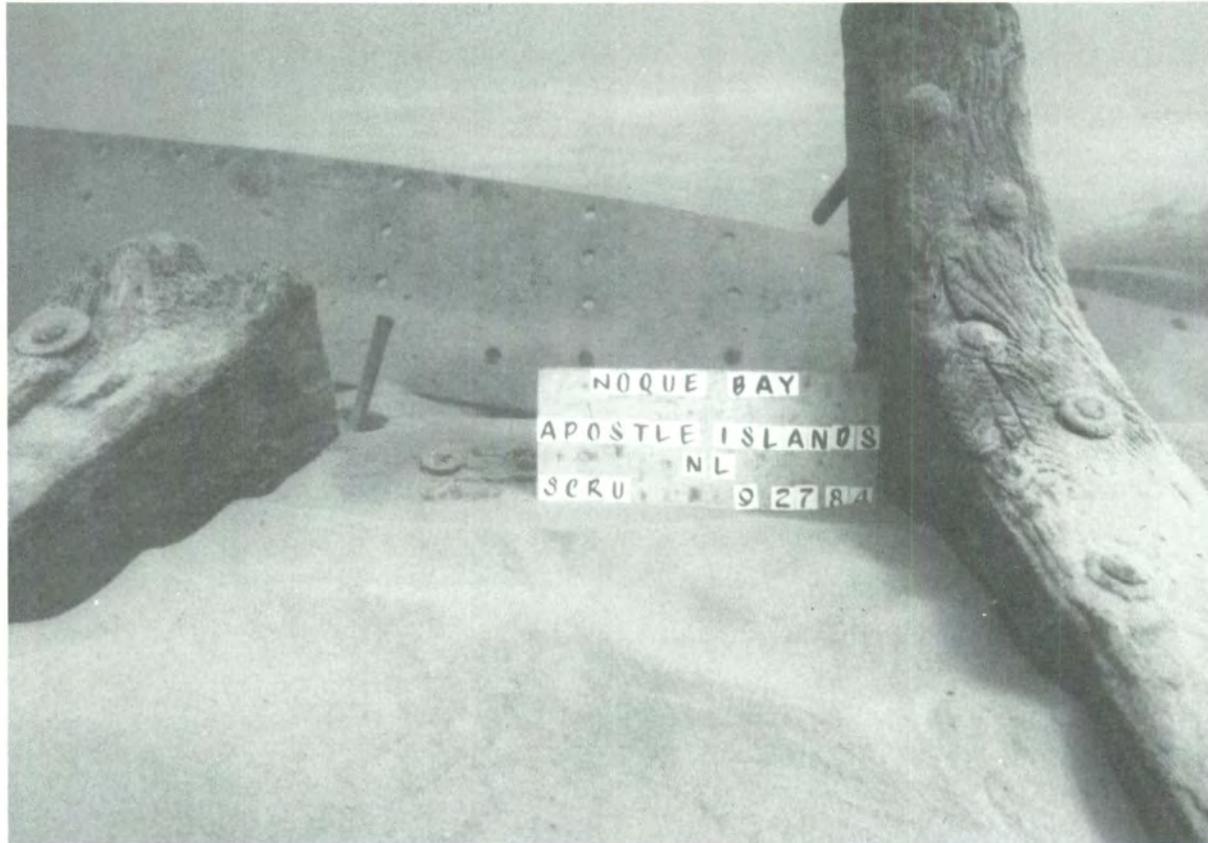
Plate 13: The hogging strap was directly tied into the deck beams and knees at the level of the main deck. Natural knees were used throughout the vessel. Fasteners through the knees are 7/8 nails with clench washers.

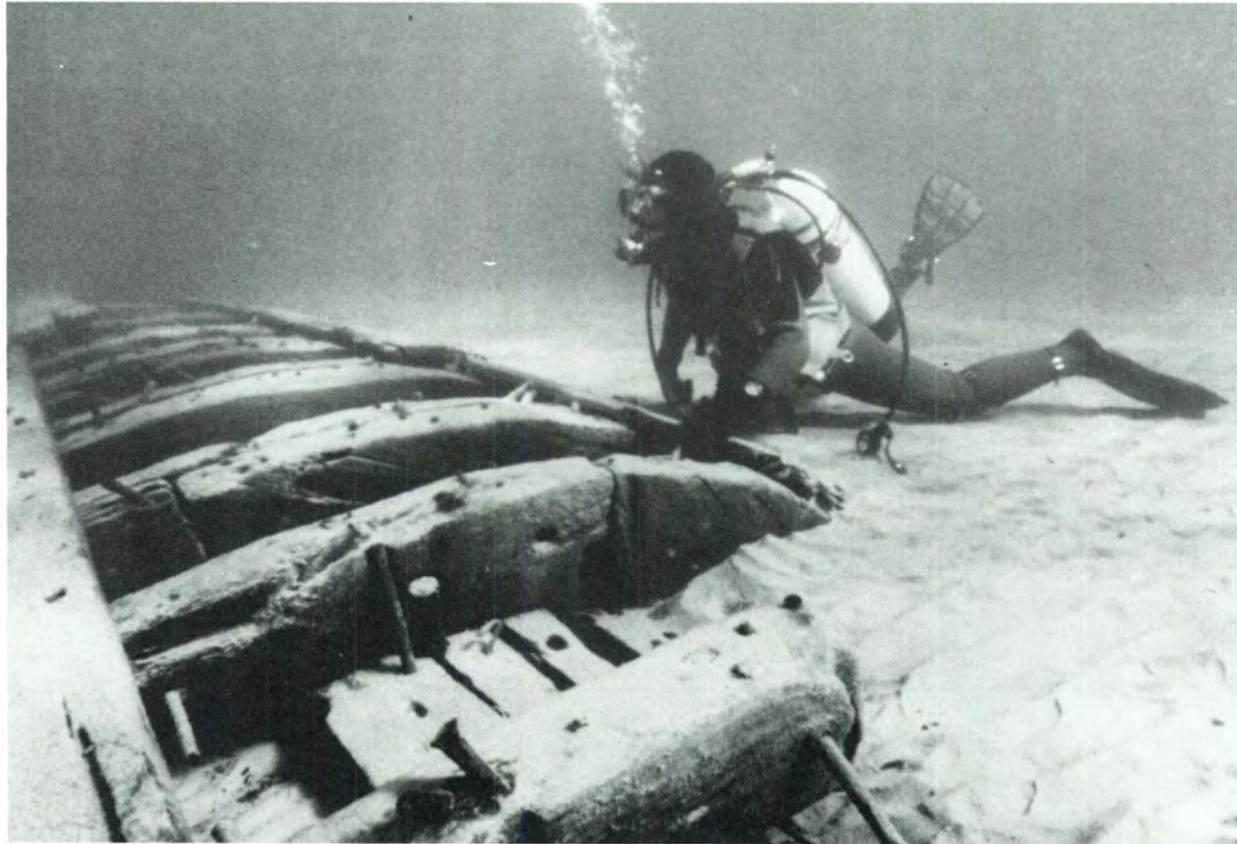
Plate 14: Park Ranger Elen Maurer examines a large section of outboard up port side which broke above the turn of the bilge. Fasteners, frames, hull and ceiling planking are exposed. Photo by Joe Strykowski.

The combined length of the port side sections, which are exposed on the site, is 84 feet 4 inches. This represents just over 40% of the ship's port side. Deep sand and limited time on site prevented additional testing on the port side of the vessel to determine whether there is additional port side present on the site.

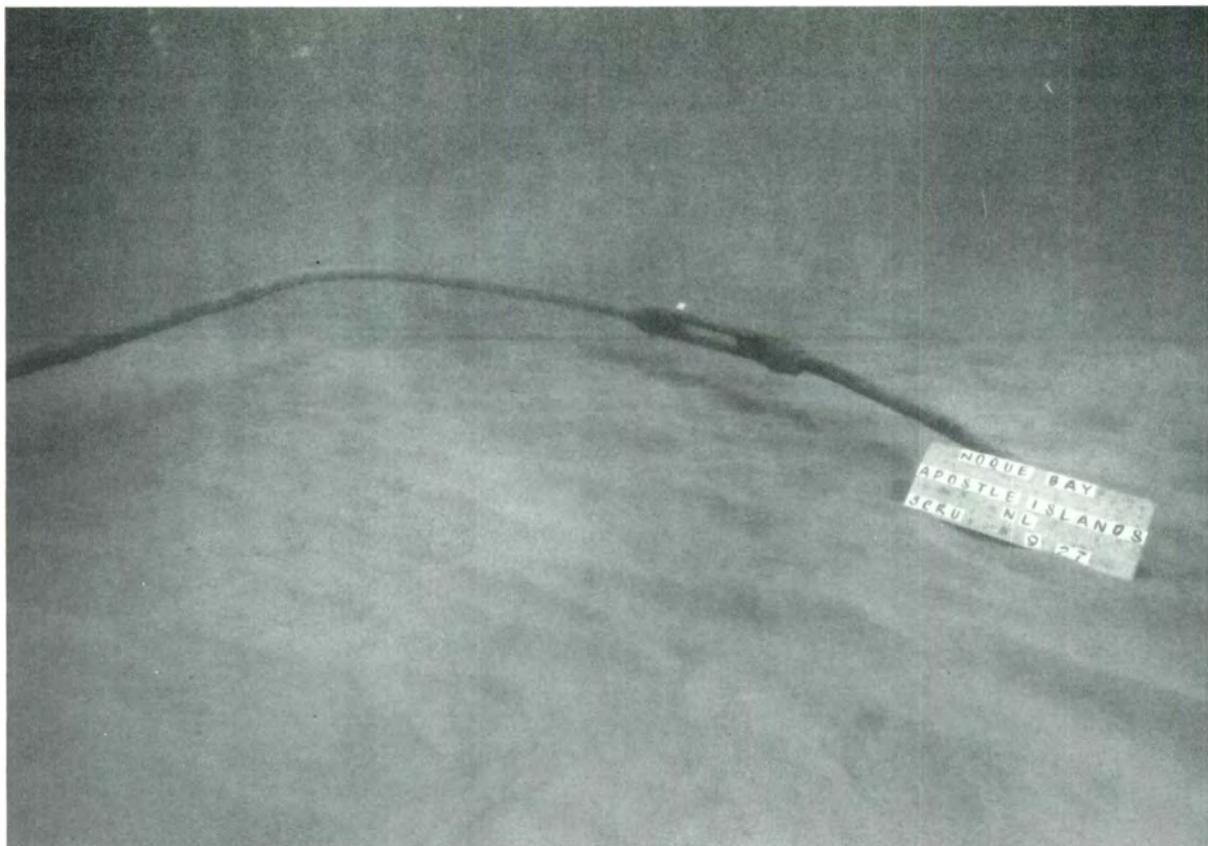
Another section of truss rod is located approximately 20 feet east (lakeward) of the 40-foot long piece of starboard hull (Plate 15). The exposed portion of the rod is approximately 26 feet long; the remainder is buried in the sand. This rod section has a turnbuckle, 24 inches long, articulated at one end. In total, there is approximately 80-feet of truss rod and 4 turnbuckles exposed on the starboard side of the vessel.

Plate 15: A long section of truss rod was located east of the main concentration of wreckage. The turnbuckle is 24 inches long and is one of 4 found on the starboard side of the vessel.

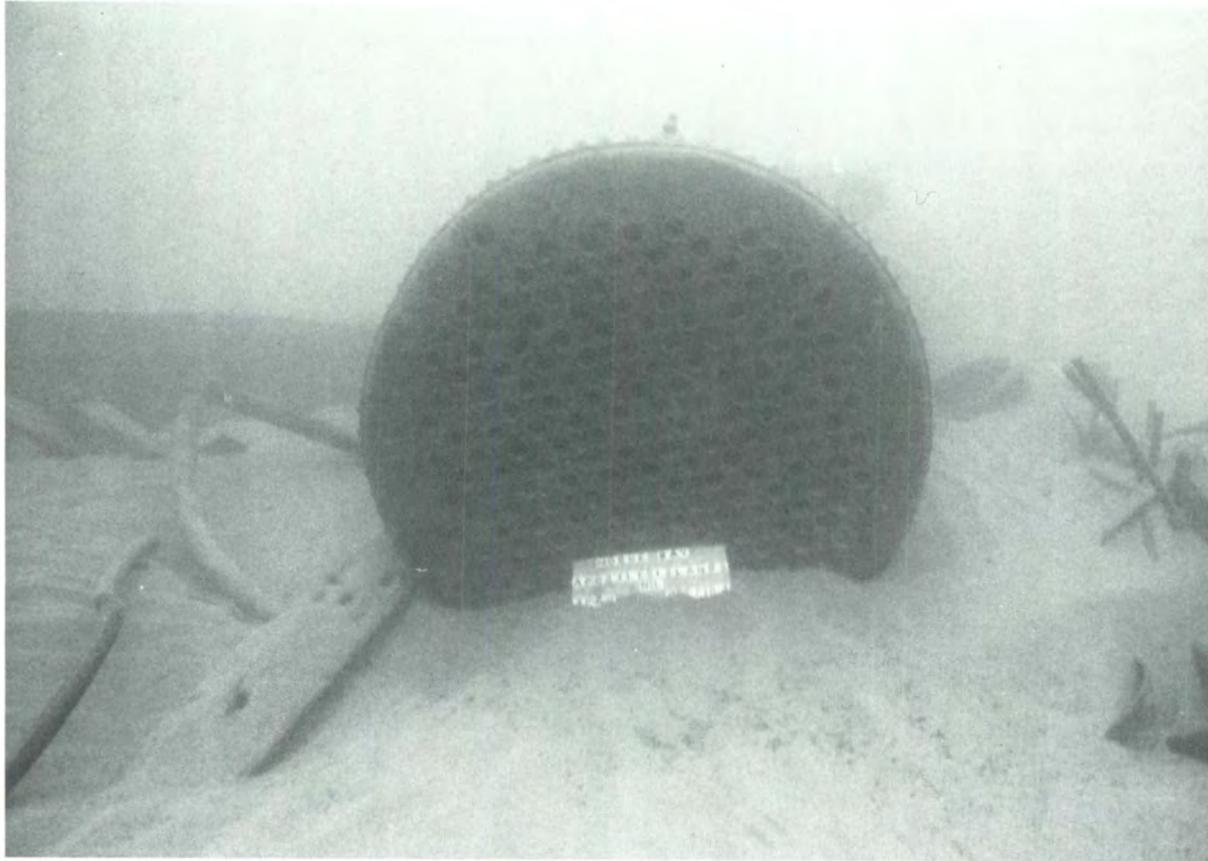
Plate 16: NOQUEBAY's donkey boiler, seen here lying on its side with the top of the boiler tubes exposed, is in an excellent state of preservation. Several pieces of coal, the boiler grates, piping and associated gauges were found in the immediate area.

Despite her exposed location and the potential for damage from ice shelving, NOQUEBAY's donkey boiler and wheel are in also in good condition. Ice damage to these fragile elements, seen elsewhere in Lake Superior on some of Isle Royale's wrecks, would have flattened or dented these items. With the exception of bent spokes and a crack in the rim, which could have easily occurred during the wrecking process or at any other time since her loss, NOQUEBAY's wheel is a fine example of a patent steering gear. The donkey boiler shows no signs of flattening or any distortion from its original shape.

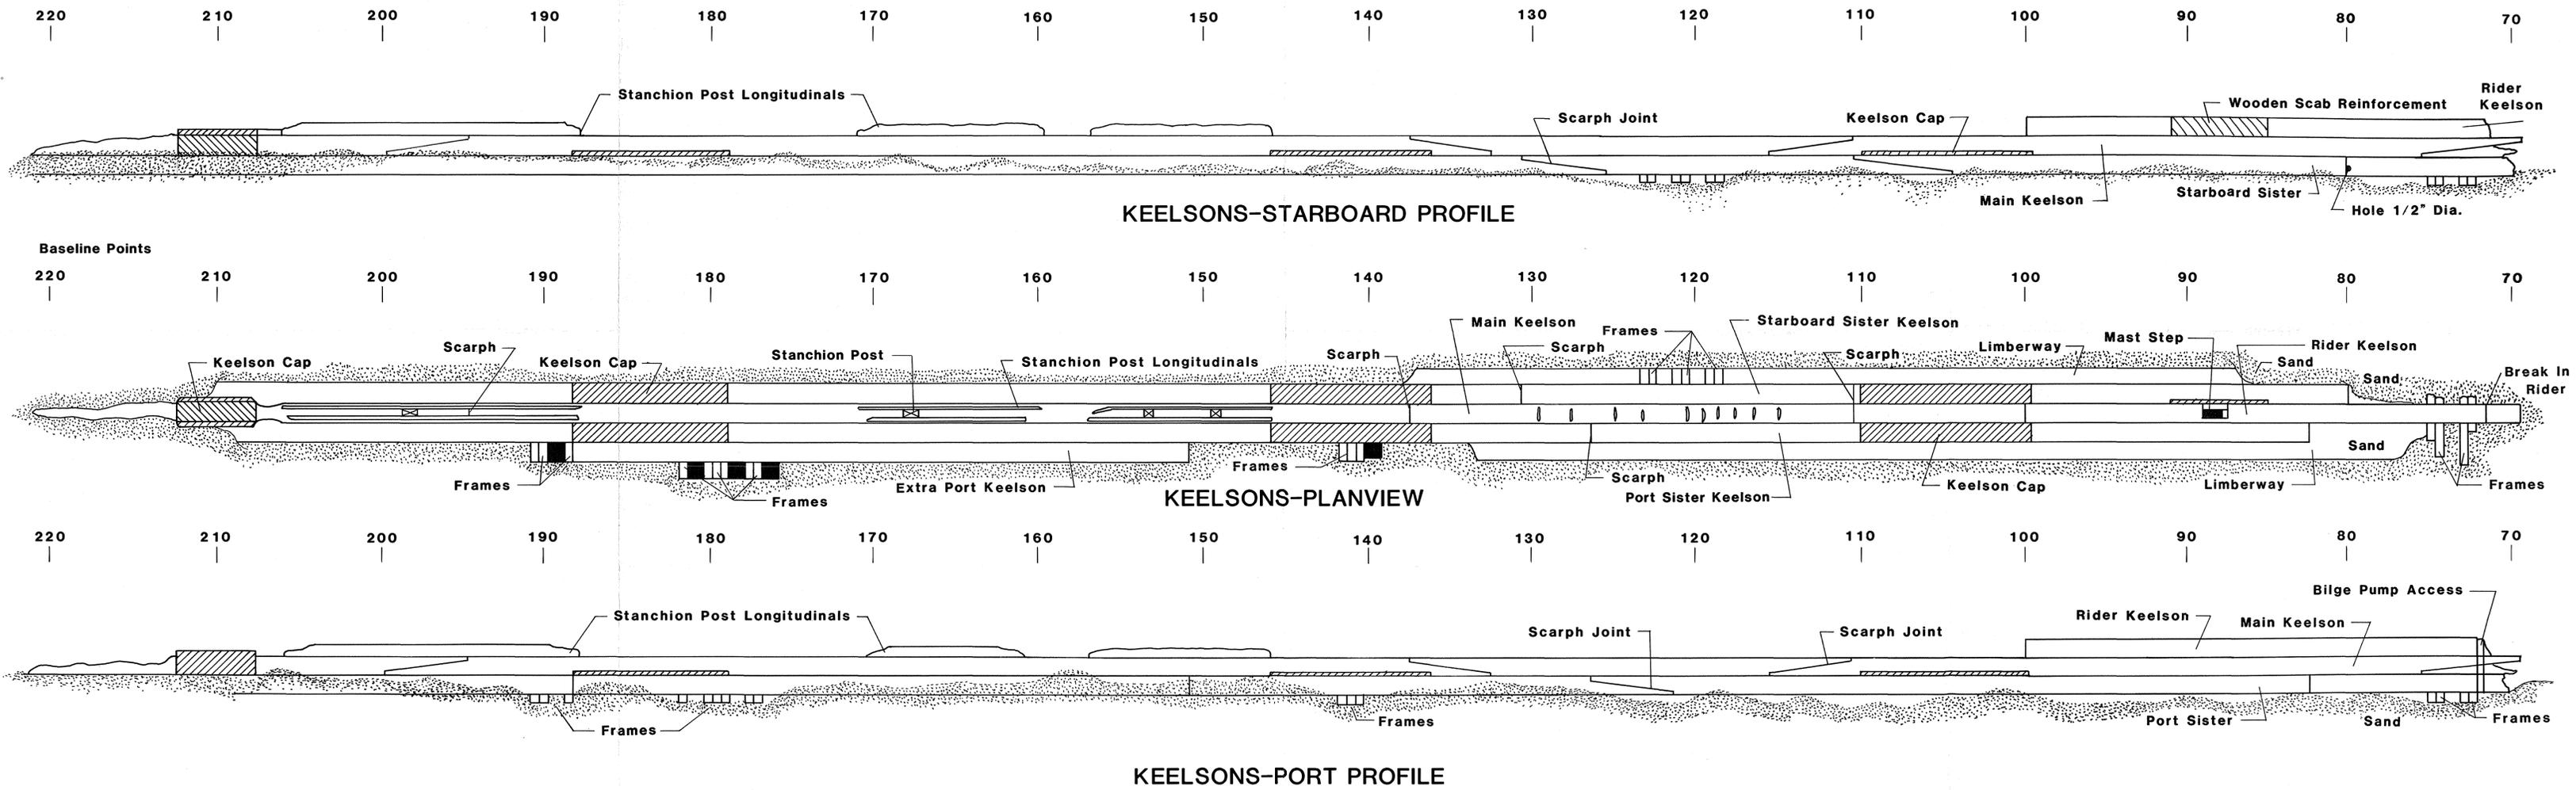
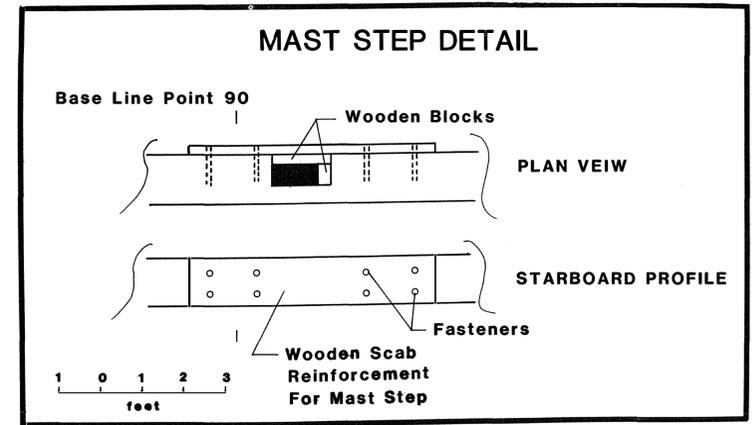
Figure 10: Centerline Keelson Plan and Profile Views

Several features were noted along the main and rider keelsons (see Figure 10 Centerline Keelson Plan located in the pocket inside the back cover of this report). Immediately forward of the main keelson break at base line point 72, a notch or groove 4 inches in diameter, round in cross-section, was found which passes vertically through the rider and main keelsons and extends to the limberway. The groove is clearly visible on the port side of the keelsons. It is most likely a bilge pump access. No remains of the bilge pump were located.

Between base line point 110 and 130 several deep grooves across the top of the main keelson were found. These grooves match exactly the size of the nails used for the centerline hold stanchion-post longitudinals. These elements are also referred to as stringers in some contemporary literature (Buffalo Morning Express, September 1882). At this point on the keelson there are no remains of the centerline hold stanchions or the longitudinal strength members. It is not until base line point 146 that remains of these longitudinals are found (Plate 9). The longitudinals are 3 inches wide and 9 inches deep; the extant section at this point measures 11 feet 3 inches. Two stanchion-post remnants are located at

The last several feet of the main keelson, toward the bow, show clear evidence of burning. The charred timber is intact with numerous nails sticking up which once held the top and bottom main keelson timbers together.
