# Submerged Cultural Resources Study

USS ARIZONA MEMORIAL  
and

PEARL HARBOR NATIONAL HISTORIC LANDMARK

Southwest Cultural Resources Center Professional Papers  
No. 23

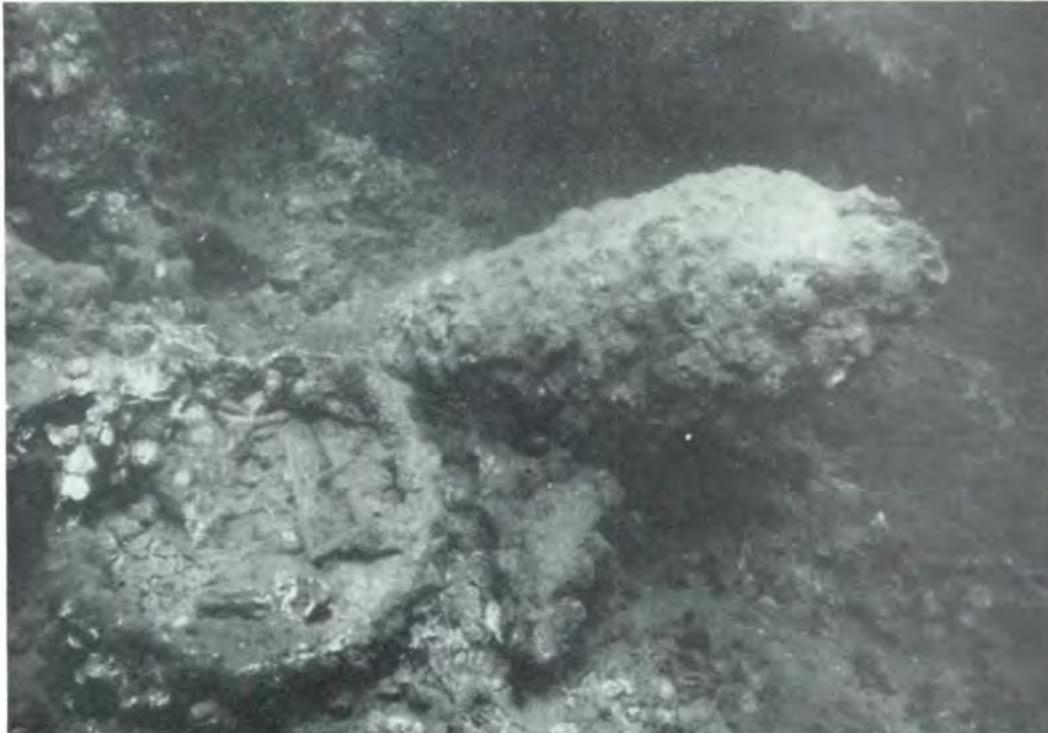
*Figure 3.13. Air cylinder protrudes from debris on deck of USS ARIZONA. US Navy EOD divers were called in to rupture the bottle in case it was still under pressure. (NPS photo by Larry Murphy)*

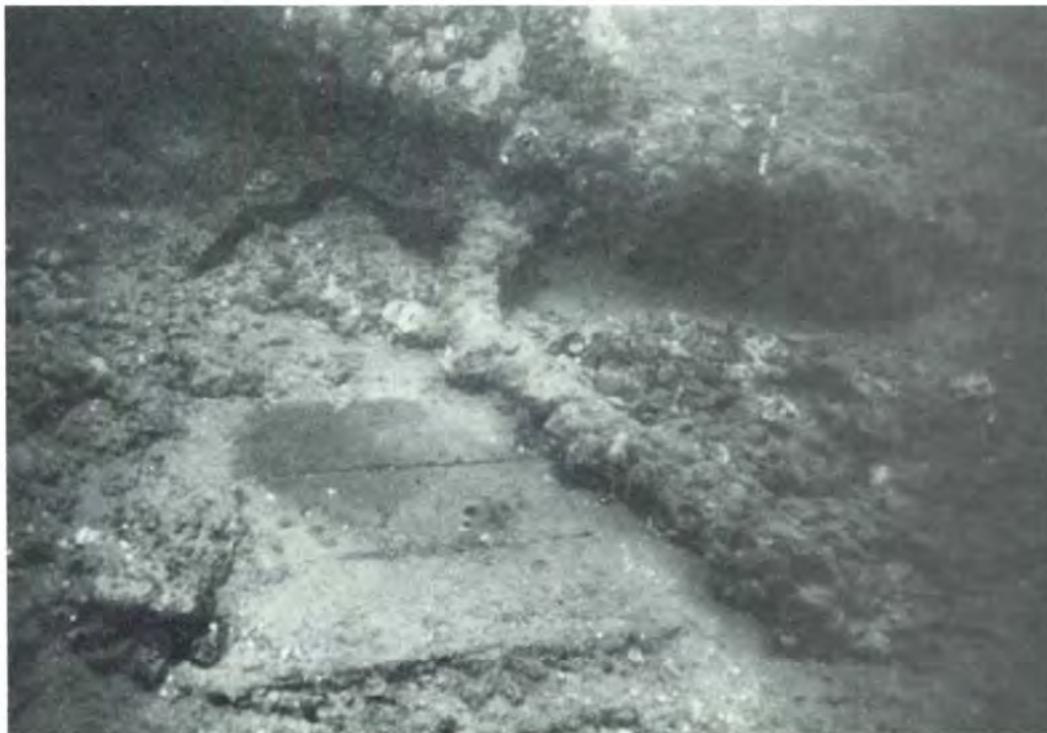
*Figure 3.14. Intact teak decking is exposed on USS ARIZONA. (NPS photo by Larry Murphy)*

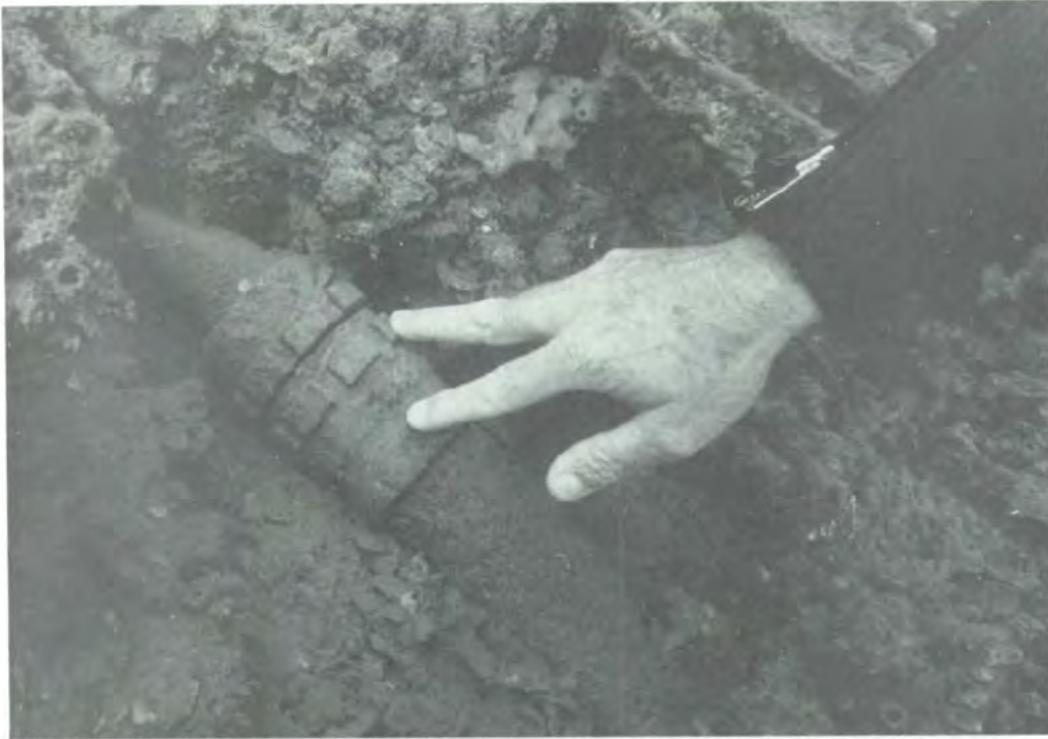
*Figure 3.17. Coupling of fire hose on deck of ship protrudes through the sediment. (NPS photo by Larry Murphy)*

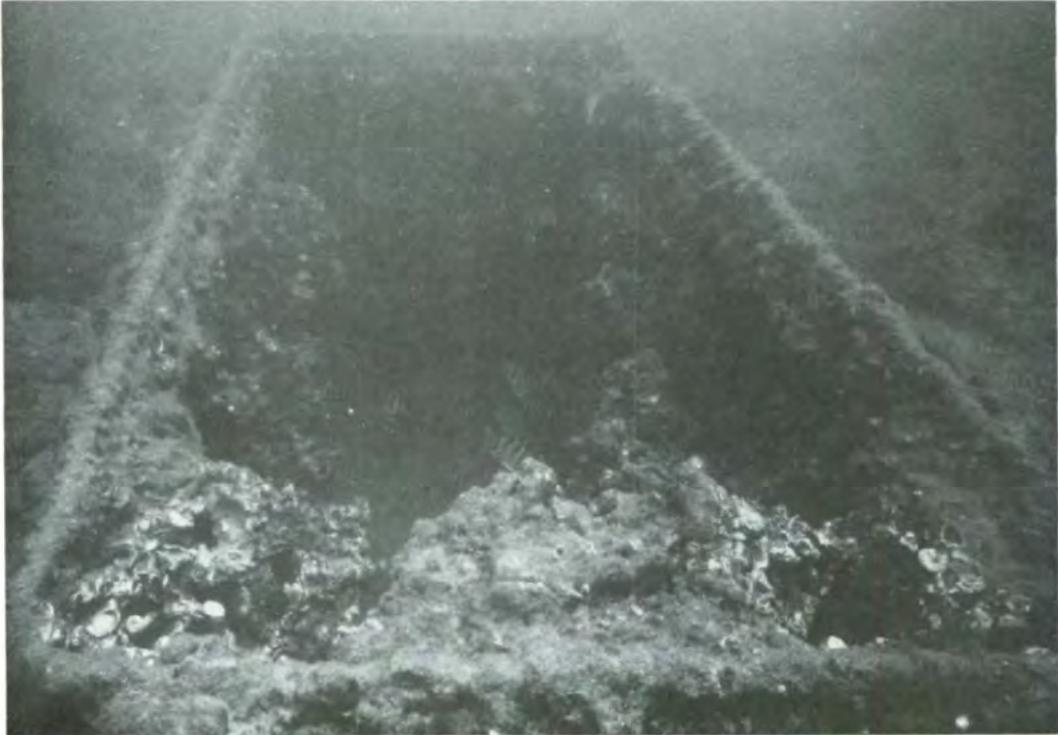
*Figure 3.19. Open hatch on USS ARIZONA with stairwell heavily fouled with marine organisms. (NPS photo by Larry Murphy)*

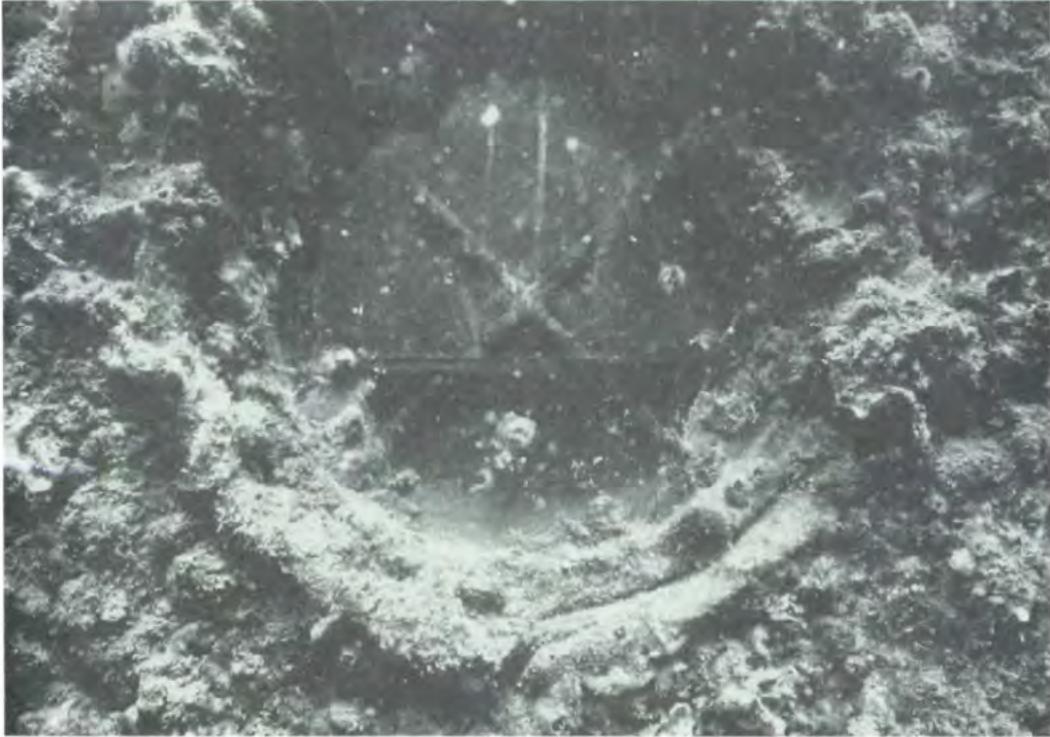
*Figure 3.21. Air is trapped between porthole blackout cover and glass on USS ARIZONA. (NPS photo by Larry Murphy)*

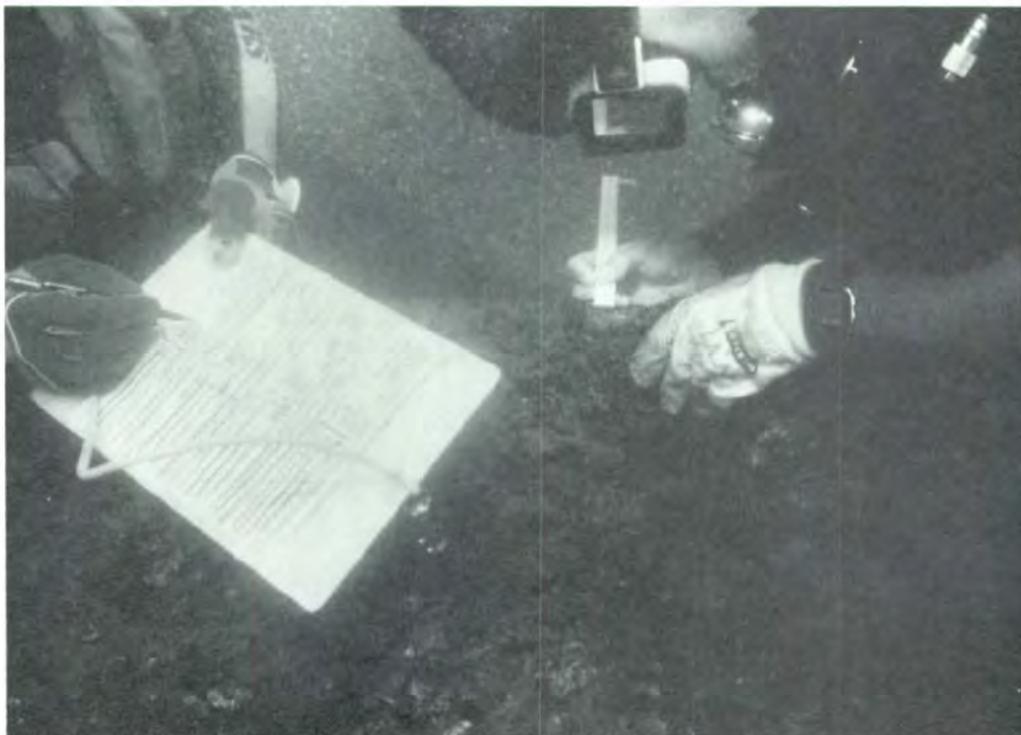
*Figure 4.5. Thickness of corrosion and biofouling was measured at selected sampling stations on USS ARIZONA. (NPS photo by Larry Murphy)*

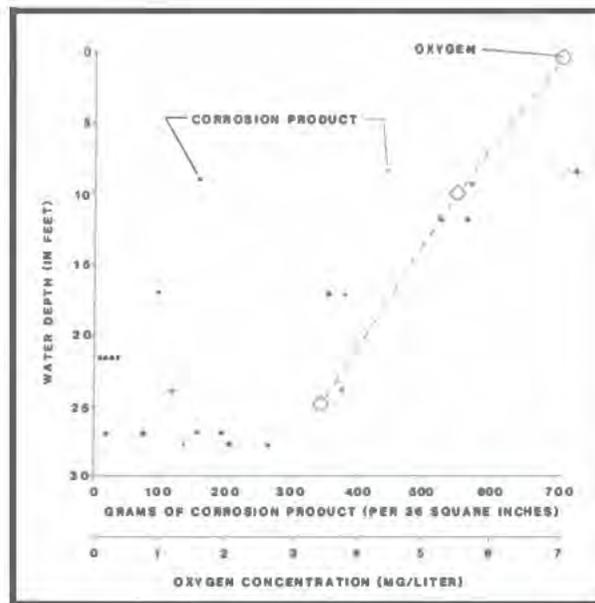
Figure 4.6. Plot of water depth versus grams of corrosion product removed from 36-inch square areas of steel surface at vertical photostations on the USS ARIZONA. For comparative purposes, typical oxygen concentrations that occur at surface and two midwater depths (R.S. Henderson, unpublished Pearl Harbor survey data, 1978-1986) are provided.
