ITS
NUMBER 9

Interpreting
The Secretary of the Interior's Standards for Rehabilitation

Subject: Inappropriate Porch Alterations

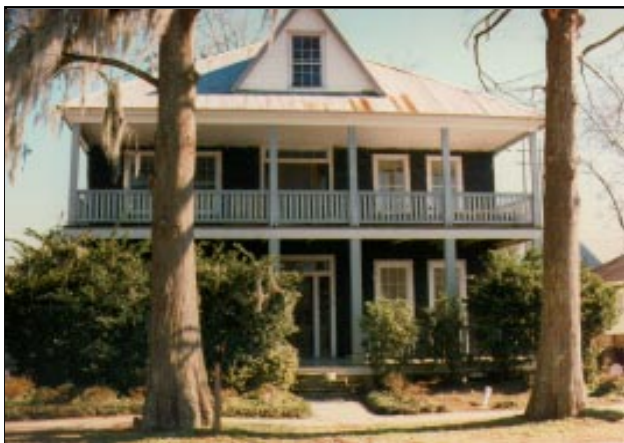
Before rehabilitation - simple historical balustrade.

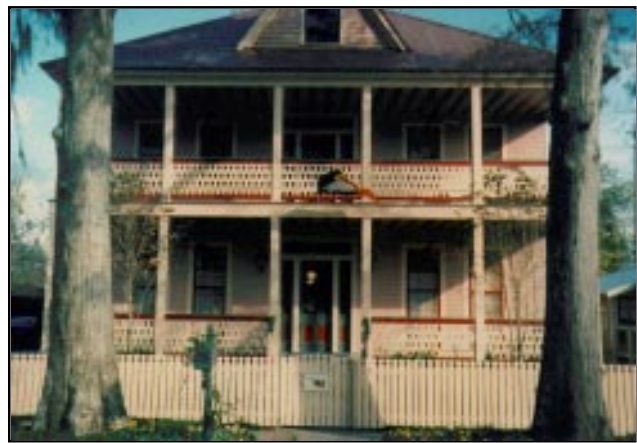
Application 1 (*Incompatible treatment*): A late-19th century boarding house was rehabilitated for use as a bed and breakfast. Prior to rehabilitation the structure had a very simple porch balustrade with rectangular vertical posts, or balusters. Historic photographs provided documentary evidence that the balustrade had always had this appearance. During rehabilitation the balustrade was replaced with one completely different in design - sawn balusters with ornate cutout shapes. The replacement gives a historically inappropriate look to the building, and an appearance it never had. To meet the Standards the owner replaced the new balustrade with one that matched the simple historic design.

After rehabilitation - inappropriate replacement balustrade.

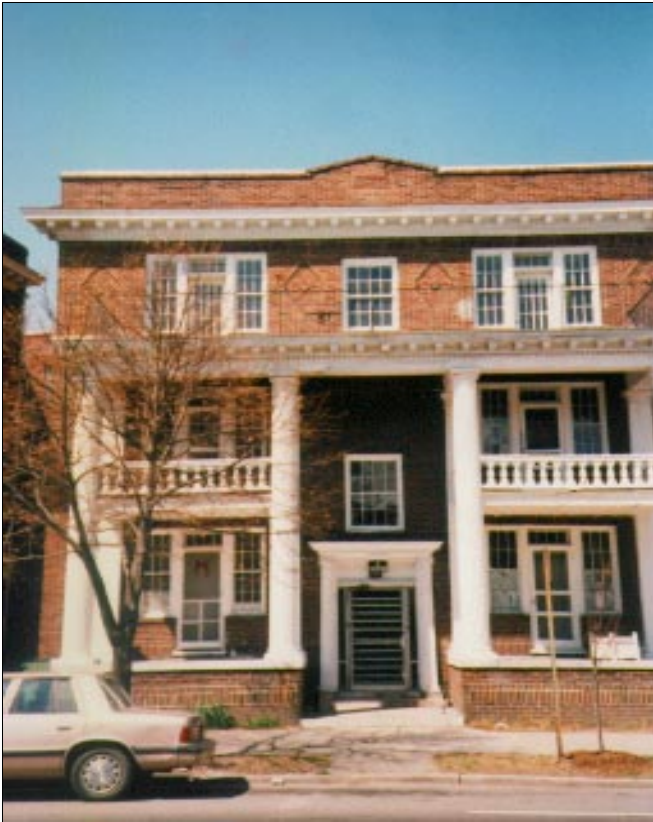
Before rehabilitation.

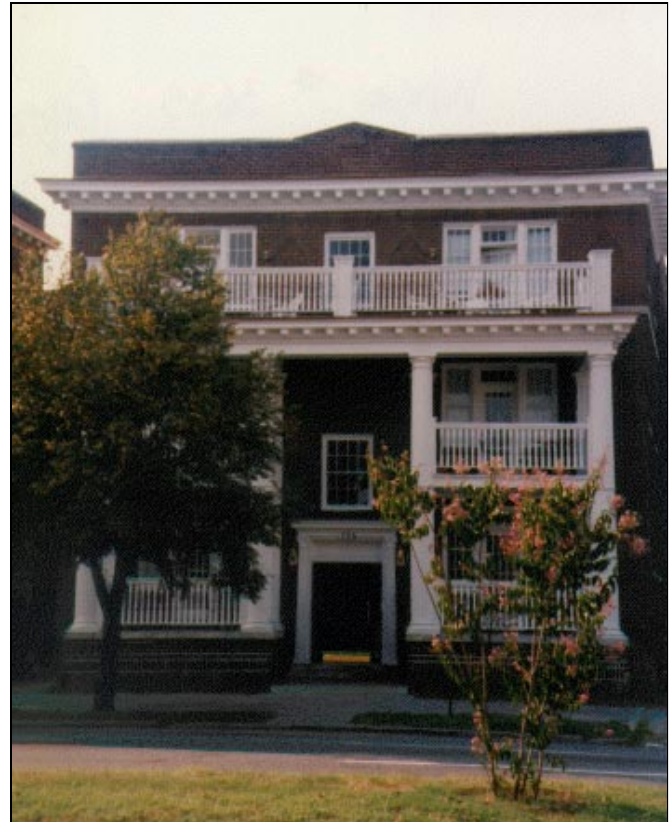
Application 2 (*Incompatible treatment*): A Colonial Revival-style apartment building, circa 1920, was rehabilitated for continued multifamily use. The front of the building was distinguished by two porches on the second story with low balustrades consisting of decorative, heavy turned balusters. As part of the rehabilitation, these balustrades, along with a non-original metal railing on the third floor level, were removed because their height did not comply with local building code requirements. They were replaced with taller balustrades with straight, narrow, rectangular balusters that did not replicate the visual qualities of the decorative historic balustrade and, therefore, resulted in dramatically altering the character of the building. These new, inappropriate balustrades were also added to the first floor porch.

The replacement balustrades are not only incompatible with the historic building itself, but they are also not in keeping with the historic district in which the building is located. Many similar apartment buildings in the district feature such porches which, with their rhythm, harmonious scale, size, and proportion, add a distinctive element to the district. Incompatible changes such as these new balustrades can cumulatively and negatively impact the overall character of a historic district.

After rehabilitation.

A more appropriate solution for meeting the safety requirements might have been to raise the existing second story balustrade, and modify the bottom of the railing to reduce the size of the opening. Another approach might have been to add a simple and inconspicuous pipe rail above the historic balustrade to meet the height requirements. From a distance this would not have been visible, and would have preserved the historic character.

There was no documentary evidence that there had ever been balustrades at the first and third floor levels. To satisfy both the Standards and code requirements it would have been preferable had the owner retained the modern metal railing that already existed on the third floor, and added a similarly simple railing on the first floor that was compatible with the building's historic character.
