ABRAHAM LINCOLN BIRTHPLACE
MEMORIAL BUILDING

HISTORIC STRUCTURE
REPORT

2001
Historic Structure Report
Abraham Lincoln Birthplace Memorial Building
Hodgenville, Kentucky
LCS#: 00002

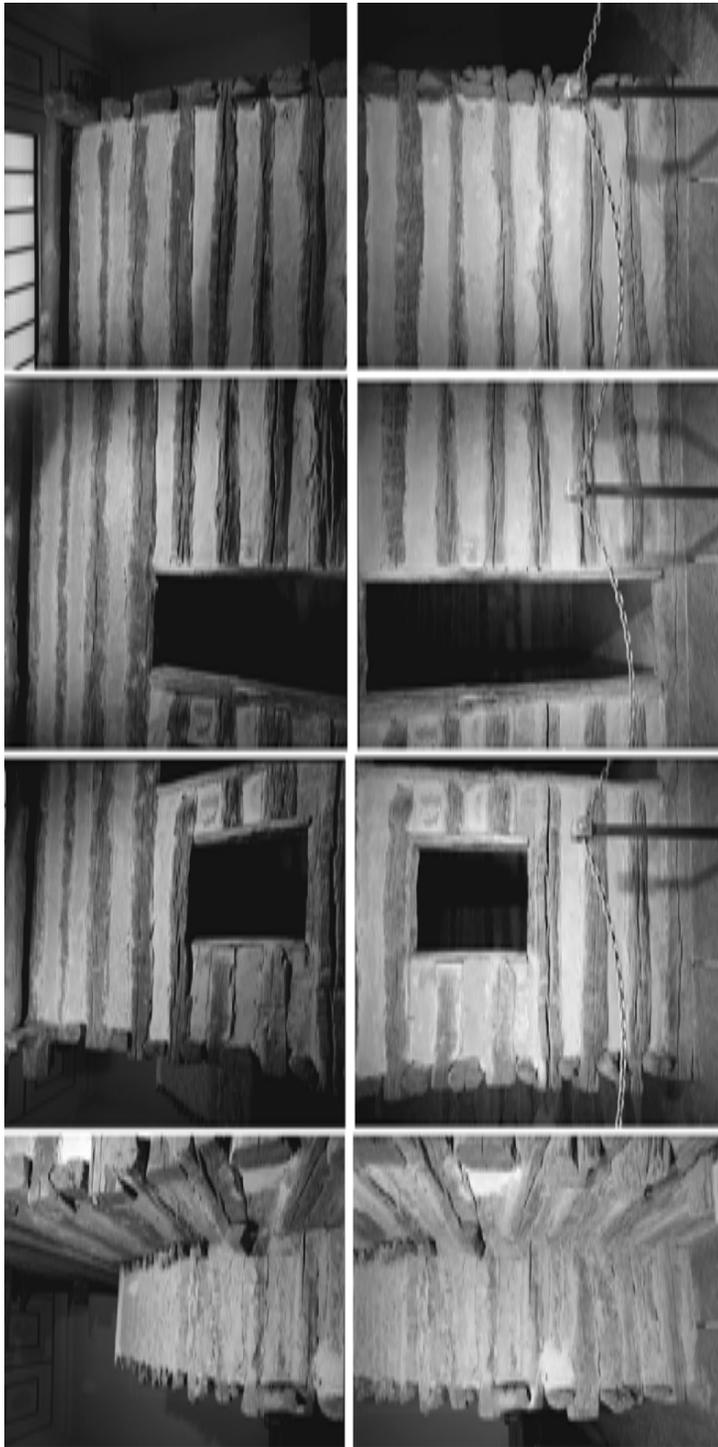
Figure 21 Abraham Lincoln Birthplace National Historic Site, condition of exterior south wall of traditional Lincoln birthplace cabin. Photographs taken June 2, 2000. National Park Service, Southeast Region Cultural Resources library.

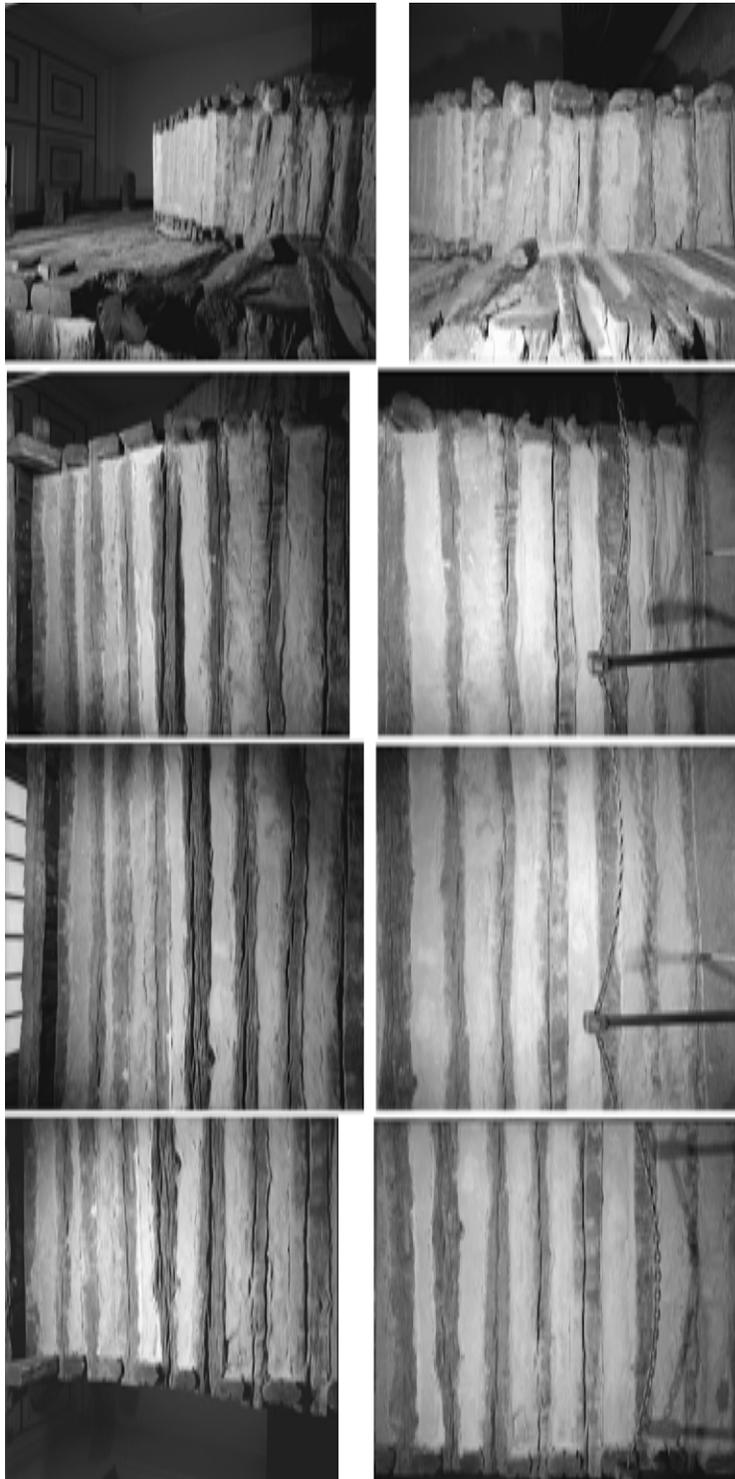
Figure 22 Abraham Lincoln Birthplace National Historic Site, condition of exterior north wall of traditional Lincoln birthplace cabin. Photographs taken June 2, 2000. National Park Service, Southeast Region Cultural Resources library.

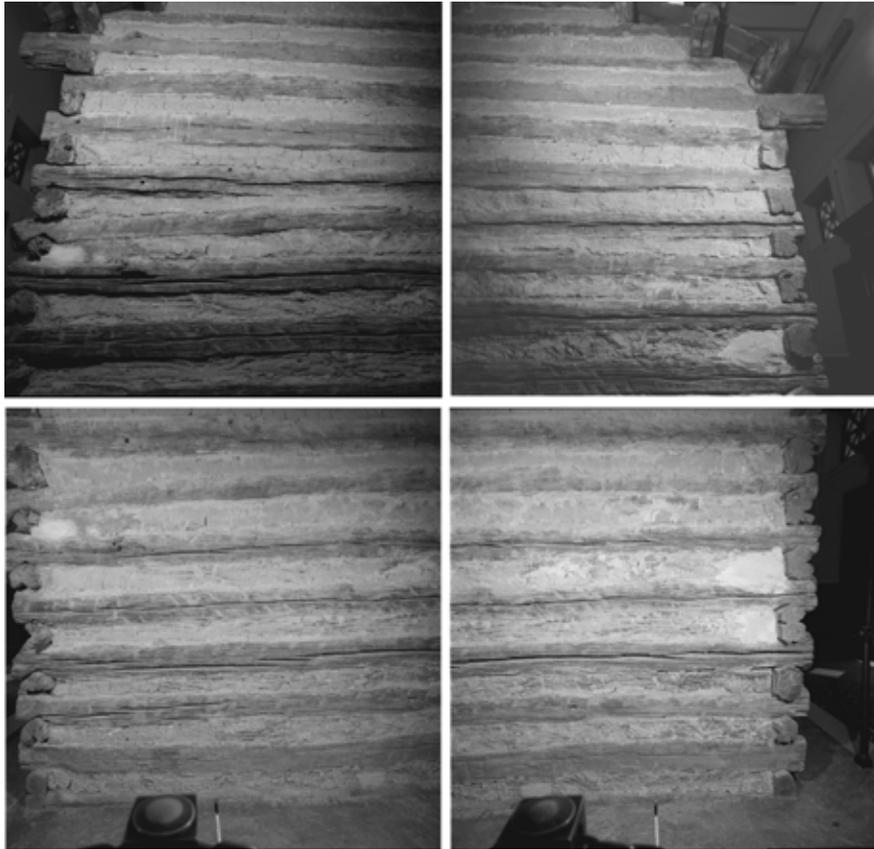
Figure 23 Abraham Lincoln Birthplace National Historic Site, condition of exterior east wall of traditional Lincoln birthplace cabin. Photographs taken June 2, 2000. National Park Service, Southeast Region Cultural Resources library.

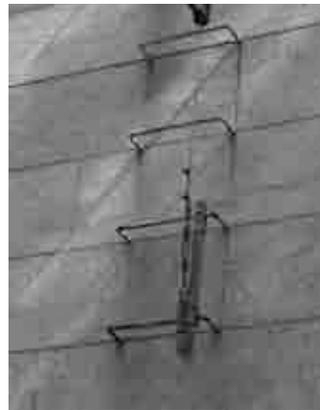
DEFICIENCY: Dirt and mildew buildup on cornice at north elevation. Rusting from the metal roof ladder on the North side has stained the surrounding stone.

Rusting from the metal roof ladder

RECOMMENDATION: Clean dirt and mildew with water, detergent and soft bristle brush (check mortar joint prior to cleaning). Remove rust by applying a poultice material to the affected area to draw the stain out of the stone.

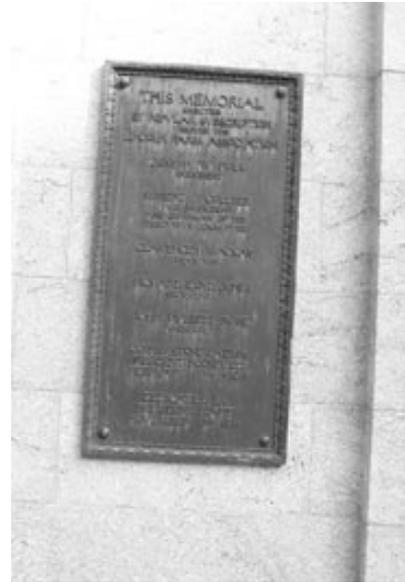
East plaque (Erection Team)

DEFICIENCY: These two plaques are now black with corrosion showing in a few areas.

RECOMMENDATION: Cleaned and restore by a metals conservator. Special care should be taken to preserve the original texture of the metal ground behind the lettering.

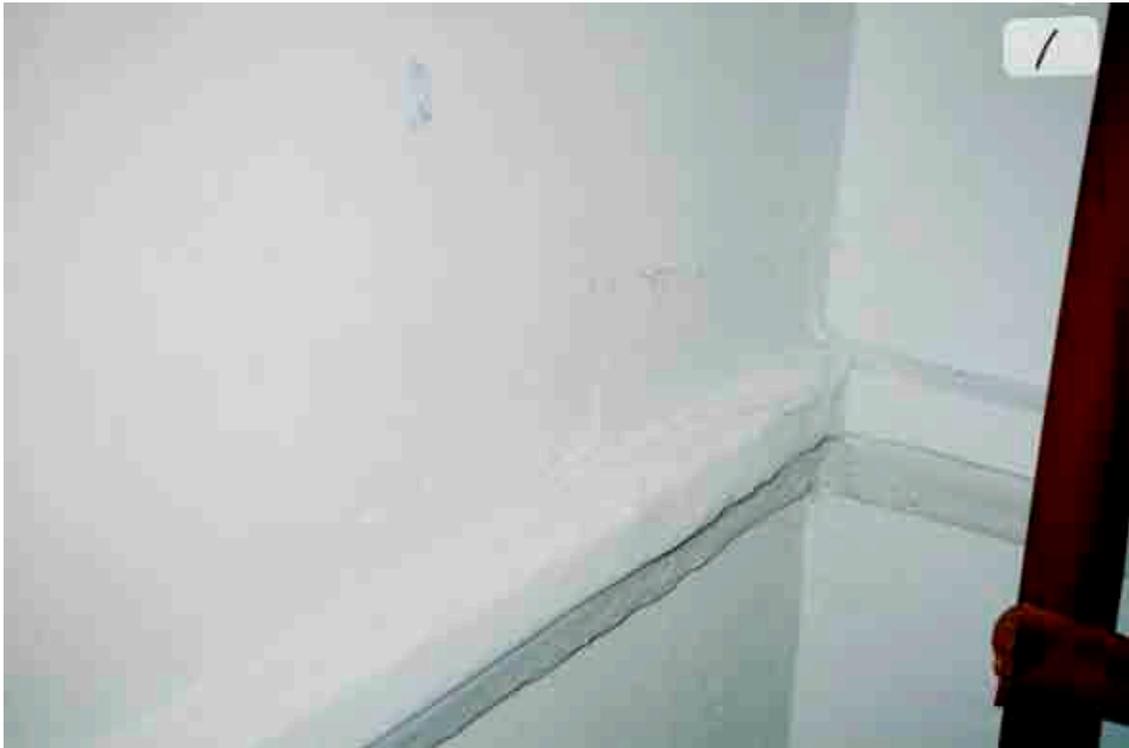
Figure 1. View of picture moulding repair work in the northeast corner. Note poor resolution of profile.

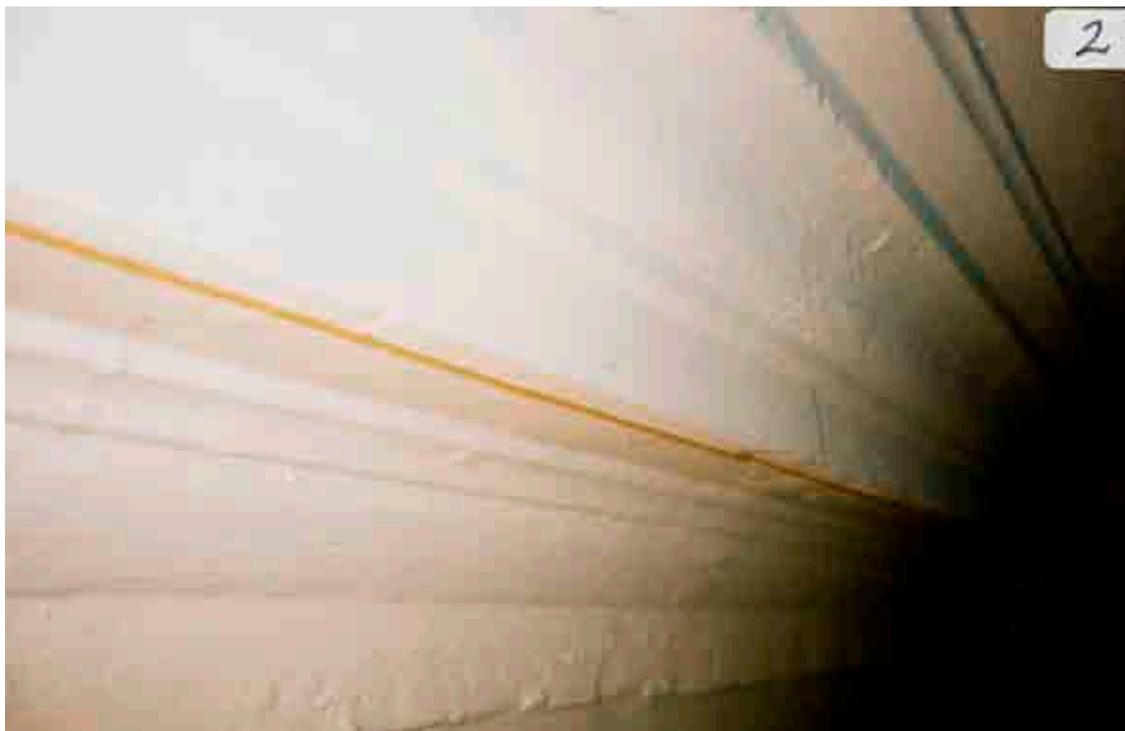
Figure 2. Cornice repair work along the north wall. Again, note poor repair of moulding profile.

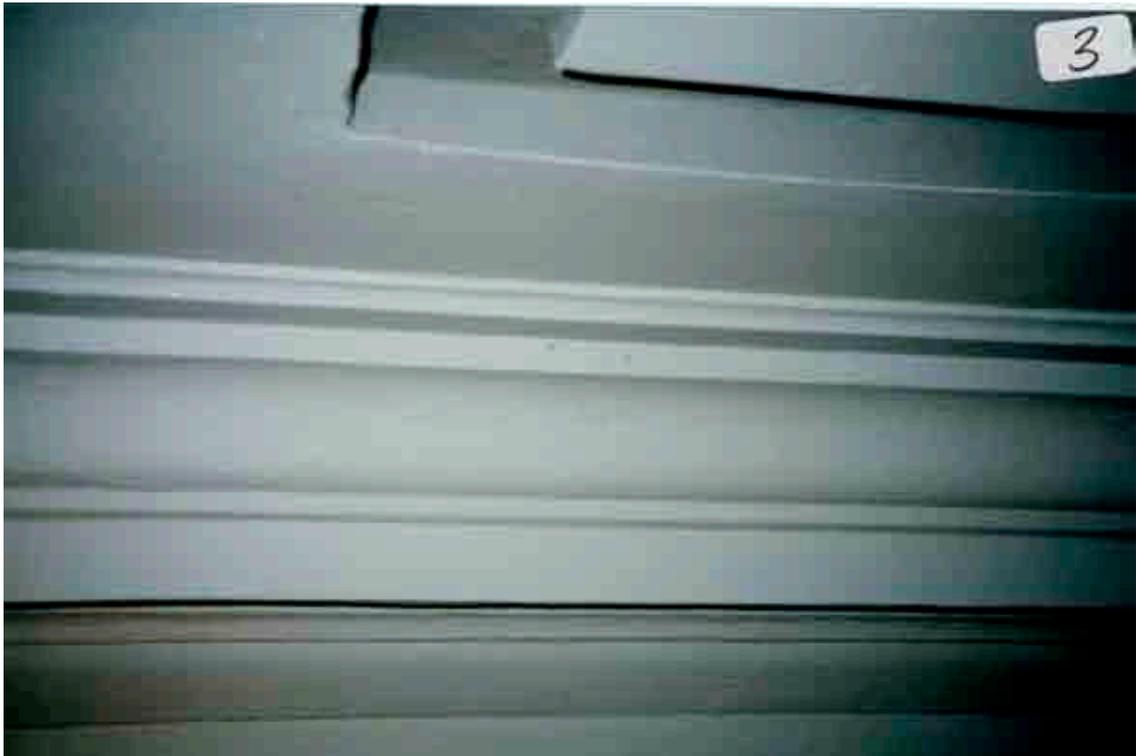
Figure 3. View of crisp profile of cornice which has not been repaired, or, if repaired, was done using a proper template.

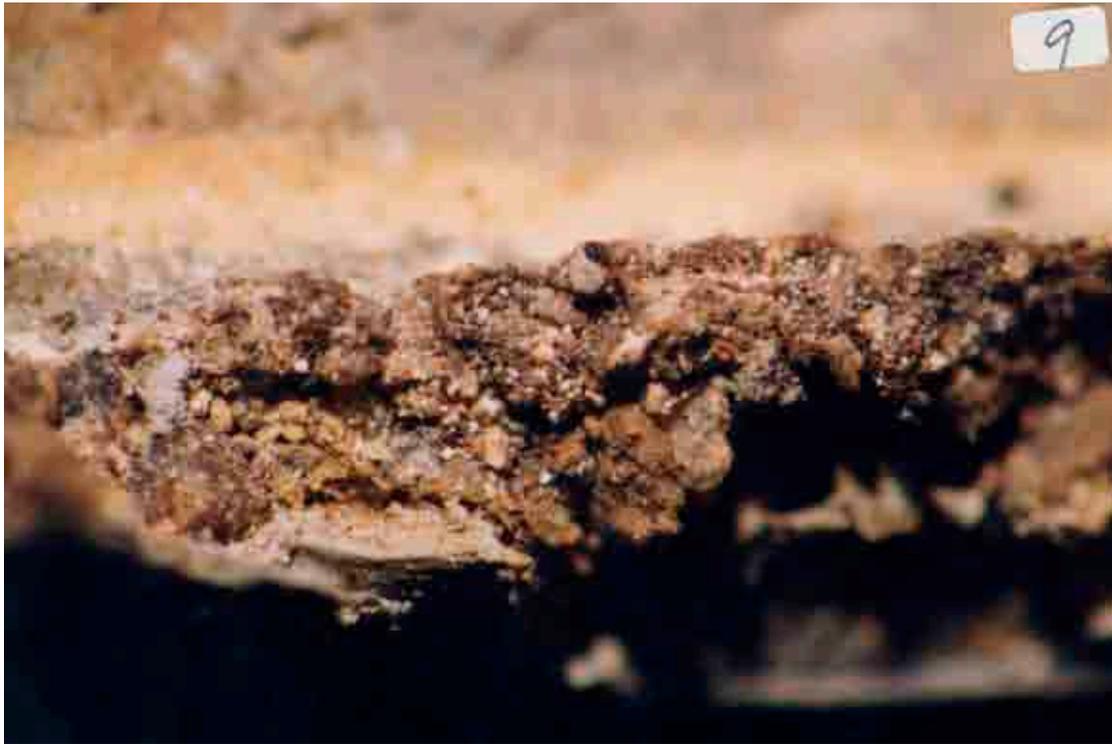
Figure 4. Photomicrograph of brown coating suggests possible sanded paint, to replicate brownstone, perhaps. The thickness, texture, and inharmonious color may be reasons why it was mostly removed.

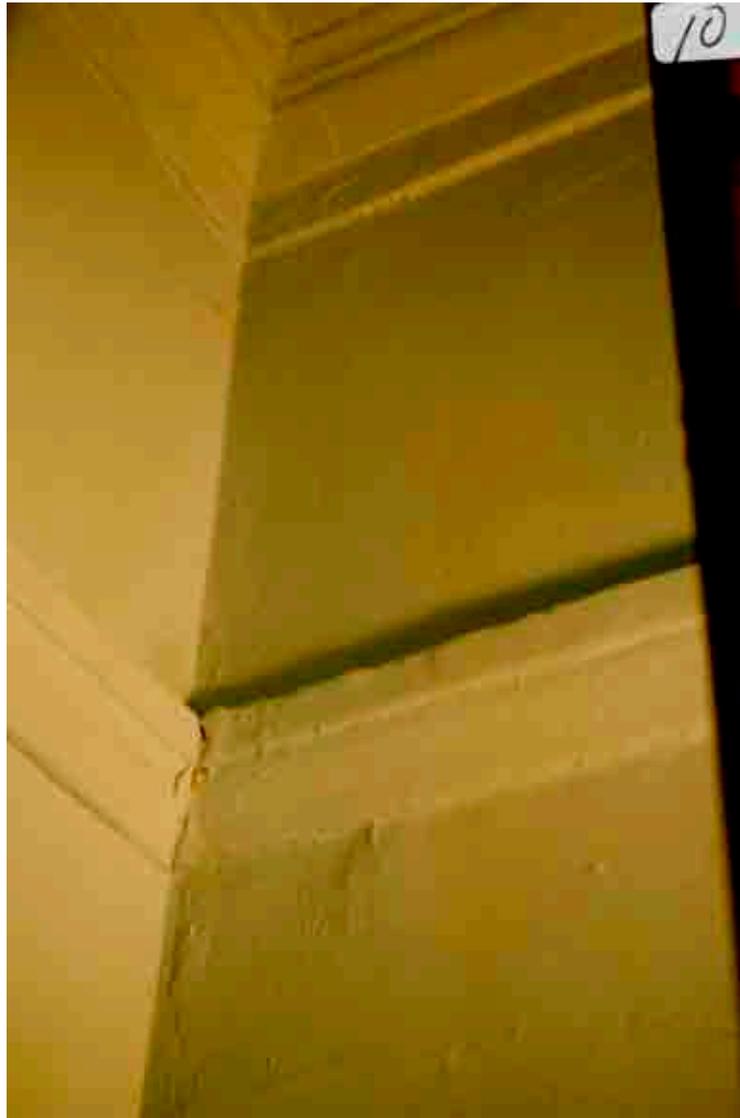
Figure 5. Poor plaster repairs of mouldings in northwest corner.

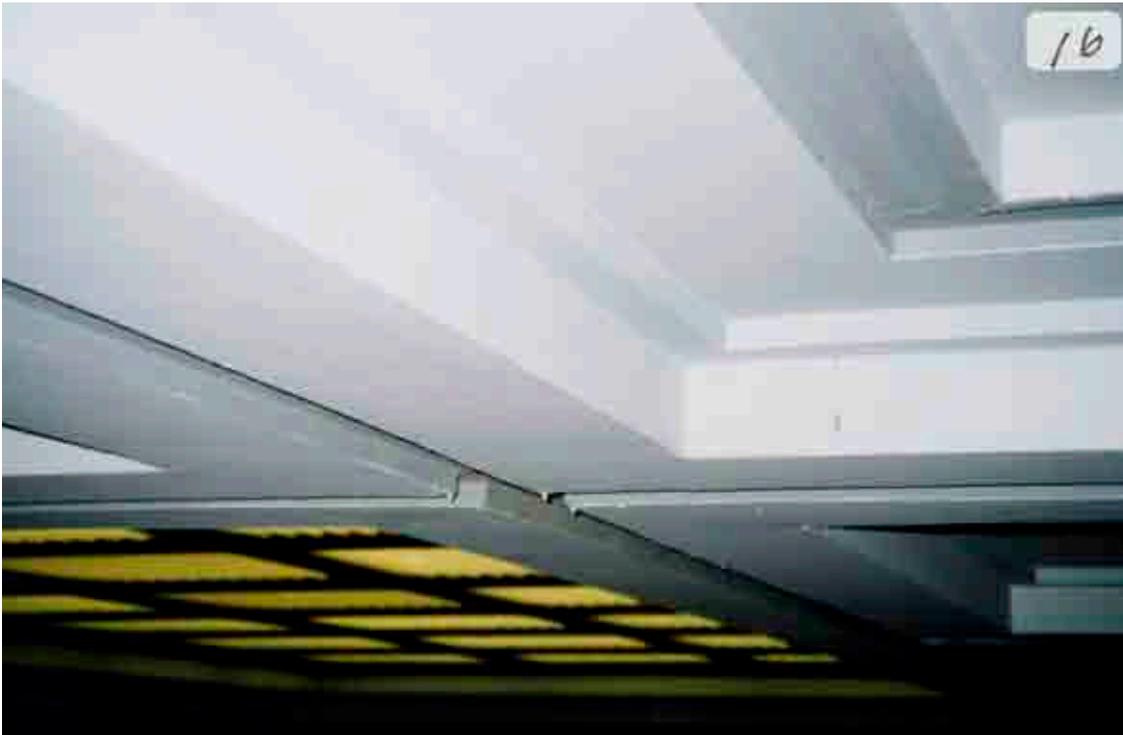
Figure 6. View across ceiling showing drips (“stalactites”) of sprayed-on recent thick coating.

The surface of the walls must be refinished to remove paint splatter and drip from decades of paint applications. This is especially problematic along the molding and other articulated surfaces like the ceiling rosettes. The walls were last repainted in 1992 and had been repainted every seven to ten years. The recommendation calls for a return to the original earth-tone color scheme. (See Paint Study, Appendix G.)

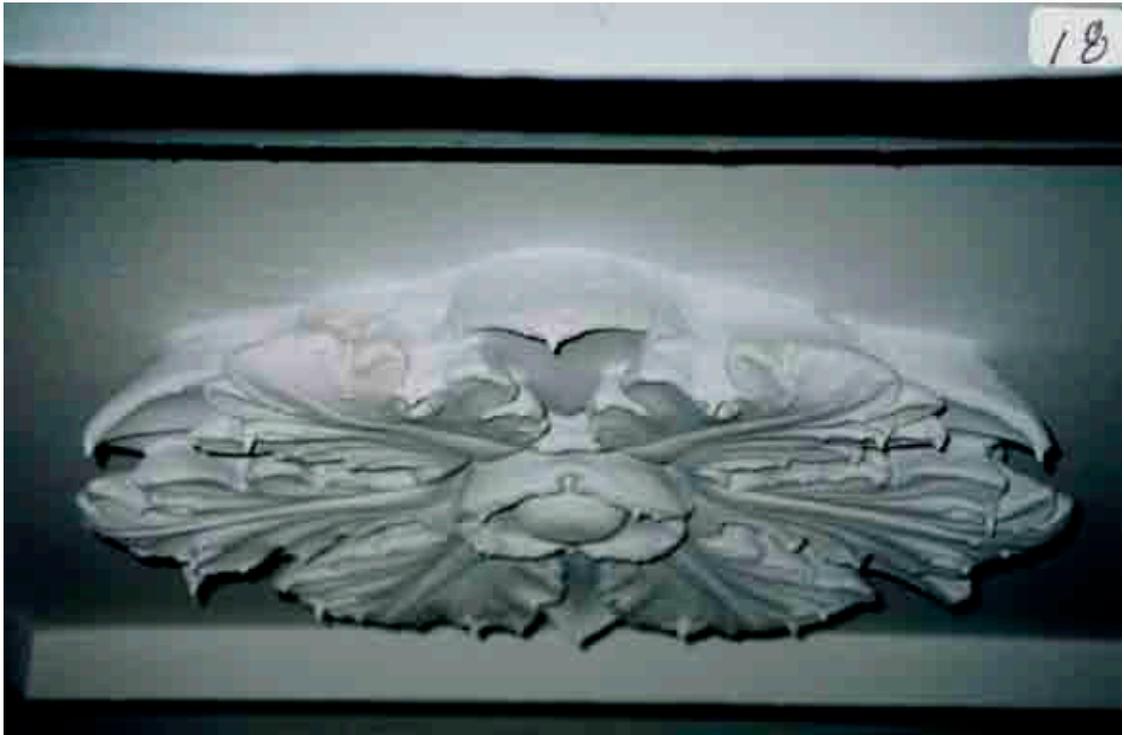
Figure 7. View of ceiling rosette showing drips of sprayed-on thick coating. Typical of all ceiling rosettes.

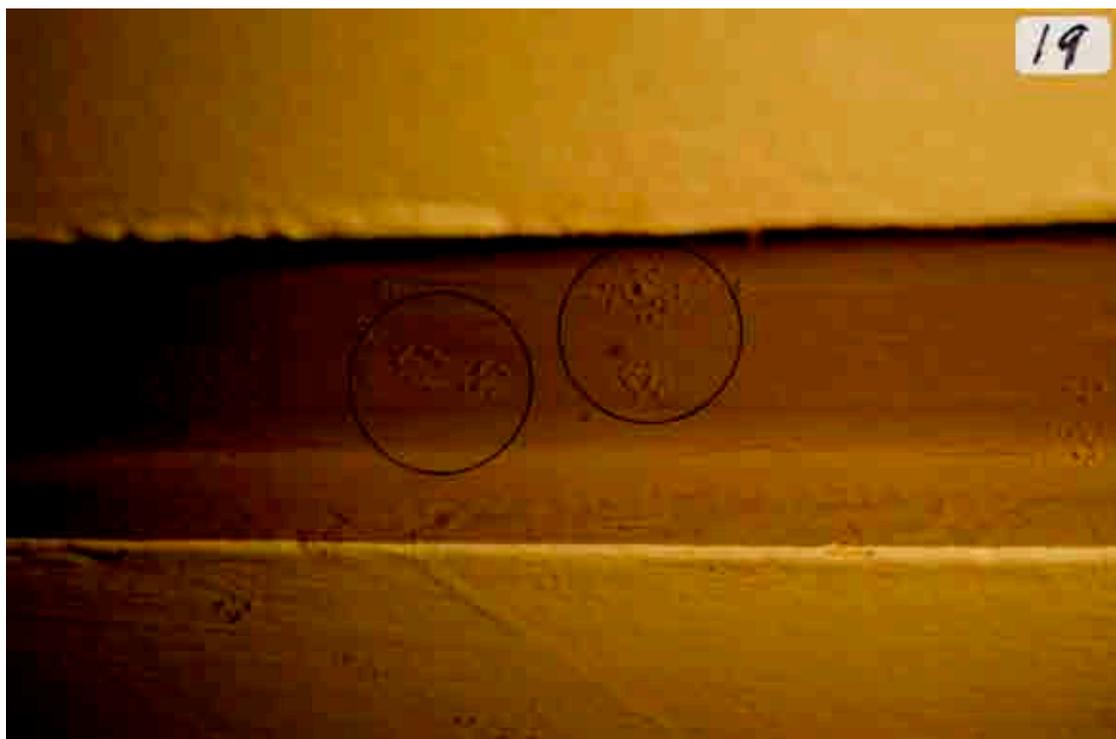
Figure 8. View of mycelia colonies on ceiling in southeast corner. Difficult to photograph.

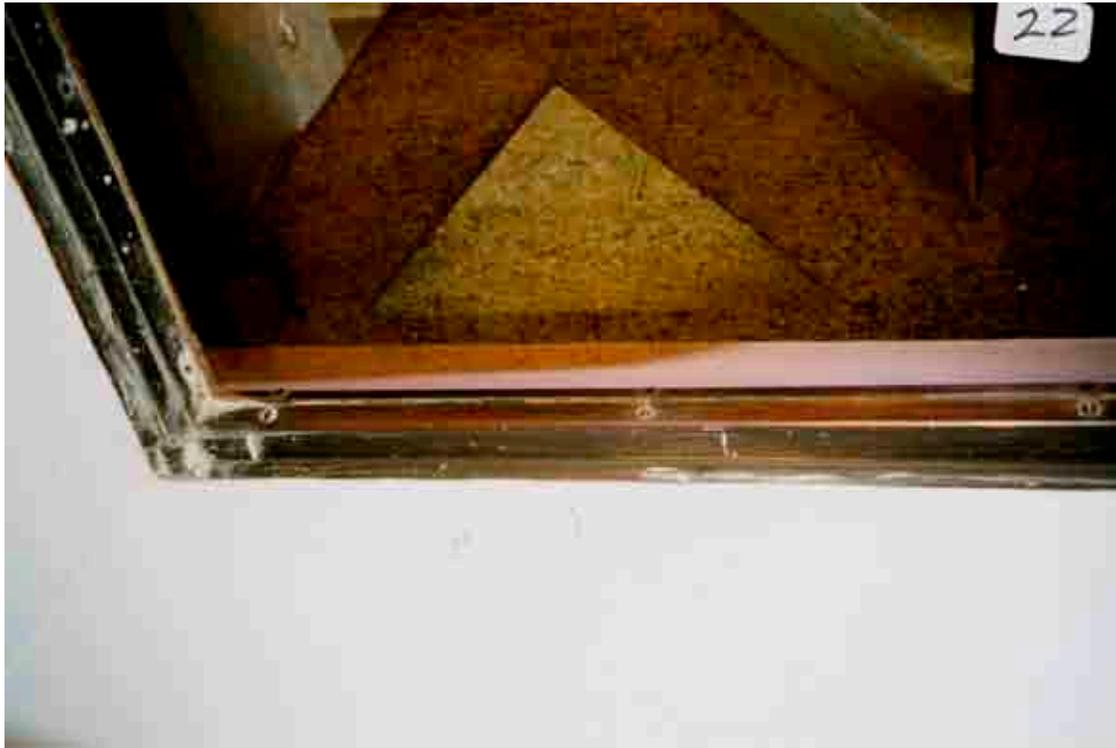
Figure 9. View of typical east/west wall window, showing bronze interior frame. Note sloppy paint work.

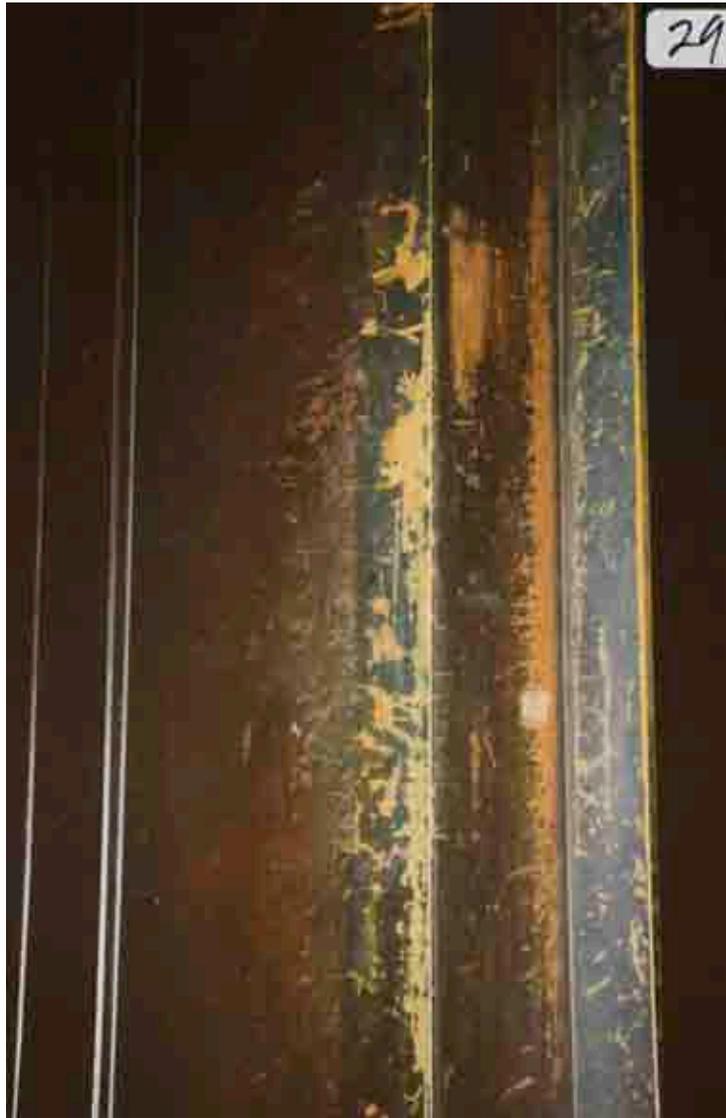
Figure 10. Severe deterioration of coatings and patina, typical on edges of all bronze doors.

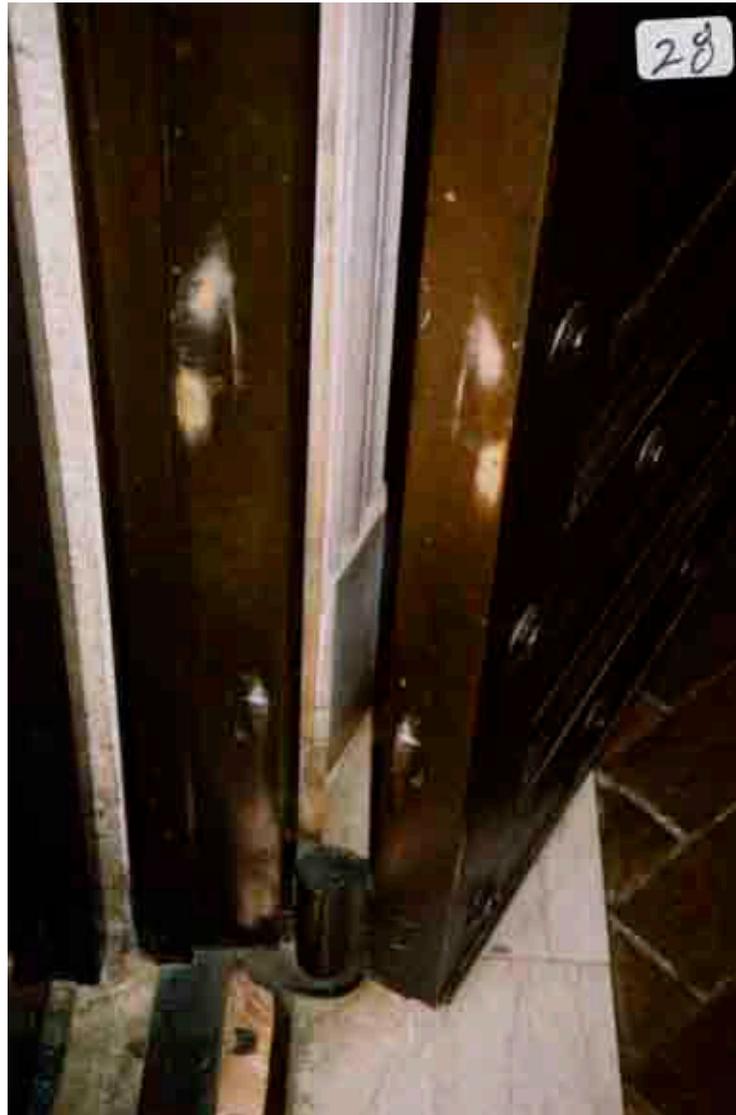
Figure 11. Unexplained damage on hinge side of south bronze door.

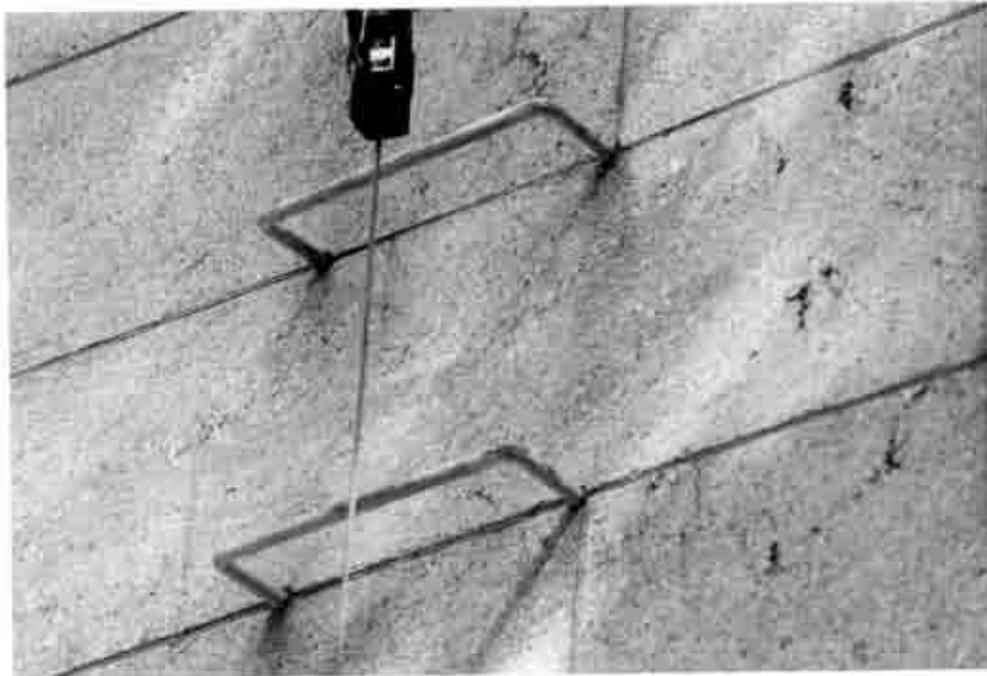
Steel rungs appear to be rusting. Extent of deterioration has not been determined. There is some outward movement in at least one rung.
