ASSATEAGUE BEACH COAST GUARD STATION

STATION HOUSE, GARAGE, AND BOATHOUSE

Assateague Island National Seashore
Assateague, Virginia

HISTORIC STRUCTURE REPORT

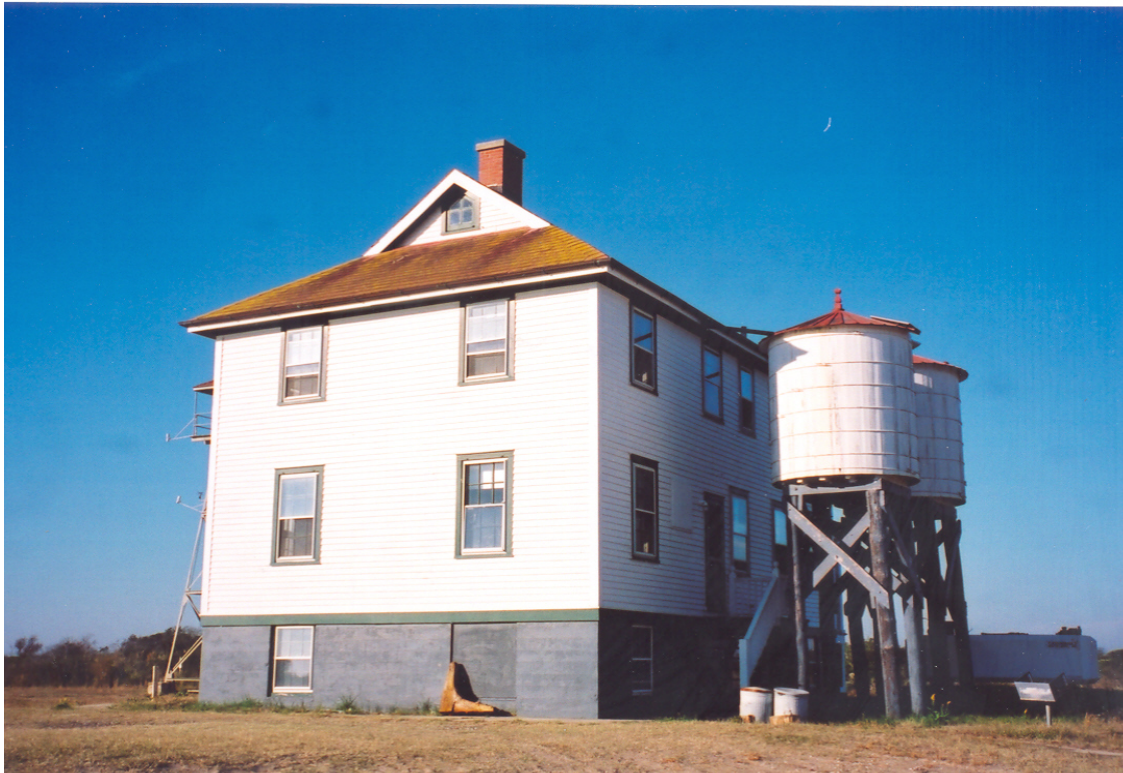
Building	Raised foundation composed of reinforced concrete slab (fig. 40). The foundation is exposed on the exterior for approximately 5 feet above the ground level
Water Tanks	10- inch thick wooden pilings set 5 feet on center (fig. 44)

Figure 44. Station House: East and north elevations (1999).

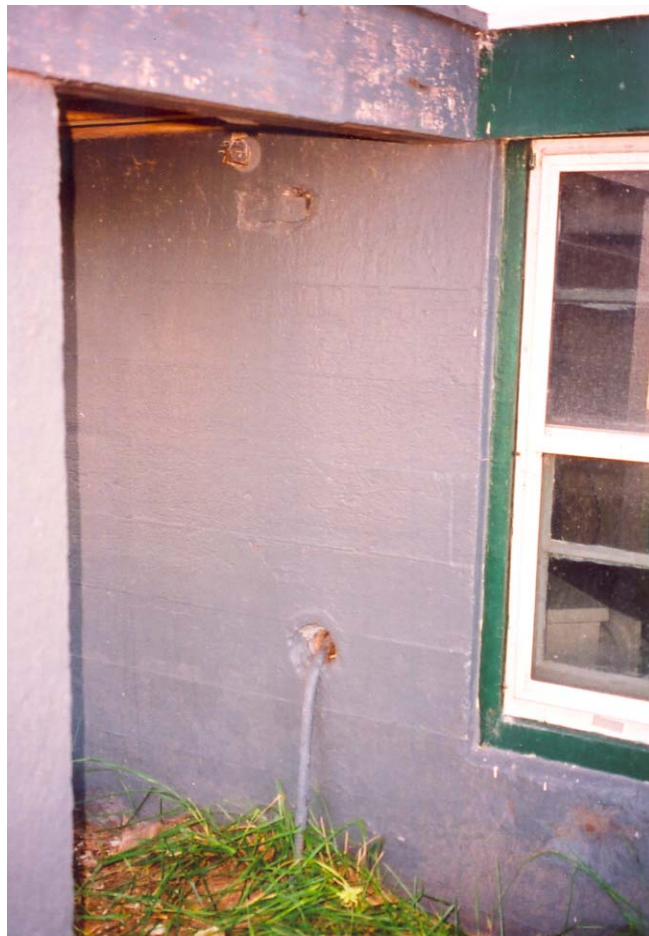
Electrical wires run underground to the building from poles on the site; conduit emerges on the exterior of the west wall of building north (left) of window W008 and enters through a hole in the foundation wall above grade (fig. 48).

Figure 48. Station House: North elevation, foundation wall under rear porch, showing former opening for conduit from water tanks [near top of view] and opening for electrical conduit (1999).

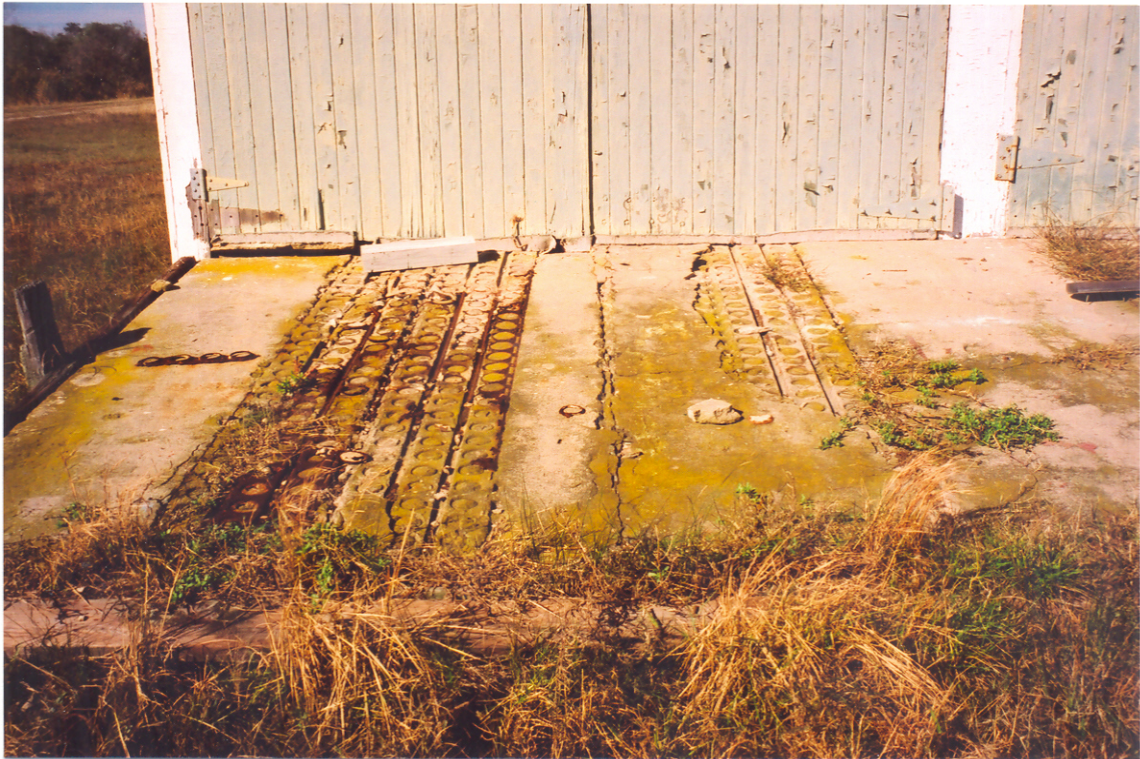
At some point the wooden- plank ramps that led up to the doorways were replaced with poured- concrete ramps. Metal traction rings were embedded in the west side of the ramp on the south façade; as explained previously, similar rings were installed on the poured- concrete flooring on the interior of the building. A thin parging of cement was later used to cover the rings.

Figure 88. Garage: South façade, ramp to doorway D102 (1999).

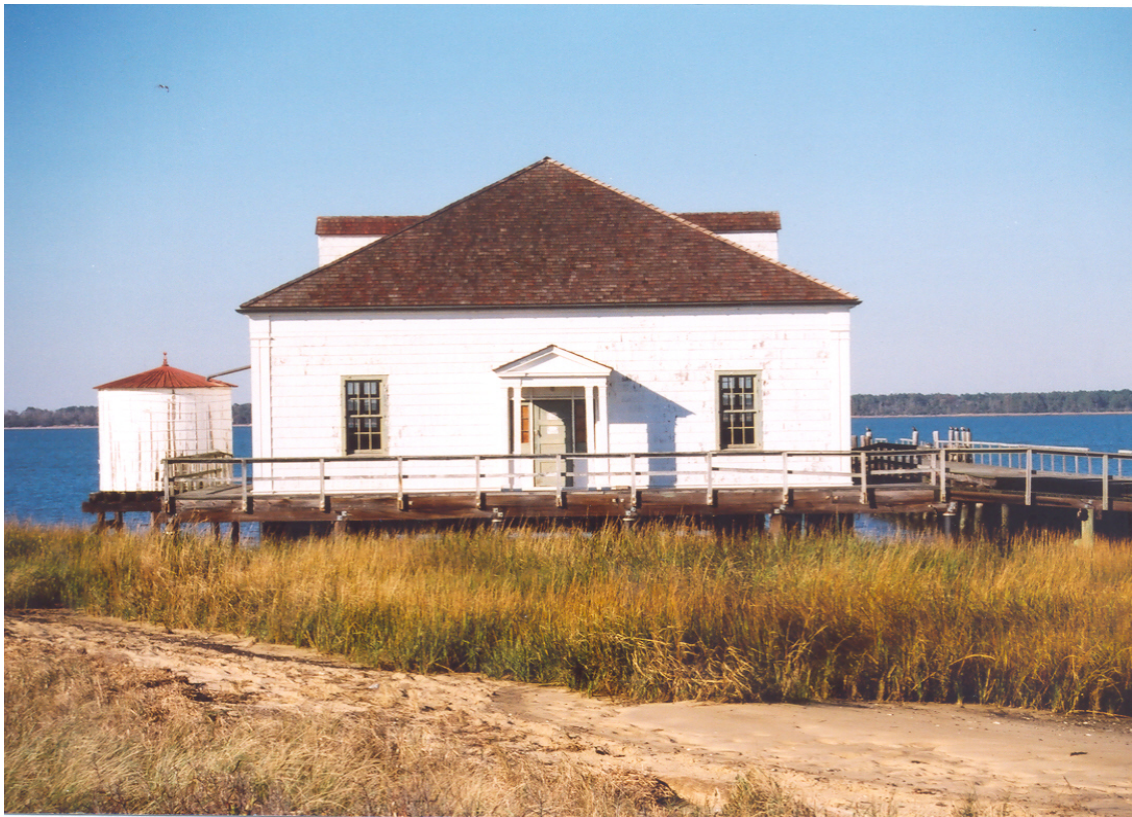
The most important exceptions are found on the boathouse. The door in the extant south-façade doorway probably dates to the early 1970s, and the sidelight glazing is missing. In addition, the original window shutters were removed sometime before 1962. The original glazed doorway and shutters were significant features in the designed exterior appearance of the structure. It is recommended that the door in the south doorway be replaced with one that is identical or very similar in appearance to the original door, and that the sidelights be reglazed. Even though the shutters were removed during the period of significance, without them the scale of the windows on the boathouse walls is out of proportion with the building and the original design of the structure is defeated. Consideration should be given to restoring shutters to the windows on the boathouse.

Figure 94. Boathouse: South façade (1999).
