Historic Structure Report for

**BUILDING 125 (PAINT SHOP)
CHARLESTOWN NAVY YARD**

Boston National Historical Park
Boston, Massachusetts

December 2003

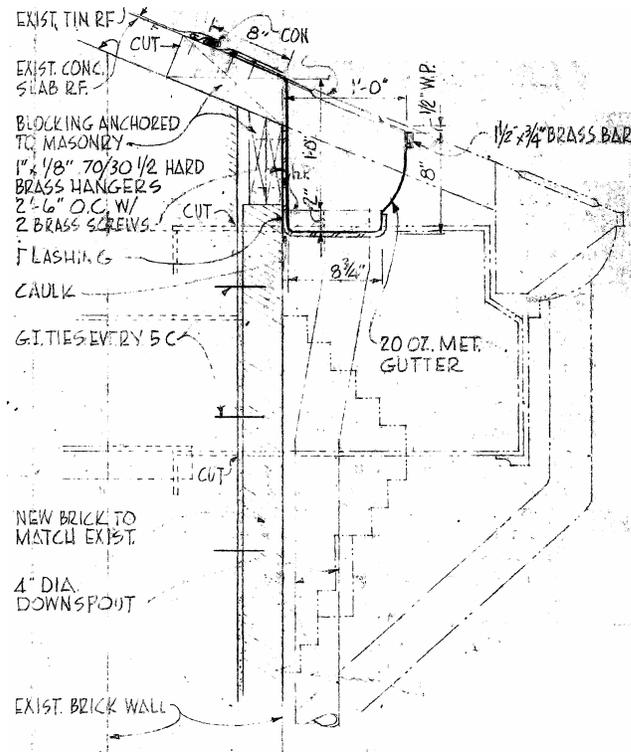
“The cornices, gutters and roofs have been repaired on numerous occasions and further repairs are not economically wise. This deteriorated condition has made complete rehabilitation mandatory and further delay will only result in excessive maintenance and repair costs.”⁵

Figure 21: Detail from drawing calling for the removal of original brick and metal cornice (2/19/1962).

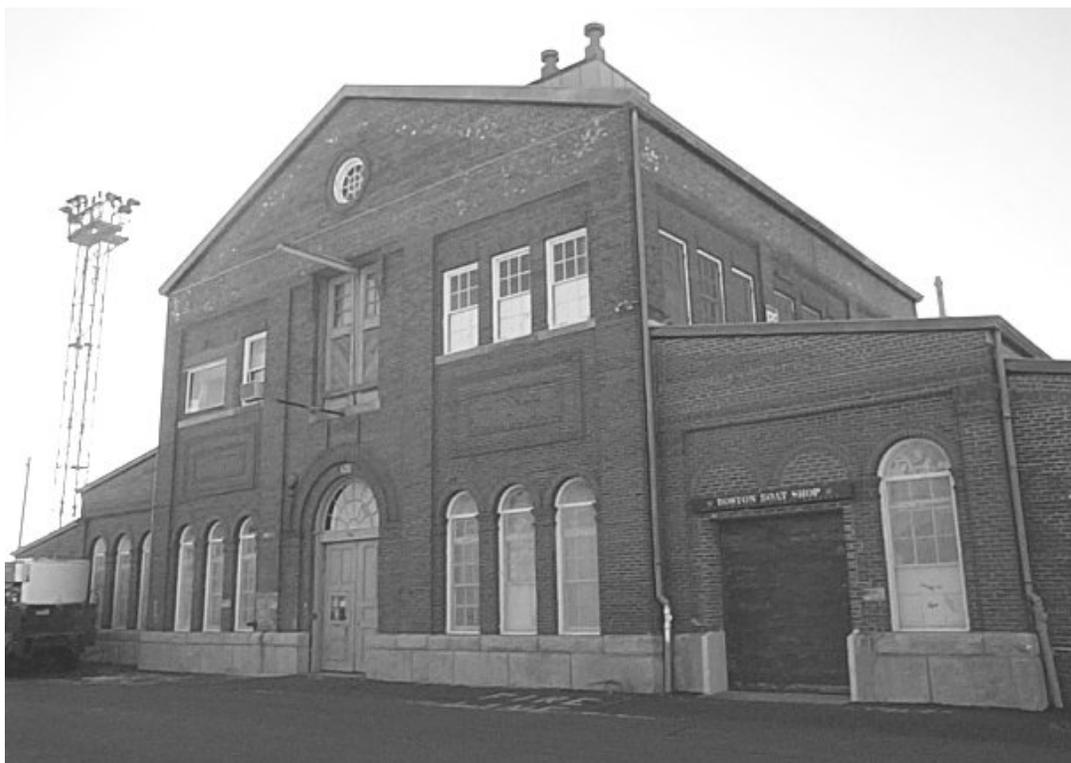
Figure 23: View of east façade. Corbelled brick cornices delineating the pediment and roof eaves were removed in the 1960's. (1/15/03)

The building is constructed of red, water-struck brick laid in common bond, articulated with brick pilasters that divide each façade of the main block into three equal recessed panels. The original corbelled brick cornices that emphasized the roof edges and formed pediments on the east and west facades are now gone, replaced by flat brick infills that contrast slightly with the adjacent original bricks. The main block and adjacent wings rest on a 3 ft. high gray granite water table. The masonry walls are in generally in good condition, with some efflorescence indicating minor water infiltration problems at a few locations. There are no serious cracks to suggest structural or settlement problems; old cracks that do occur at the joint between the original building and the north wing appear to have stabilized and are clearly due to differential settlement caused by their different foundation systems. The mortar joints appear also to be in good condition overall, with perhaps 10%-15% repointing required at the time of this report.

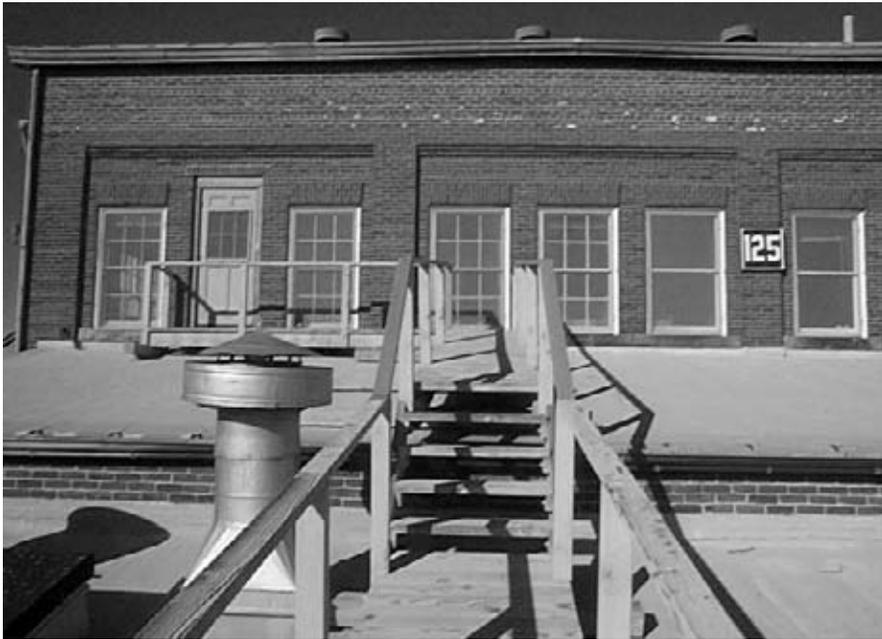
The roofs are clad with metal shingles, coated with a gray liquid membrane, over the original structural concrete roof decks. Each roof area is edged with copper rake trim and drained to copper gutters and downspouts. Perhaps some of the metal shingles are original, but major roof repairs in the 1960s and again in 1994 included significant repairs, new gutters and trim, and new membrane coatings; as a result, the roof systems appear to be in excellent condition. Rooftop assemblies also appear to be in good repair, including the elevator penthouse, ridge ventilators, and miscellaneous exhaust hoods over the north wing. The wooden fire escape over the north wing roof was rebuilt during the 1994 roof repair project.

Figure 24: View of roof over the north wing. The flat metal shingles are clad with a gray liquid membrane. The wooden fire escape was rebuilt in the 1994. (1/15/03)

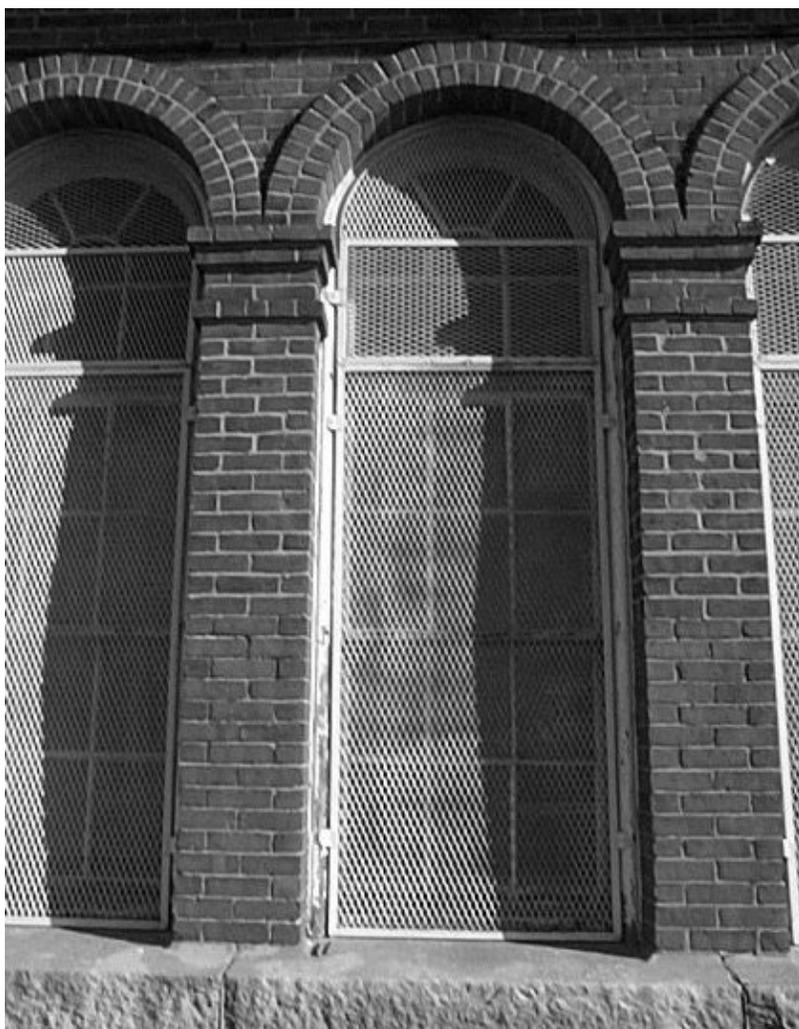
Most of the original wood, double-hung windows are intact. Their painted finish has been neglected and is typically cracked and peeling, with some wood deterioration evident, but visual inspection indicates that the windows should be restorable with minor repairs and new paint. All first floor windows (and second floor windows on the south side) have expanded metal security screens screwed directly to the window brick moldings.

Figure 25: Typical first floor window with expanded metal security screen. (1/15/03)

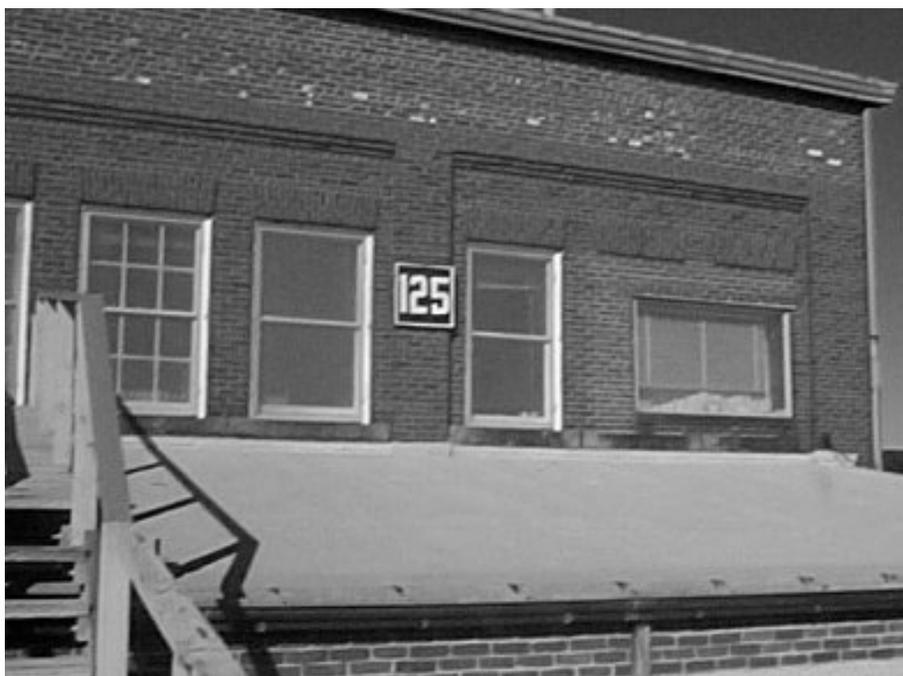
Figure 26: New windows were installed at the southeast corner of the second floor in the 1950's, including the fixed and two 1/1 double hung windows pictured here. The 6/6 window to the left is original. (1/15/03)

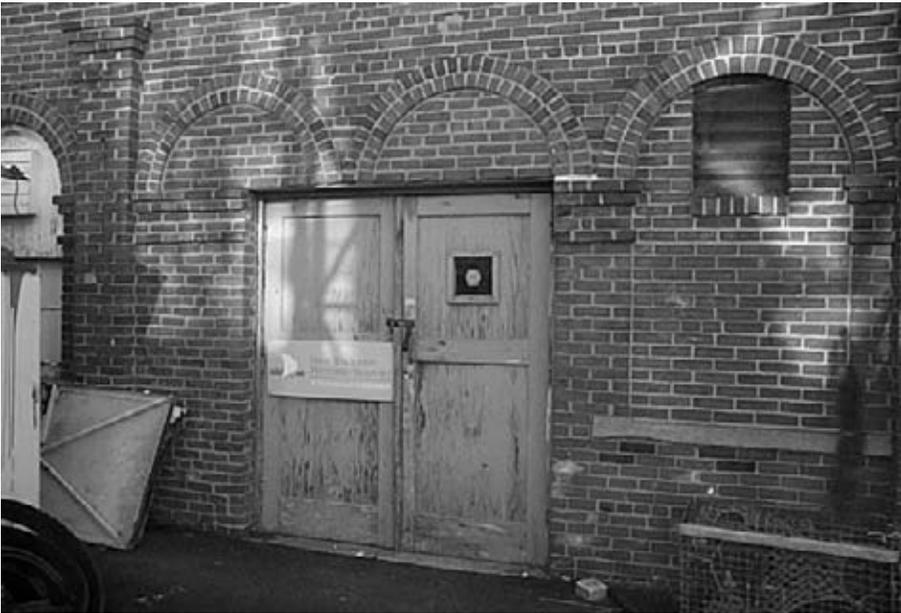
Figure 28: This pair of doors in the north wall replaced the original single door that fit into the center arch. Window openings to the left and right were filled-in. (1/15/03)

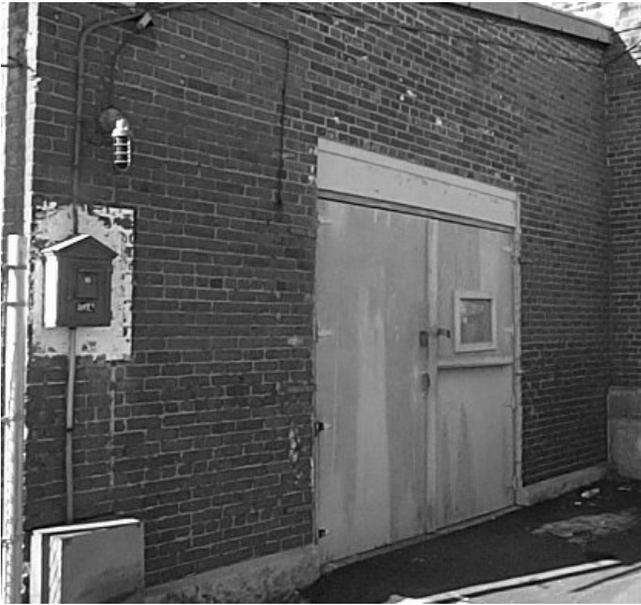
Figure 29: This hinged pair of doors in the east wall of the south wing replaced the original sliding doors. The opening was also rebuilt, with a concrete header replacing the former brick jack arch. (1/15/03)

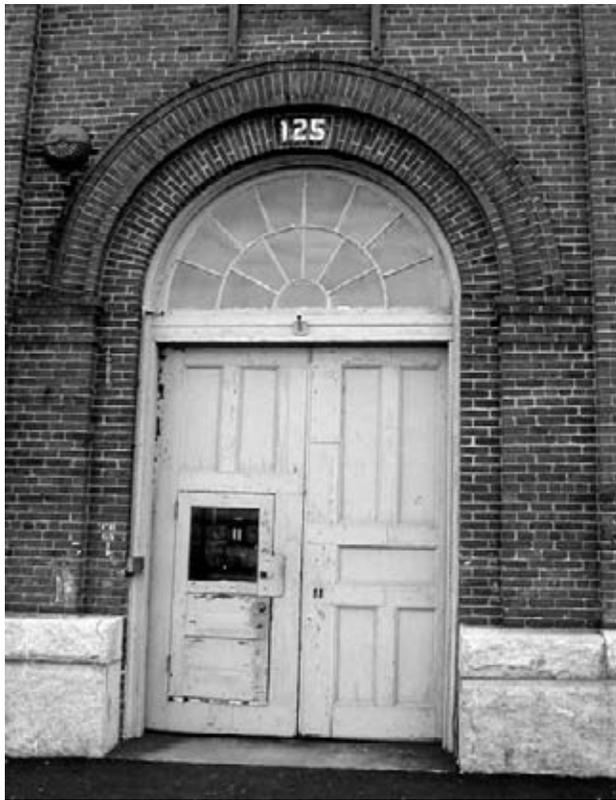
Figure 30: Main entrance door. This is probably original, though this is difficult to verify. (1/15/03)

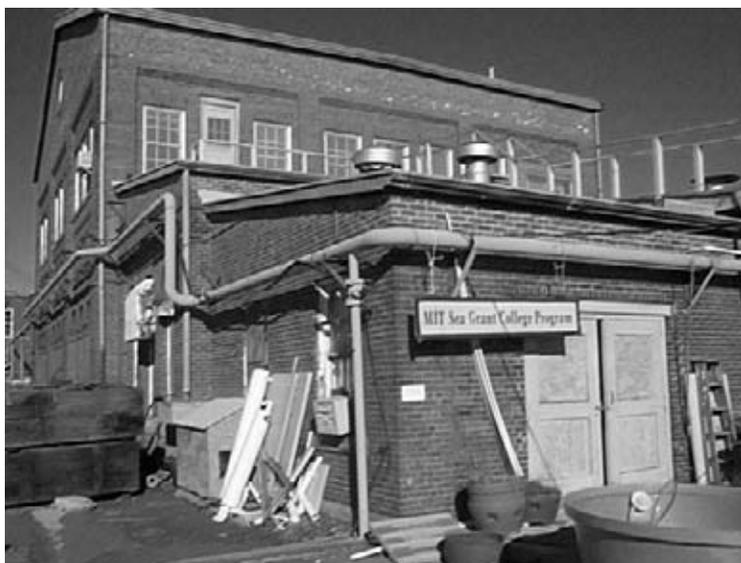
Figure 31: View of the building's southwest corner. The opening now with the pair of doors was constructed for an electrical substation in this location shortly after the building was completed. The two windows in the west wall were added at the same time. (1/15/03)

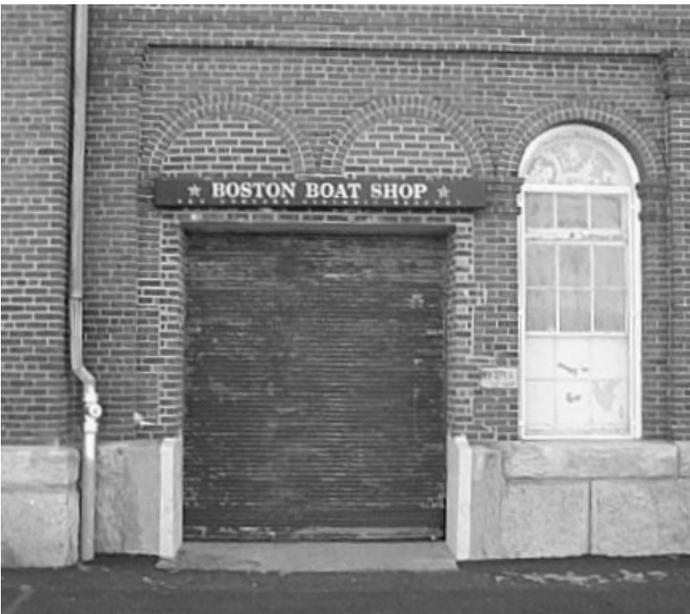
Figure 33: This coiling door in the east wall of the north wing replaced two original windows. The granite water table was also cut to make the opening. (1/15/03)

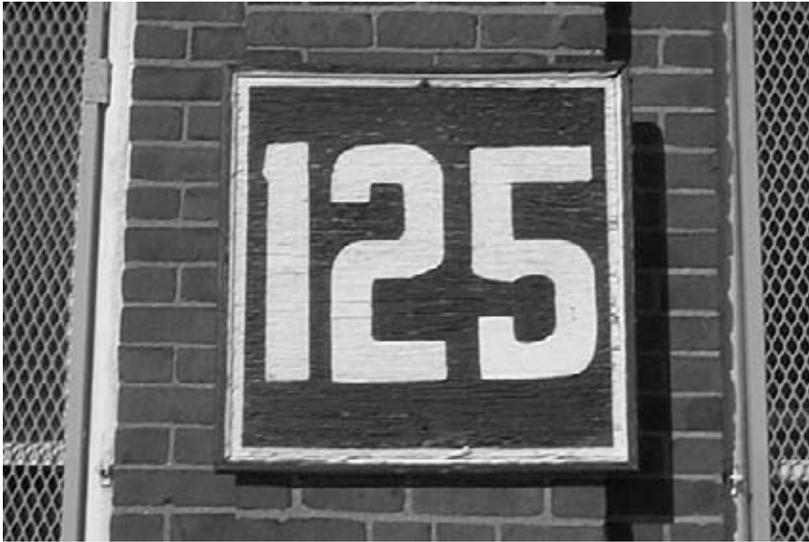
Wood building number (“125”) signs on the north and south facades and a “Baxter Road” sign at the northeast corner are probably original. The paint on them is cracked and peeling, but they appear to be restorable. Other signage placed recently by NPS tenants should eventually be removed.

Figure 34: Building number sign. Two (probably original) signs are on the building, attached to the north and south facades. (1/15/03)

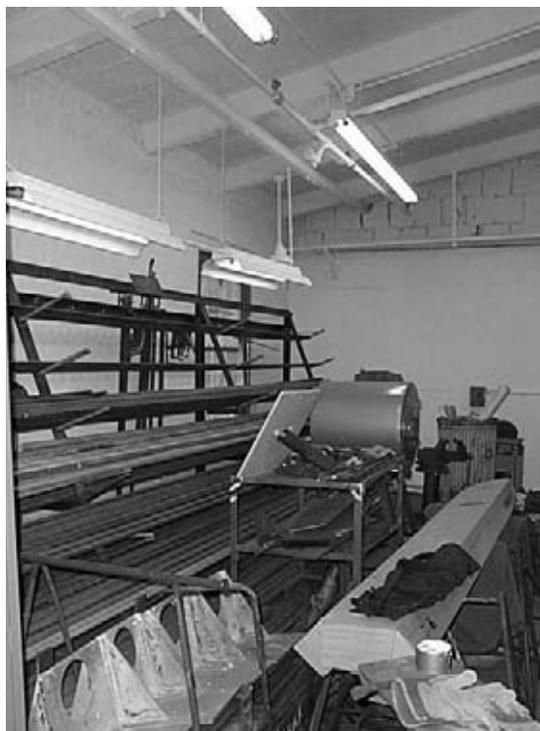
This is the remainder of the original open space, divided from Rm. 101 by a partially plastered terracotta partition. As in Room 101, the skylight has been removed and the opening covered in plywood. The single original south wall window provides natural light in the space. Uneven settlement of the floor is evident at the west side of the space where some of the original brick pavement is visible in the floor that is otherwise paved in concrete. A leaking radiator is responsible for moisture on the floor at the north side of the space. The Navy currently uses the space for metal shop storage.

Figure 36: View of room 102 looking west. The space is used for the storage of metal materials to maintain U.S.S. Constitution. (1/15/03)

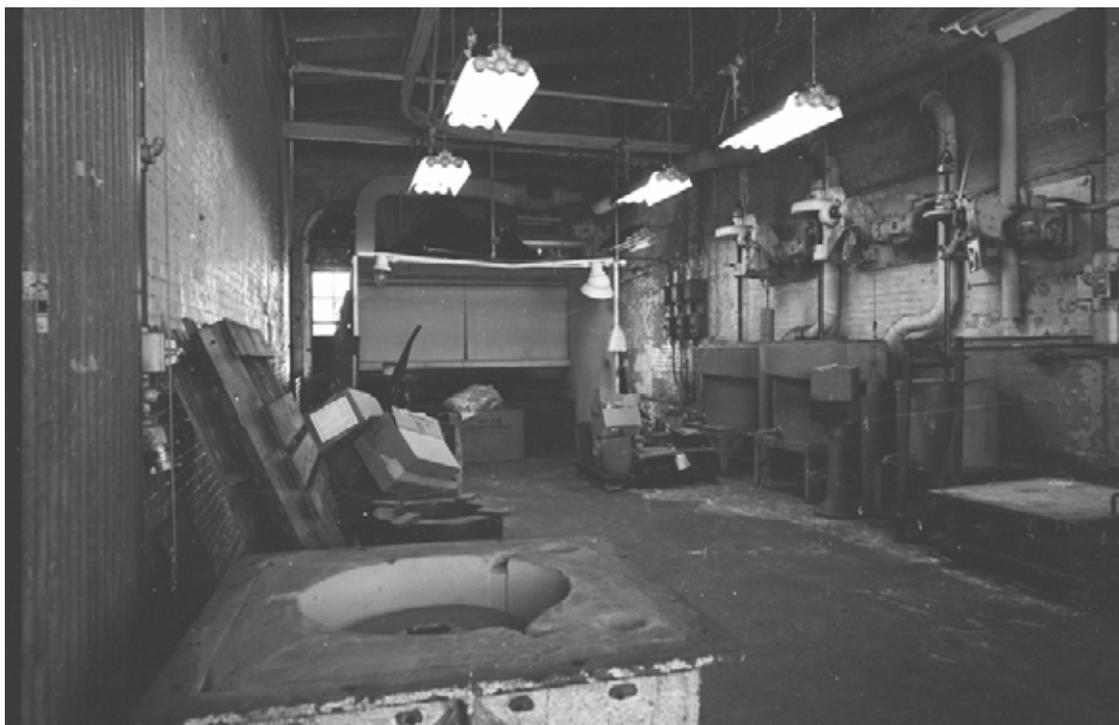
Figure 37: View of Room 103 from east, as abandoned by the Navy. Note the paint mixers along the north wall that remain in the same location today. They could be preserved as an exhibit of primary paint shop equipment. (1/15/03)
