historic structure report building 198

october 1982

BOSTON
CHARLESTOWN NAVY YARD

HISTORIC STRUCTURE REPORT
BUILDING 198
CHARLESTOWN NAVY YARD
BOSTON NATIONAL HISTORICAL PARK
MASSACHUSETTS

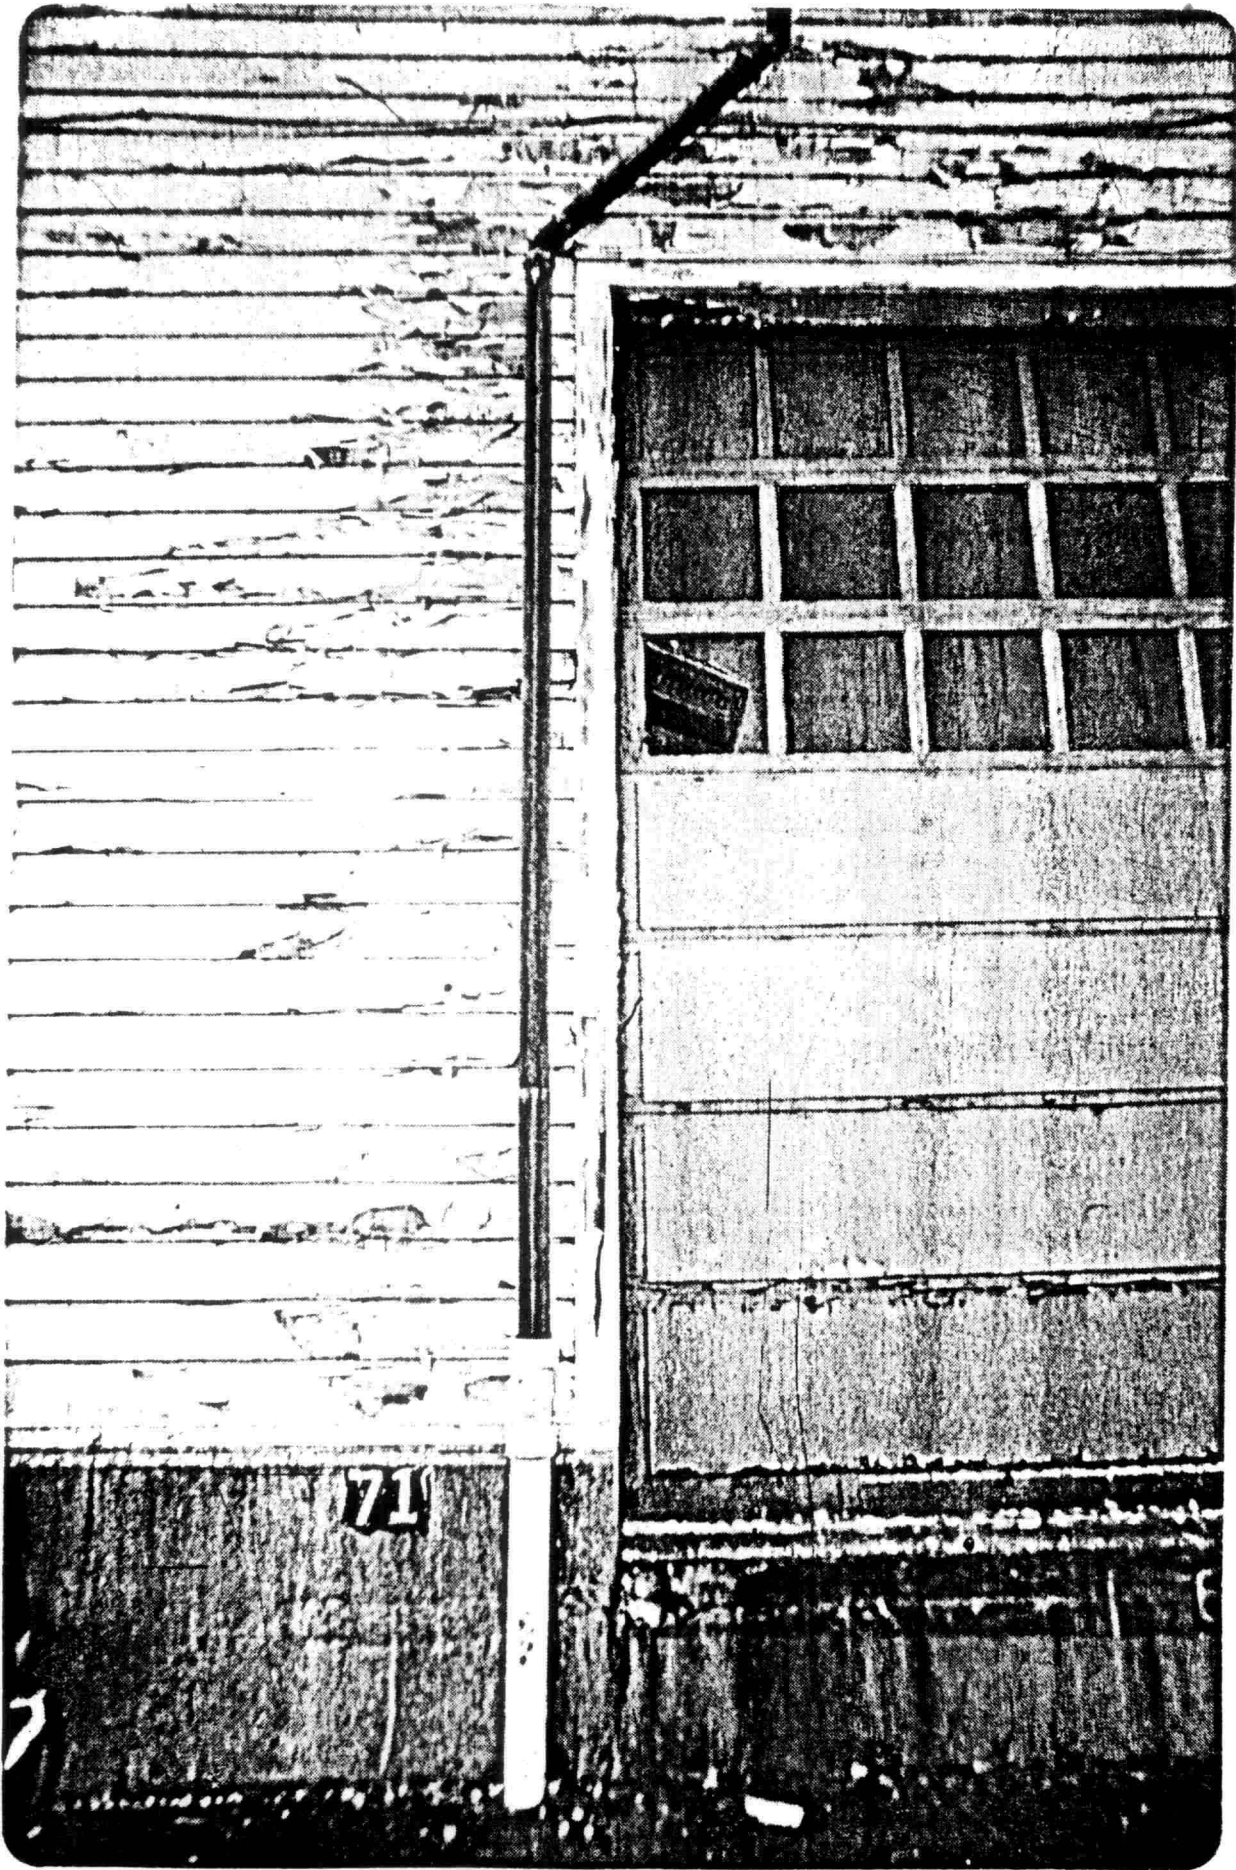
Boston Naval Shipyard - Building 198
Plate 2
Exterior North Elevation - wood siding
deterioration, roof drain and overhead
doors.

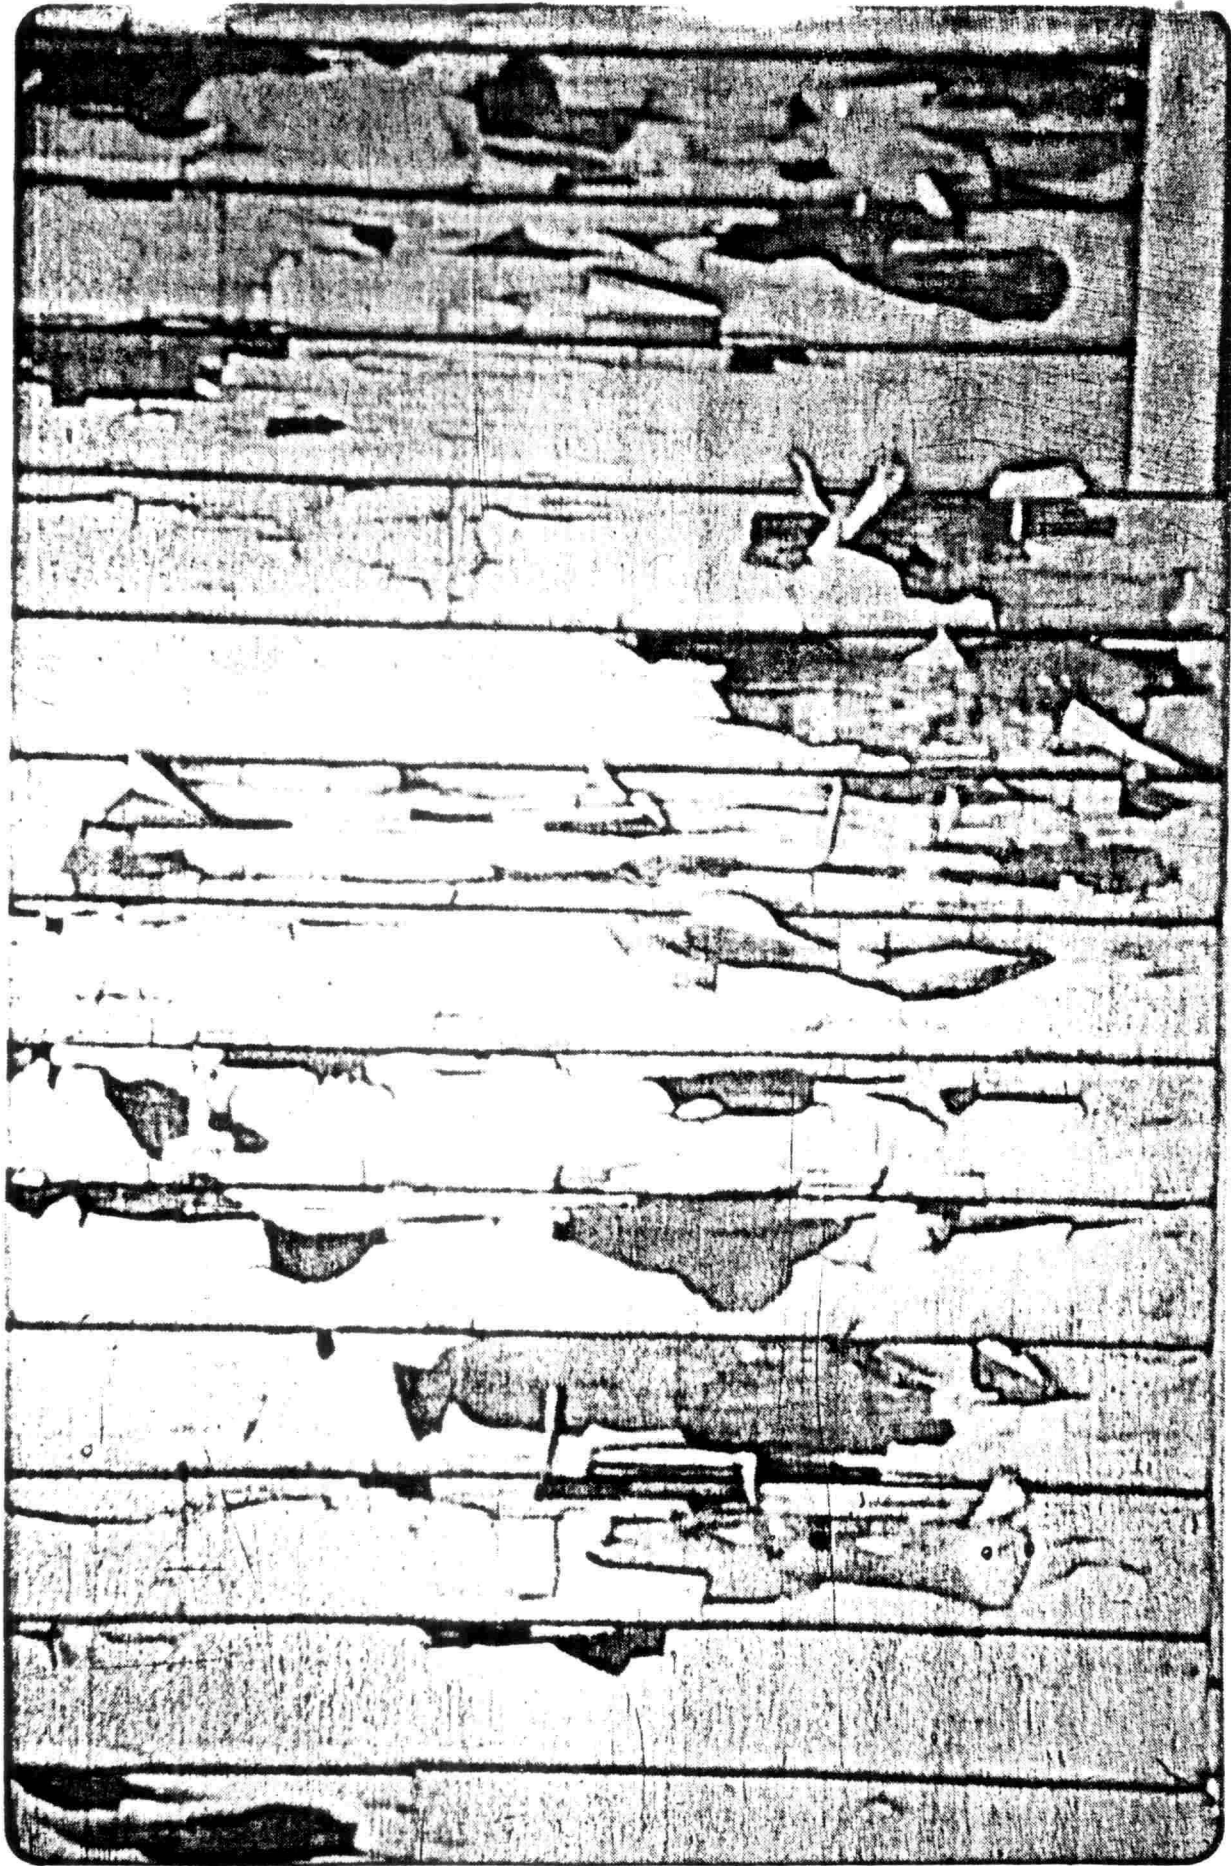
Boston Naval Shipyard - Building 198
Plate 3
Exterior North Elevation - detail of
wood siding deterioration

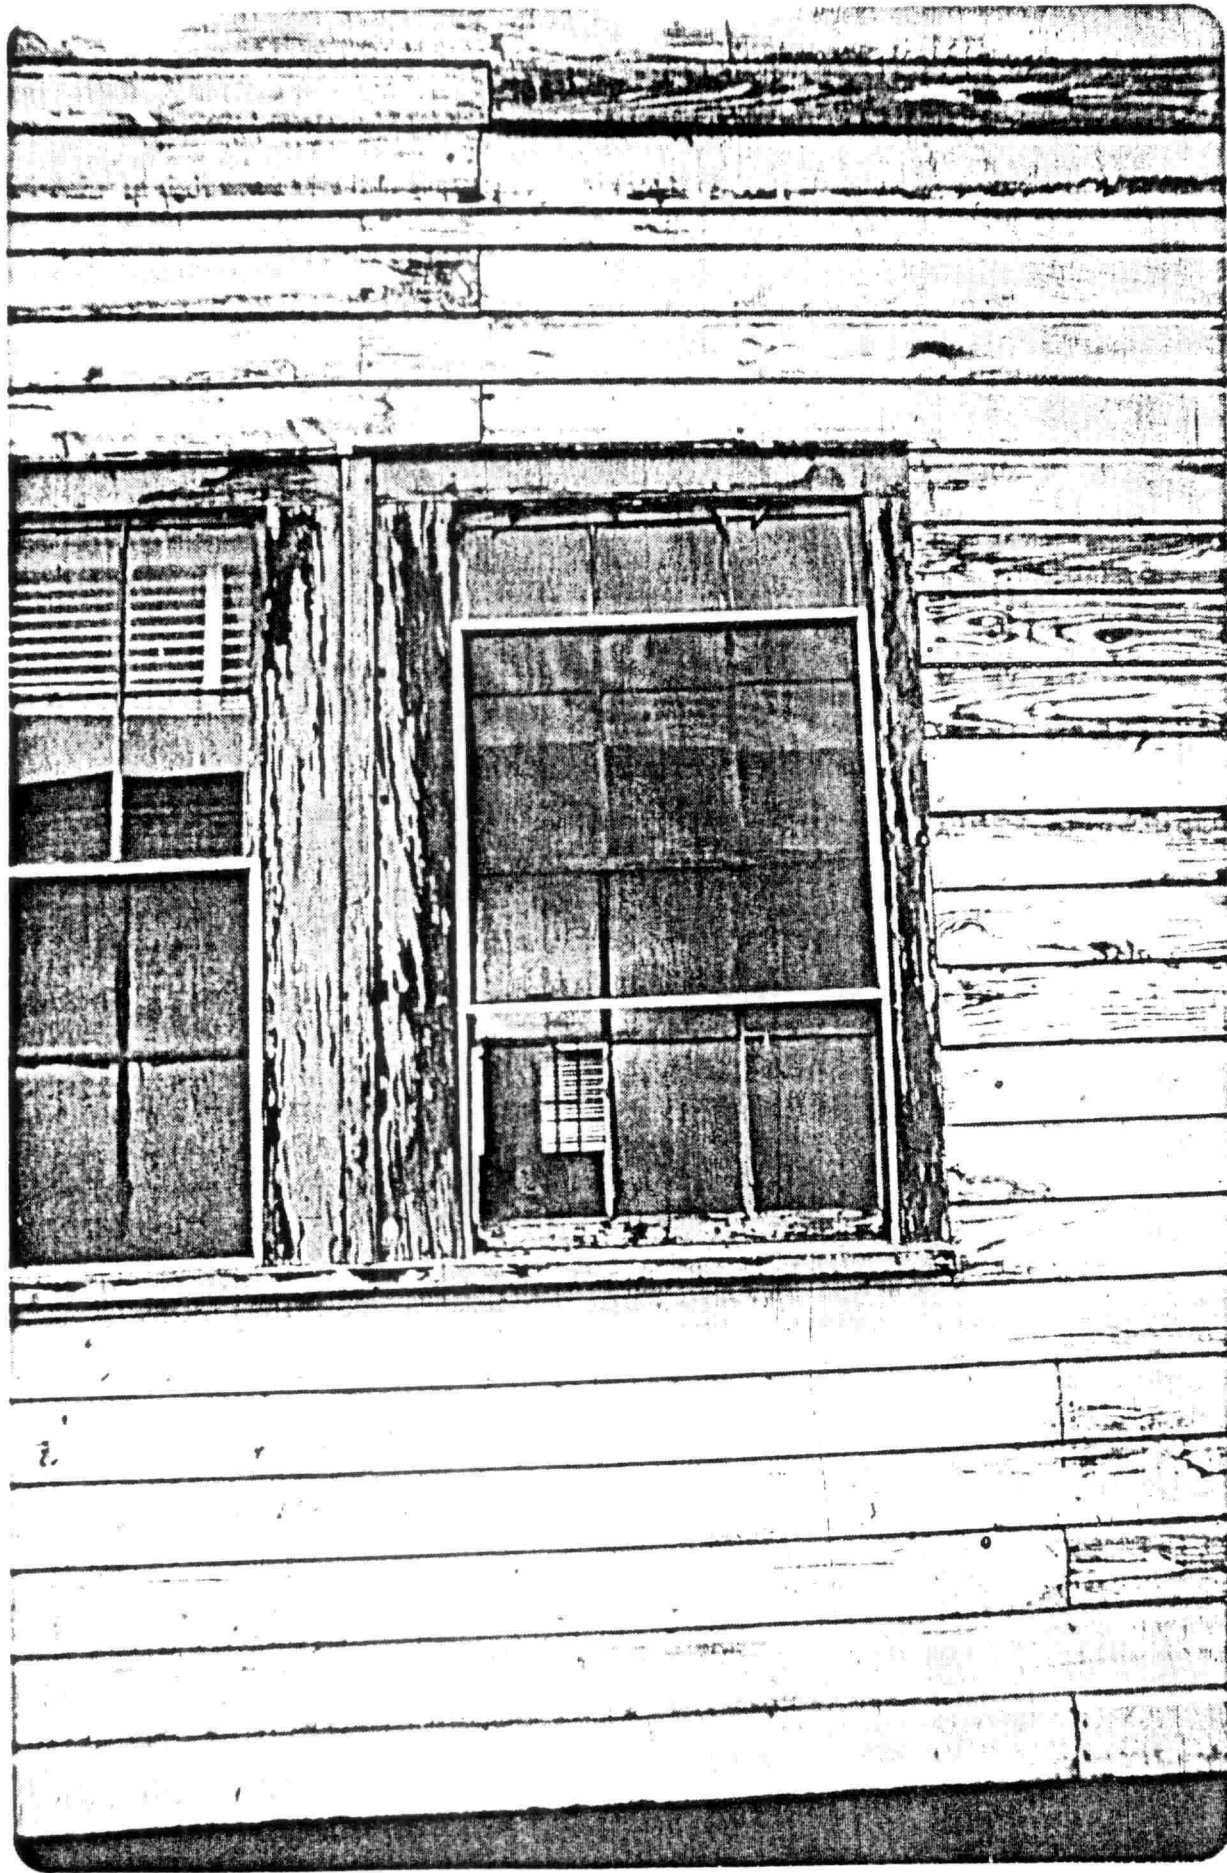
Boston Naval Shipyard - Building 198
Plate 6

Exterior elevation of west wing 3rd level. Window, siding, screen, and roof flashing deterioration.

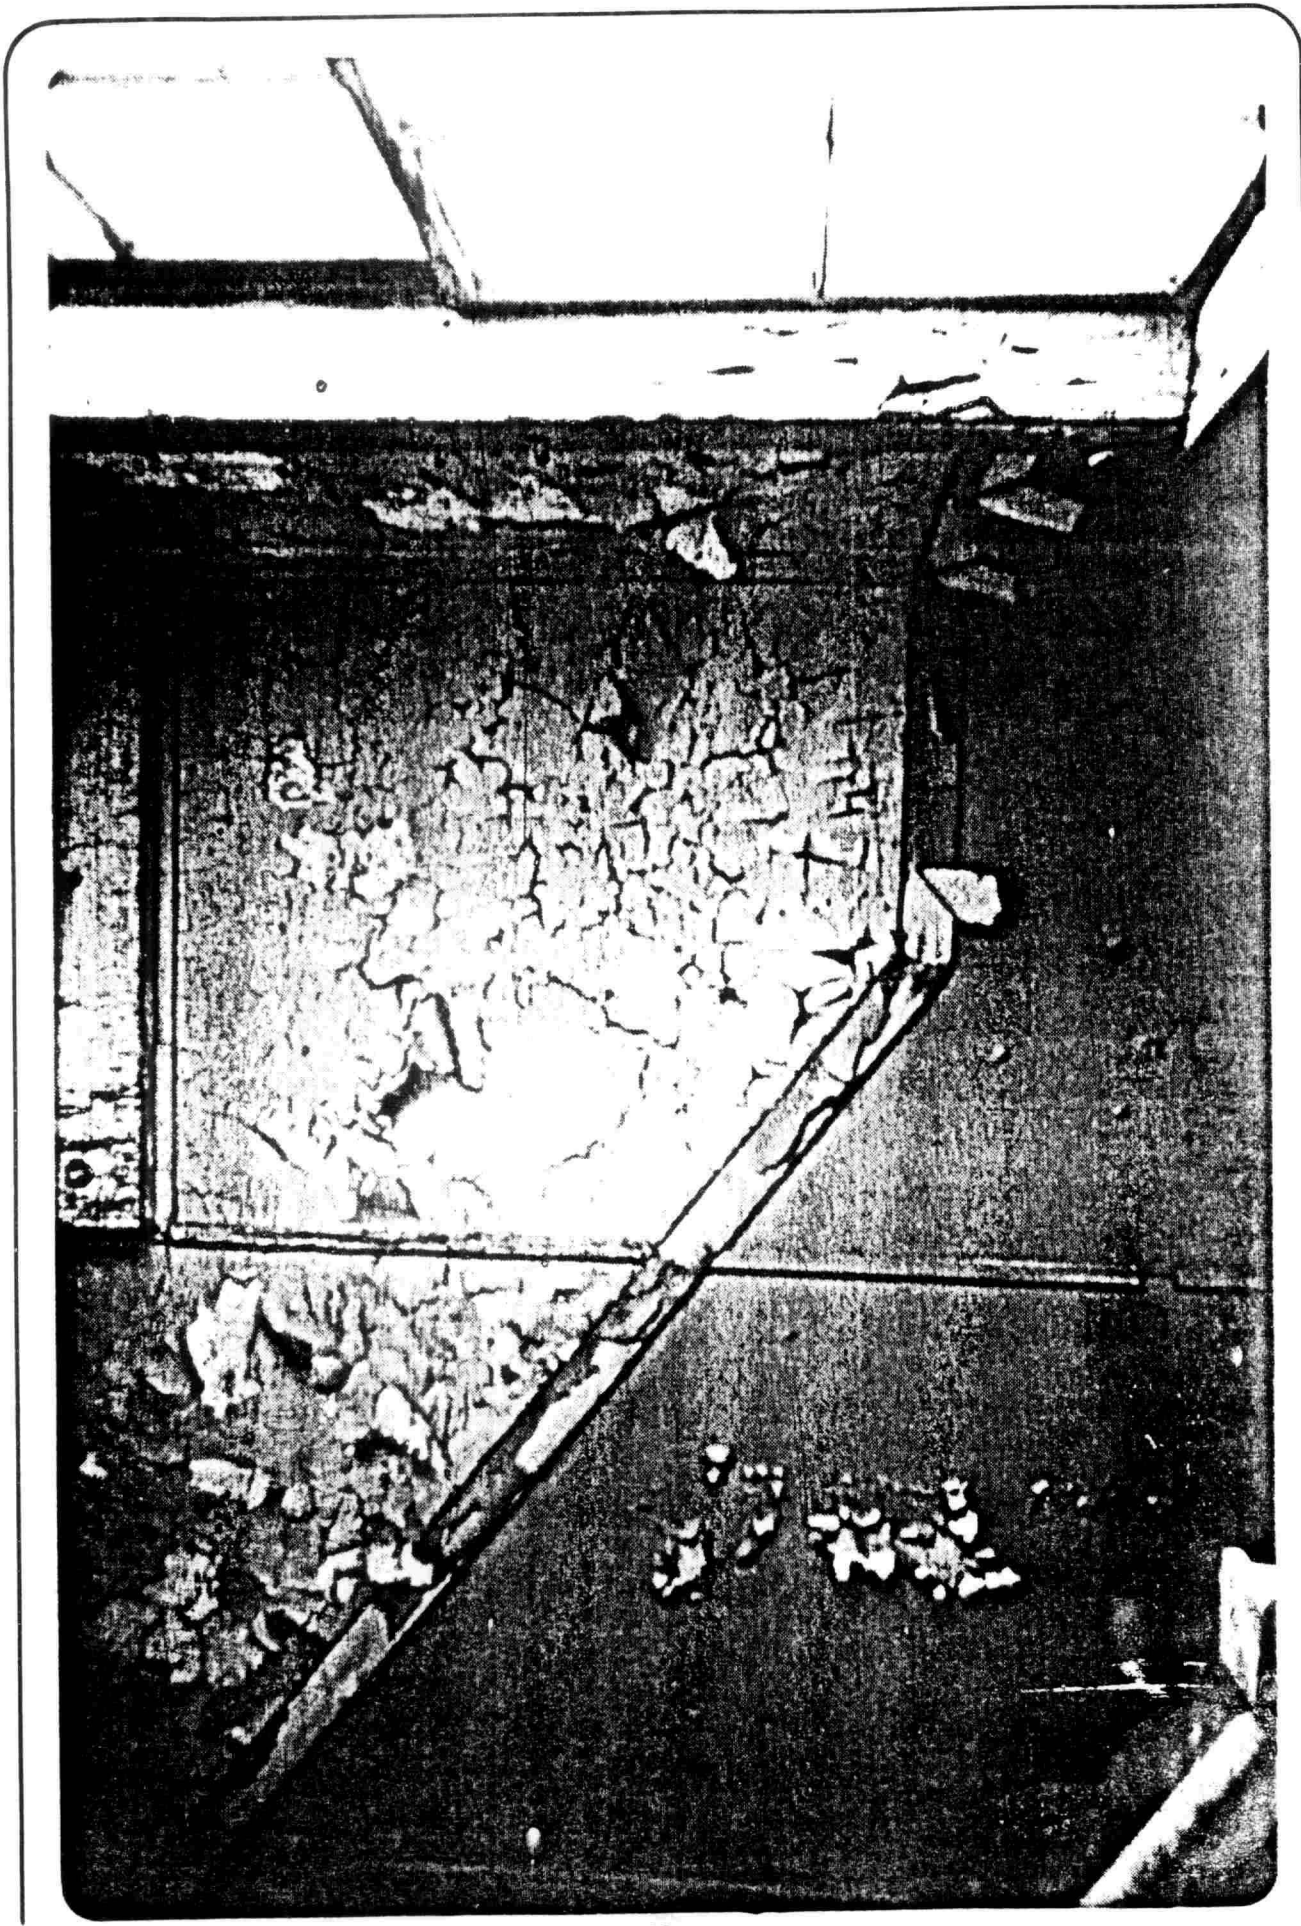
Boston Naval Shipyard - Building 198
Plate 12
Interior - West stair enclosure, 2nd
level, south wall, window, walls, hand-
rail and stair deterioration

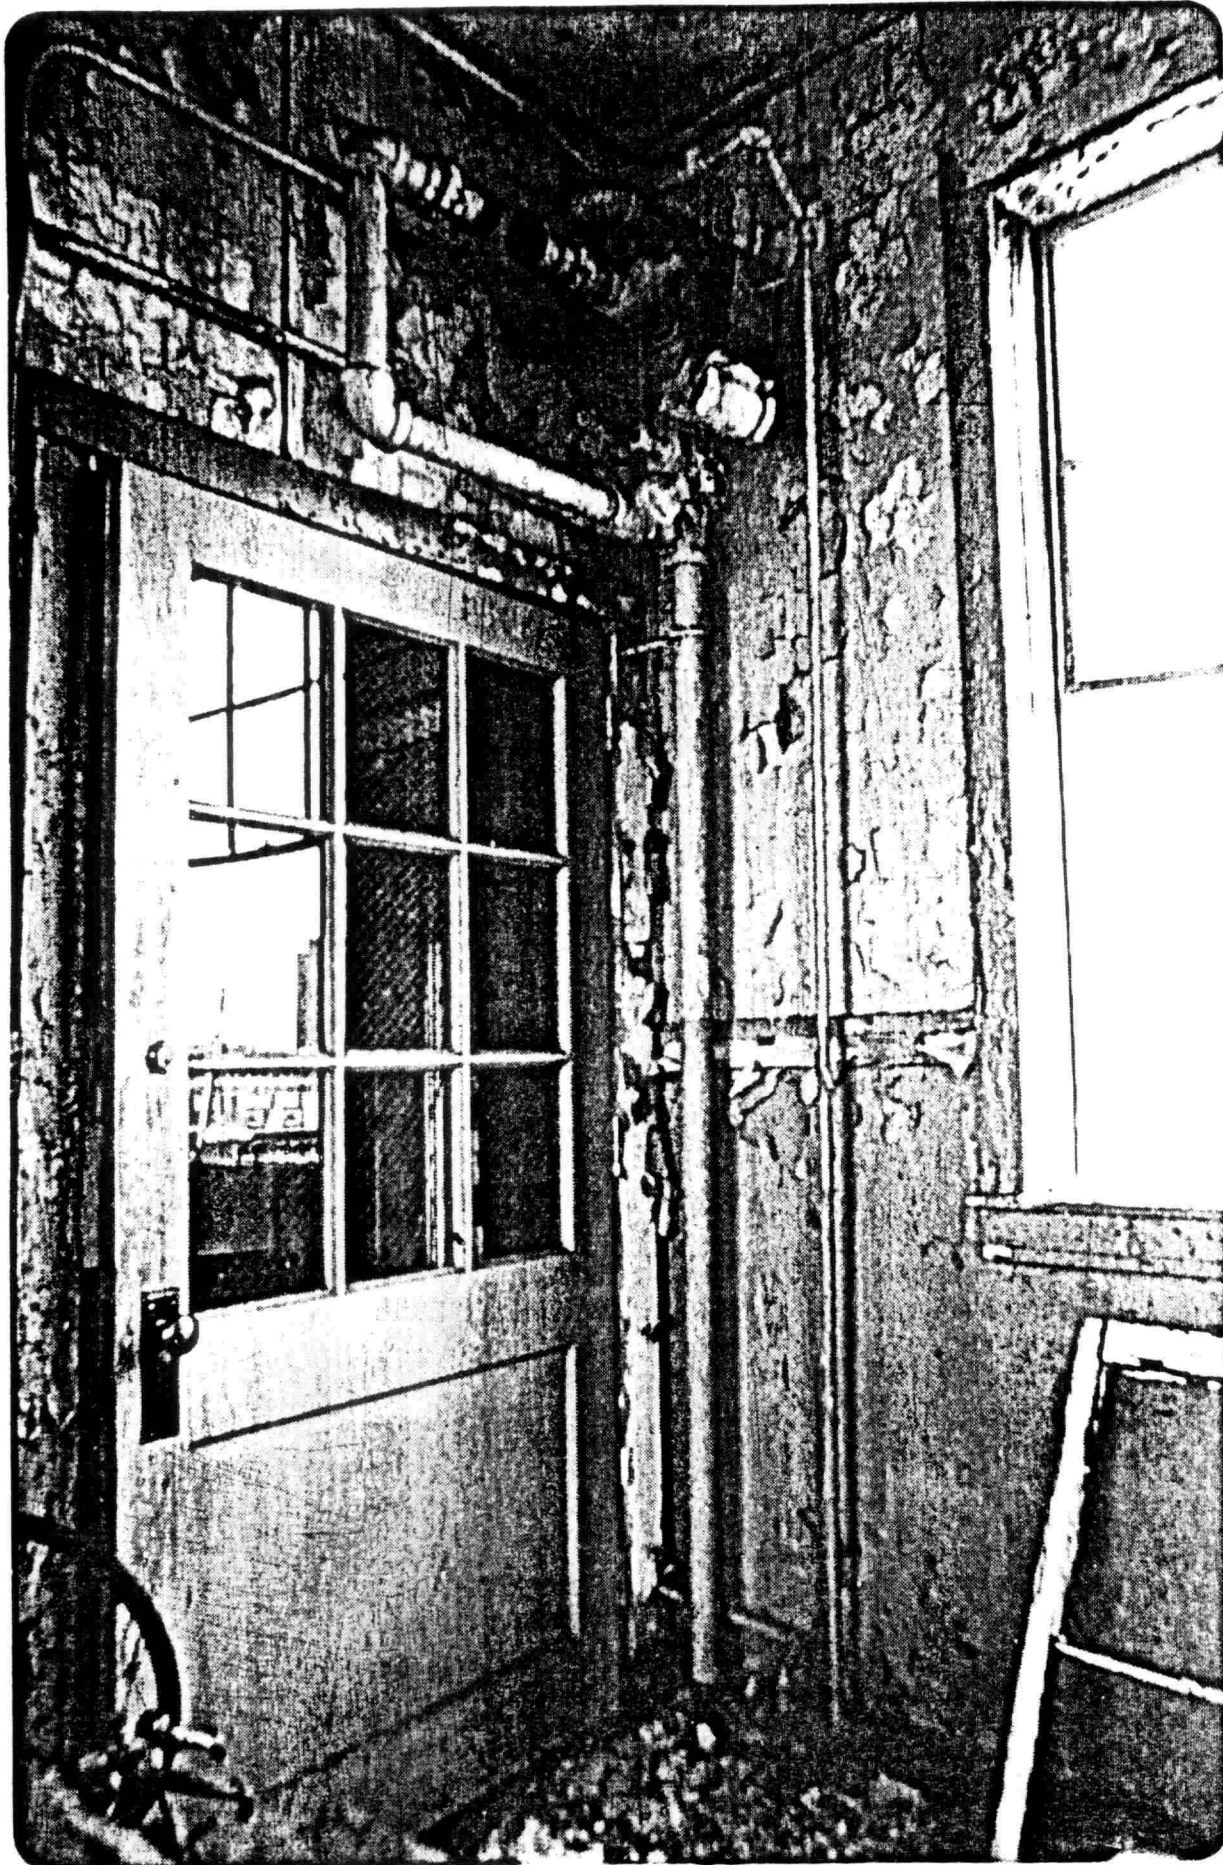
Plate 13

Interior - West stair enclosure, 3rd
level, south wall, pipes broken, window
missing, wall ceiling and door
deterioration

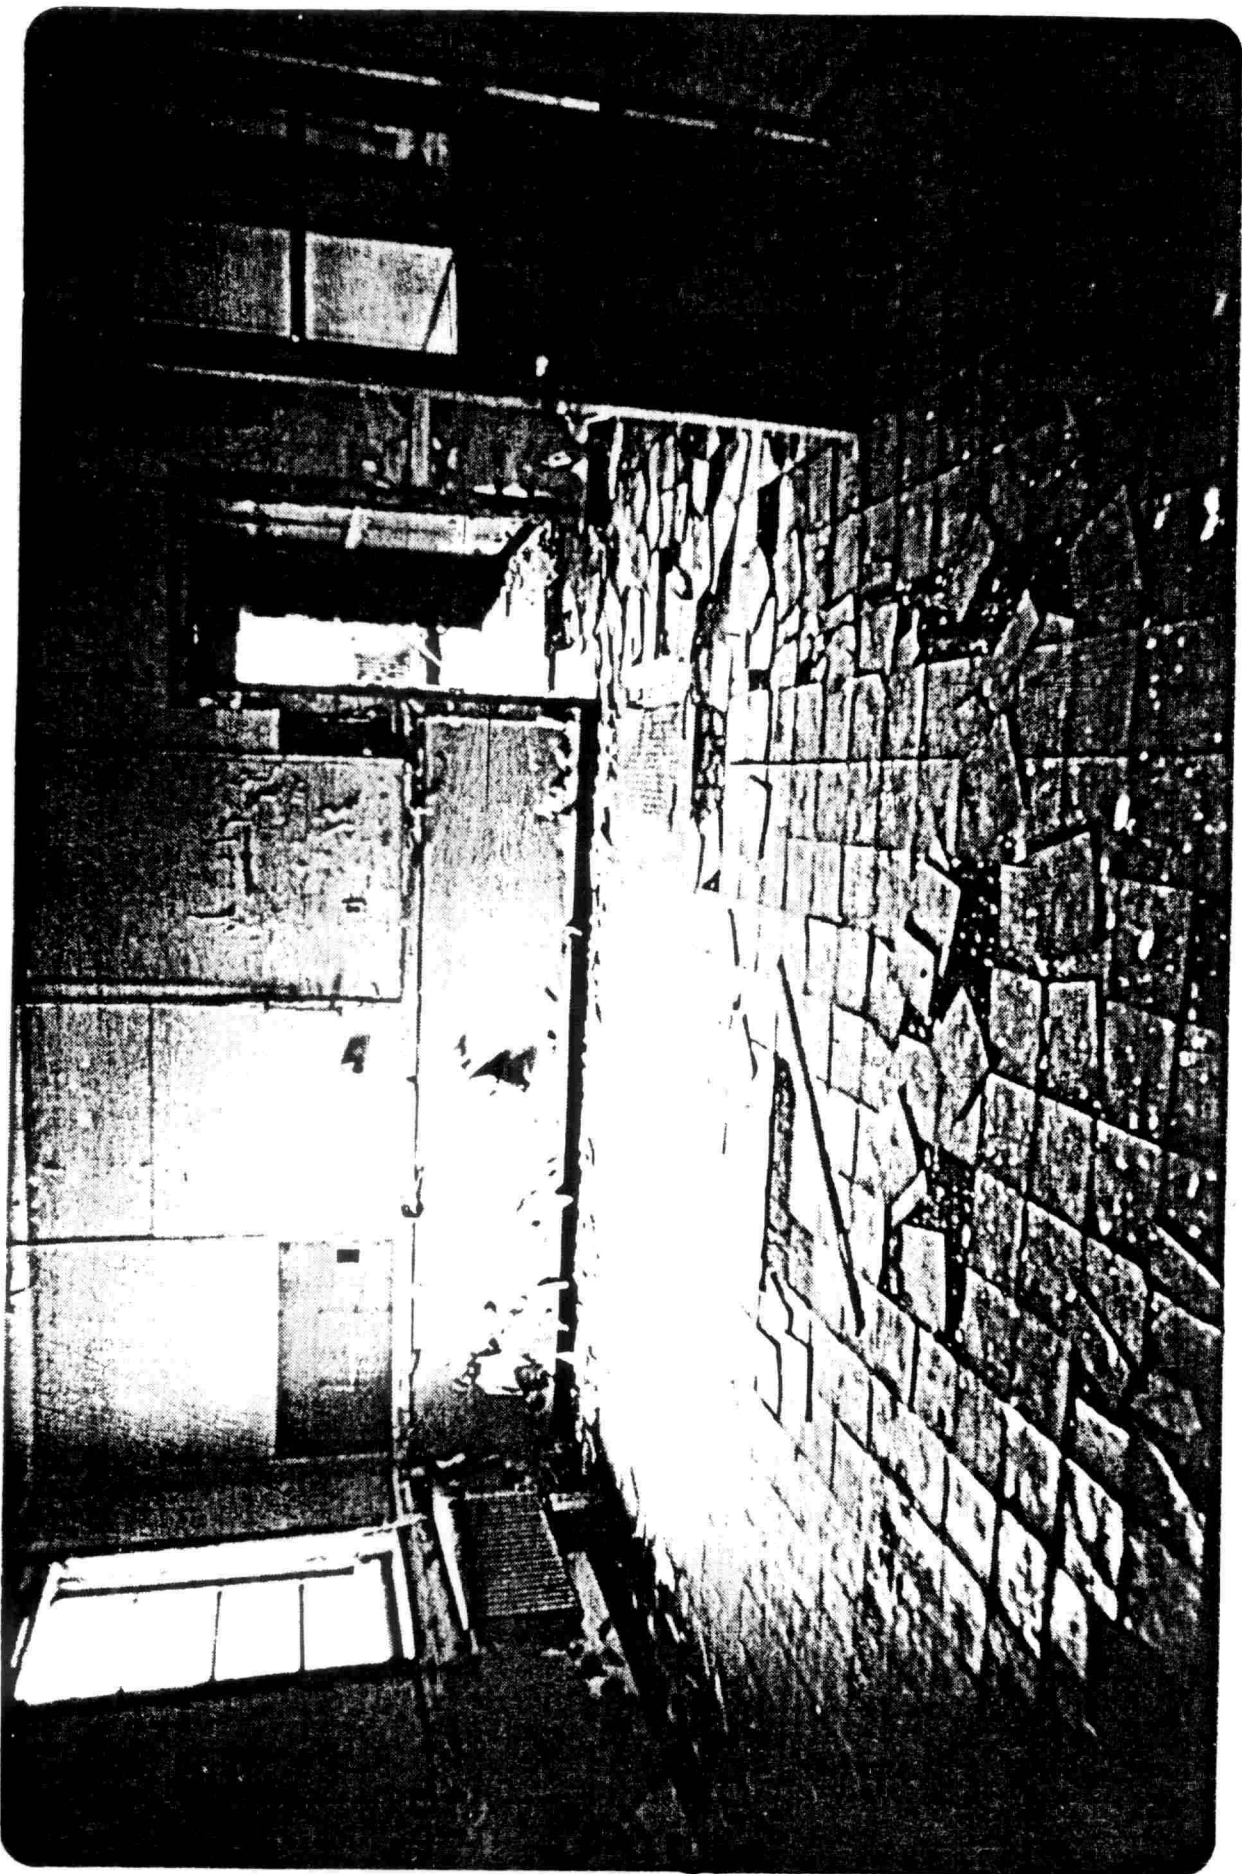
Boston Naval Shipyard - Building 198
Plate 14
Interior 3rd floor level, east barracks
center section, looking north, floor
wall, ceiling, window and door
deterioration

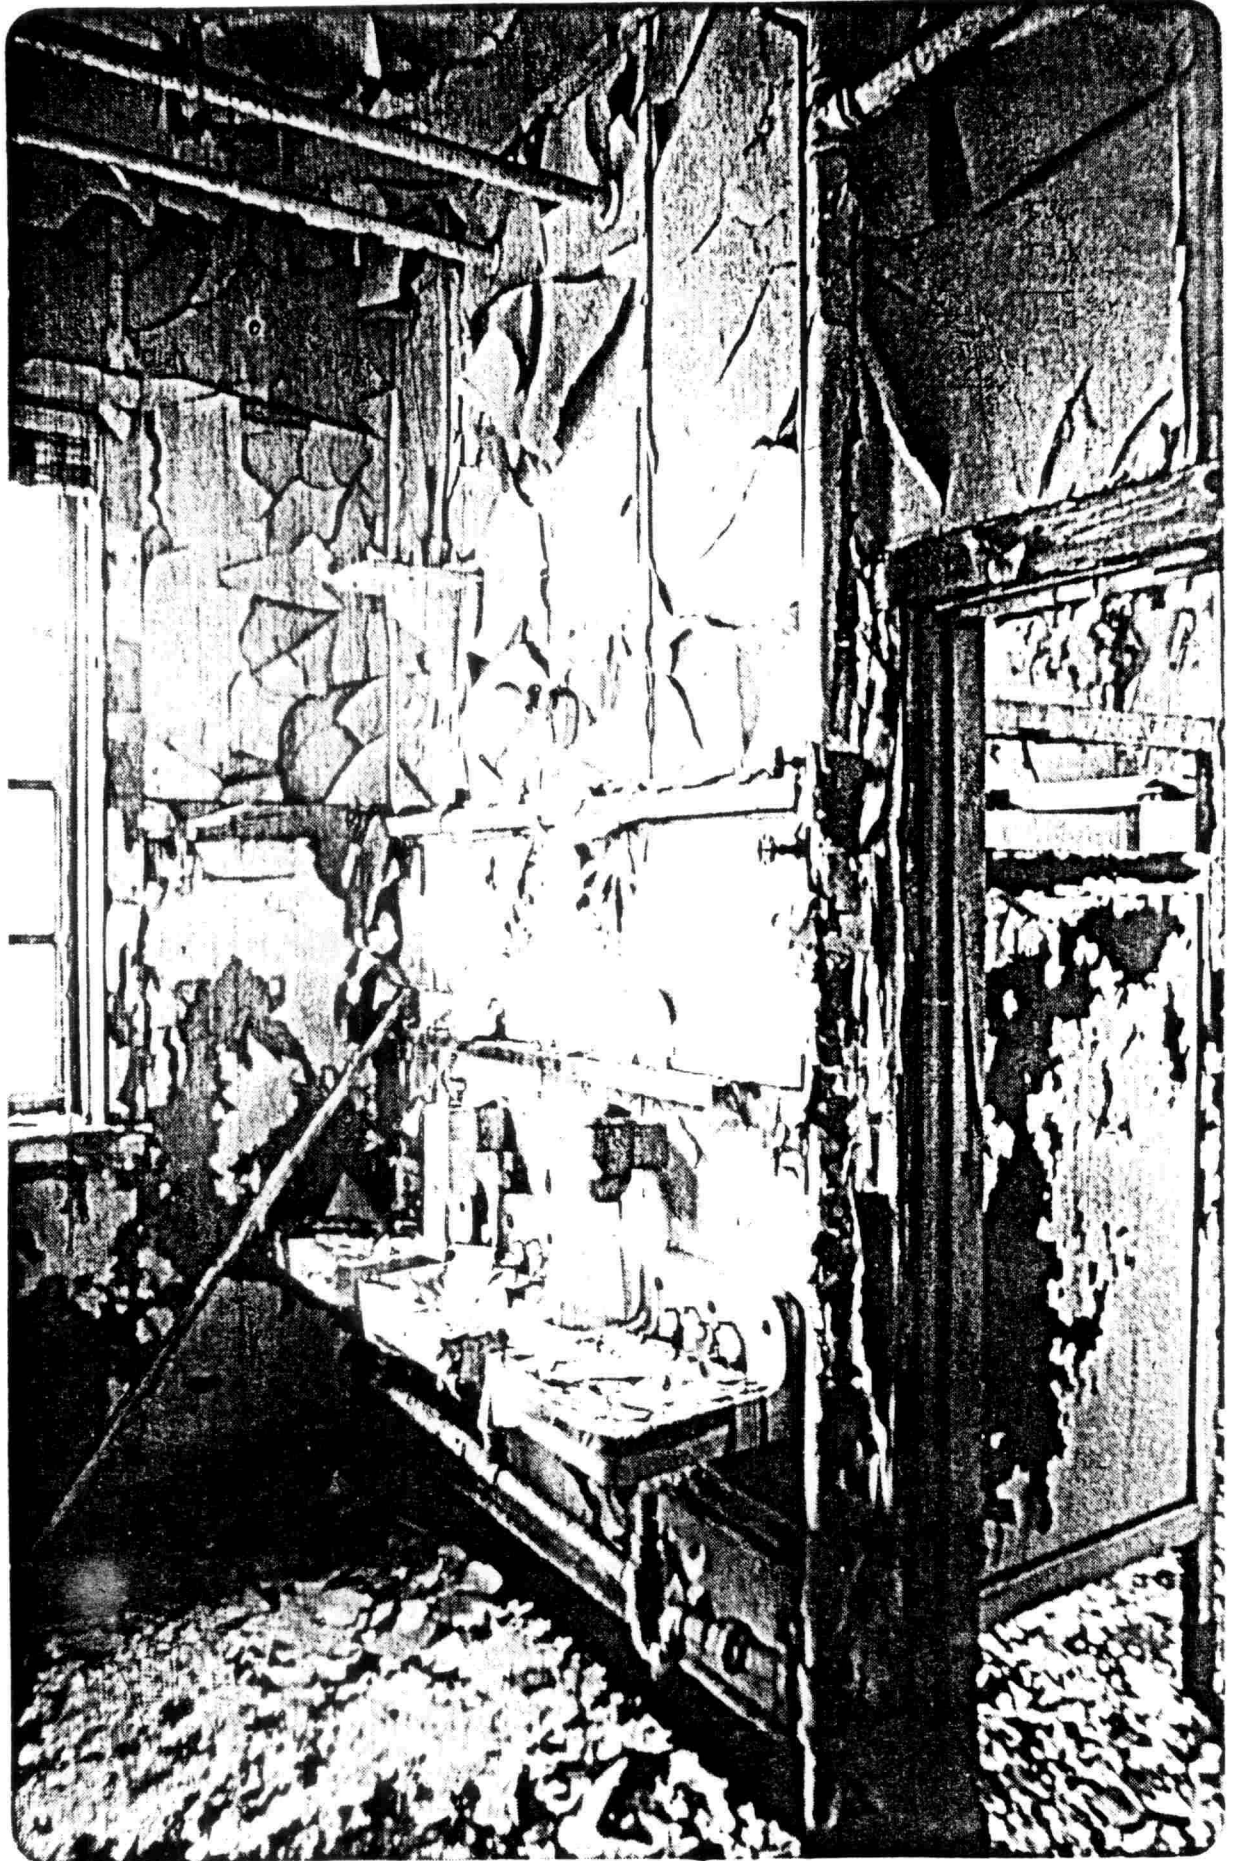
Plate 15

Interior, 3rd level, east barracks, rest
rooms, south wall, floor wall, ceiling,
door, window, plumbing fixture
deterioration

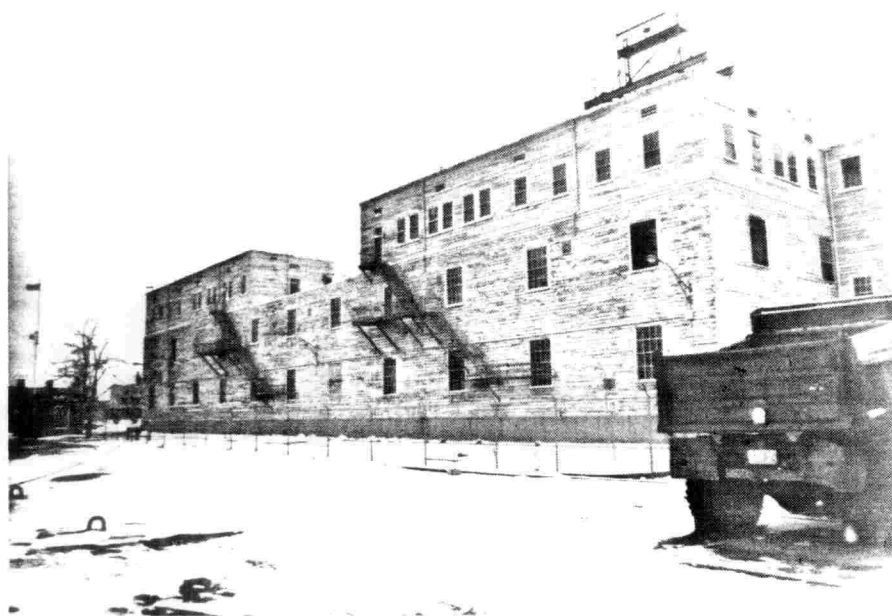
Illustration 13. Southeast corner showing missing sash at second floor, structure on roof for lights, relationship to adjacent Building 32. Note also one added vent replacing a window sash at the third-floor level.

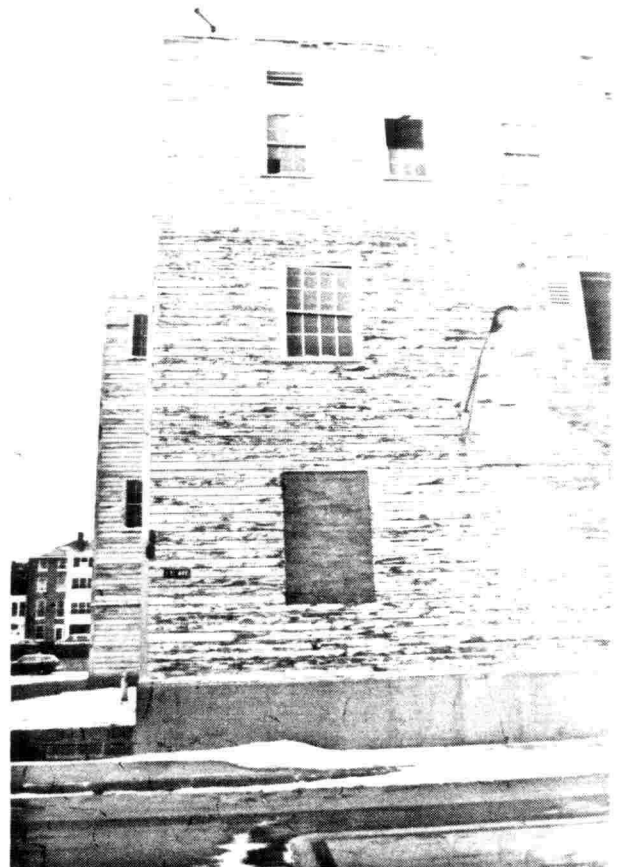
Illustration 17. Western portion of the south facade.
Note the missing sash at second and third floors.

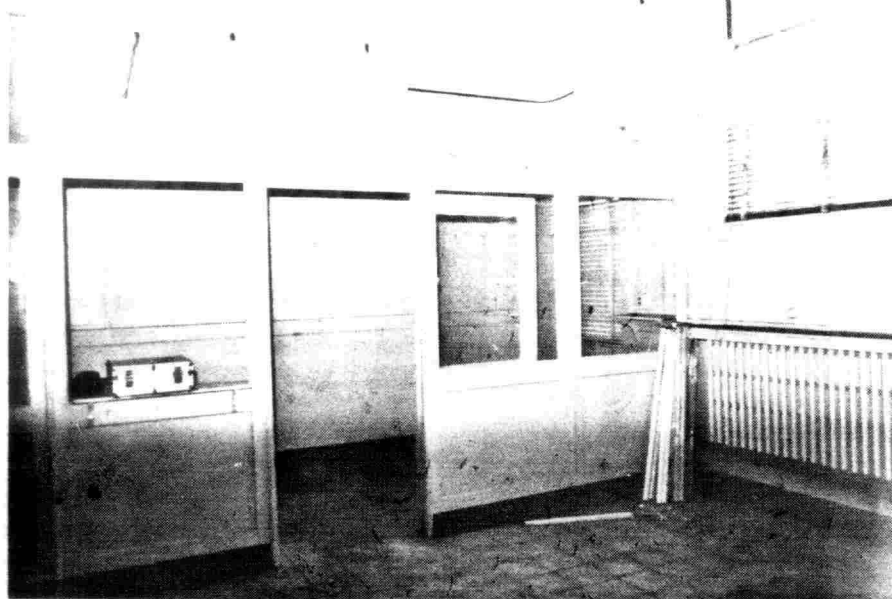
Illustration 30. West wall of Room 112 from Room 104. Note the standing water on floor due to leakage through floor above and missing window sash.

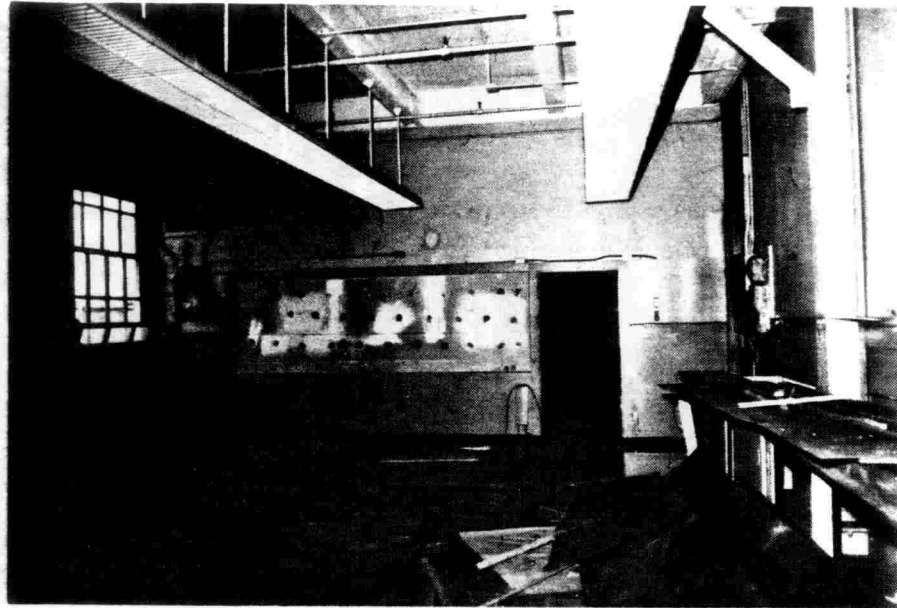
Illustration 42. Room 206 - typical classroom. Note vent in lower corner, fallen blackboard, damaged tiles on floor, missing sash.

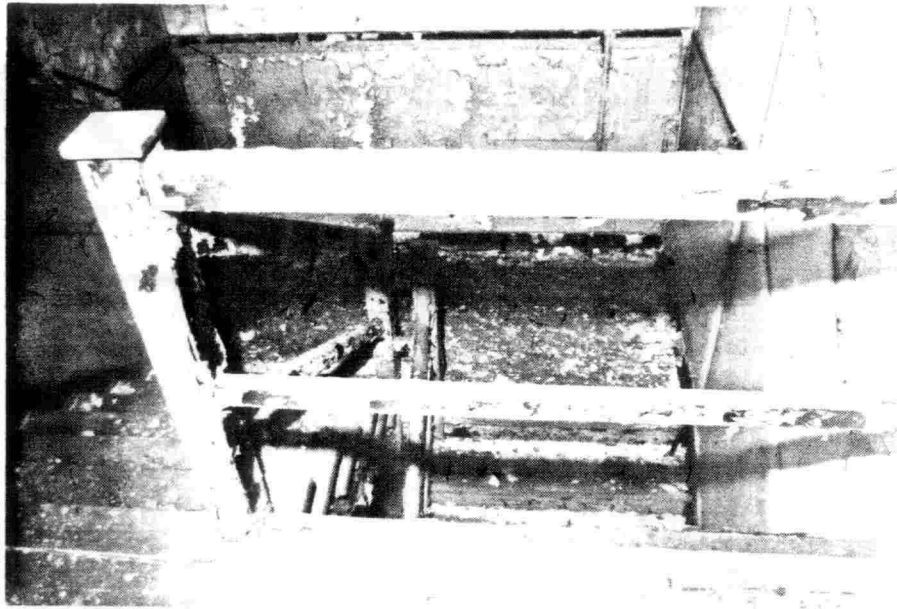
Illustration 46. Room 217 - missing sash on south and east walls has caused much damage. Parts of the missing sash are on the floor in this room.

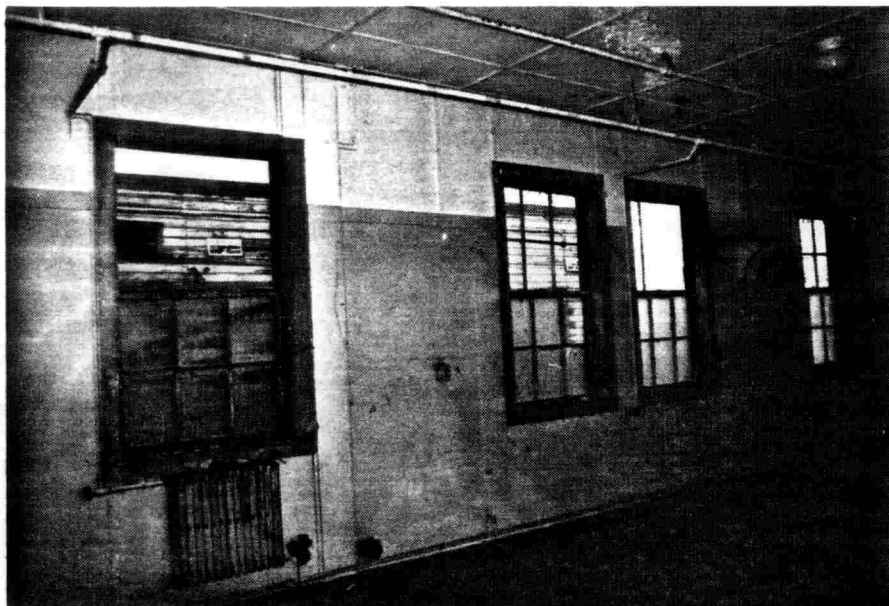
Illustration 51. Room 317 - hallway looking east toward Rooms 325, 326. Note water damaged floor. Doors on right lead to Rooms 319 and 321. Doors on left lead to Rooms 322, 323 and 324.

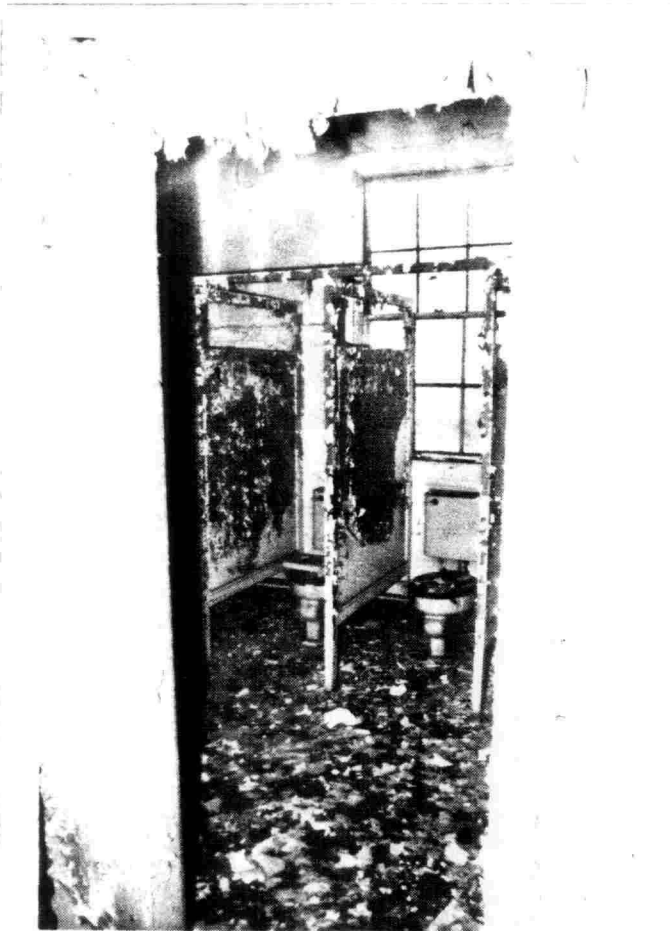
Illustration 52. Room 328 - Low partitions have been removed - some sash missing.

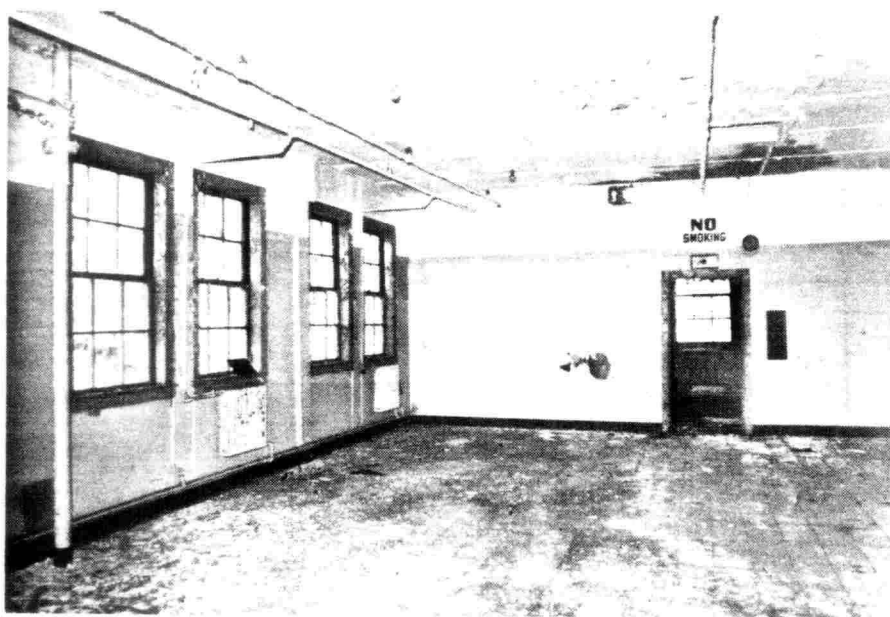
Illustration 55. Room 336 - looking west at west addition to third floor. Door missing.
