HISTORIC STRUCTURE REPORT

THE OLD POINT LOMA LIGHTHOUSE  
CABRILLO NATIONAL MONUMENT  
SAN DIEGO, CALIFORNIA

by  
F. Ross Holland, Jr.  
Historian

March 1981

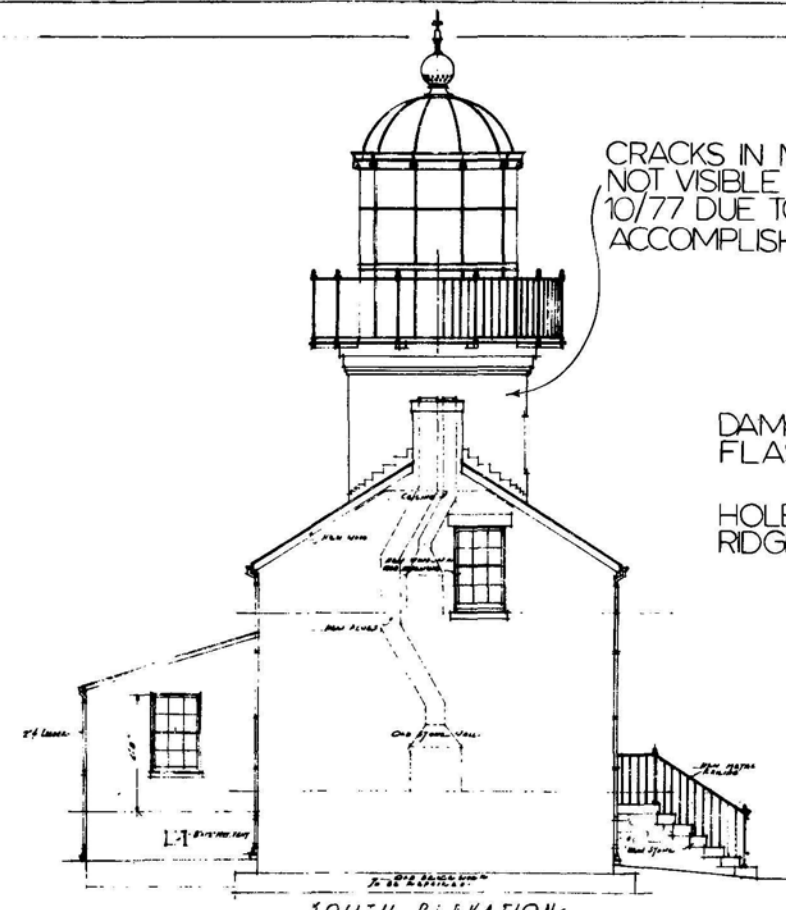
CRACKS IN MASONRY TOWER WERE NOT VISIBLE AT TIME OF RECORDING, 10/77 DUE TO REPOINTING & PAINTING ACCOMPLISHED EARLIER THAT YEAR

DAMAGED FLASHING  
HOLES IN RIDGE

MOISTURE DAMAGED PLASTER  
STANDING WATER

ELEC. OUTLET CLOSE TO STANDING WATER

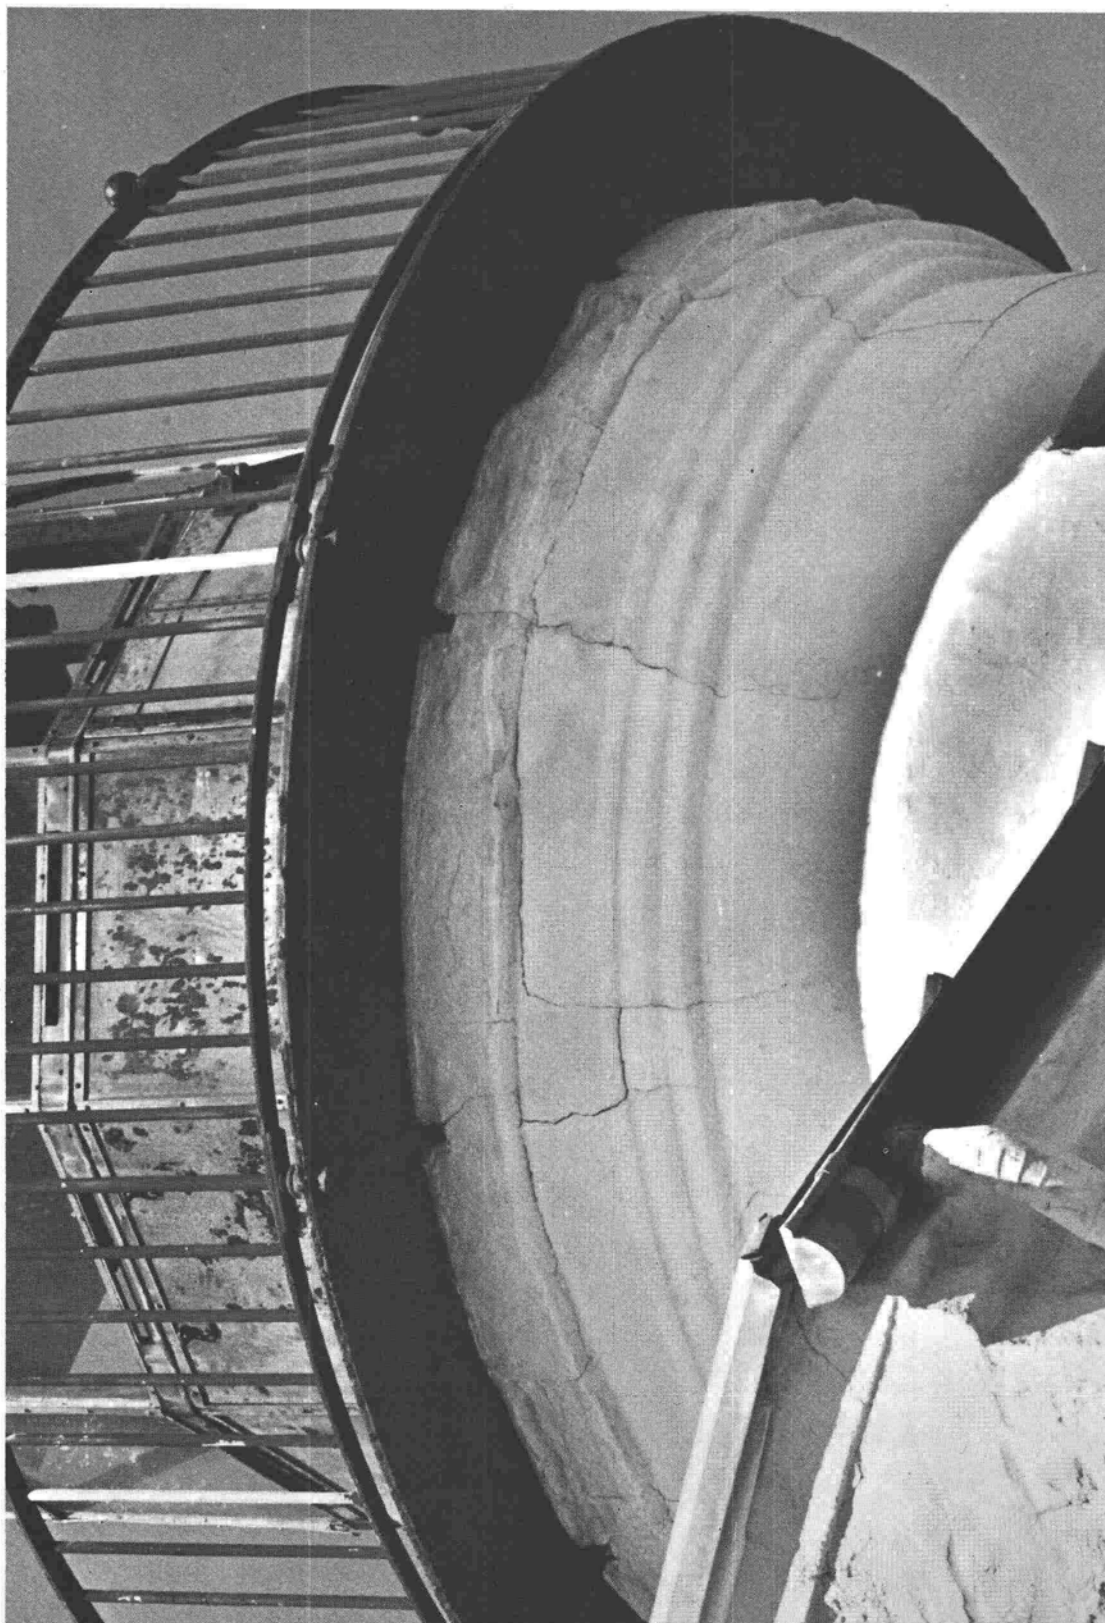
OLD POINT LOMA LIGHTHOUSE TOWER PRIOR TO THE MOST RECENT CAULKING AND REPAINTING, 1977.  
NOTE THE CRACKS IN THE MASONRY. National Park Service photograph Cabrillo National Monument.

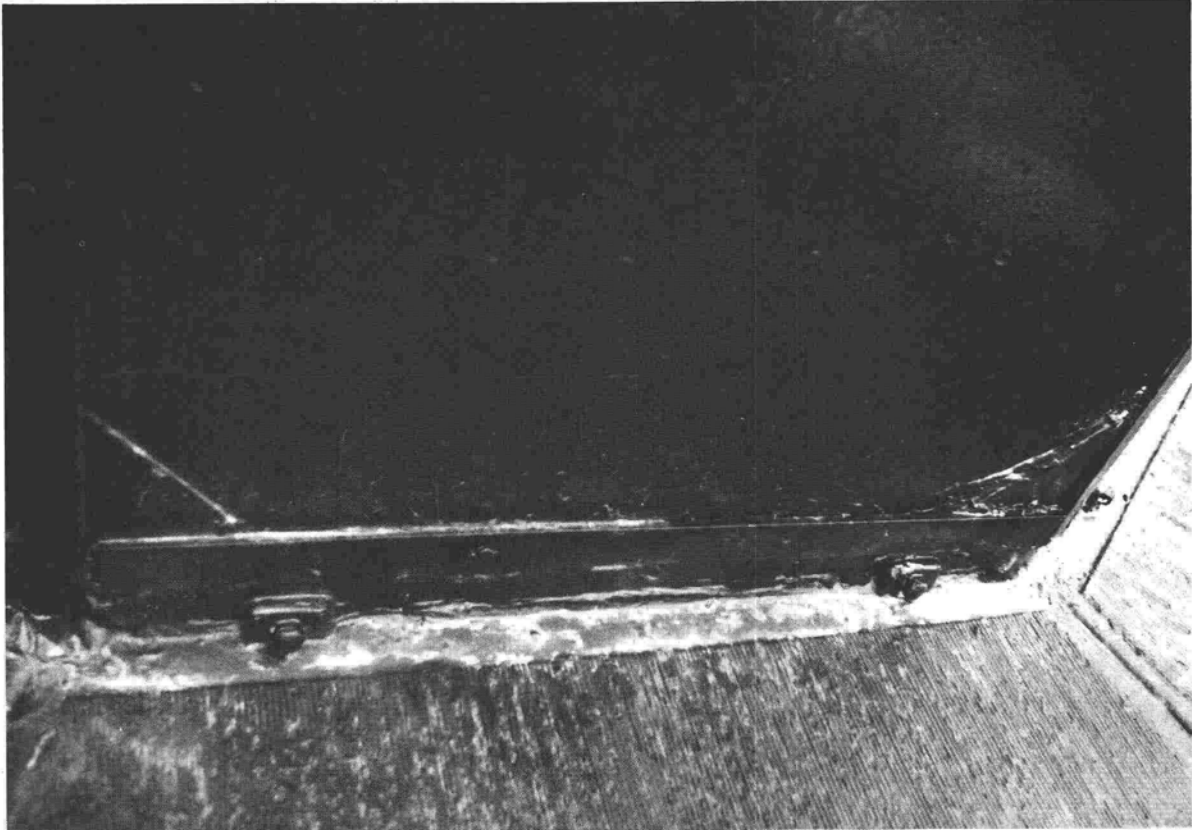
Parts of the floor gutters have disintegrated from corrosion. Many of the lower corners of the iron wall plates have disintegrated where these components meet the base of the astragals. Here again is a potential of moisture getting to the embedded iron in the masonry tower. The park has temporarily alleviated this situation by applying caulking at these joints and painted over them.

OLD POINT LOMA LIGHTHOUSE, EXISTING PANEL ON LANTERN, 1977.  
NOTE WHERE LOWER CORNERS HAVE BEEN PATCHED. National Park  
Service photograph by H. G. Law.

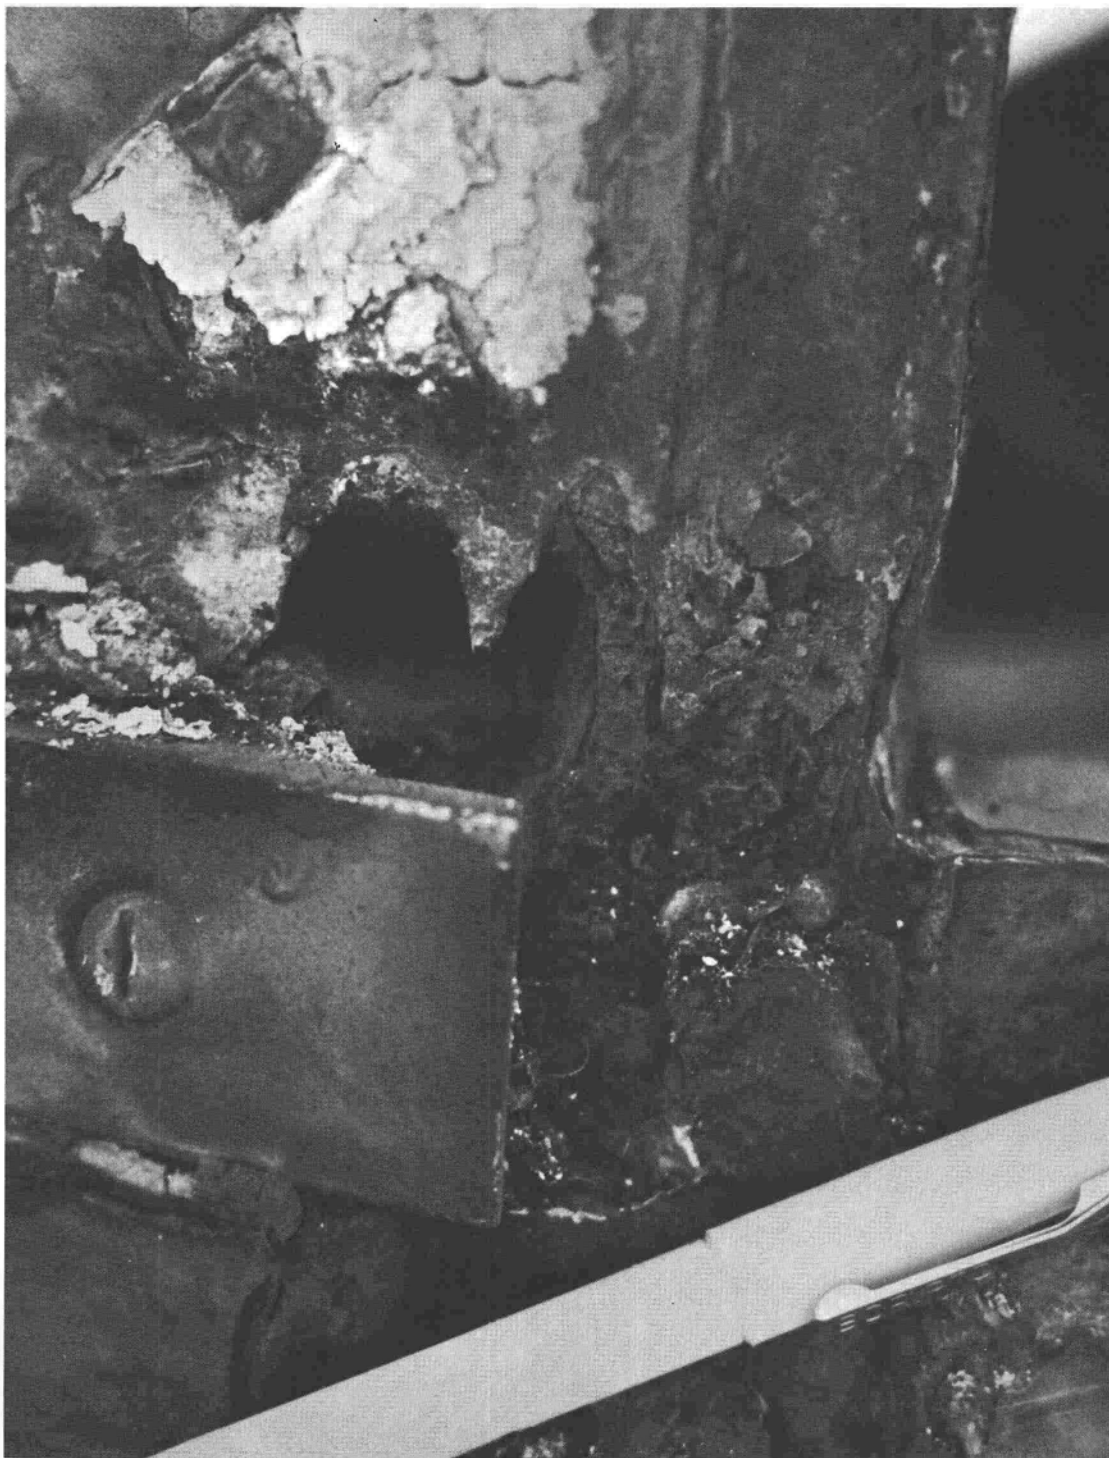
OLD POINT LOMA LIGHTHOUSE, 1977, DETAIL AT BASE OF LANTERN  
SHOWING DETERIORATED CONDITION OF A PANEL CORNER AND ADJACENT  
ASTRAGAL. National Park Service photograph Cabrillo National  
Monument.

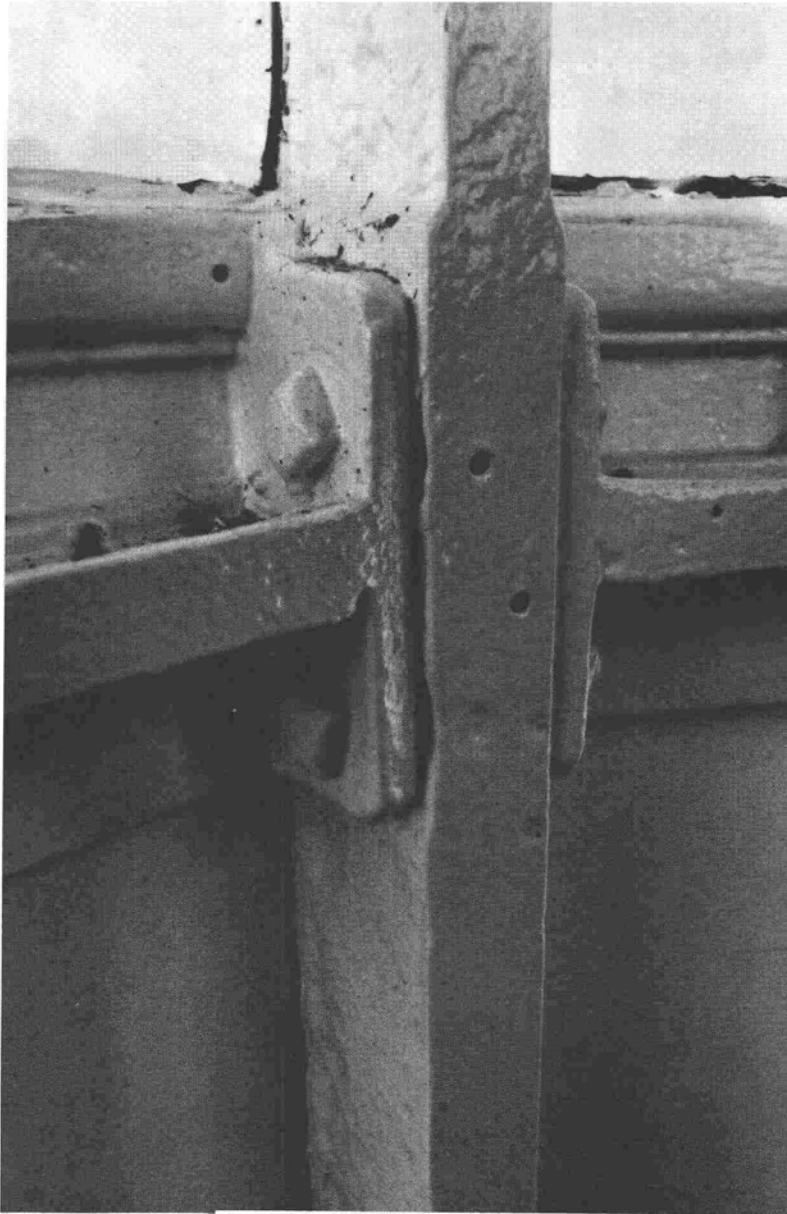
Metals and alloys can be arranged in a table of decreasing chemical activity (galvanic series). The further apart a given pair of metals in the series the greater the potential for dissimilar metal attack. This is most important when specifying a copper alloy (brass) to be in contact with an iron. Another variable can be the ratio of exposed area of the more active in relation to the less active type. It appears that early lighthouse builders knew what they were doing. The replacement brass (copper alloy) should be of a type to resist corrosion in a marine environment as well as be as close as possible in galvanic series to the existing adjacent iron.

OLD POINT LOMA LIGHTHOUSE, 1979. TYPICAL DETAIL OF WINDOW SILL/  
GUTTER CONNECTED TO THE VERTICAL ASTRAGAL. NOTE THE GAPS LEFT  
FROM PIT CORROSION. THESE GAPS ARE IDEAL FOR THE CREATION OF  
MORE PIT CORROSION. National Park Service photograph by H. G. Law

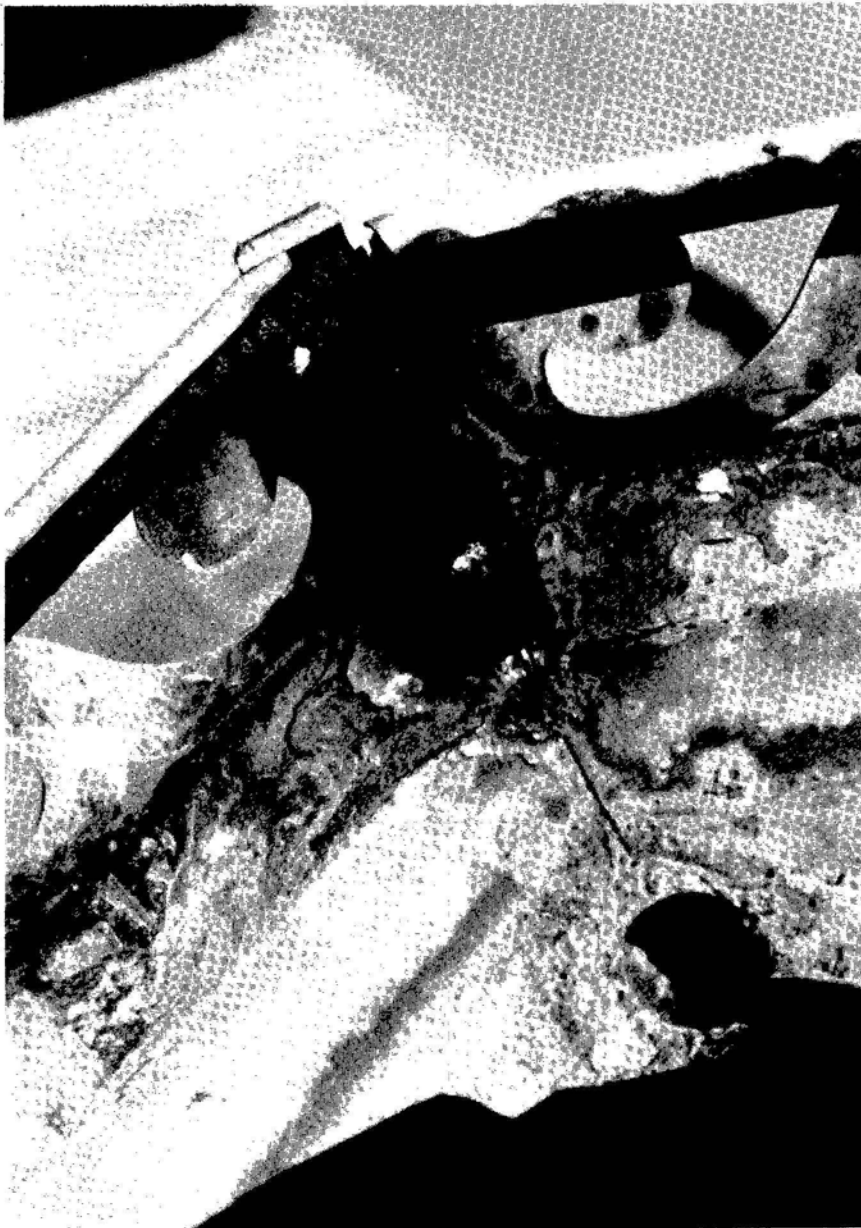
The cornice of the lantern, made of sheet copper, is supported by iron brackets that are in a deteriorated condition. Many of the iron rods that span from bracket to bracket are missing. One of the brass cleats over the joints of the cornice is missing. These brass cleats are connected to the cornice brackets with screws. Many of the cleats are in danger of falling off because of the deteriorated condition of the cornice brackets. This condition also creates a leakage possibility along the gutter.

OLD POINT LOMA LIGHTHOUSE, 1977. DETAIL OF BACK OF  
LANTERN CORNICE. NOTE CONDITION OF CORNICE BRACKETS.  
National Park Service Photograph, Cabrillo National Monument.

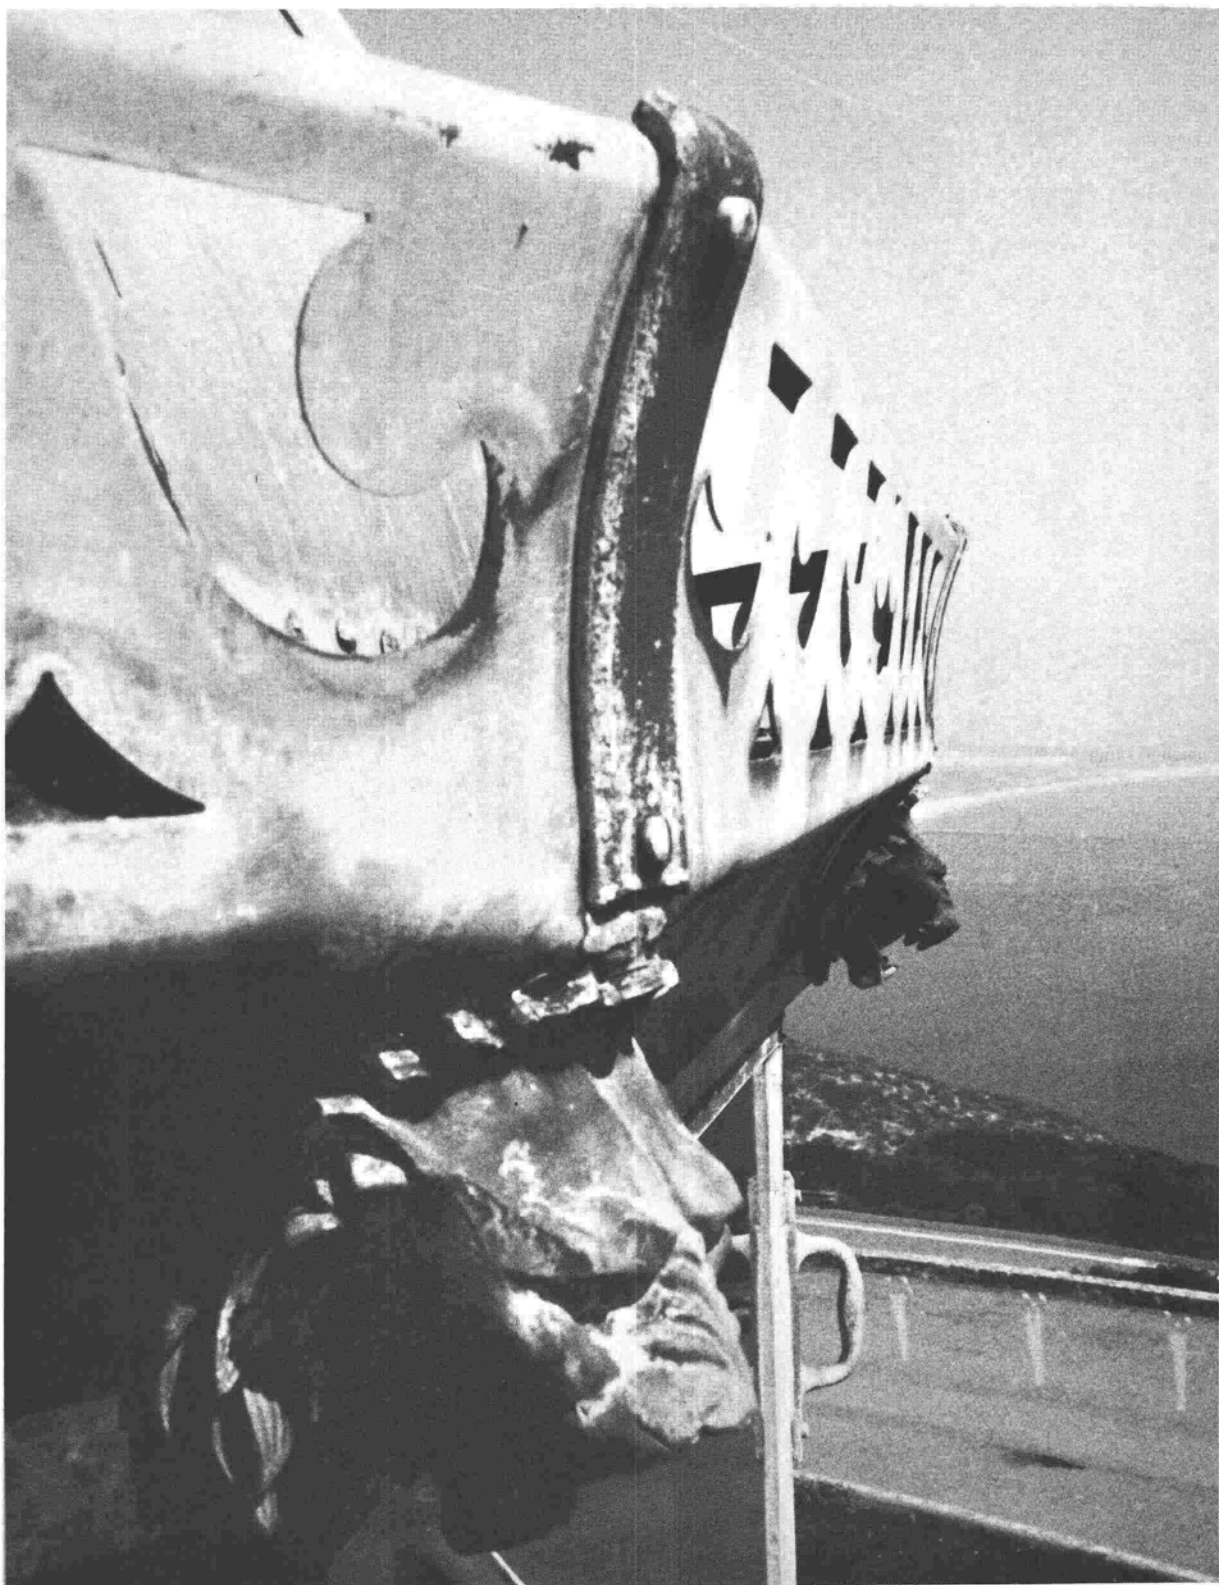
OLD POINT LOMA LIGHTHOUSE CORNICE DETAIL, 1977. NOTE CORNICE MATCHES THE ONE AT POINT PINOS BUT NOT WHAT APPEARS ON OLD PHOTOGRAPHS OF POINT LOMA. National Park Service photograph by H. G. Law

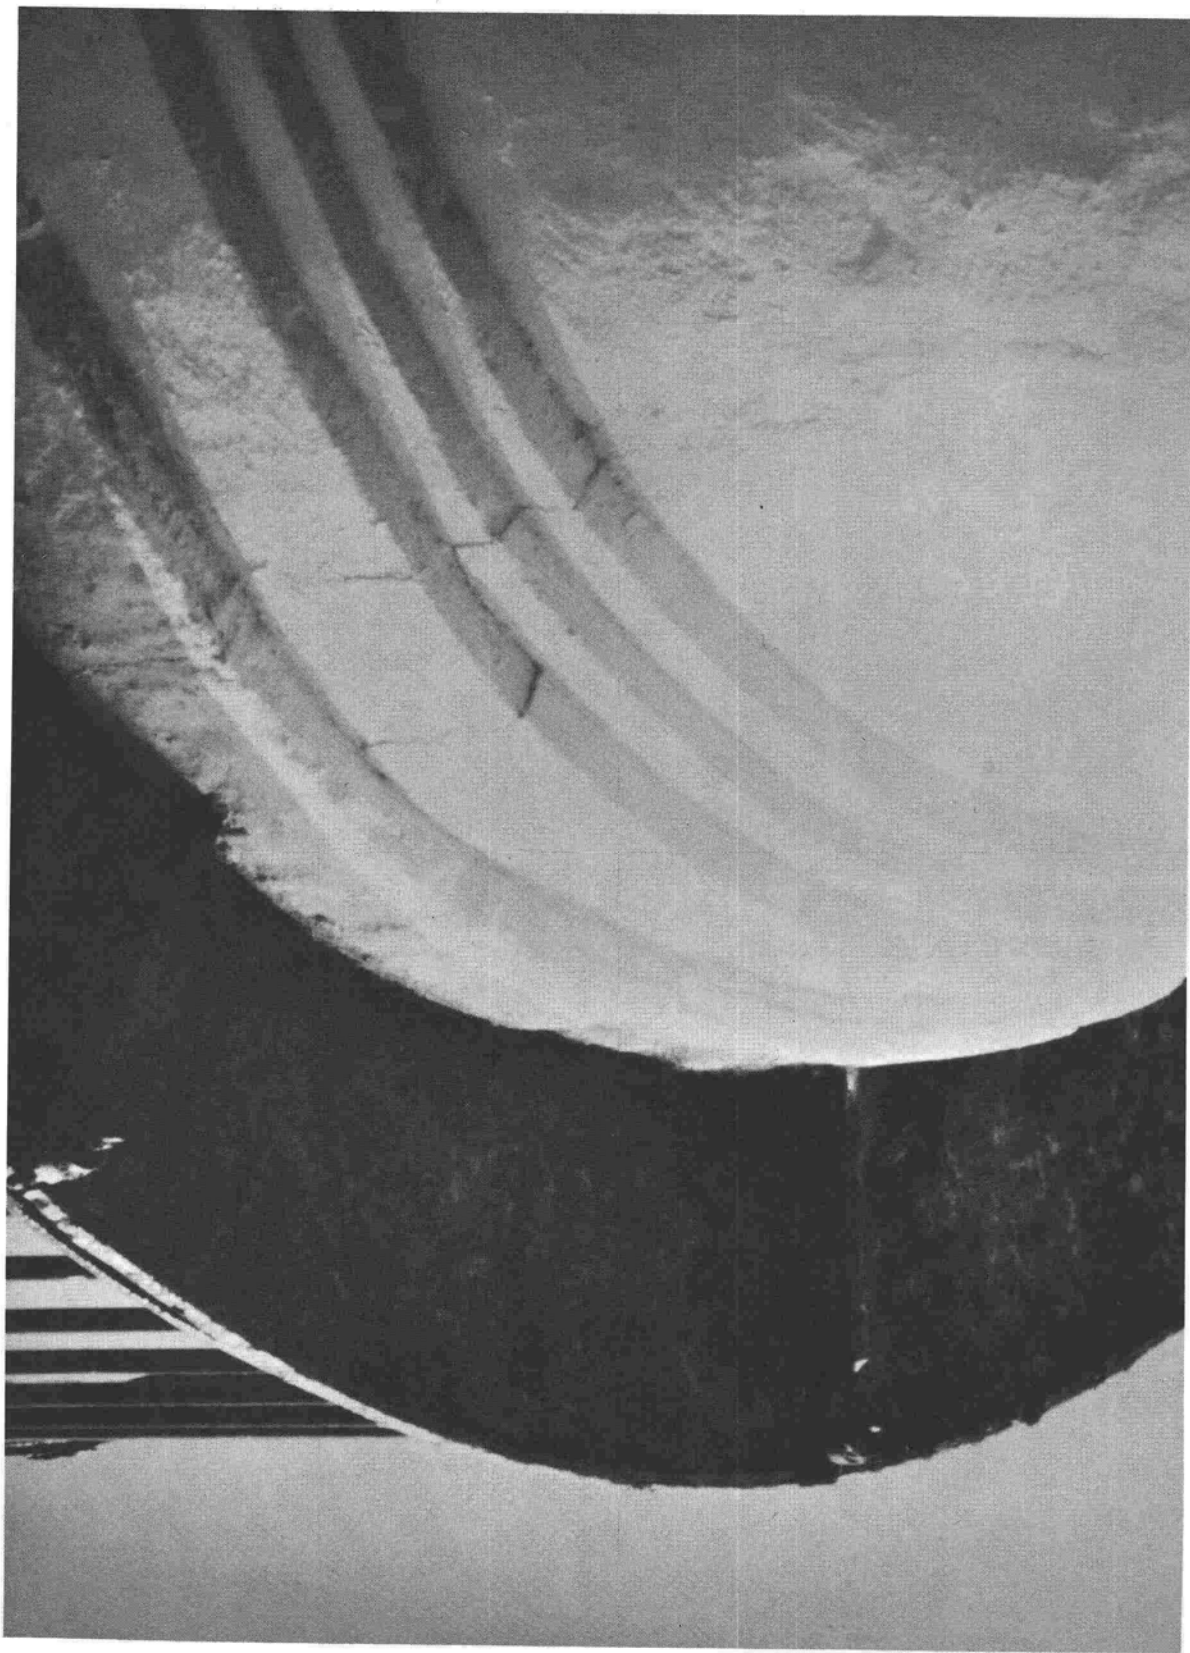
OLD POINT LOMA LIGHTHOUSE, DETAIL OF TOWER SHOWING CORRODED CONDITION OF THE GALLERY DECK.  
National Park Service Photograph, Cabrillo National Monument, 1977.

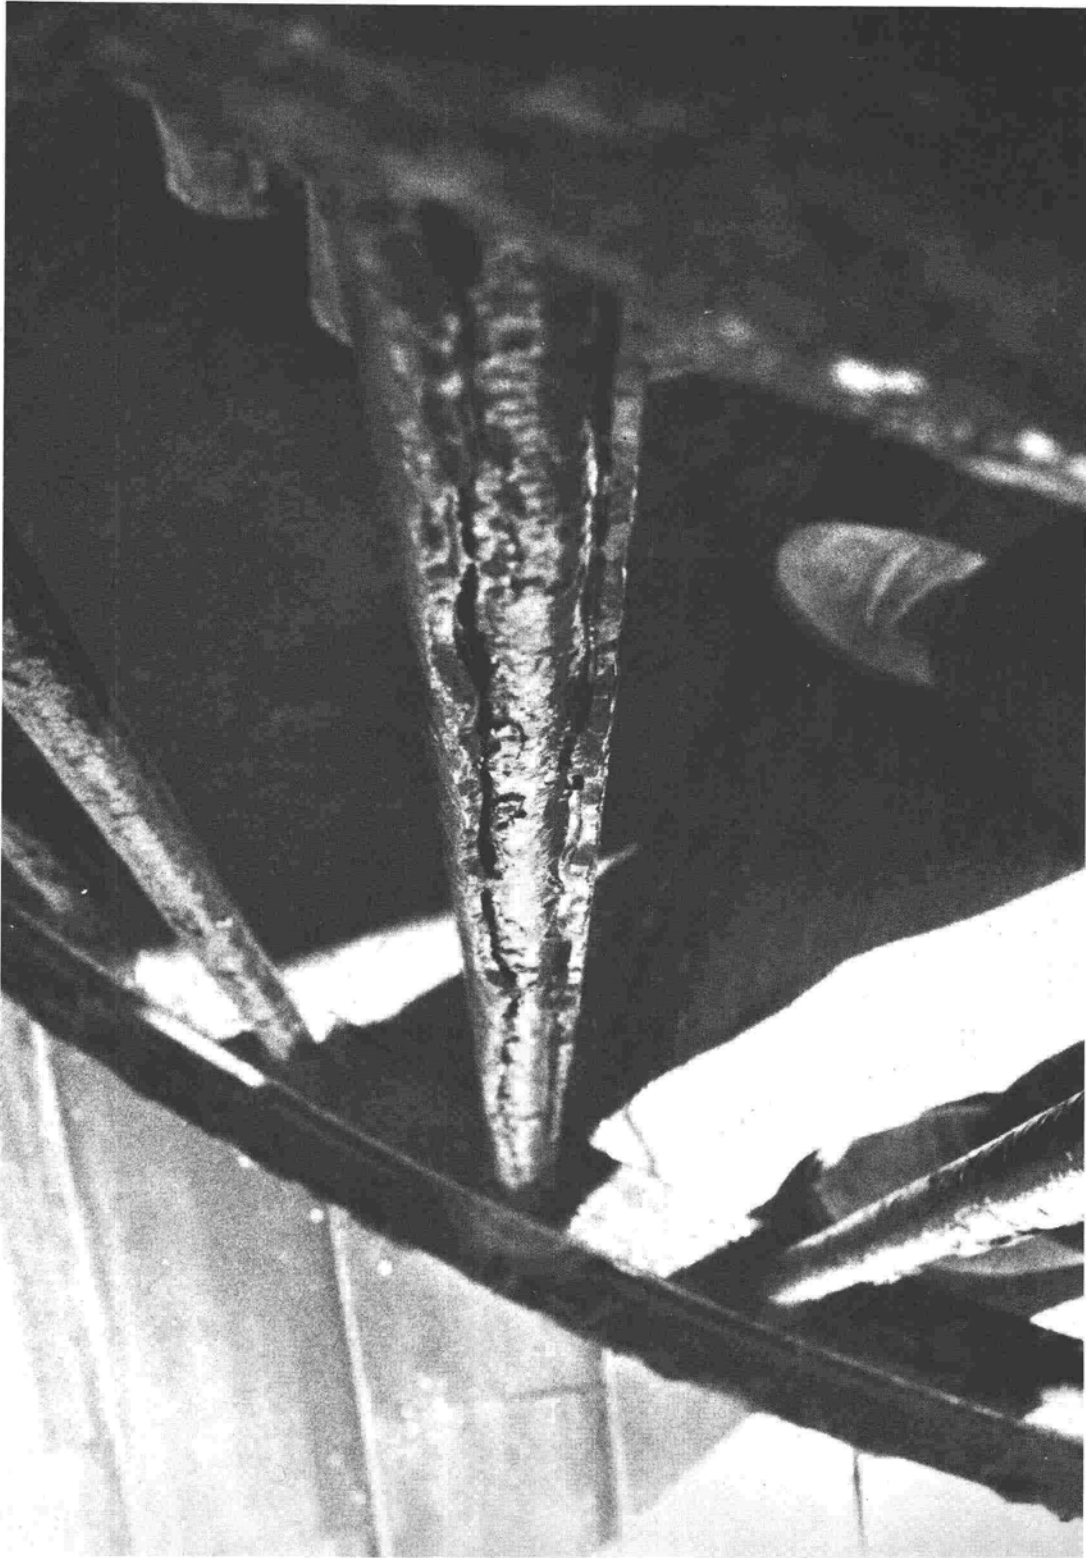
OLD POINT LOMA LIGHTHOUSE, DETAIL OF GALLERY POST SHOWING  
DETERIORATED CONDITION OF THE IRON PIPE, 1977. National  
Park Service photograph by H. G. Law.

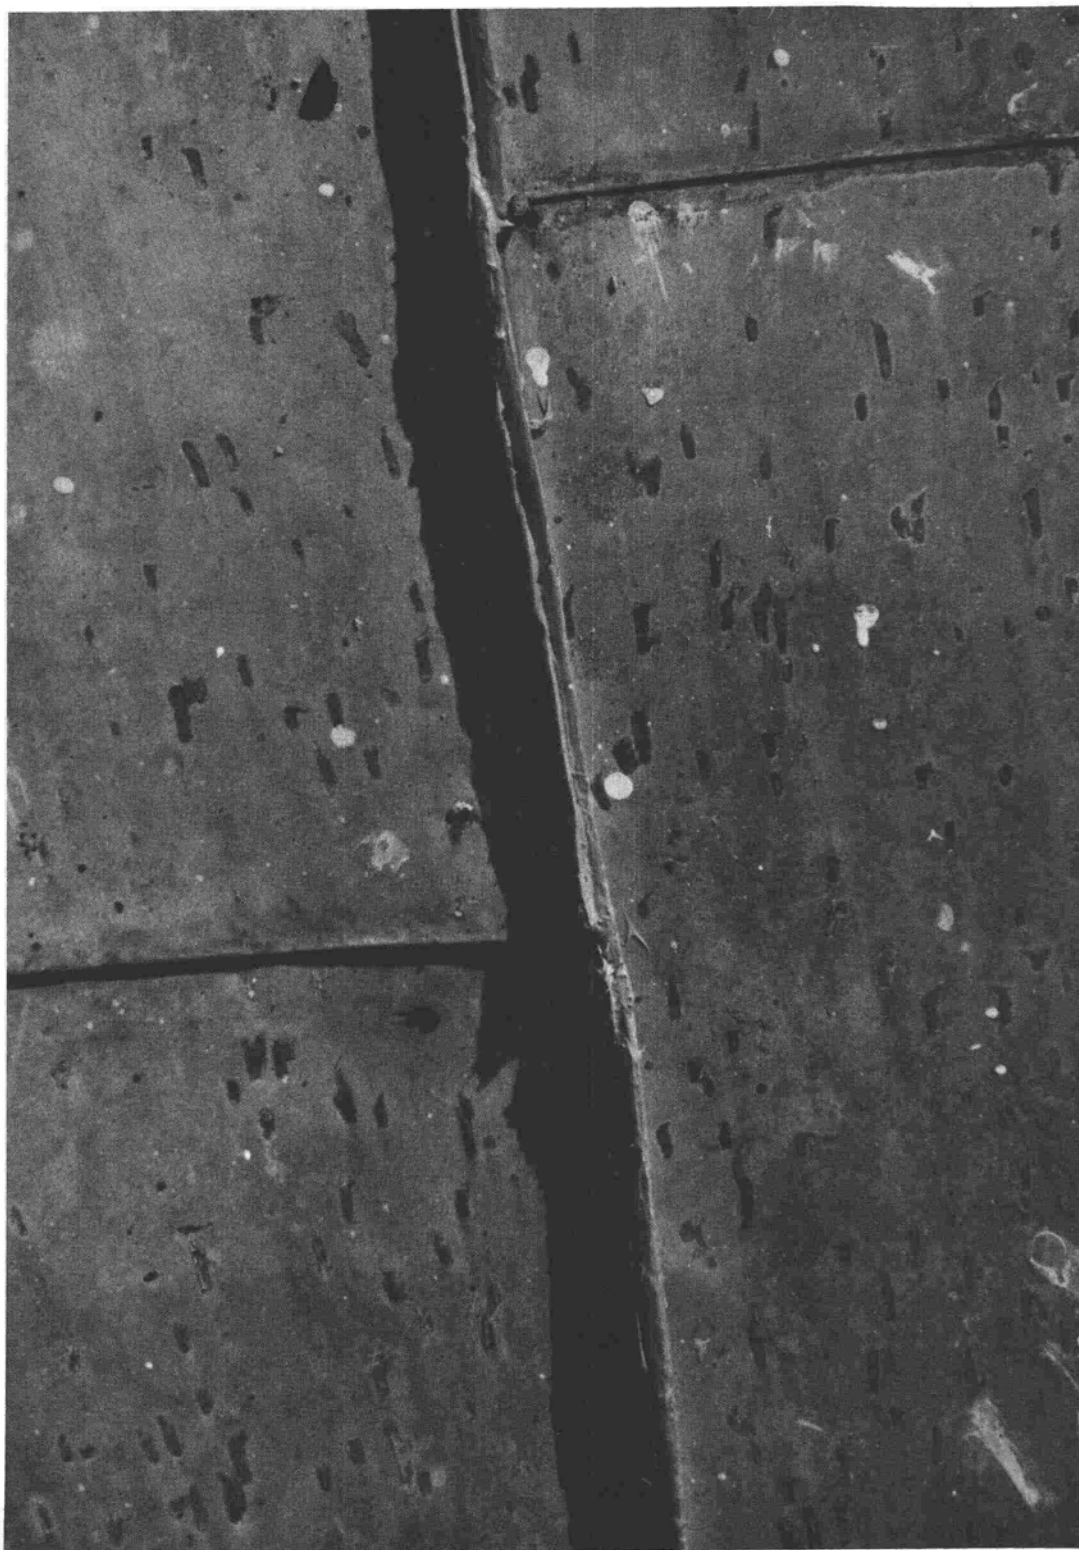
OLD POINT LOMA LIGHTHOUSE, DETAIL OF STANDING SEAM ON THE  
EXISTING COPPER ROOF, 1977. NOTE CAULKING IN CRACKED SEAM  
National Park Service photograph by H. G. Law

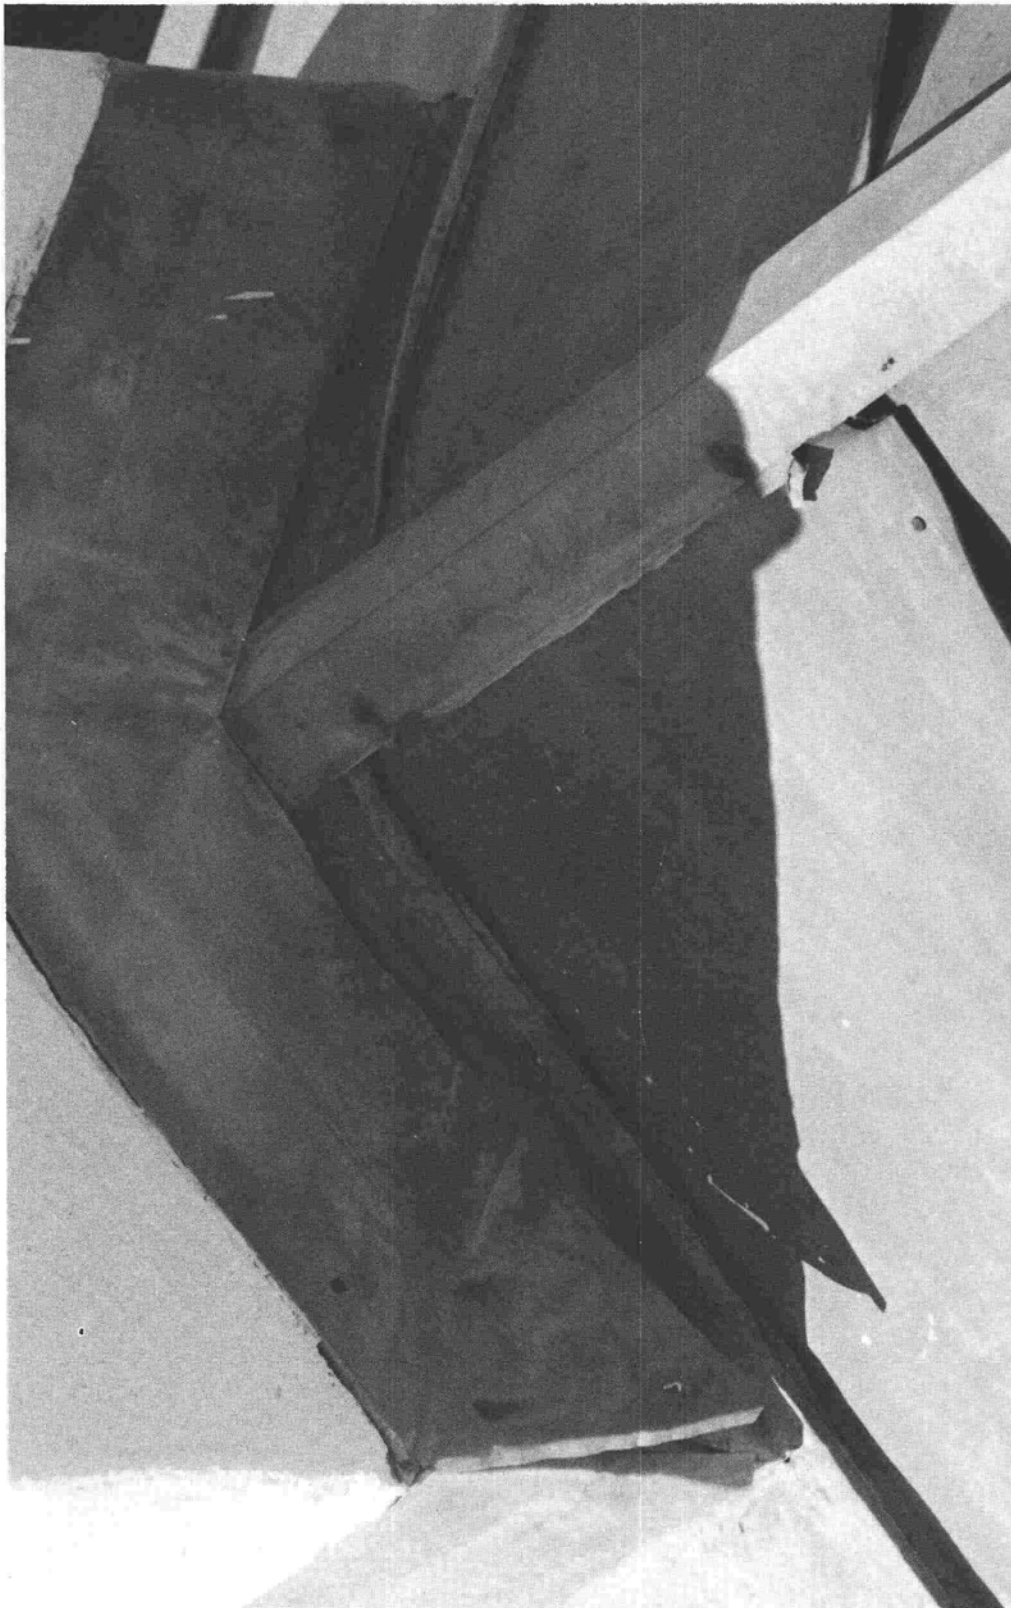
OLD POINT LOMA LIGHTHOUSE, EXISTING FLASHING DETAIL ON ONE OF THE CHIMNEYS, 1977.  
NOTE THE CONDITION OF THE ROOFING. National Park Service photograph by H. G. Law

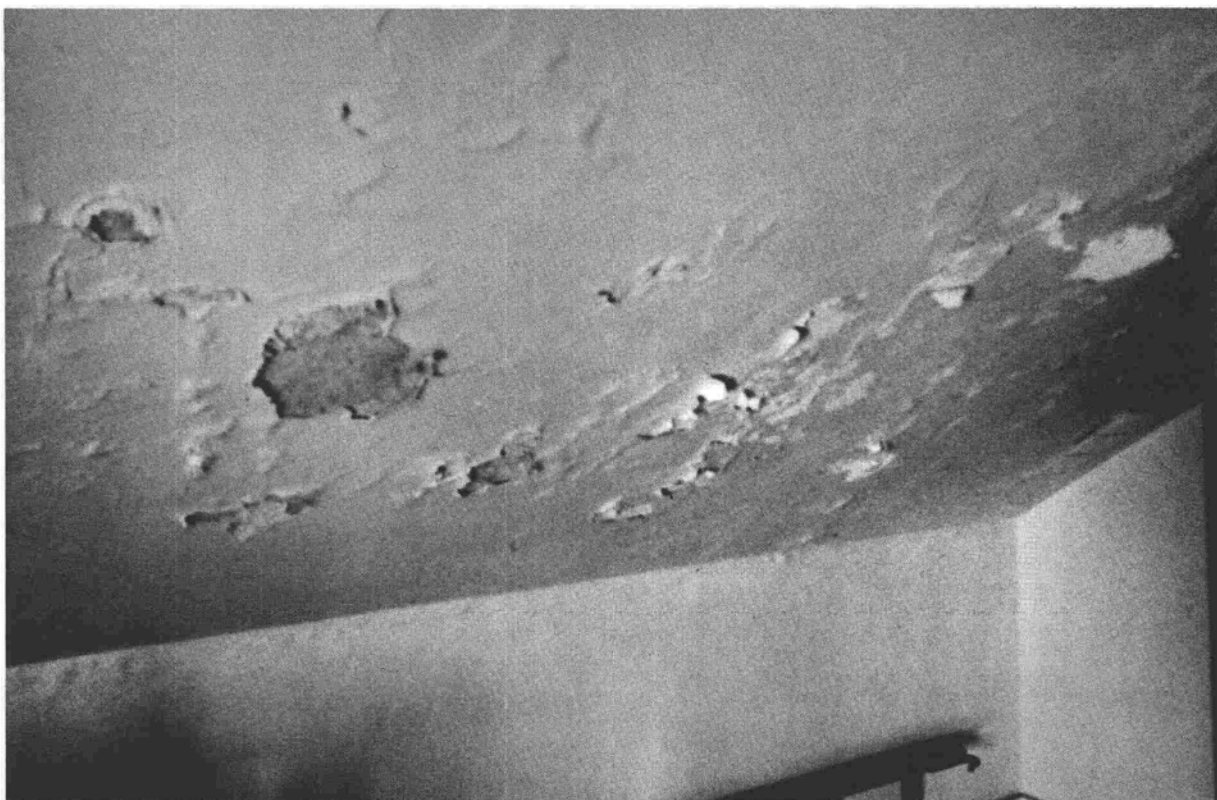
The second story ceilings show signs of moisture damage in the plaster. The moisture sources are probably a combination of two different conditions. One of these is the probable roof leakage, and the other is condensation of air moisture due to the lack of air circulation in the roof structure. The only visible means of circulation of air between the roof and ceiling are two vents in the ceiling connecting the roof structural space with the rooms. There is no ventilation to the outside. The existing vents are located on the opposite sides of the rooms at the lower portion of the ceiling and at the same level. The rooms are also somewhat limited in circulation by being closed off from the rest of the building. The doors and windows are kept closed.

OLD POINT LOMA LIGHTHOUSE, SECOND STORY CEILING OF THE DWELLING, 1979. NOTE DETERIORATED CONDITION OF THE PLASTER. National Park Service photograph by H. G. Law

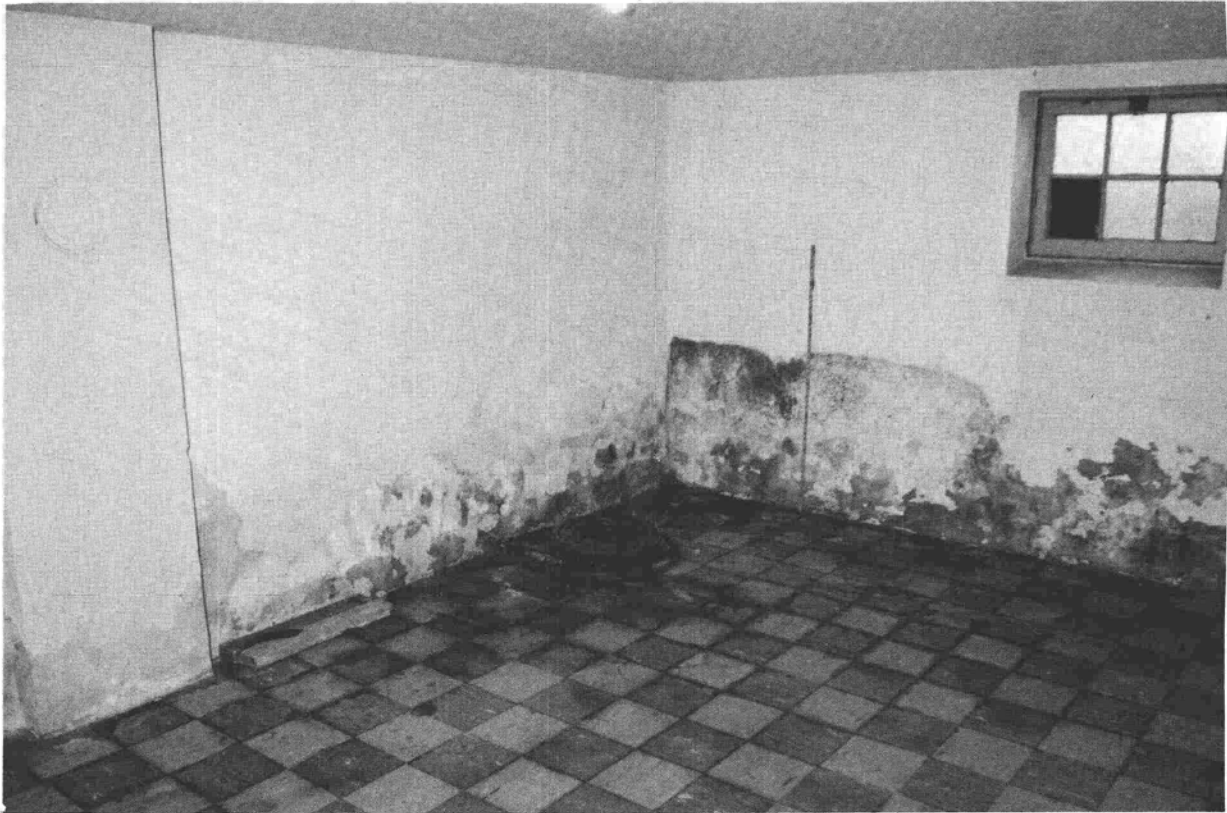
OLD POINT LOMA LIGHTHOUSE, NORTH EAST CORNER OF THE  
BASEMENT SHOWING MOISTURE DAMAGED WALLS, 1977. National  
Park Service photograph by H. G. Law
