OLD HARBOR LIFE-SAVING STATION

Cape Cod
National Seashore

HISTORIC STRUCTURE REPORT

June 1988

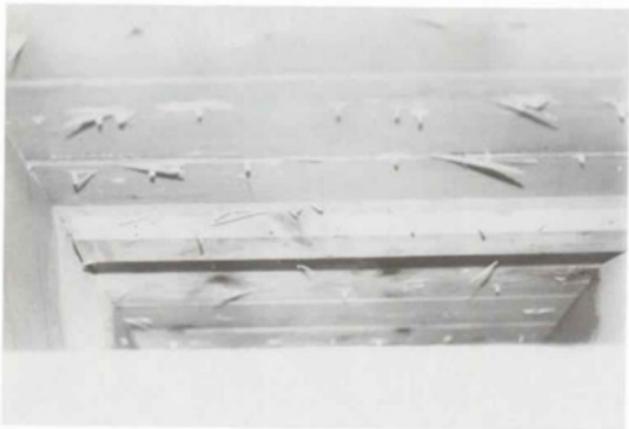
Illustration 9. Ceiling of Quarters, Paint Evidence
of 1910 Relocation of Original Knee Wall.

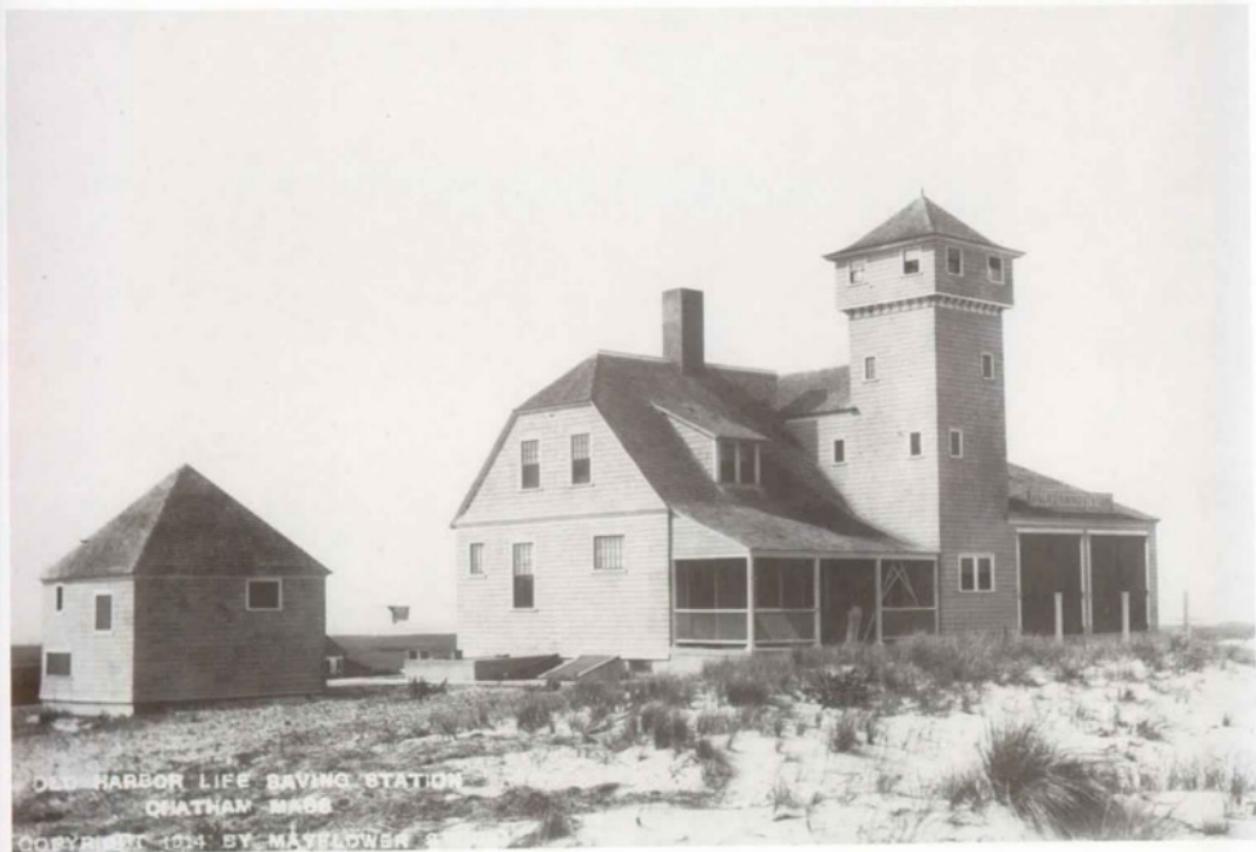
Illustration 13. Exterior View of Old Harbor Life-Saving Station, 1914.

The seacoast environment continued to decay the materials with which the Old Harbor station was built. Figure 13 shows the station in 1914. By that time, the sheathing below the sill board of the Boat Room had rotted, as had the boat ramp in front of the Boat Room's north doors, and the gutter on what is now the east side of the station.¹²⁶ Whether or not these items were replaced is unknown; no authorization for repairs was found, but considering the nature of past approvals, repairs probably were authorized and completed.

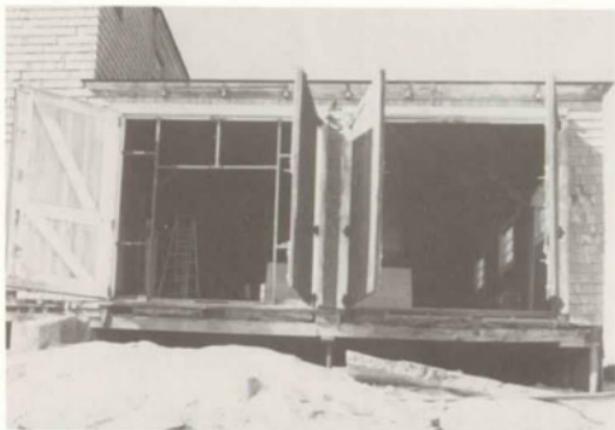
Illustration 26. North-Elevation Boat Room Doorways,
Framing for Screen Within Doorway 115.

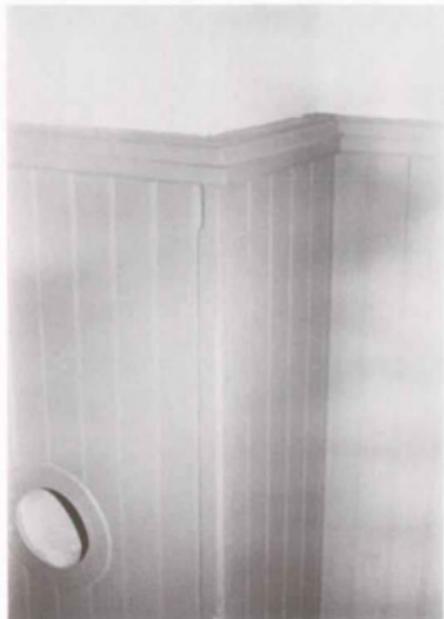
Illustration 38. Mess Room: Reproduction Chimney
Wainscot With Original Corner Piece.

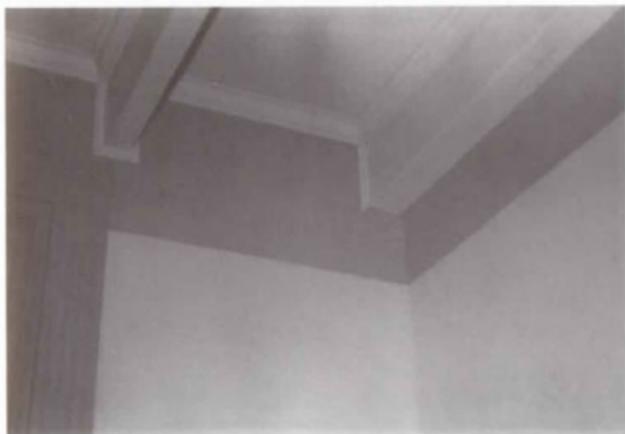
Illustration 39. Mess Room: Cornice Paint and
Ceiling Moldings.

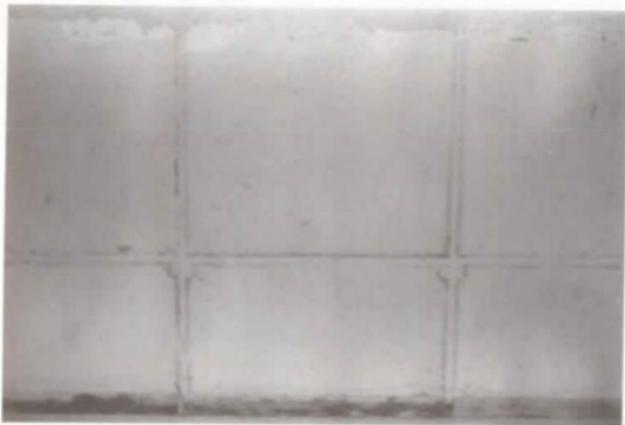
Illustration 50. Locker Room: Evidence of Former East-Wall Lockers.

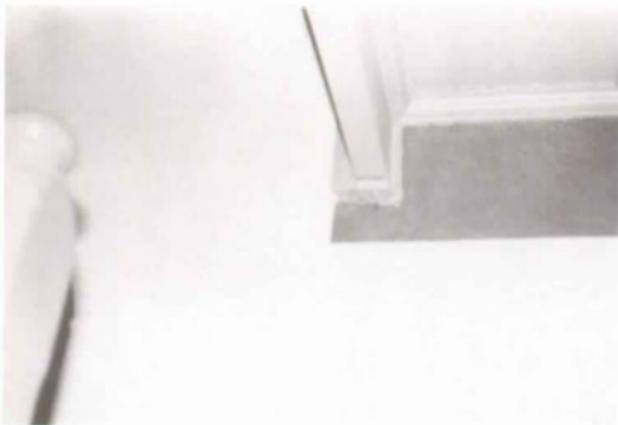
Illustration 51. Second-Floor Stair Hall: Cornice Paint on North Wall.

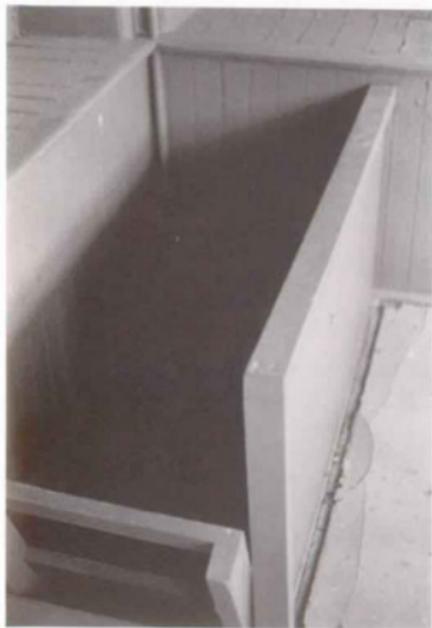
Illustration 56. Lookout:
Posthistoric Opening in Floor.

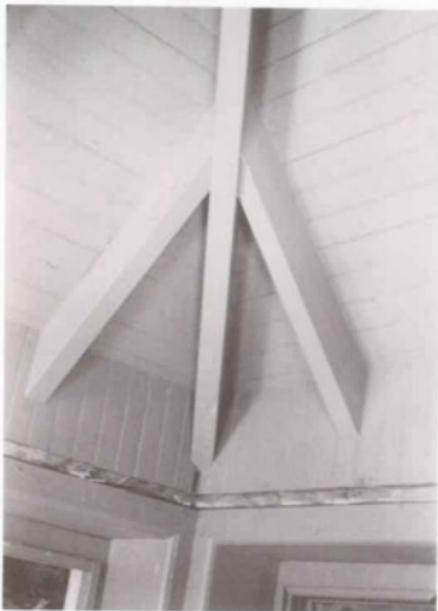
Illustration 58. Lookout: Upper Wall Tier and Hip Rafter.

The "jambs" and "soffit" of the recessed middle tier are covered with smooth lumber (fig. 58). This material appears to be original, despite the fact that the original drawings call for these areas to be covered with matchboarding. The "back" of the recessed middle tier is finished with the same type of matchboarding used on the lower tier of wall. This material is also used on the upper tier of wall.
