CAPE HATTERAS NATIONAL SEASHORE

BODIE ISLAND
LIGHTHOUSE & OIL HOUSE

HISTORIC STRUCTURE REPORT

**Cultural Resources Division
Southeast Regional Office
National Park Service
December 2004**

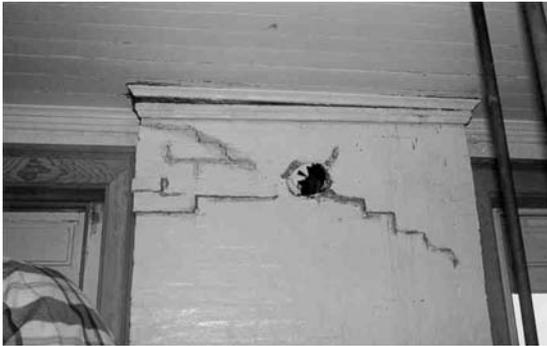
Figure 8 1989 USCOE photo showing cracked masonry in Oil Room interior chimney.

In the Oil House, the ceiling boards and wood molding next to the south chimney wall exhibited signs of water damage, likely caused by deteriorated chimney flashing or bricks. There were cracks and displaced bricks on the inside chimney walls that were probably caused by thermal expansion. The Corps recommended that the wood framing around the chimneys be checked for deterioration and replaced if warranted and that the chimneys be checked for soundness. They suggested that flashing around both chimneys be replaced, and, though the roof did not appear to be leaking, that roof replacement would likely become necessary within the next several years.

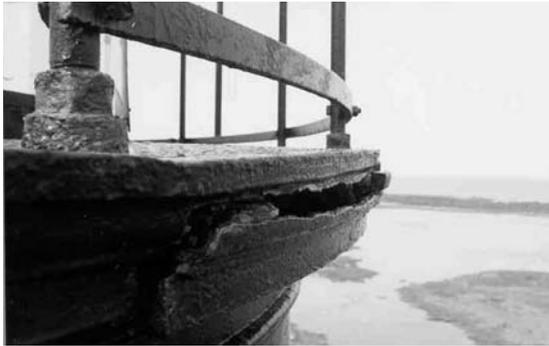
Figure 9 1989 USCOE photo showing deterioration of exterior edge of lantern gallery.

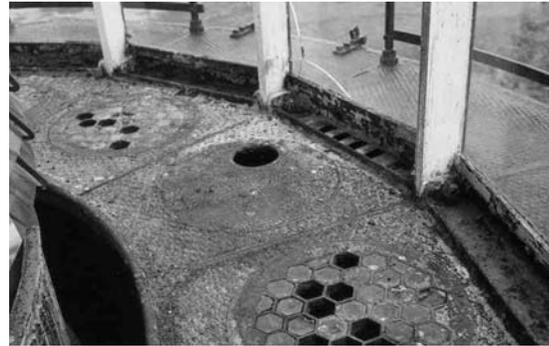
Figure 10 1989 USCOE photo showing missing lantern deck prisms.

- Refinish and seal the wood floor in the Work Room.
- Clean the marble floors in the Oil House and Tower and replace any cracked or missing tiles.
- Securely install replacement prisms in the Lantern level grating floor.

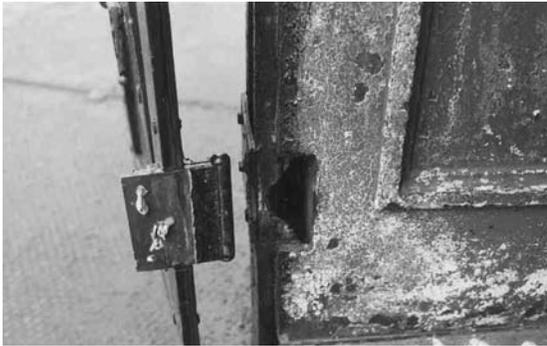
Figure 11 1989 USCOE photo showing detached hinge on door to gallery.

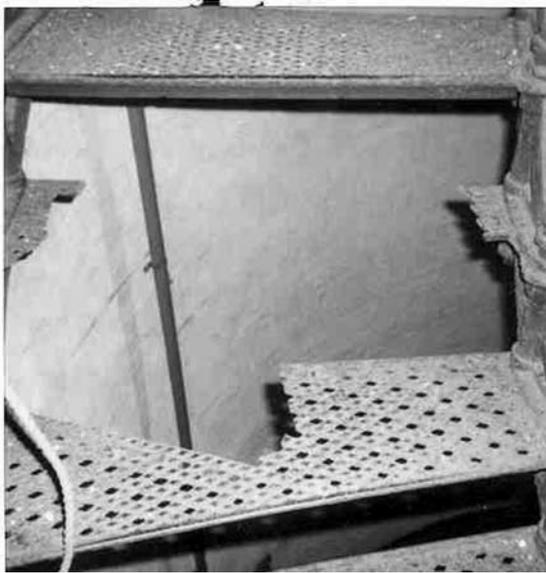
Figure 12 USCG close-up photograph of damage to stair treads, 1992.

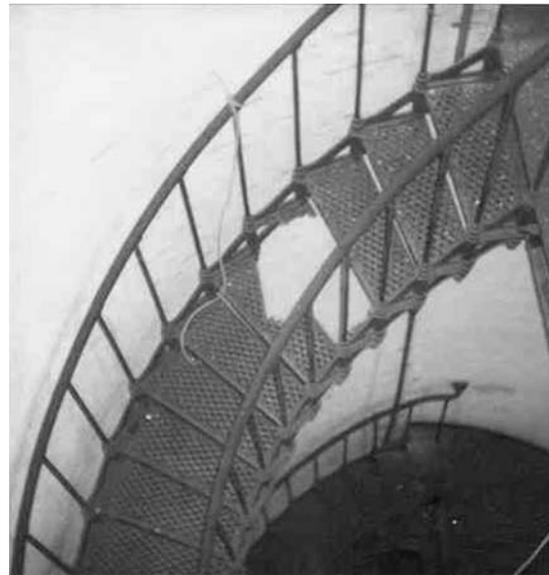
Figure 13 USCG photograph of damage to stair treads, 1992.

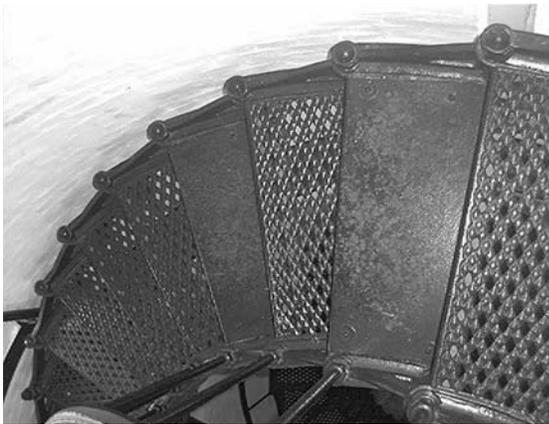
Figure 14 Existing repairs to stair treads.

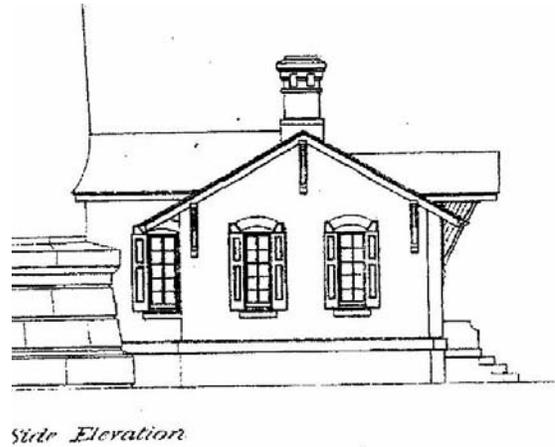
Overall, the north elevation is in sound condition. However, there are signs of past stress in the cracks over the west window in the elevation. This crack has been patched and painted, is sealed, and appears to be inactive.

Figure 18 Drawing detail of north elevation.

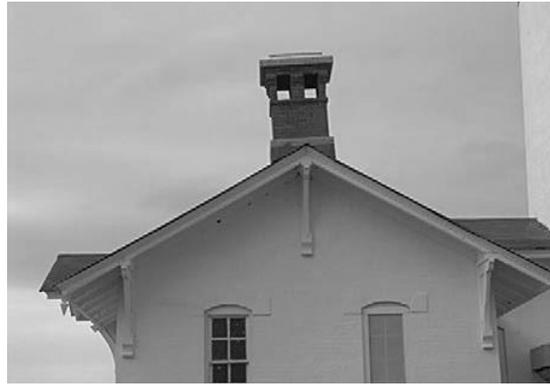
Figure 28 South chimney above the Oil Room.

Preservation efforts in these areas should include removal of damaged materials only and replacement to match existing. There was no

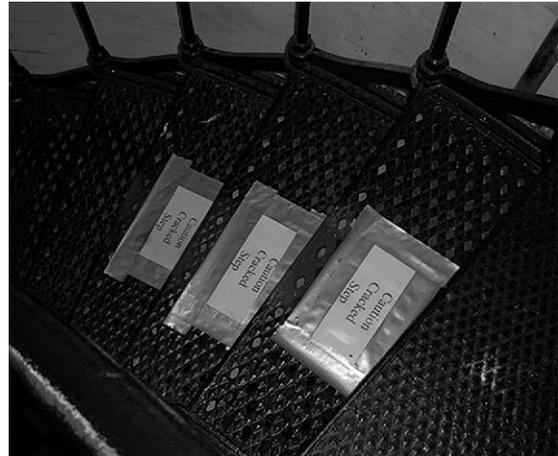
Figure 29 Three treads with notable cracks, below Landing #1.

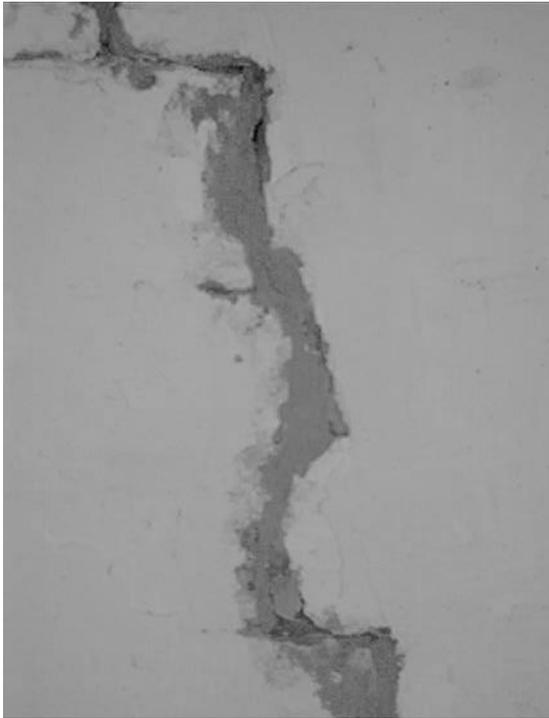
Figure 30 Detail of vertical crack on south side of masonry wall.

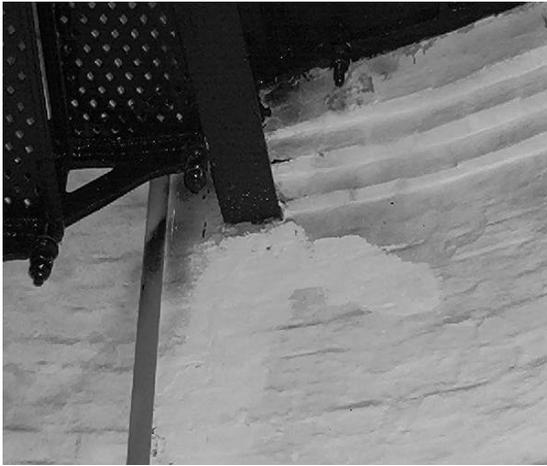
Figure 31 Detail of masonry repair located above landing support beam.

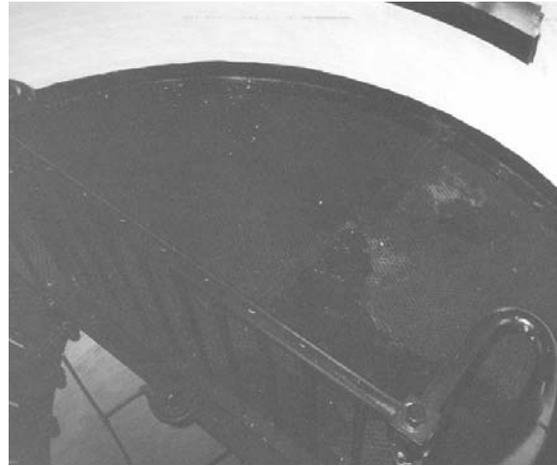
Figure 32 Detail of water collecting on landing that accesses Service Room.

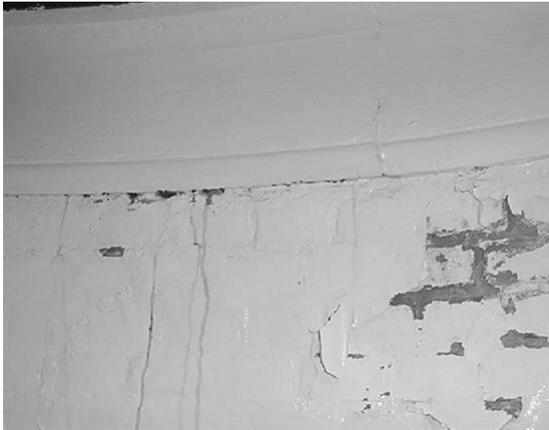
Figure 33 Detail of peeling paint in Watch Room.

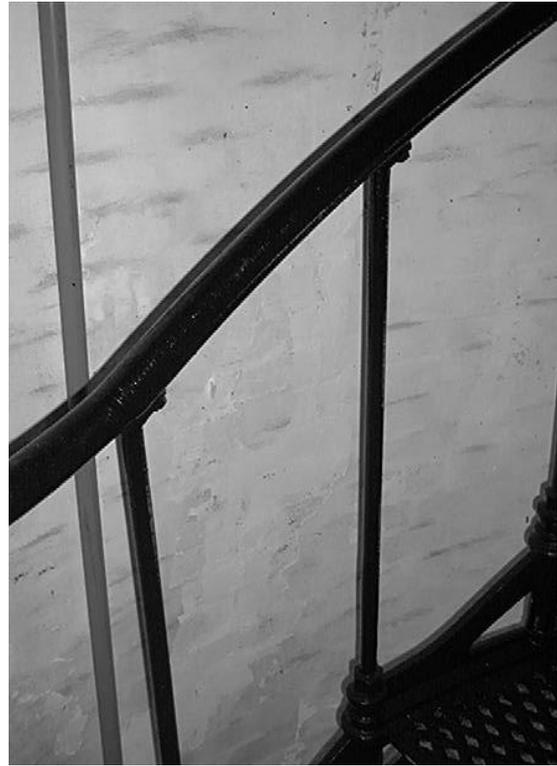
The exterior gallery was not analyzed for public access. Visual observation of the condition of the surface and supports indicates that considerable strengthening of the gallery members would be required before visitors could safely be allowed on the gallery. Such strengthening would include re-fabrication of missing and deteriorated parts, both of the ornamental ironwork and structural components such as

Figure 35 Detail of handrail.

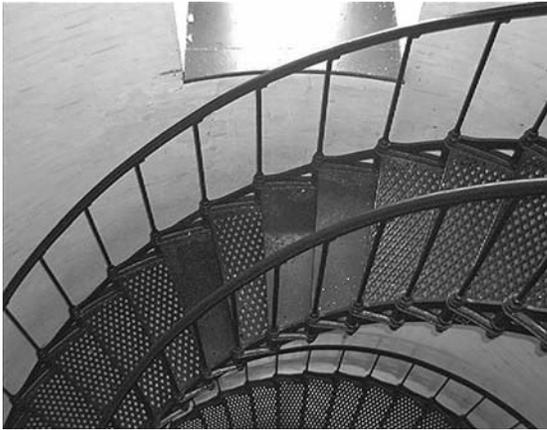
Figure 43 Detail of stair showing tread repair.

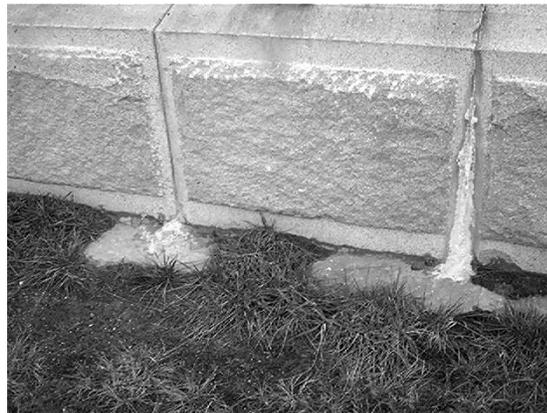
Figure 44 Detail of foundation showing mortar leaching.
