CAPE LOOKOUT NATIONAL SEASHORE
Coast Guard Station Boat House
**HISTORIC STRUCTURE
REPORT**

2004
Historic Structure Report
Coast Guard Station Boat House
Cape Lookout National Seashore
Cape Lookout Village
LCS#: 09t830

Historic Structure Report

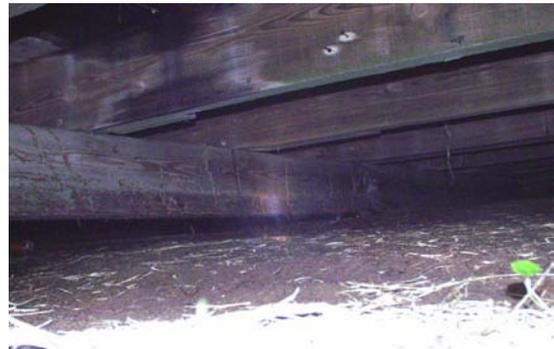
Figure 25 View of floor framing near rear of house. (NPS-SERO-CR, 2003)

There is evidence that termites have attacked the floor framing, but the damage may not be widespread. Walls are generally plumb, floors are level, and the roof shows no visible signs of structural deficiencies.

- Inspect and repair sills and joists when building is relocated.

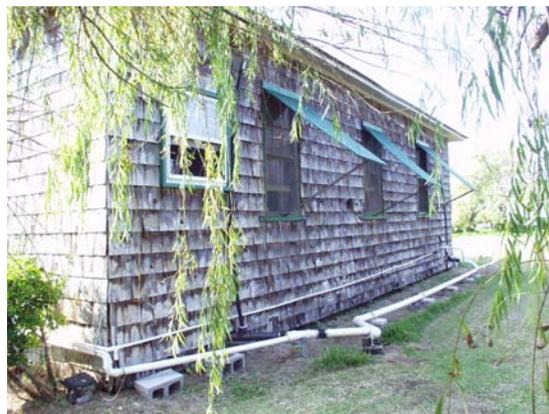
Figure 27 View of rear (northwest) side of house, showing typical exterior finishes. (NPS-SERO-CR, 2002)

- Remove cedar shingles; repair original drop siding.
- Repair existing soffit, window and door casing, and window sills.
- Remove wood- shingle roofing and install standing- seam metal roof.

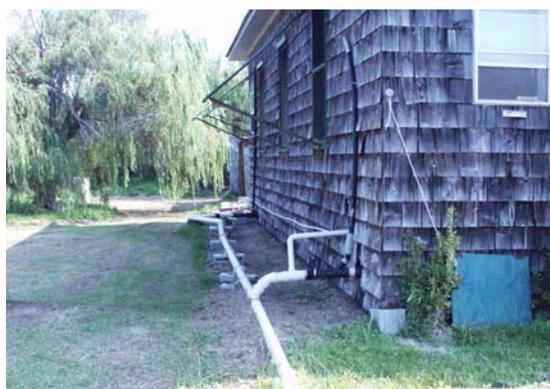
Figure 39 View of waste lines at rear of house. (NPS-SERO-CR, 2003)

The condition of the wiring could not be examined. Water and sewer lines are relatively new but are run in an *ad hoc* fashion across the rear of the house. There is no central heating.

- Install new water supply and waste lines if new rest rooms are installed.
- Design electrical system with simple lighting to serve exhibits.
- Install smoke/fire detector system.
- If necessary, install electrical baseboard heaters.
