CAPE LOOKOUT NATIONAL SEASHORE
Cape Lookout Lighthouse
Keeper's Dwelling (1907)
**HISTORIC STRUCTURE
REPORT**

**Historical Architecture, Cultural Resources Division
Southeast Regional Office
National Park Service**

2002
Historic Structure Report
Cape Lookout Lighthouse Keeper's Dwelling
(1907)
Cape Lookout National Seashore
LCS#: 091838

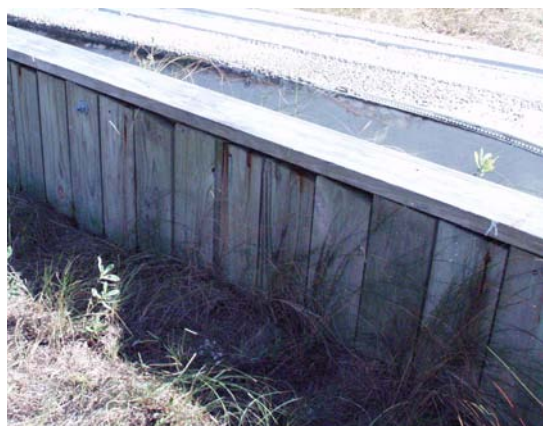
Figure 2 View of flood wall surrounding house. (NPS-SERO-CR, 2002)

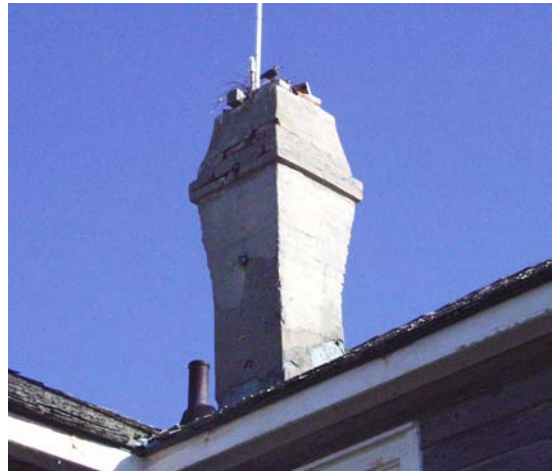
Chimney: The house was constructed with a single brick chimney stack that originally served a fireplace in the sitting room (Room 101) and a cook stove in the kitchen. When the house was moved, the foundation of the chimney was lost, but the original fireplace and chimney stack were moved intact and reset on a concrete block foundation. The chimney is

Figure 4 View of chimney. (NPS-SERO-CR, 2002)

- Match original foundation brick, if located, or, if not, match brick on existing historic chimney.
- Remove stucco from chimney, repair chimney as necessary.
- Continue research to document appropriate roof covering in the 1940s at the end of the period of significance.

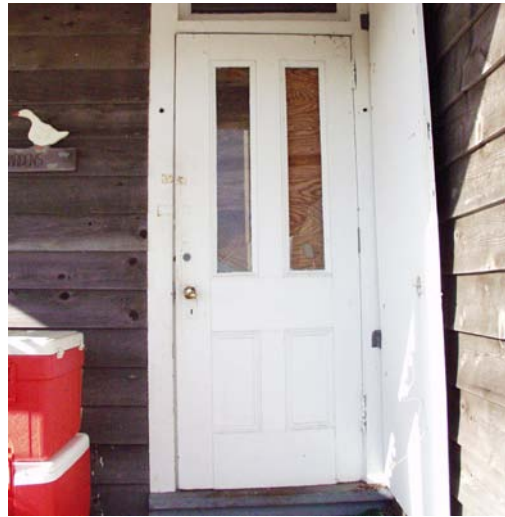
The original front door, which was similar to the existing back door, has been lost. The present front door is a modern, solid-core, wooden door, 3'-0" by 7'-0". The back door opening is 2'-8" by 6'-6" and has a single-light transom 15" by 32". The door, which is 1-3/4" thick, has two, molded, vertical panels below two narrow, vertical lights. The presence of an added 1"-thick strip of wood along the outside stile of the door and alterations to that side of the door frame may be indications that the door is not original; but all of these changes

Figure 8 View of back door. Original front door was of a similar design. (NPS-SERO-CR, 2002)

may simply be the result of old damage and repairs to the door, which closely resembles the door indicated on the original architectural drawings for the house. Vandals recently broke one of the back door's beveled-glass lights.

- Repair and preserve all existing window sash.
- Repair and preserve all wood- framed window screens; where missing, install new wood- framed screens.
- Repair and preserve back door.
- Replace modern front door with replica of original.
- Remove plywood shutters on porches if the added security is unnecessary.

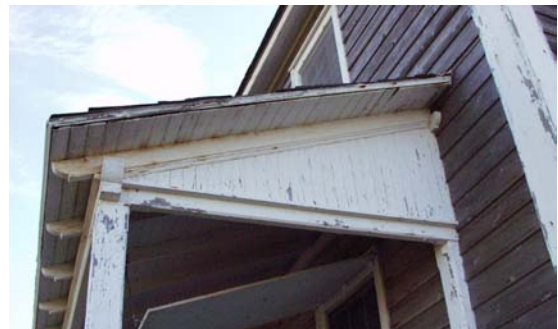
Most of the material on the two porches is historic, except for the front porch floor framing, which has undergone major repairs. Floor joists are typically 2" by 4" on about 18" centers. Flooring is tongue- and- groove, 1- 1/8" by 3", except on the west end of the front porch where the flooring is around 1- 1/8" by 2- 1/2". Posts are 5- 3/4" by 5- 3/4", nearly 8' tall, and have chamfered edges. Headers also have chamfered edges and measure around 2- 3/4" by 6". The ends of the headers project beyond the

Figure 12 View of west end of front porch. (NPS-SERO-CR, 2002)

- Inspect framing of kitchen floor and perimeter sills for possible damage; repair as necessary.
- Reconstruct floor framing for front porch.
