Cape Lookout National Seashore

**Cape Lookout**  
**Life-Saving Station**  
**HISTORIC STRUCTURE REPORT**

Historical Architecture, Cultural Resources Division

2004

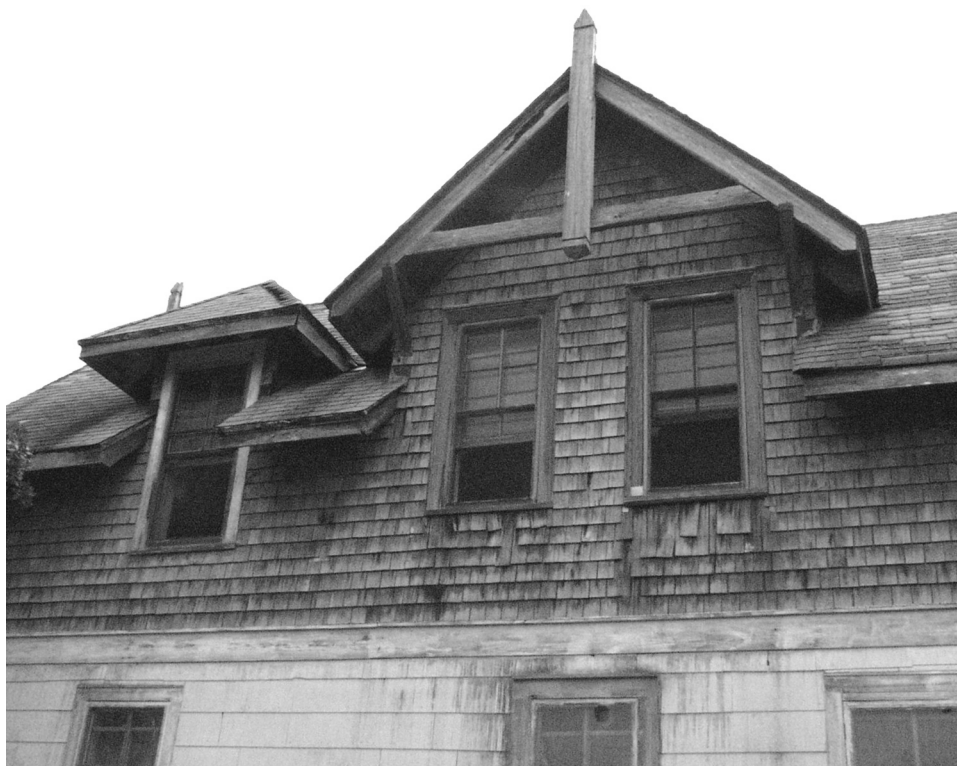
Most of the historic exterior finishes remain in place, although the original shiplap siding at the first floor has been covered with cement-asbestos shingles. The wood shingles at the second floor level are very worn, particularly on the south and west sides of the building, and there is widespread deterioration of other woodwork, due mainly to the failure to periodically repaint the building. The roof covering, which is now approaching thirty years old, is long past its useful life, and shingles are missing from several areas.

**Figure 54** View of typical exterior sidings, with wood shingles at second floor and asbestos over drop siding at first floor. (NPS-SERO-CRS, 2002)

- Remove and salvage cement- asbestos siding.
- Repair drop siding and wood- shingle siding.
- Repair and re- install missing gable finial.
- Repair all exterior woodwork as needed, matching existing materials.

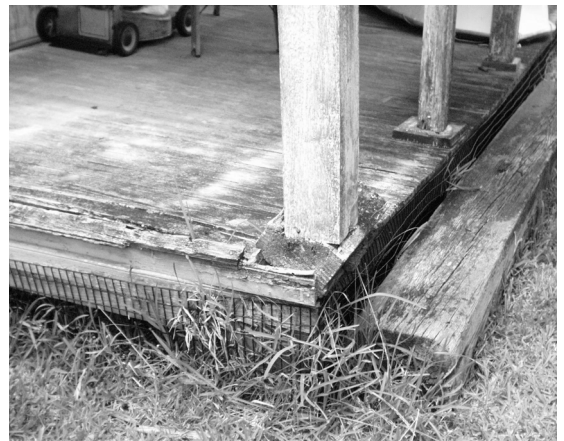
which are badly deteriorated. The porch roof at the second floor level has pulled away from the wall of the house as much as two inches, endangering the stability of the entire porch. In addition, the “lean-to” containing Room 100 (which was part of the original building) is in very poor condition, with portions of the floor severely rotted. Significant termite damage elsewhere in the building was not seen in the current investigation, but there is a very good likelihood of finding concealed damage once repairs get underway.

**Figure 60** View of northeast corner of front porch, showing corner post seriously destabilized by deterioration of the sills at that location. (NPS-SERO-CRS, 2002)

- Inspect and repair sills and joists when building is relocated.
- Reconstruct floor system in Room 100.
- Repair porches.
- Reconstruct front porch stairs.
- Rescreen front porch if desired.
- Reconstruct missing balustrades at both porches.
