Cape Lookout National Seashore  
GASKILL - GUTHRIE HOUSE  
**HISTORIC STRUCTURE  
REPORT**

**Historical Architecture, Cultural Resources Division  
Southeast Regional Office  
National Park Service**

2004

2004  
Historic Structure Report  
Gaskill- Guthrie House  
Cape Lookout Village  
CAPE LOOKOUT NATIONAL SEASHORE  
Harker's Island, NC  
LCS#: 272049

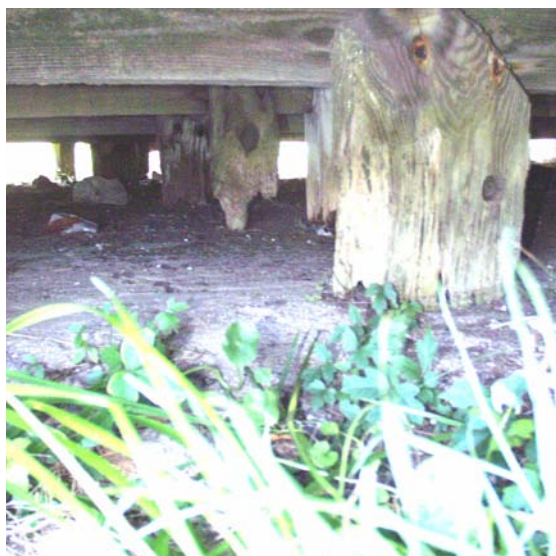
**Figure 20** View of rotted wooden piers that formerly supported floor joists at mid-span. (NPS-SERO-CRS, 2002)

The wood frame of the main body of the house is within inches of the ground, with the sills set on a series of wooden piers, 8" - 12" in diameter, sunk to some indeterminate depth into the ground. Most are, at best, in fair condition, and concrete block have been inserted at some locations to provide additional support.

- Replace all piers, replicating size and placement of originals.

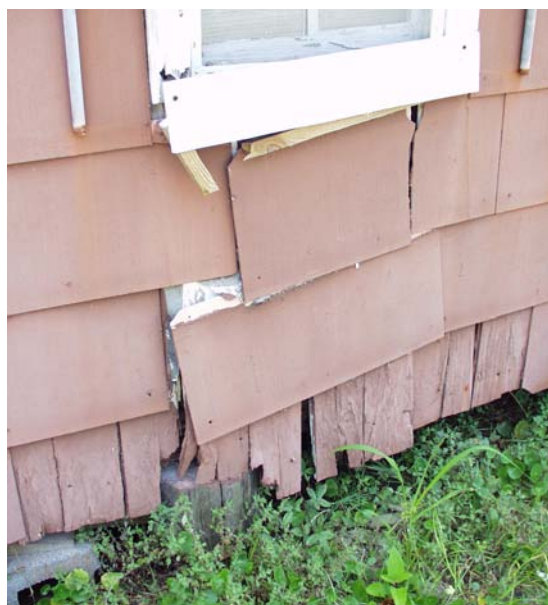
*Floors:* Original floor joists are generally 2" by 6- 1/2" (actual dimension), set on 32" centers. Single 2" by 6- 1/2" boards form the perimeter sills of the original house. As noted above, the mid- span supports for these joists have rotted, which has left the floor system unstable. In addition there has been severe sill damage at several locations, especially on the northeast side of the house.

**Figure 24** View of damaged siding on northeast side of house, the result of major sill damage in this location. Original board siding is exposed across bottom of wall. (NPS-SERO-CRS, 2002)

- Reduce span of joists and rafters by adding intermediate members.
- Repair termite- damaged and/or rotted sills and other framing elements as necessary.
- Reconstruct original porches.
- Restore original roof line.

- Remove asbestos siding, reusing or stockpiling the shingles.
- Repair and preserve underlying tongue- and- groove siding.

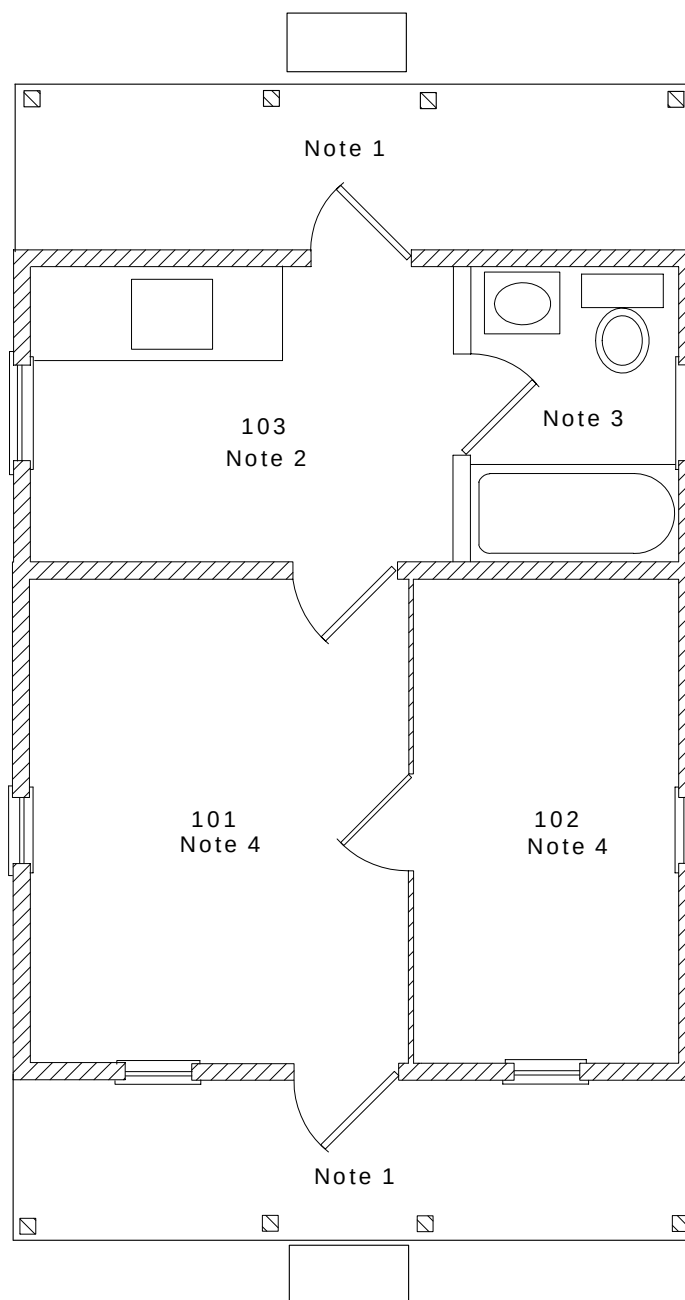
**Figure 31** Proposed plan for treatment and use. (T. Jones, NPS-SERO-CR, 2003)

1. Reconstruct porch using details seen in O'Boyle photographs.
2. Rehabilitate kitchen.
3. Construct partition wall and install new bathroom.
4. Remove hardboard paneling, repair framing, replace hardboard paneling.
