Cape Lookout National Seashore
Portsmouth
GEORGE DIXON HOUSE
**HISTORIC STRUCTURE
REPORT**

2004
Historic Structure Report
George Dixon House
Cape Lookout National Seashore (CALO)
Portsmouth, NC
LCS#: 12519

Historic Structure Report

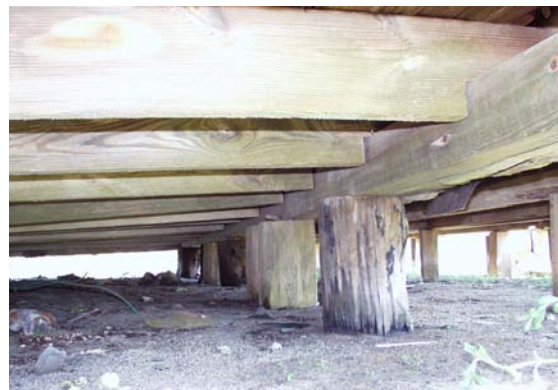
Sills and Plates: Perimeter sills have undergone extensive repairs and modifications, especially on the southeast side of the house where the original sill has been replaced by a stacked trio of boards, 2" by 6- 1/2". The 6" by 8" sill at the front wall of the house appears to be typical of the original sills. A beam, 6' by 7", runs through the house from end to end and supports the walls above that separate front from rear rooms. Support piers near the middle of this beam (under the central hall) appear to have been undermined and/or otherwise been displaced. As a result, the beam has broken and partially collapsed, causing nearby joists to split and allowing the center of the house to drop several inches.

Figure 11 View northeast of front sill, showing typical joist/sill connections and wooden piers. (NPS-SERO-CRS, 2002)

- Replace sill at southeast end of house and collapsing sill running through center of the house; repair other sills as necessary; raise and level building structure.
- "Sister" new floor joists to broken joists.
- Inspect stud connections to sills and plates and repair as needed.

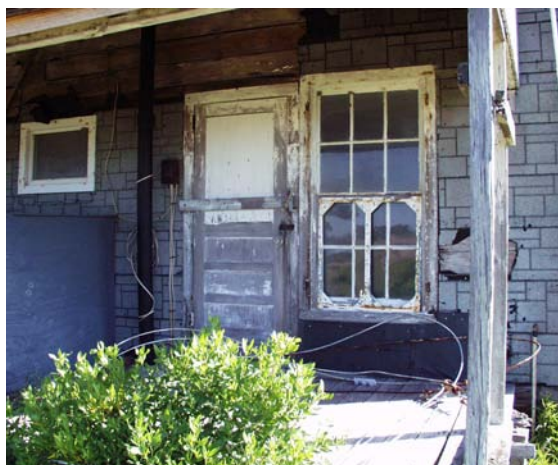
Figure 13 View of original, 6/6 window with typical wood frame for screening. Original location for back door opening was at window at extreme left in this image. (NPS-SERO-CRS, 2002)

- Replace front door with four- panel door similar to those that remain on the interior.
- Replace window on northwest side of Room 102 with a four- panel door, similar to the other exterior doors.
- Remove and close existing back door.
- Restore original back door opening, using typical four- panel door.

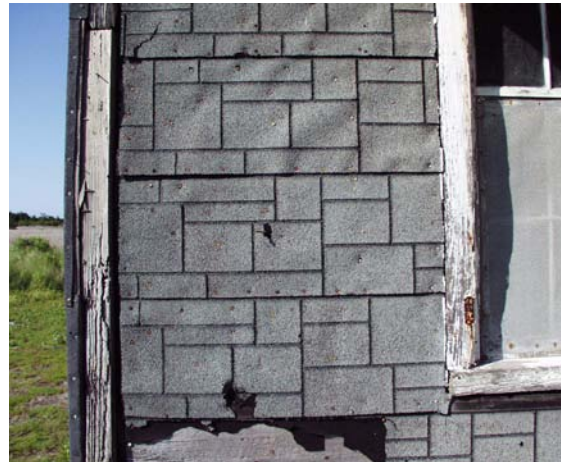
The exterior of the house was also stripped of its original siding. Old siding and material removed from the interior appears to have been used to resheath the house with flush- laid boards that were then covered with the present asphalt composition panels. The old wood- shingled roof covering remained in place but within a few years had been replaced by green, asphalt- composition, “hurricane” shingles.²⁹

Figure 14 View of added asphalt siding. Note part of shutter hinge on adjacent window casing, which is original. (NPS-SERO-CRS, 2002)

- Remove existing asphalt siding, preserving at least one complete panel in the park's permanent collection.
- Identify original 1" by 8" siding material, and re- install all sound material as lapped siding, replacing missing material as necessary.
- Paint siding and trim as dictated by careful analysis of surviving finishes.

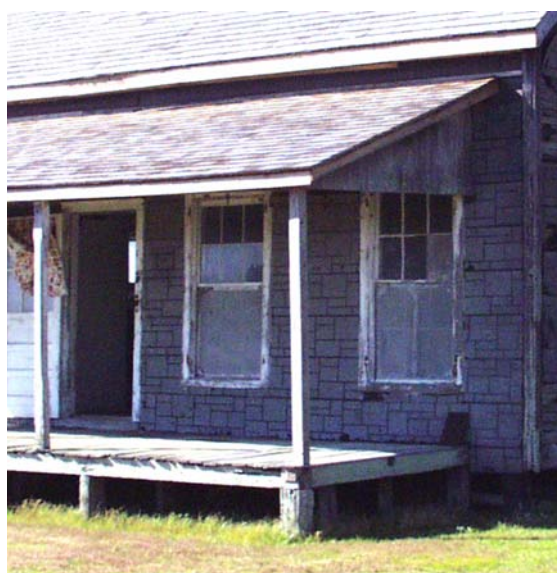
Figure 15 View of front porch; column at left is original. (NPS-SERO-CRS, 2002)

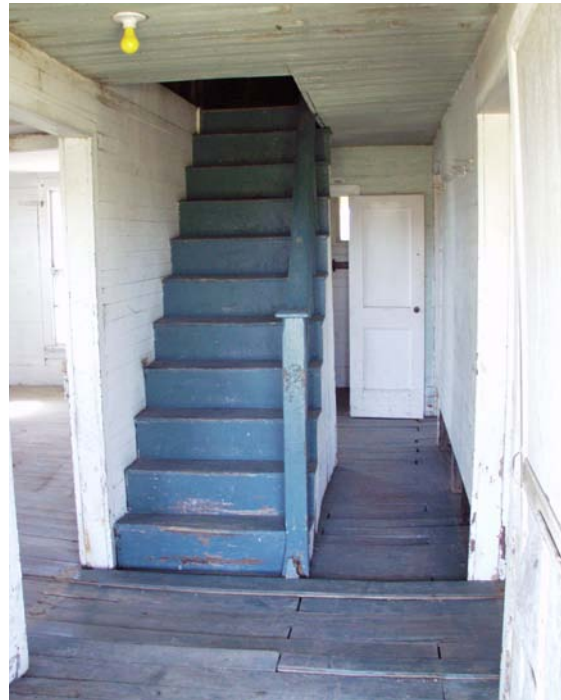
Figure 16 View of hallway (Room 100) from front door. (NPS-SERO-CRS, 2002)

Floors: Flooring is 5"- wide, painted, tongue-and- groove boards. The collapsing sill that runs through the center of the house has

caused major deflection of the floor around the middle of the hall.

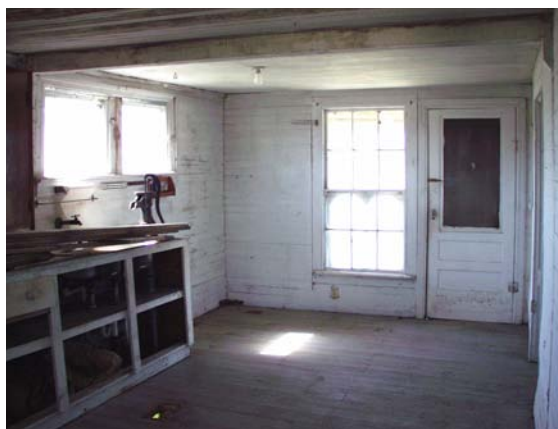
Figure 21 View west showing what was Room 103, now combined with Room 104. (NPS-SERO-CRS, 2002)

When the original porch door from this room was closed after World War II, the sash that had been part of the window on the south wall of Room 103 appears to have been recycled to fill this opening, since it matches the original sash in Room 101 and elsewhere.

- Remove existing windows in Room 103 and replace with original window now in Room 102.

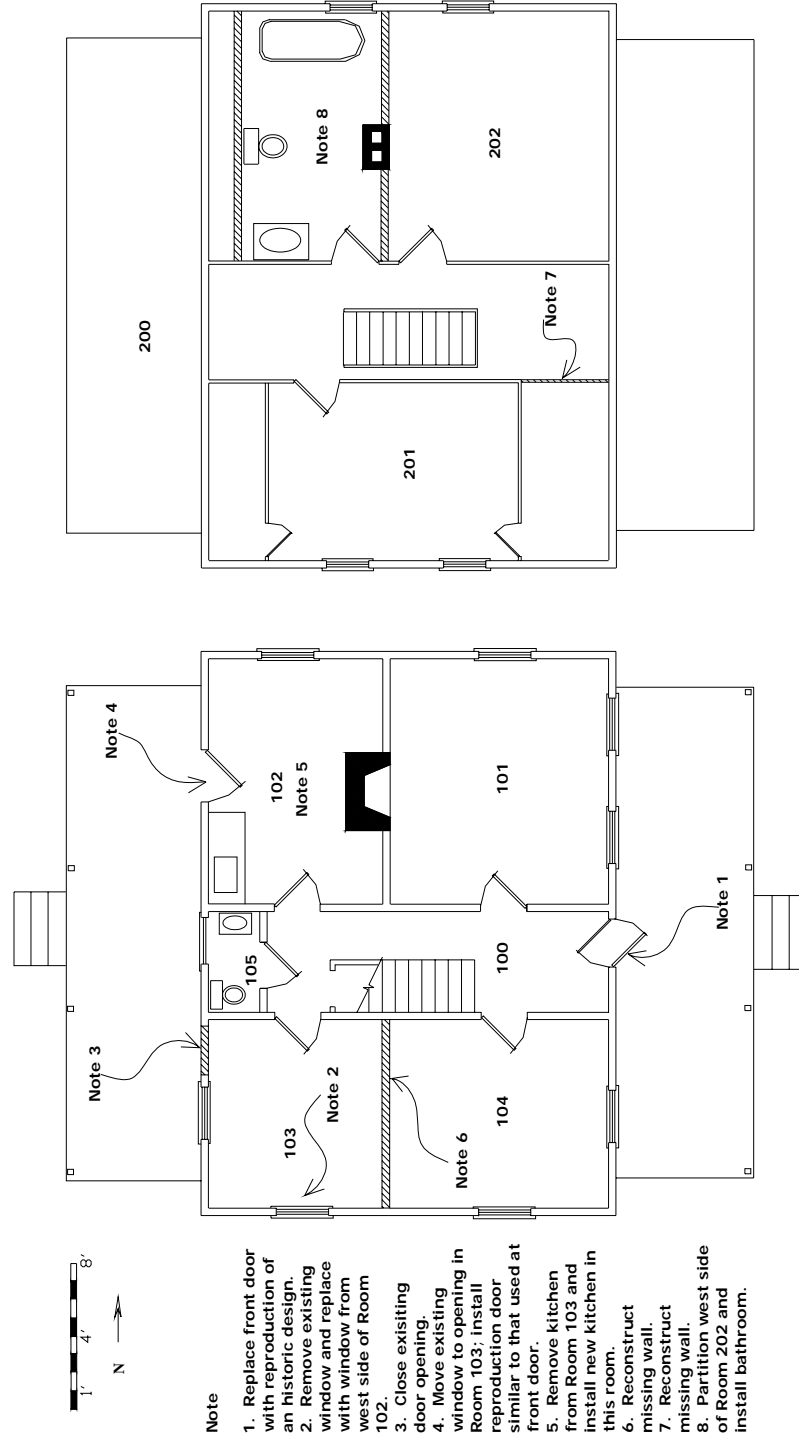
Figure 29 Proposed plan for treatment and use. (T. Jones, SERO-CR, 2003)

- Preserve existing interior finishes, especially the original double-beaded tongue-and-groove boards that have survived.
- Remove existing bathroom.
- Install new bathroom in Room 202, avoiding alterations to the ceiling in Room 102.
- Install modern kitchen in Room 102.
- Rebuild wall between Rooms 103 and 104.
- Reconstruct ceiling in Room 202.
- Reconstruct missing walls and ceiling at front (east) end of center hall.
- Repair finishes in Room 201, preserving as much of the historic wallpaper as possible.
- Install modern electrical and plumbing systems.
