Cape Lookout Lighthouse

Historic Structure Report

December 2008

Joseph K. Oppermann - Architect, P.A.

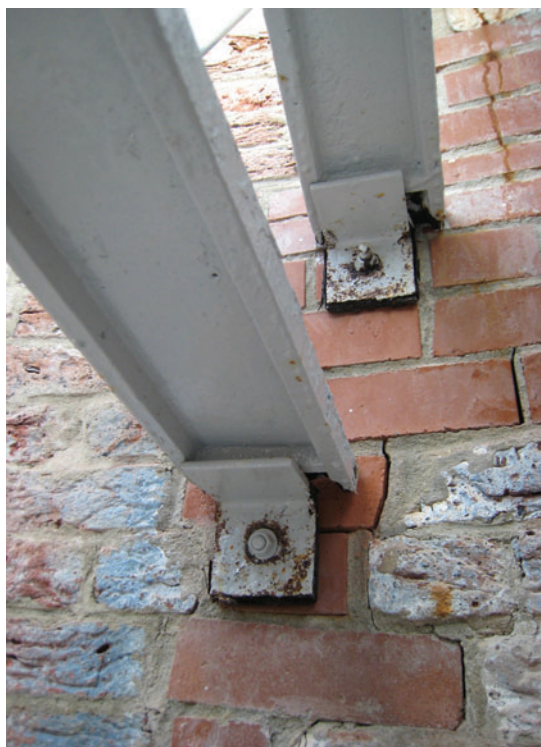
Figure C-8 Modern masonry repairs in Watch Room.

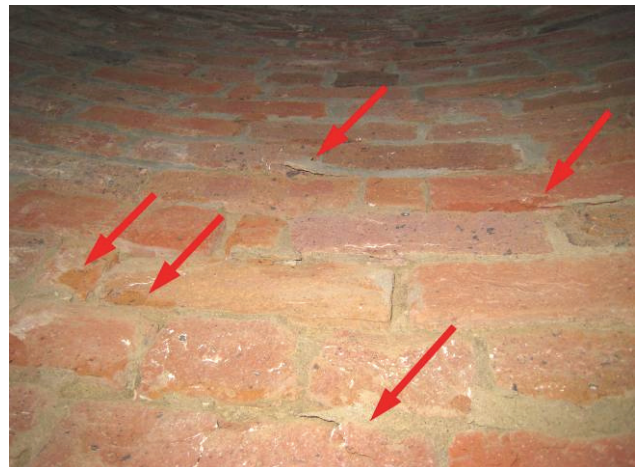
The mortar joints of both the outside and inside walls have a width of about ½" and are struck flush. However, on the core wall interior face, it is clearly evident that portions of the brickwork have been re-pointed with a hard, Portland cement-rich mortar. The re-pointing mortar is also fairly impermeable as evidenced by the re-pointed joints sitting proud, hard and rigid, while the adjoining bricks have spalled well back from the face of the mortar. Similar spalling has not occurred on bricks adjoining the earlier mortar.

Figure C-10 Spalling brick adjoining Portland cement-rich repointing mortar.

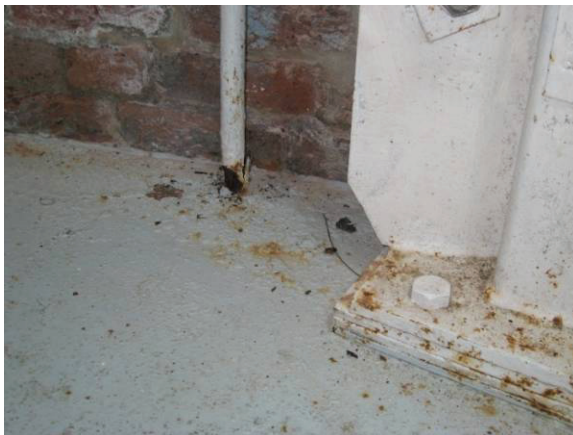
Figure C-22 *Corroded connecting rod at Watch Room floor plate.*

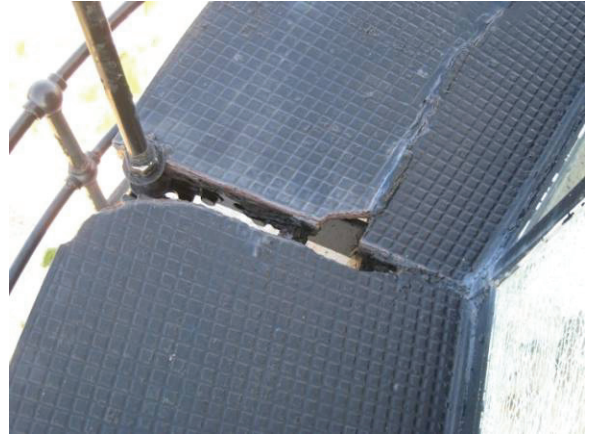
Figure C-23 *Broken floor plates of Lantern Gallery.*

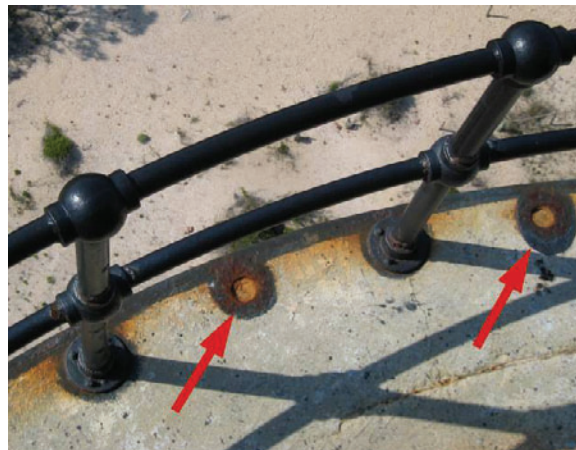
At unknown date(s), the original 1914 railing and air lock were removed. The imprint of the air lock is still visible in the deck's cement. Remnants of the stanchion anchors remain in place (Figure C-25). A salvaged section of the 1914 railing is in the North Carolina Maritime Museum (Figure C-24). The current railing is a replica of the original 1914 railing. It stands 45" tall and is constructed of two 2" round rails and 2½" round stanchions, all of steel.

Figure C-25 Remnants of 1914 stanchion anchors and replacement railings of unknown date.

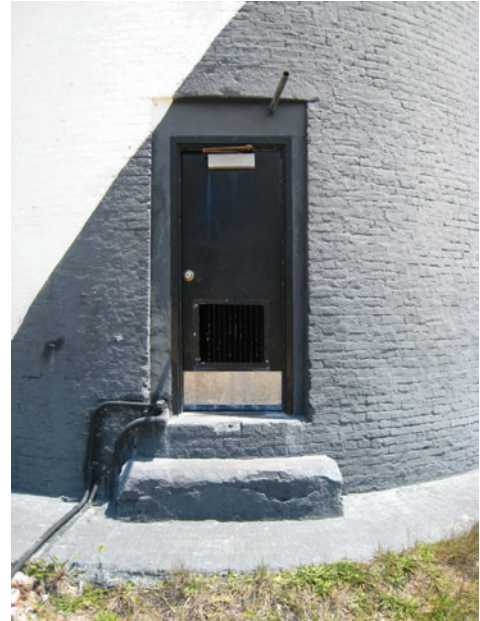
Figure C-28 Original masonry opening for First Floor doorway with modern infill and steel door.

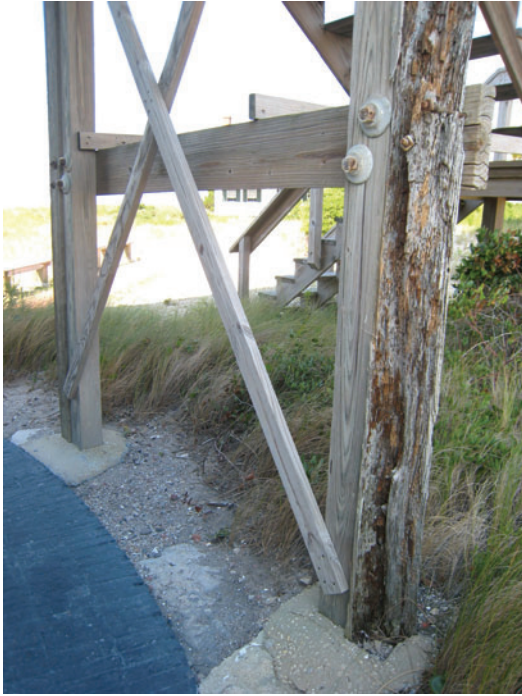
Figure C-34 Two earlier but twentieth-century and severely deteriorated wood posts and one cross beam

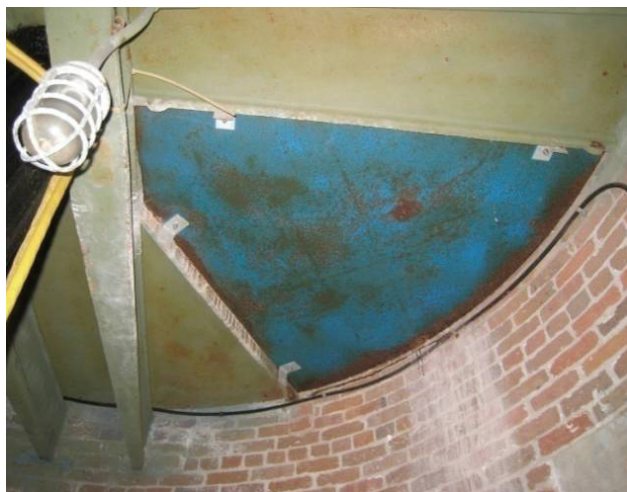
One exception is a single plate among the six at the Second Floor which is clearly a modern replacement. Its design is unlike any other floor plate and it is painted a

Figure C-44 Modern replacement floor plate at Second Floor landing.

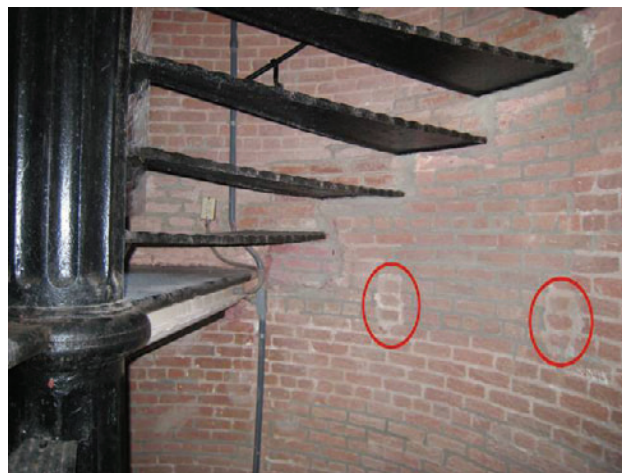
Figure C-68 Two masonry patches presumably associated with the 1864 framing for temporary stairs.

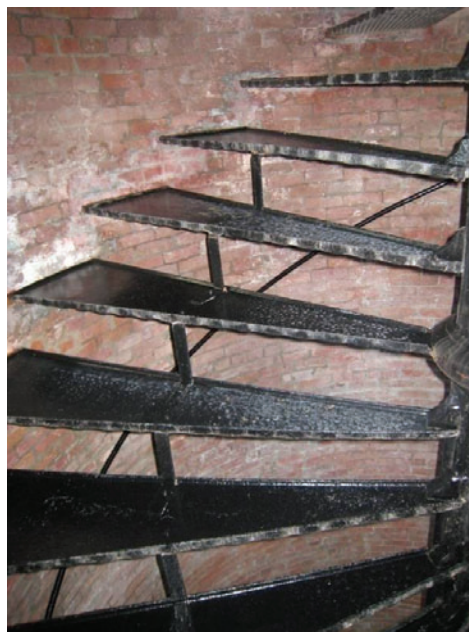
Figure C-74 Metal strap reinforcement of unknown installation date.

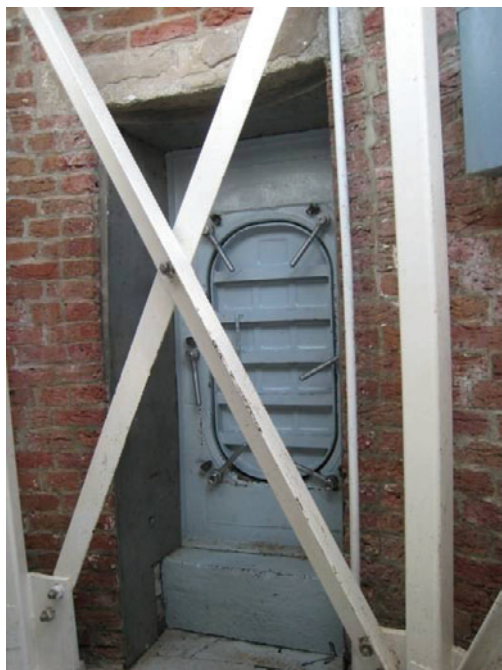
Figure C-87 Reinforcing steel added in 1989 partially blocks ship's hatch to Observation Deck.

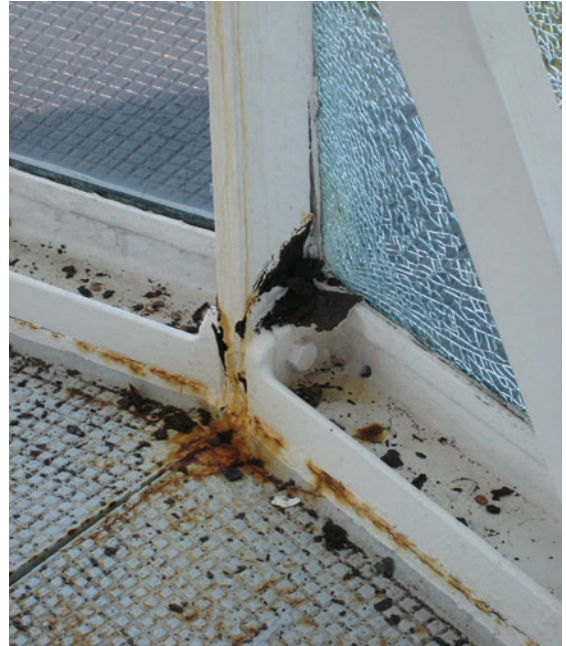
Figure C-98 Deteriorated iron framing.

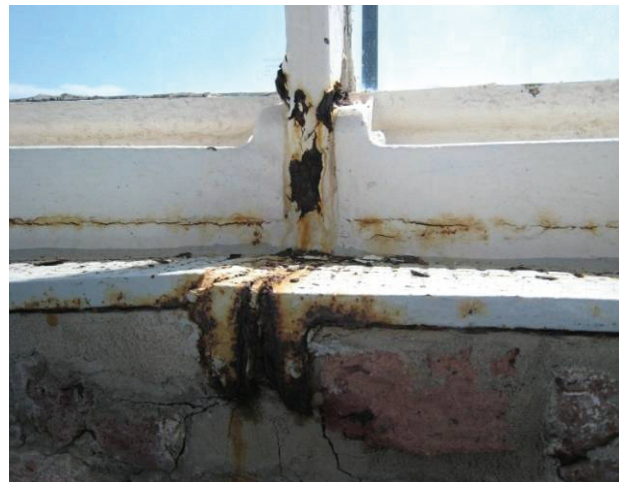
Figure C-104 Extensive corrosion of cast-iron framing.

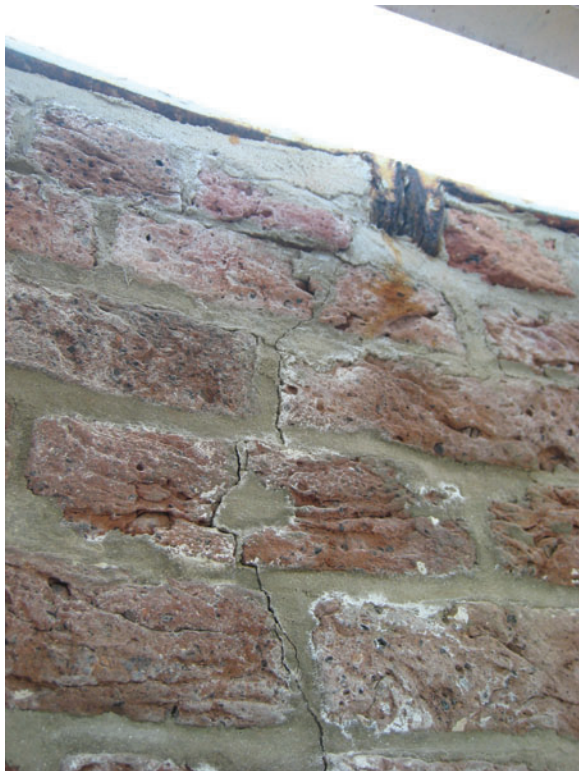
The 1989 addition of steel reinforcement both inside and outside the top of the tower was a significant change in character, however. One that stabilized but did not correct a long-developing weakness. The investigations identified the deteriorating iron tension ring imbedded at the top of the masonry and associated ironwork of the lantern as the unalleviated sources of the masonry jacking.

Figure C-105 *Through-wall cracks in masonry at top of Tower.*

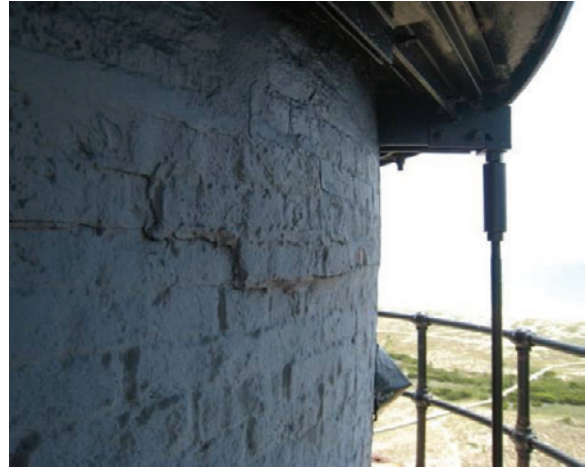
Figure C-107 Displaced masonry and supplemental tie rods.

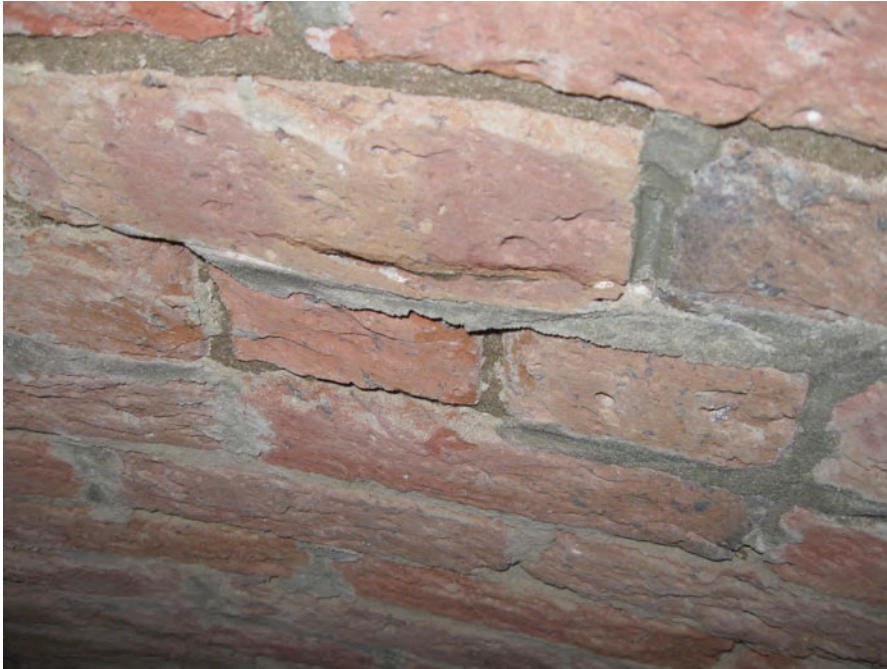
Figure 20. Cape Lookout Lighthouse, September 2008. An area where inappropriate Portland cement based re-pointing mortar has caused the original brick to spall and the original mortar to deteriorate. Photograph by author.
