Cape Lookout National Seashore

Portsmouth Life- Saving Station

# Historic Structure Report

2006

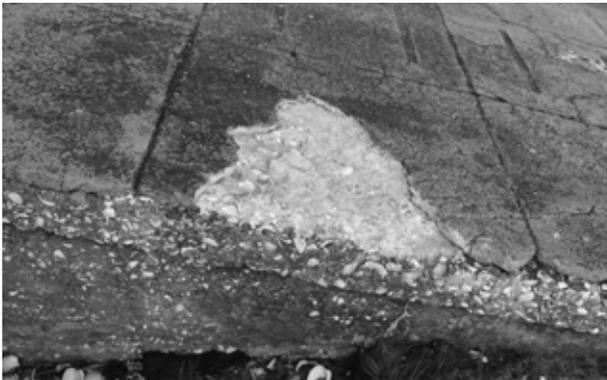
FIGURE 56. View of deterioration on ramp to small boat-room door. (T. Jones, NPS, 2005)

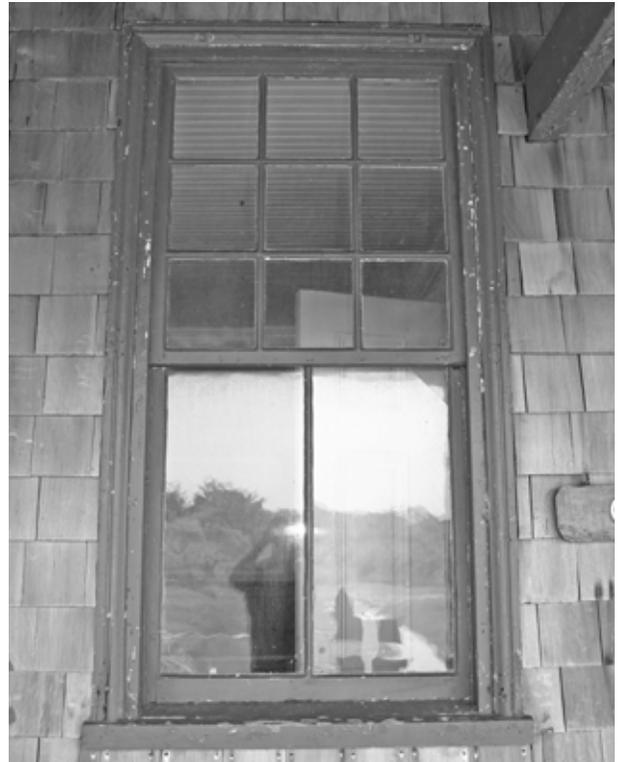
*Condition:* Some of the sash may have been replaced, and most are in good condition, although many of the counterweight ropes are broken and there are several panes of broken glass. The sash in the attic window, which are almost certainly original, are badly weathered, primarily because the interior side of the sash has not been maintained. At the northeast end of the boat room (Room 107), recent storms badly damaged both windows (w- 6 &

FIGURE 76. View of W-2, a typical nine-over-two window. (T. Jones, NPS, 2005)

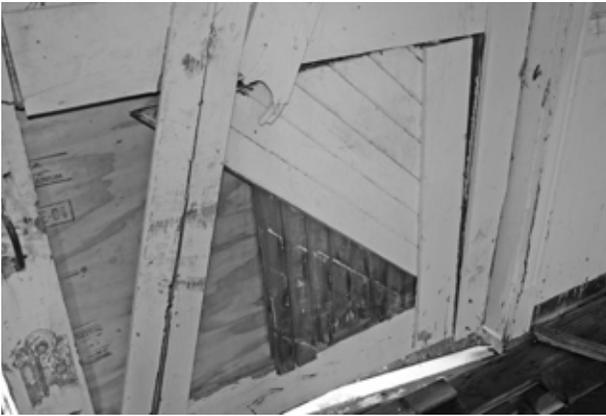
FIGURE 84. View of damage to lower panel of leaf of Boat Room door D-5. (T. Jones, NPS, 2005)

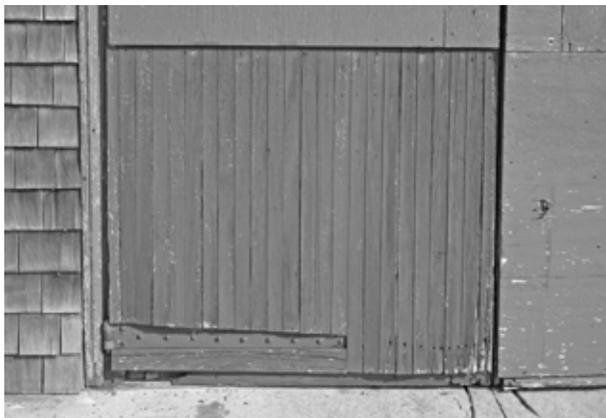
FIGURE 85. View of one leaf of double doors at D-3, showing typical original hinge and added layers of tongue-and-groove material and plywood. (T. Jones, NPS, 2005)

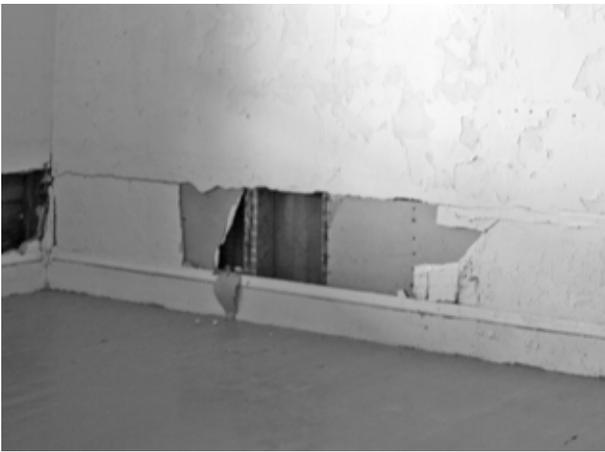
FIGURE 89. View of water-damaged plaster on rock lath in Room 106. (T. Jones, NPS, 2005)

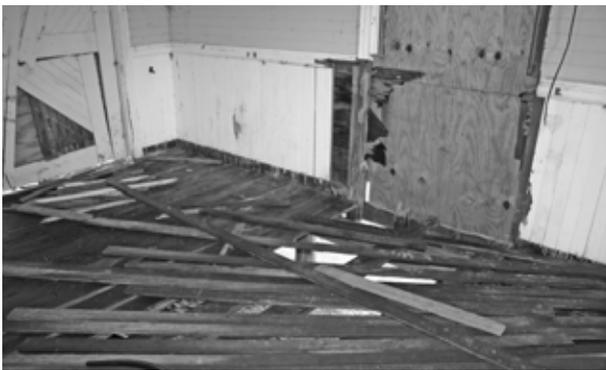
FIGURE 121. View of flooring damaged by storm surge in 1993. (T. Jones, NPS, 2005)

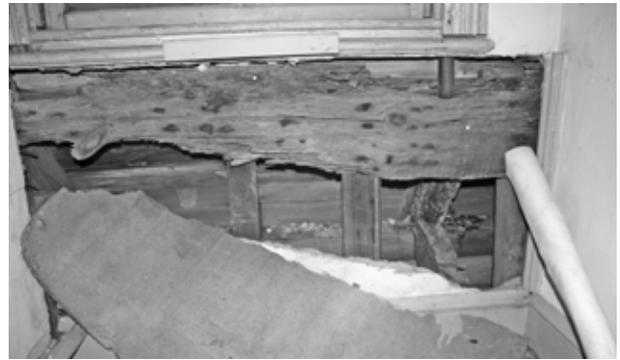
FIGURE 142. View damaged wall below window in Room 202. (T. Jones, NPS, 2005)
